Inspection Photos

API: 05-017-07717

Operator: VECTA OIL & GAS

Inspection Date: 1/14/2020

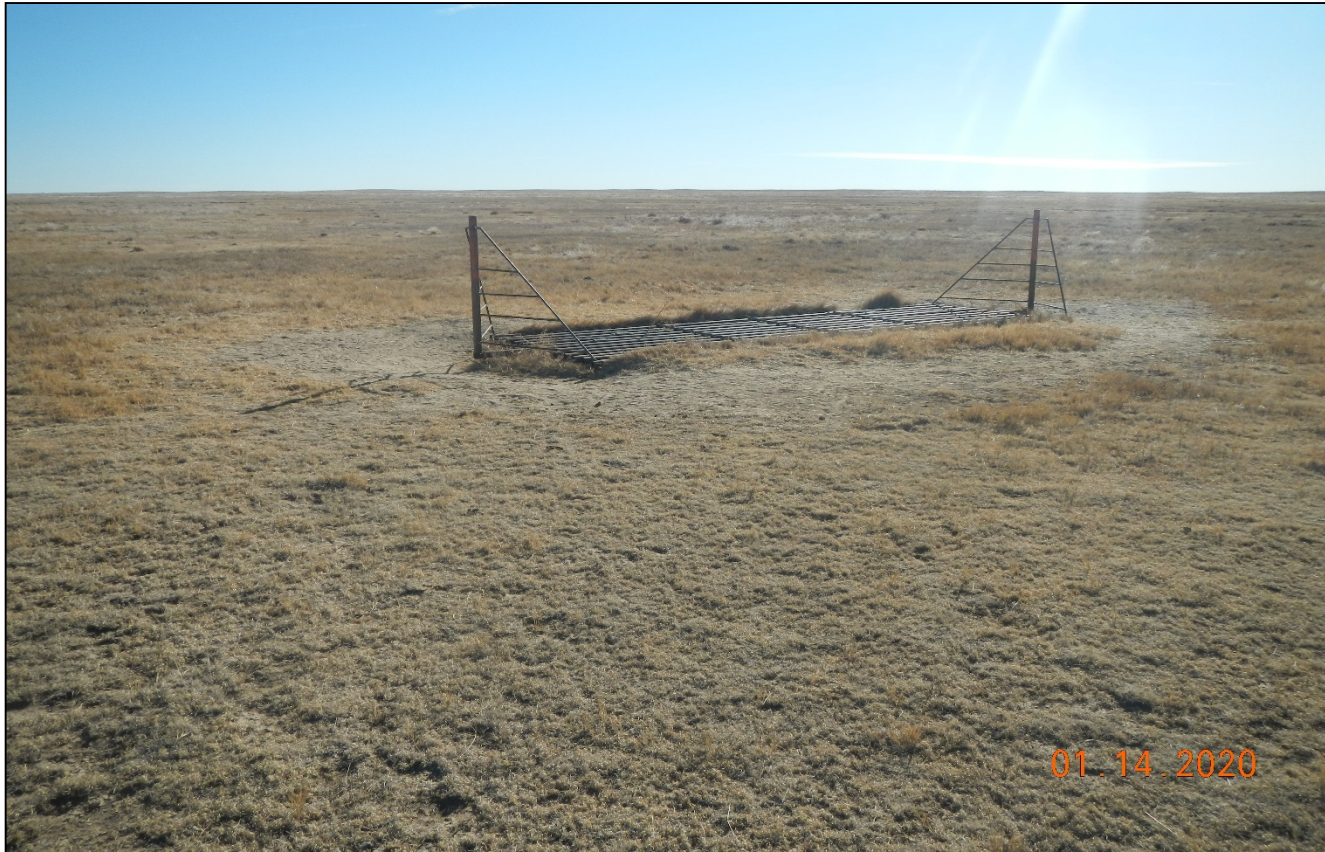
Photo 1. Facing south toward the location. There is a cattle guard that remains at the location which needs to be removed.

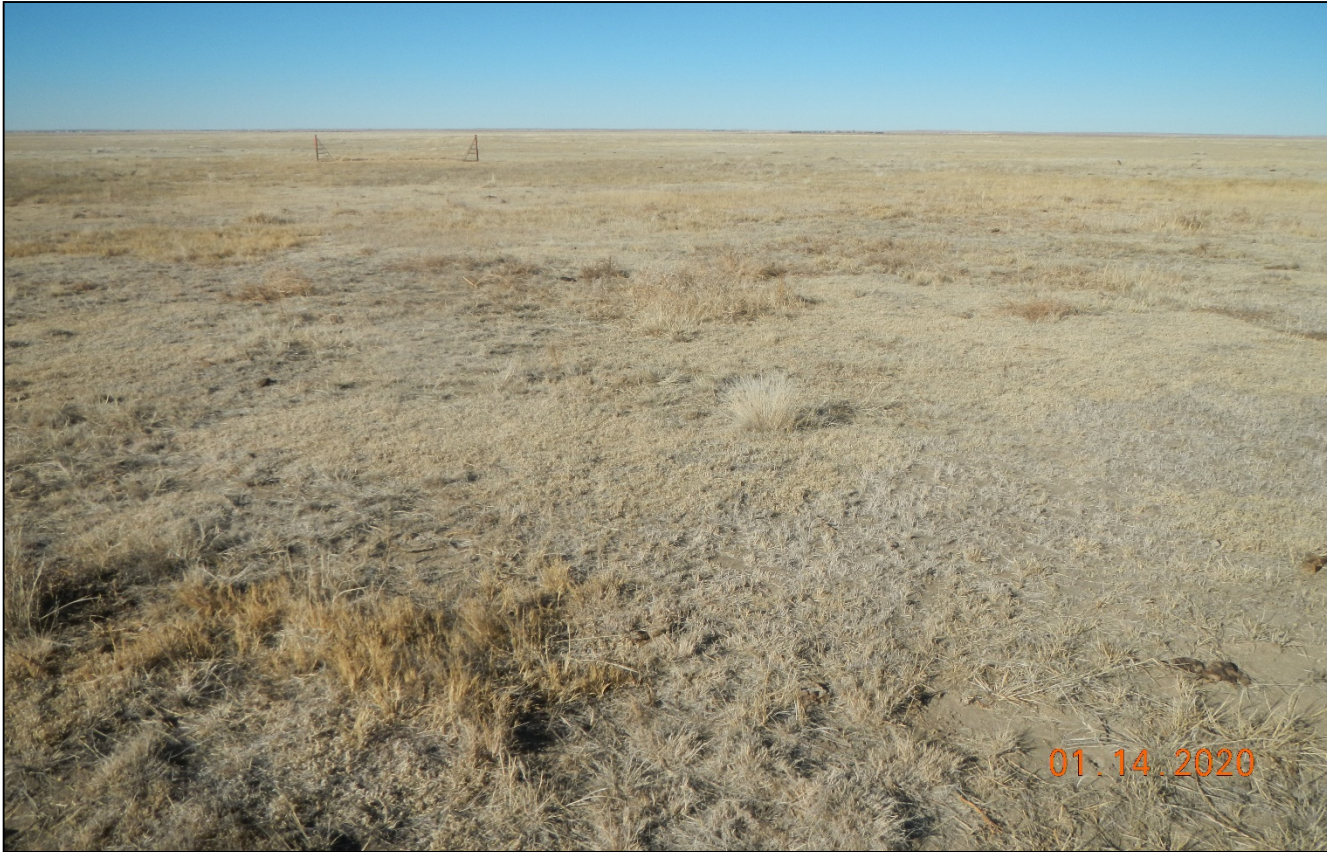
Photo 2. Center of the location facing north. Native vegetation appears to be fully established.

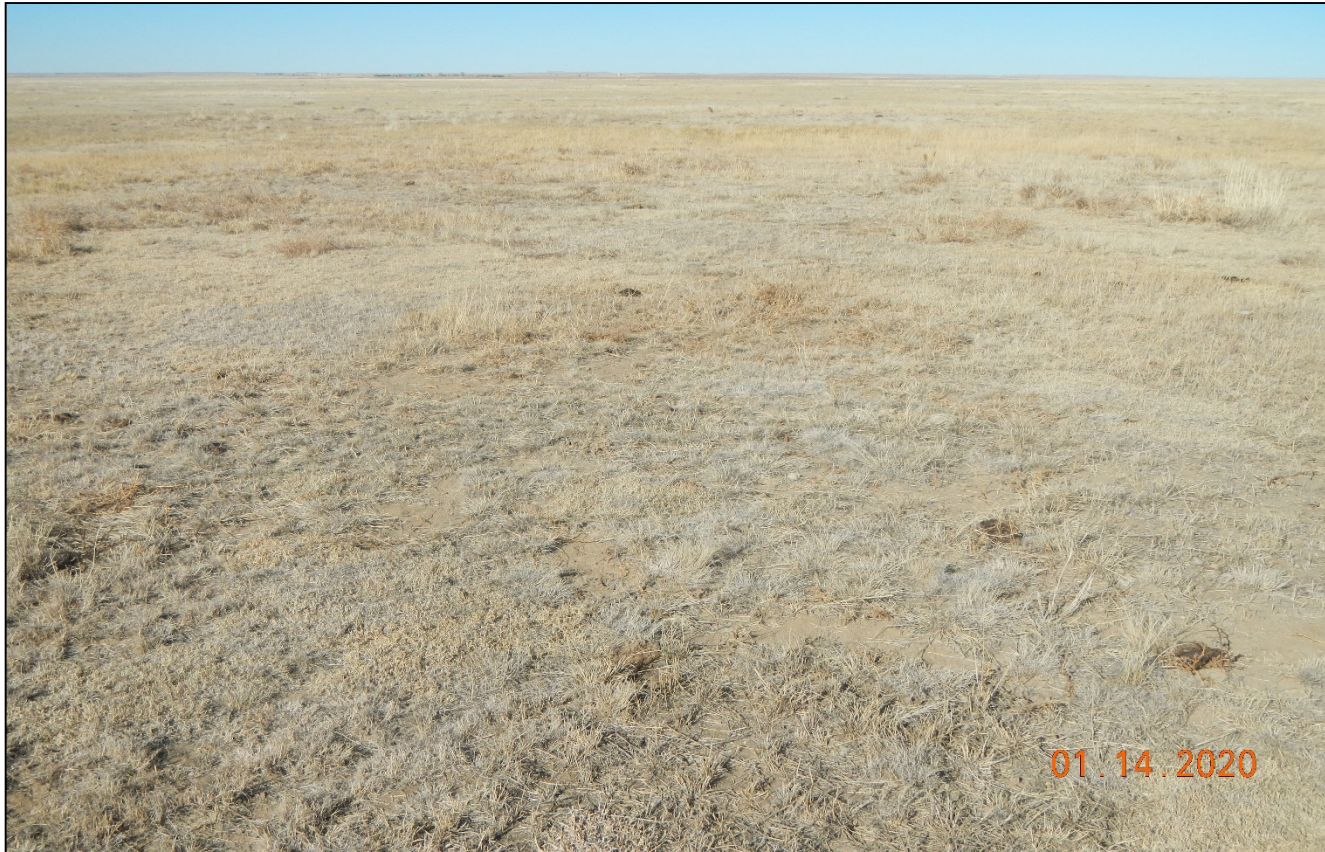
Photo 3. Center of the location facing west. Native vegetation appears to be fully established.

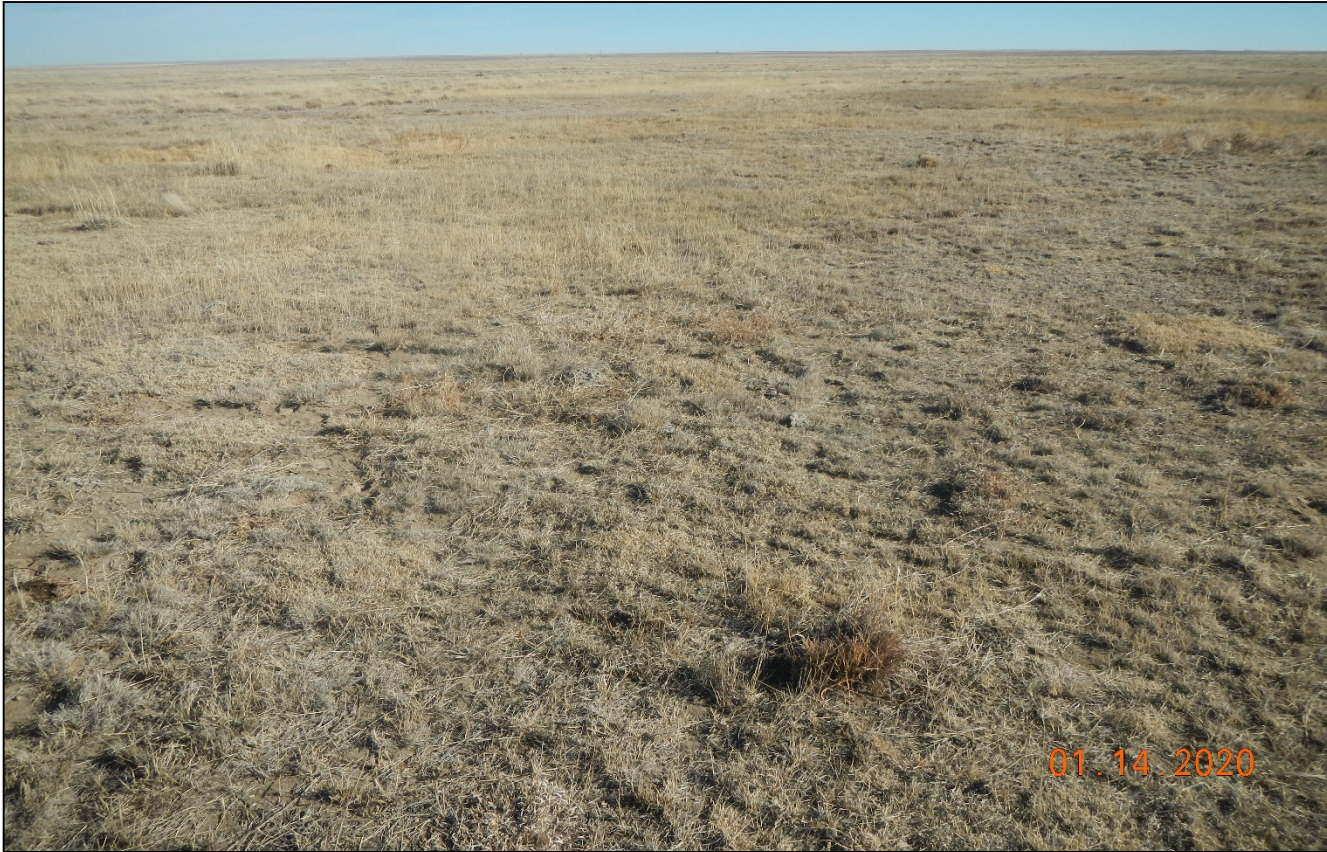
Photo 4. Center of the location facing east. Native vegetation appears to be fully established.

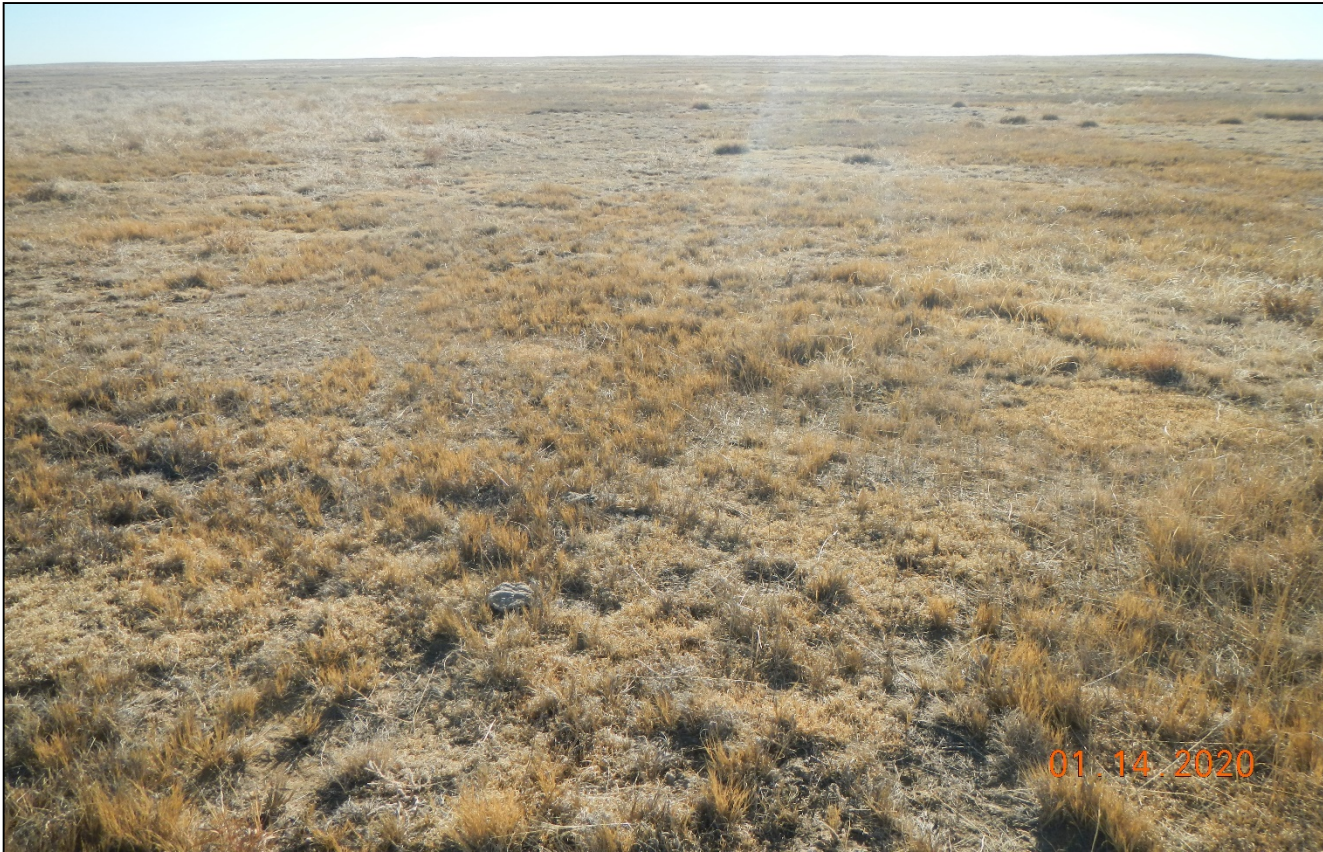
Photo 5. Center of the location facing south. Native vegetation appears to be fully established.

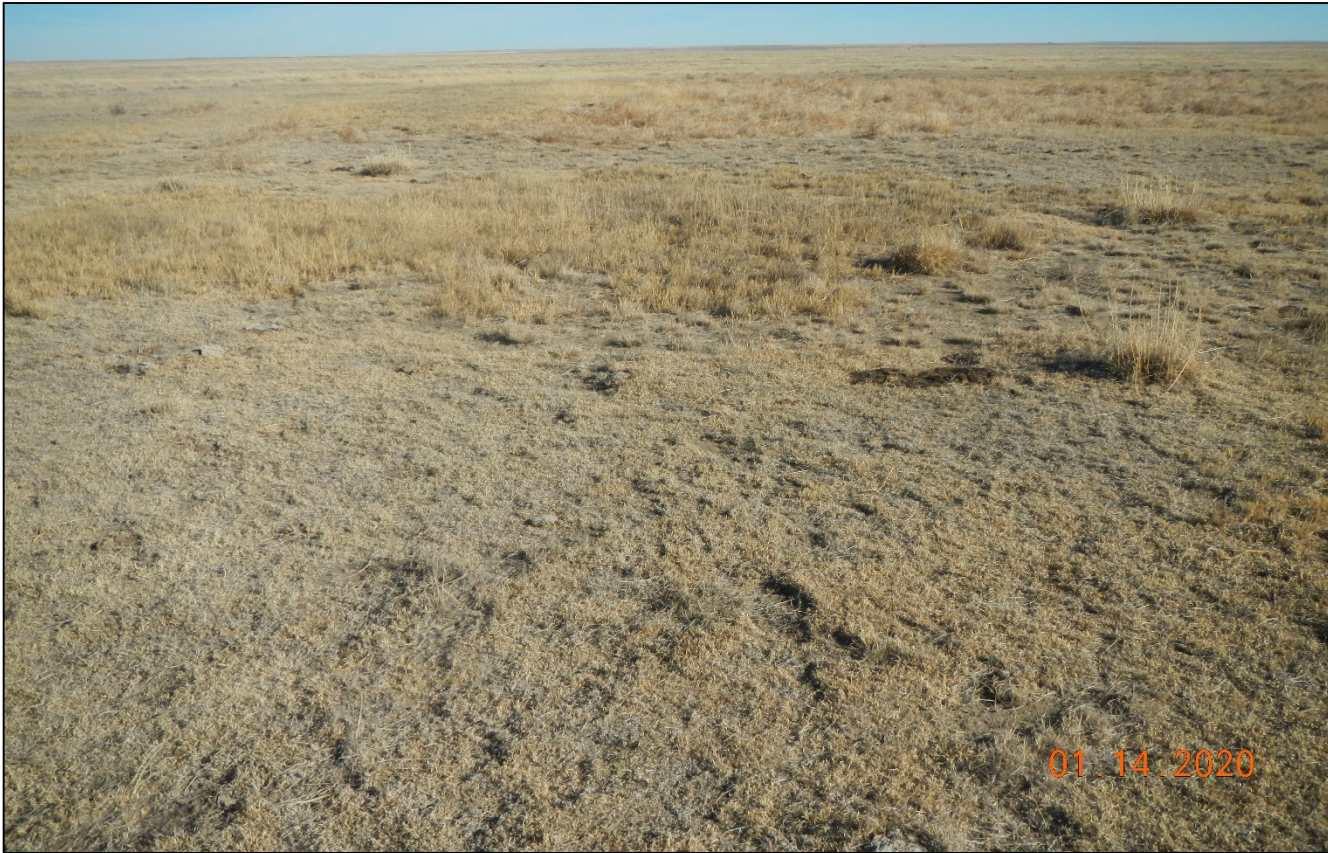
Photo 6. Facing east toward the undisturbed pasture.
