# Inspection Photos

API: 05-017-07715

Operator: VECTA OIL & GAS

Inspection Date: 1/14/2020

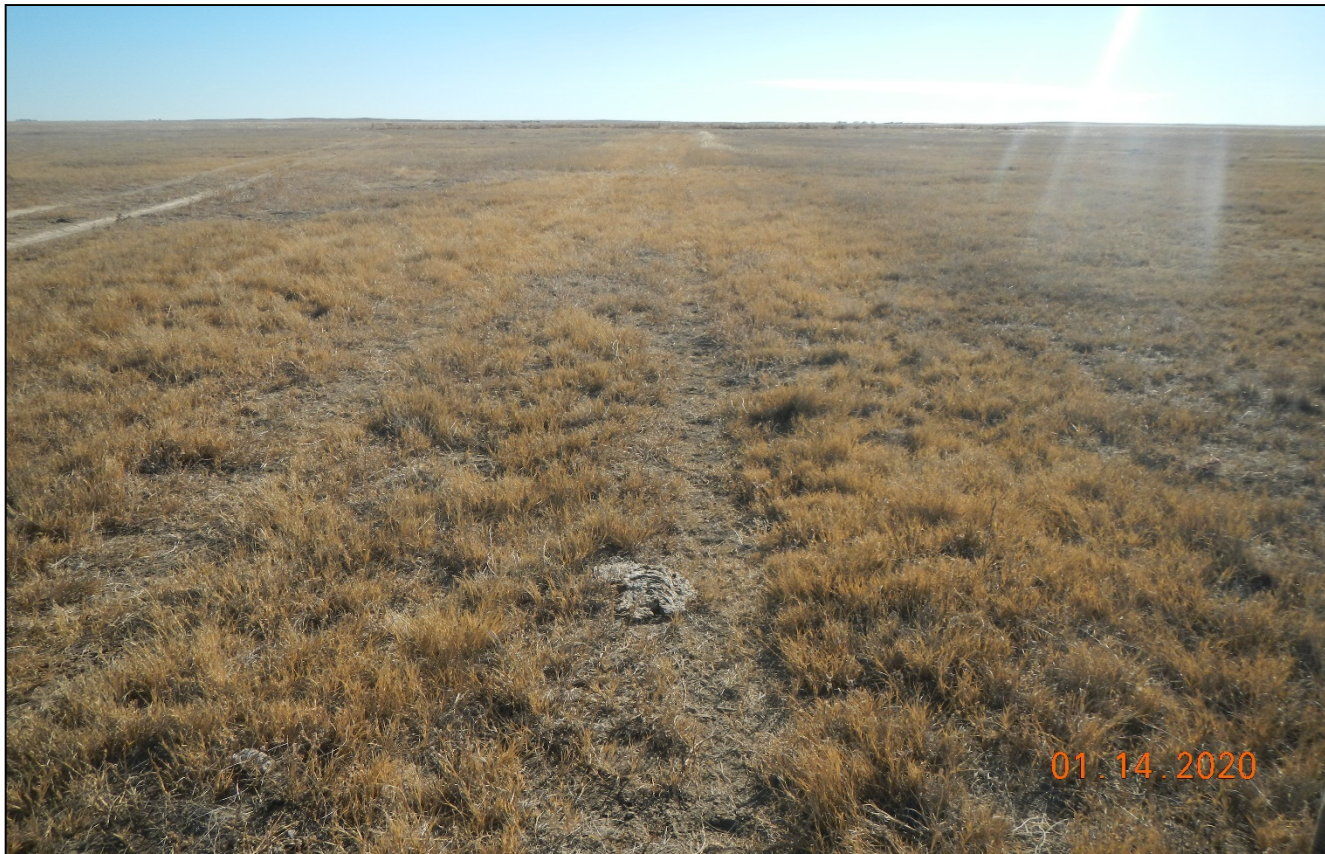
**Photo 1.** Facing south along the former access road.

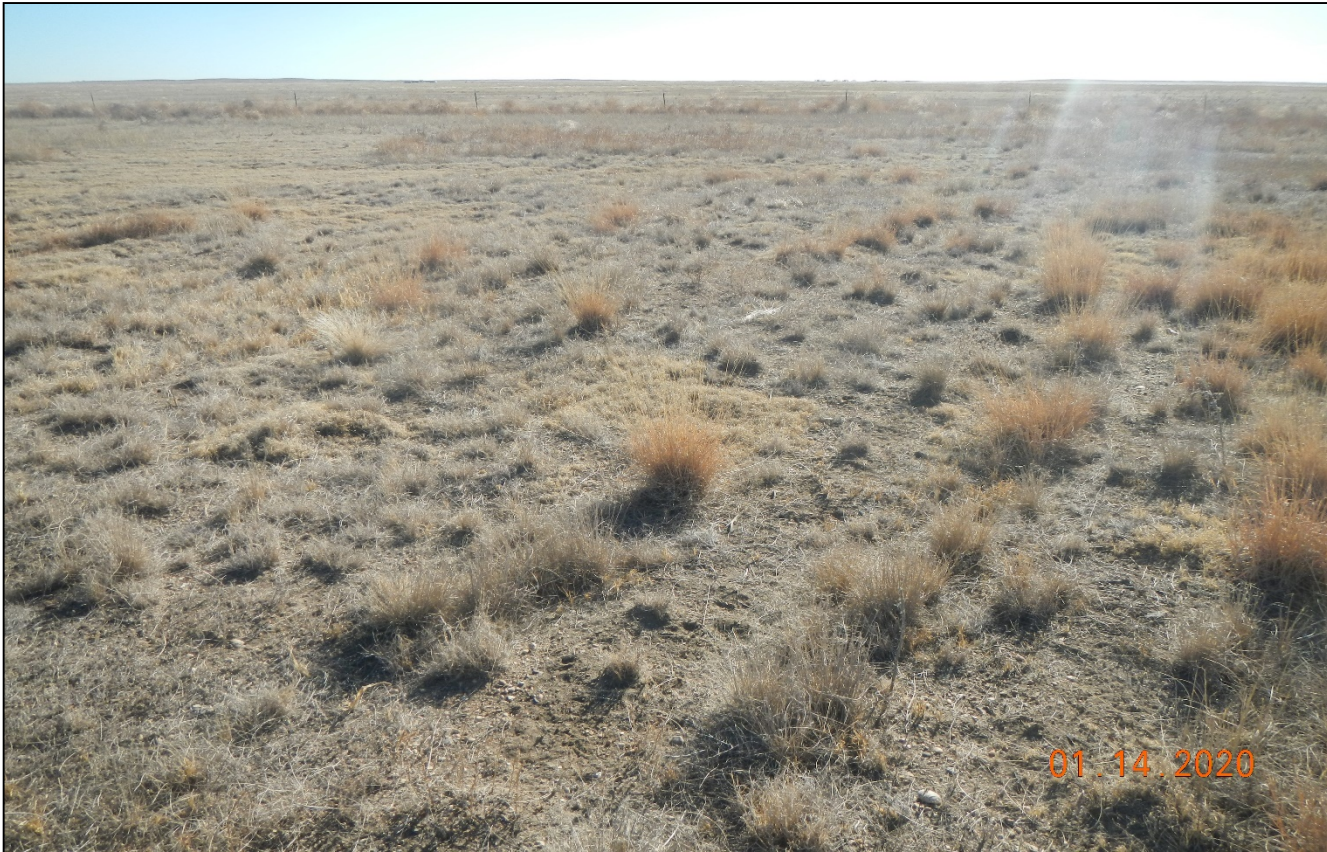
**Photo 2.** Center of the location facing south. Native vegetation is well established in the southern portion of the location.

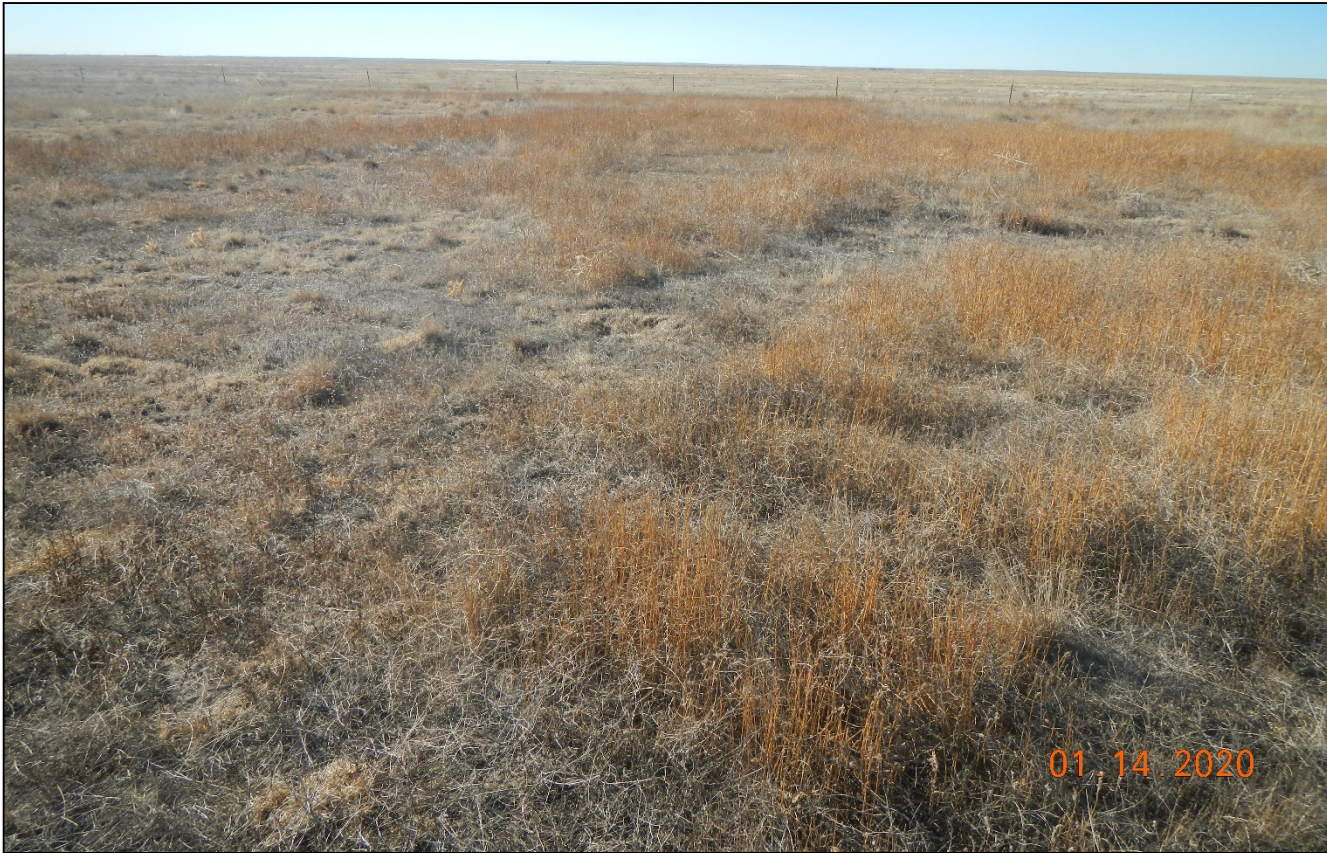
**Photo 3.** Center of the location facing west. There is undesirable weeds towards the western portion of the location.

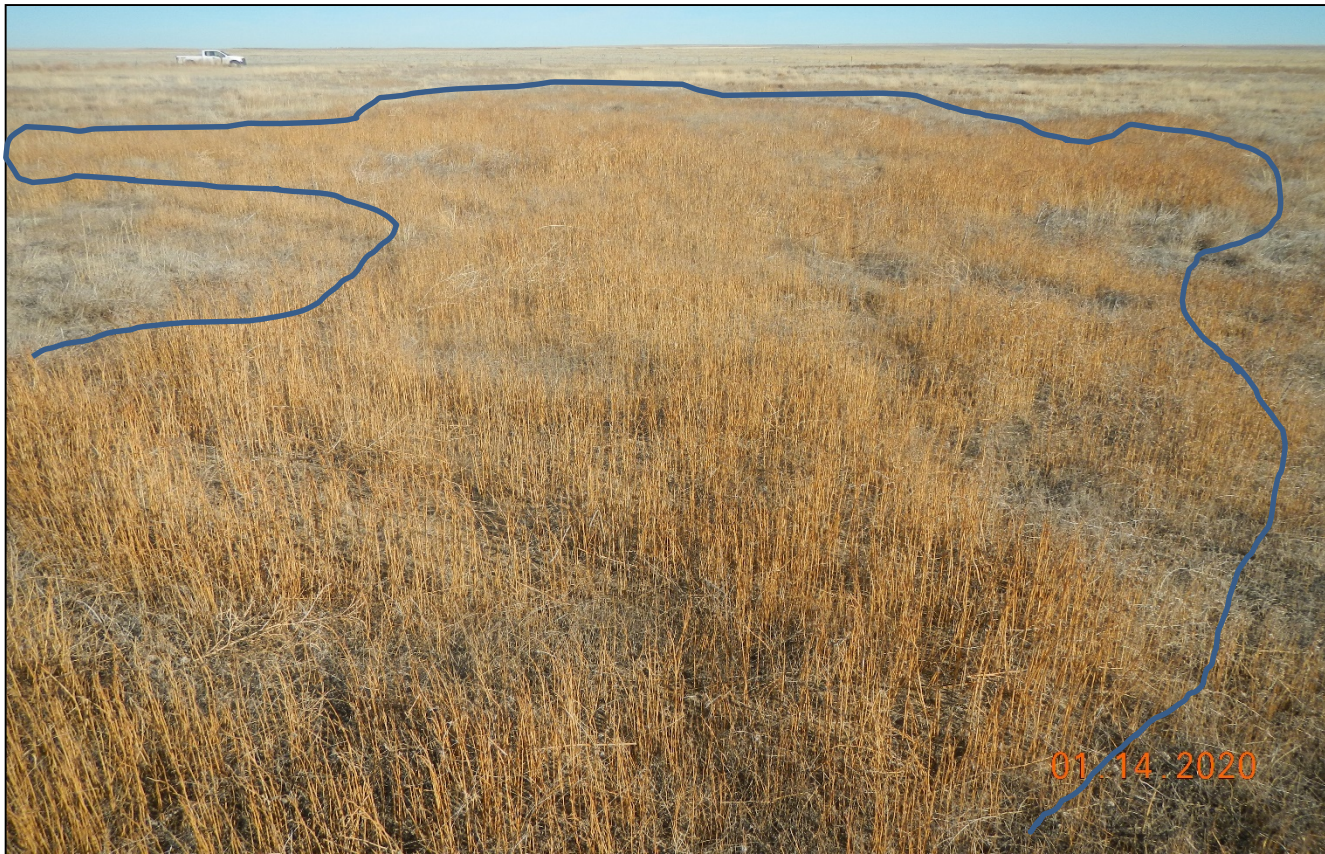
**Photo 4.** Facing west at the center of the location. The area highlighted is predominately undesirable weeds (Kochia).

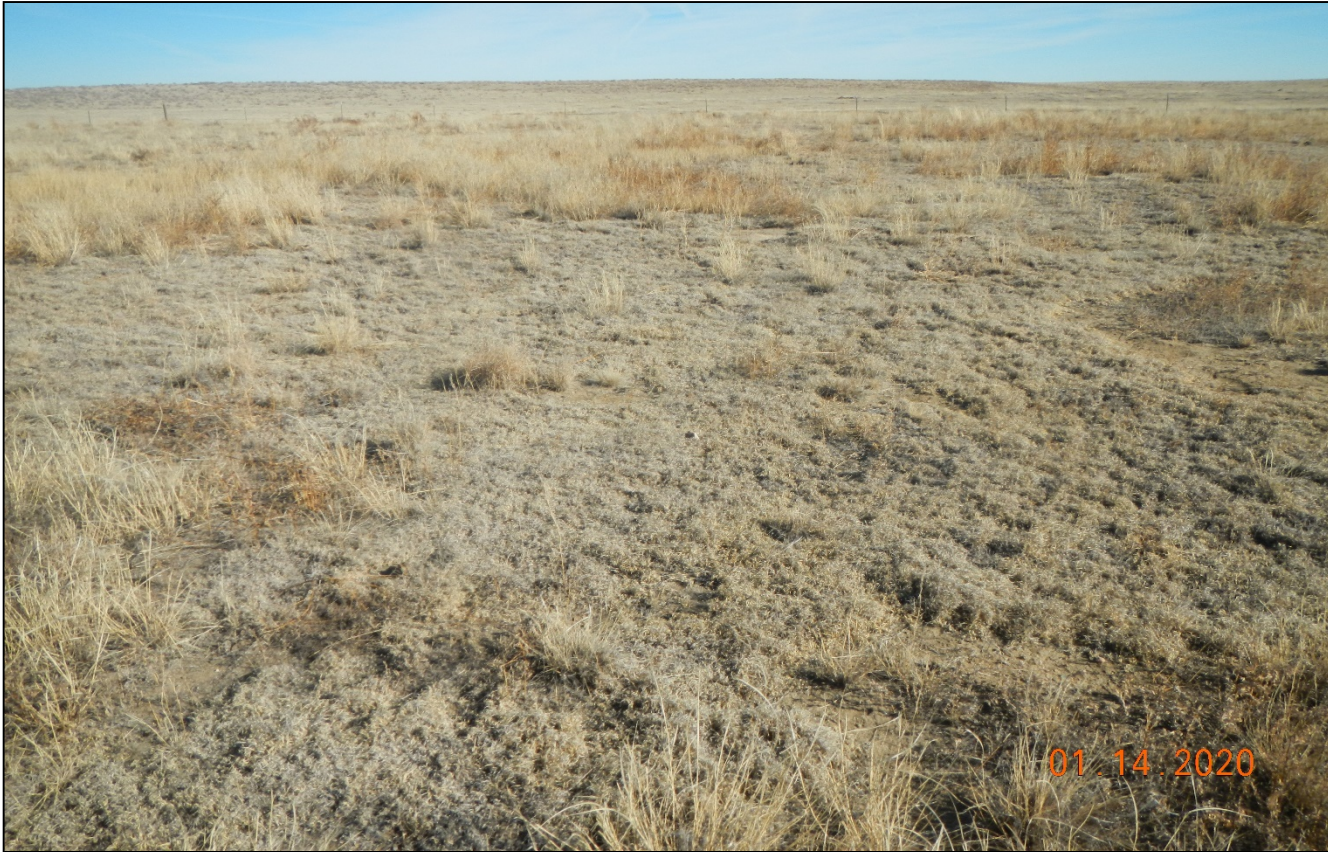
**Photo 5.** Center of the location facing east. Native vegetation is established well at the east portion of the location.
