Inspection Photos

Location Name: Pointer 43-25 followup ca date 2-17-20

API#: 05-071-09766

INSP. #: 695102060

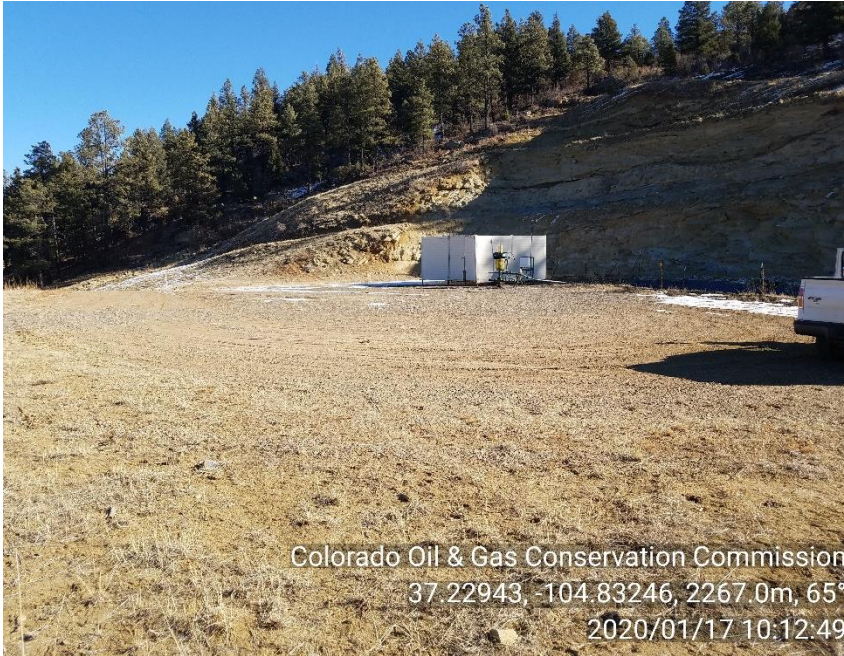
PHOTO 1: LOCATION

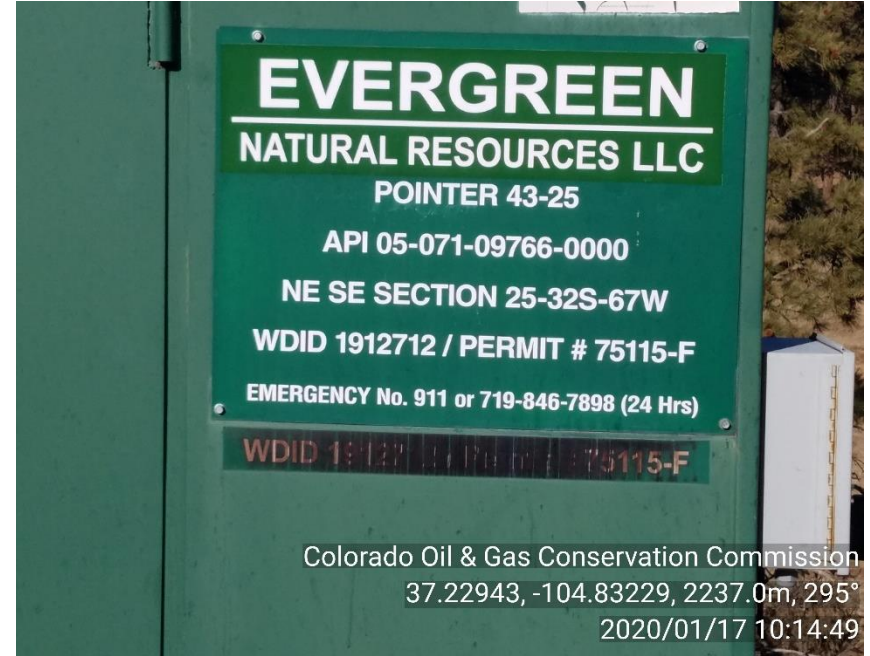
PHOTO 2: WELL SIGN

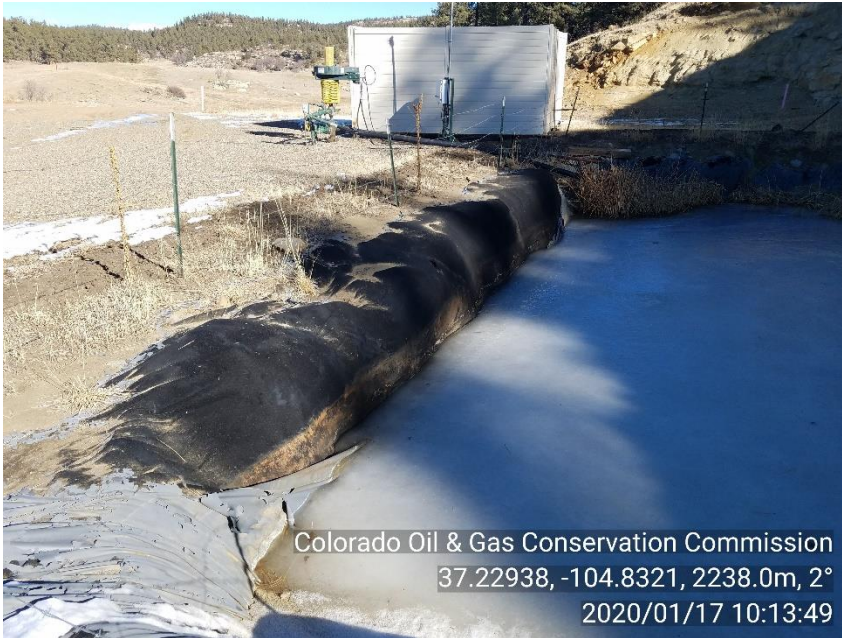
PHOTO 3: PIT LINER IS DETERIORATING THERE ARE SEVERAL PLACES WHERE LINER IS CRACKED AND TORN THIS IS THE SECOND NOTICE OF PIT LINER NOT MAINTAINED, IF CA IS NOT ADDRESSED BY THE NEXT INSPECTION ENFORCEMENT MAY BE CONSIDERED. MAINTAIN LINER IN ACCORDANCE WITH RULE 904. CA DATE 2-17-20

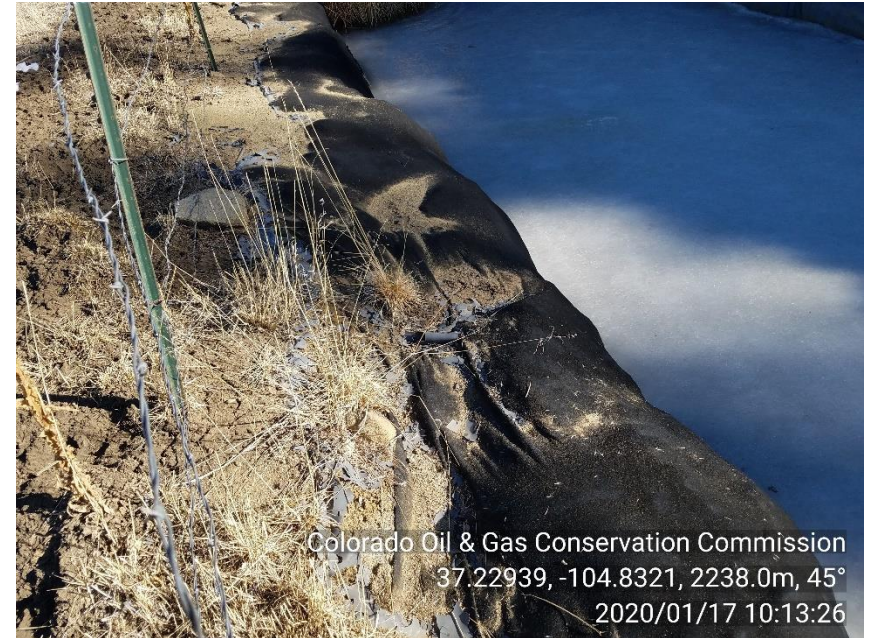
PHOTO 4: ANOTHER IMAGE OF PIT LINER DETERORATION.

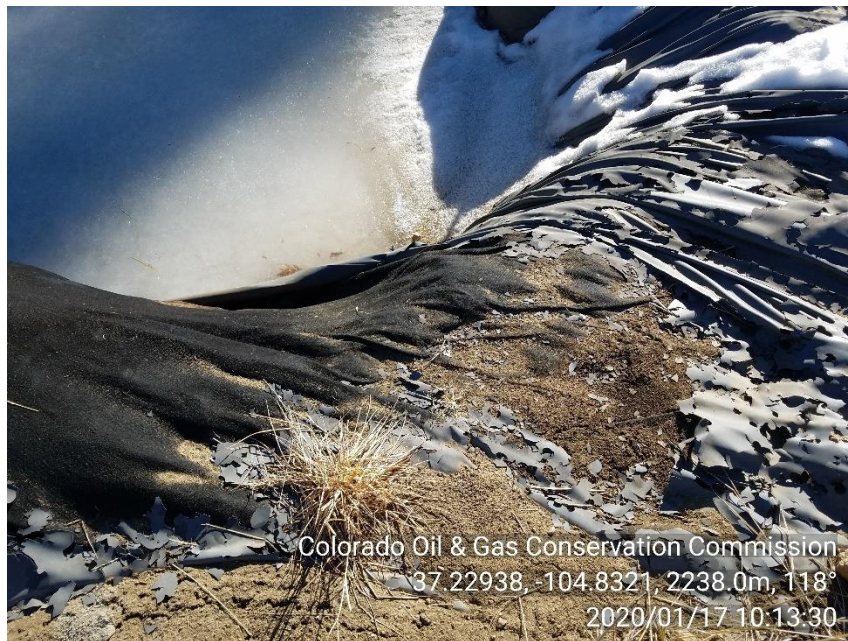
PHOTO 5: ANOTHER IMAGE OF PIT LINER DETERORATION.

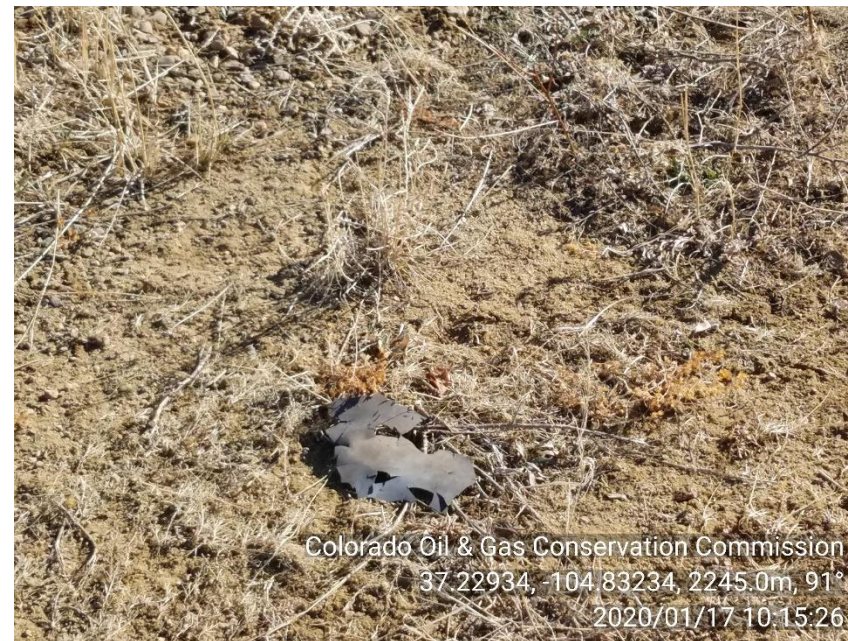
PHOTO 6: PEACES OF PIT LINER APP. 60' TO THE NORTHWEST OF PIT (THERE ARE PIECES OF LINER IN SEVERAL PLACES ON LOCATION AND AROUND LOCATION OFF PAD). **POLICE LOCATION AND SURROUNDING AREA FOR PIECES OF PIT LINER AND DISPOSE IN ACCORDANCE WITH GOOD HOUSEKEEPING RULE 603.f. CA DATE 2-17-20**
