Inspection Photos
Location Name: CORTINA 23-25
API#: 05-071-08340
INSP. #: 695102063

COLORADO
Oil & Gas Conservation
Commission
Department of Natural Resources

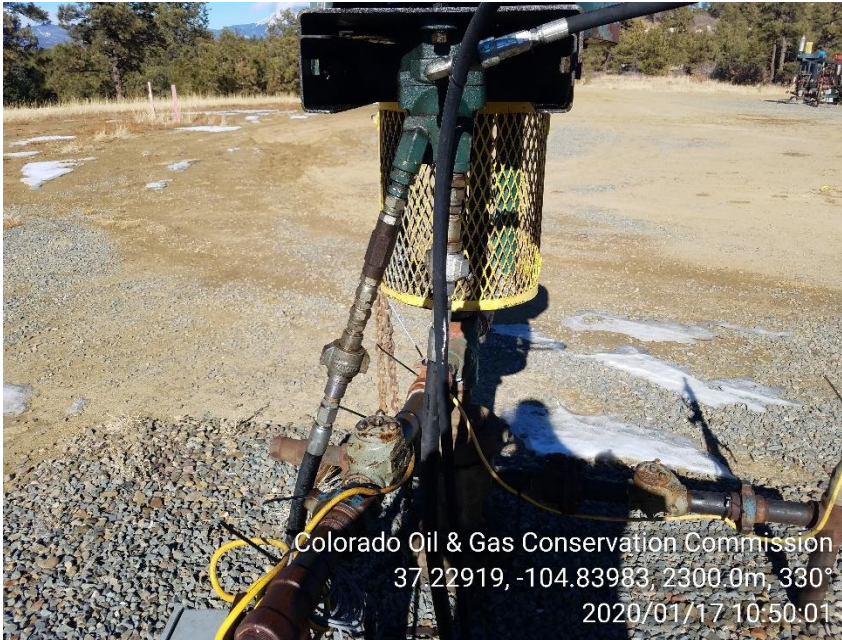
PHOTO 3: IT APPEARS THAT THE DRIVEHEAD HYDRAULIC MOTOR IS LEAKING FLUID. Securely fasten all valves, pipes, and fittings to ensure good mechanical condition, inspect at regular intervals and maintain in good mechanical condition per Rule 605.d. CA DATE 2-1-20

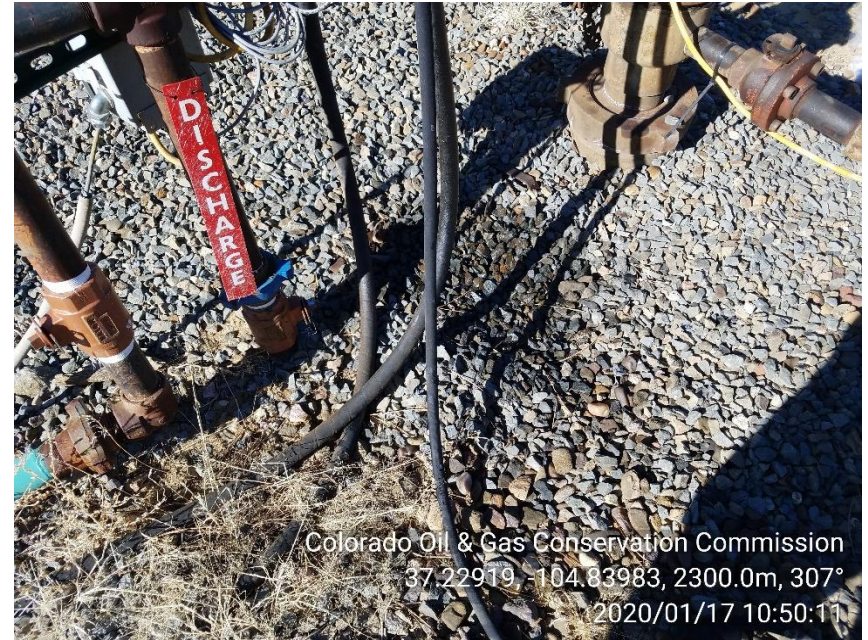
PHOTO 4: AREA OF IMPACTED SOIL UNDER DRIVEHEAD MOTOR APPEARS TO BE FROM LEAKING HYDRAULIC MOTOR. Conduct maintenance on equipment, cleanup stained material and review self inspection processes. CA DATE 1-22-20.

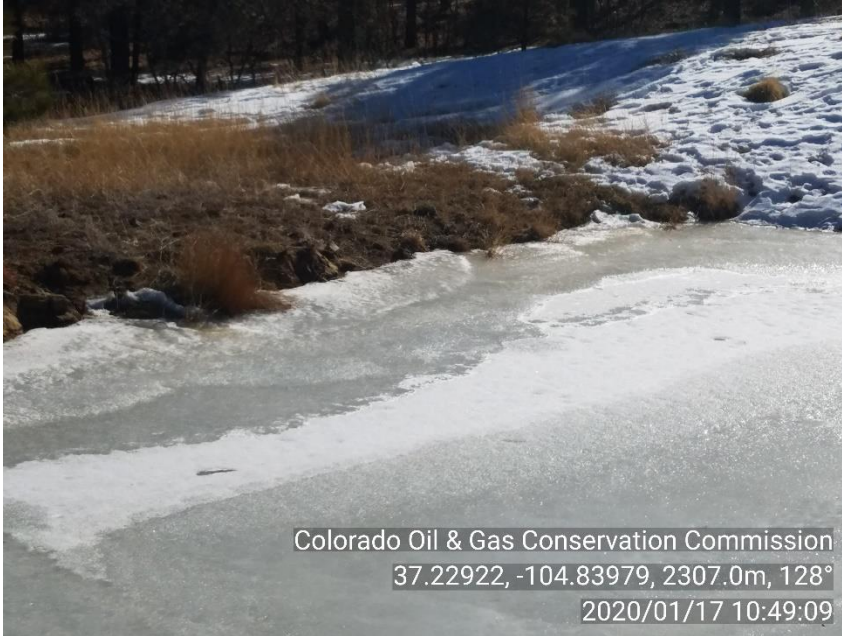
PHOTO 5: PRODUCED WATER IN EARTH PIT IS ABOVE 2' FREEBOARD (SPOKE WITH ED ROMERO BY PHONE TO HAVE FLUID LEVEL REDUCED). REDUCE FLUID IN PIT TO MAINTAIN AT LEAST 2' OF FREEBOARD IN PIT PER RULE 902.b. CA DATE 1-18-20
