Inspection Photos

API: 05-121-11025

Operator: DAVIS, LLC* EDWARD MIKE

Inspection Date: 1/15/2020

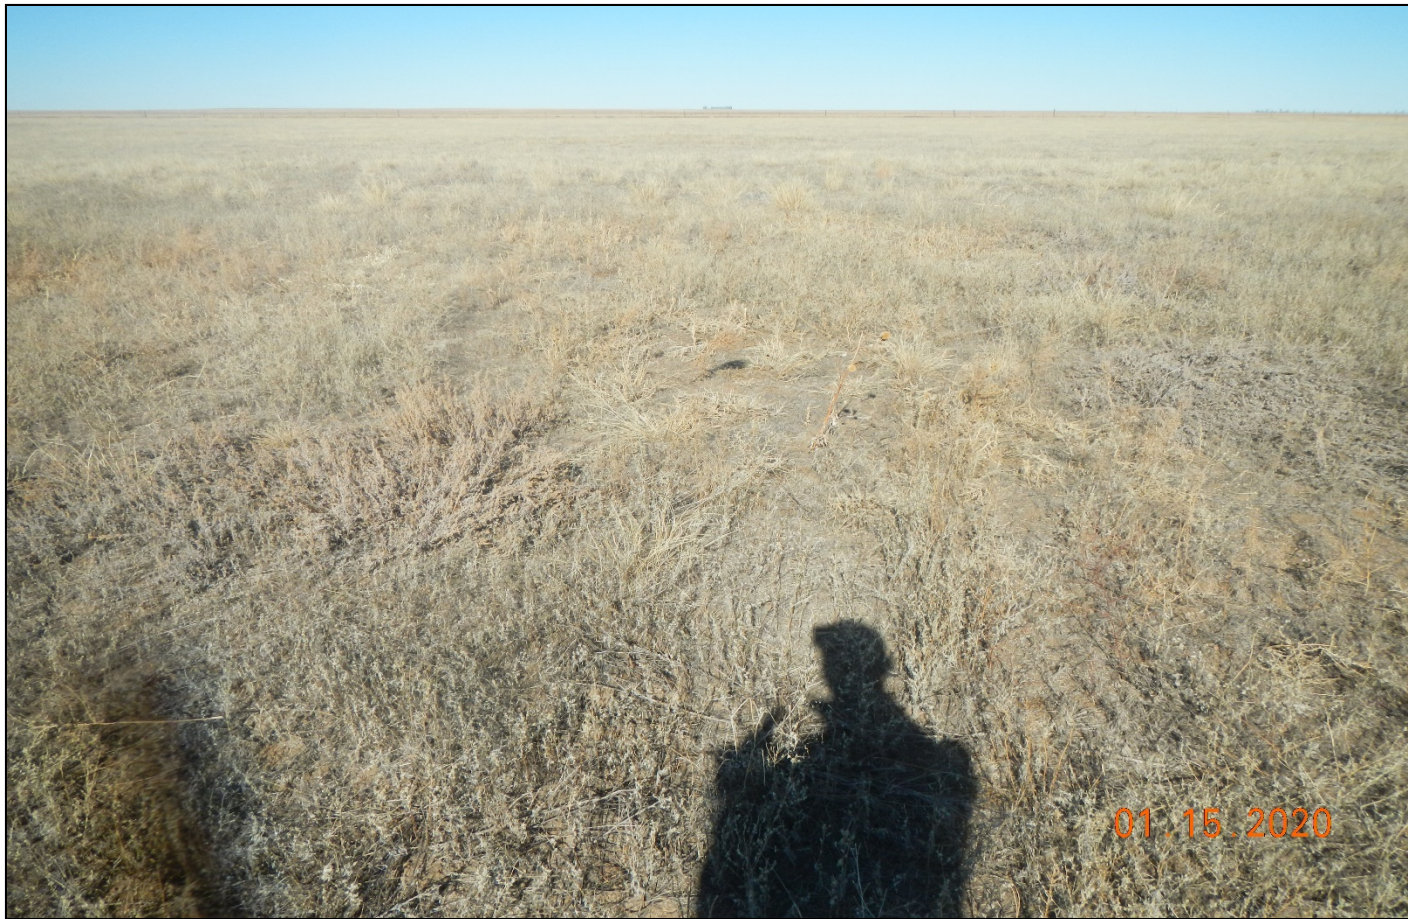
Photo 3. Center of the location facing north.

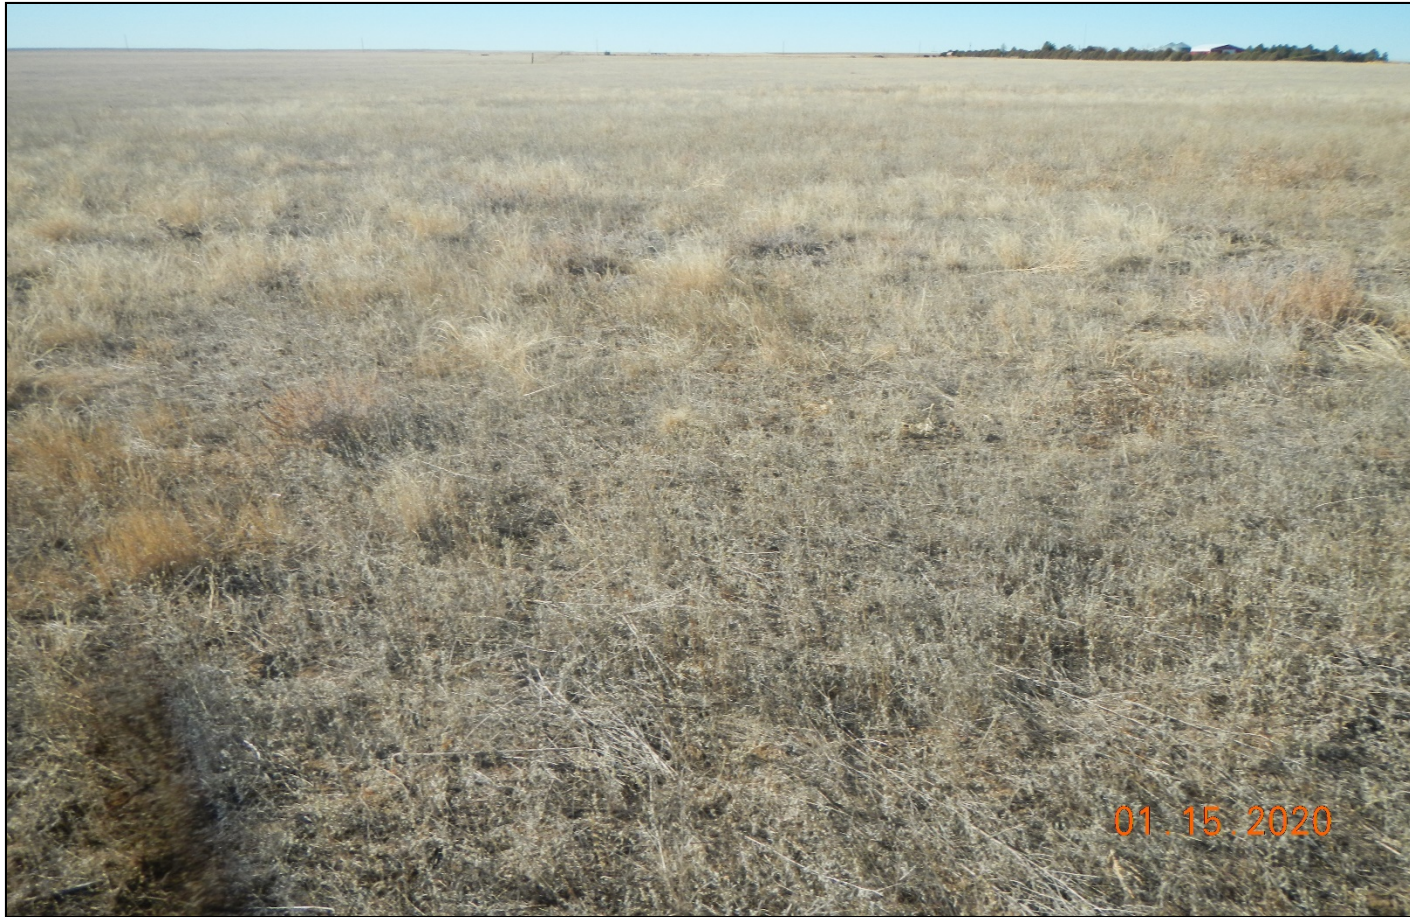
Photo 2. Center of the location facing west.

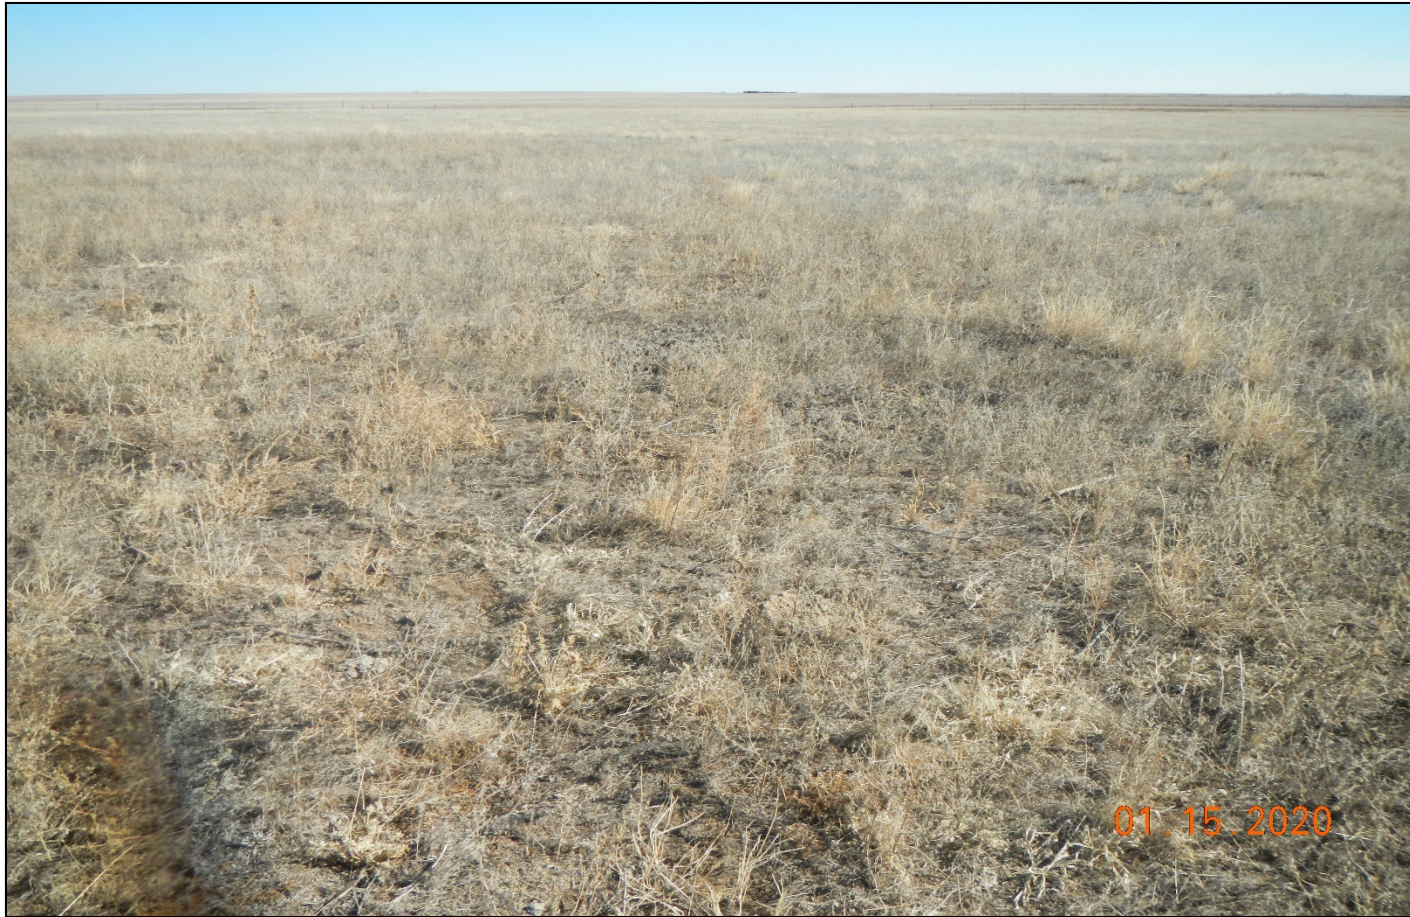
Photo 4. Center of the location facing east.

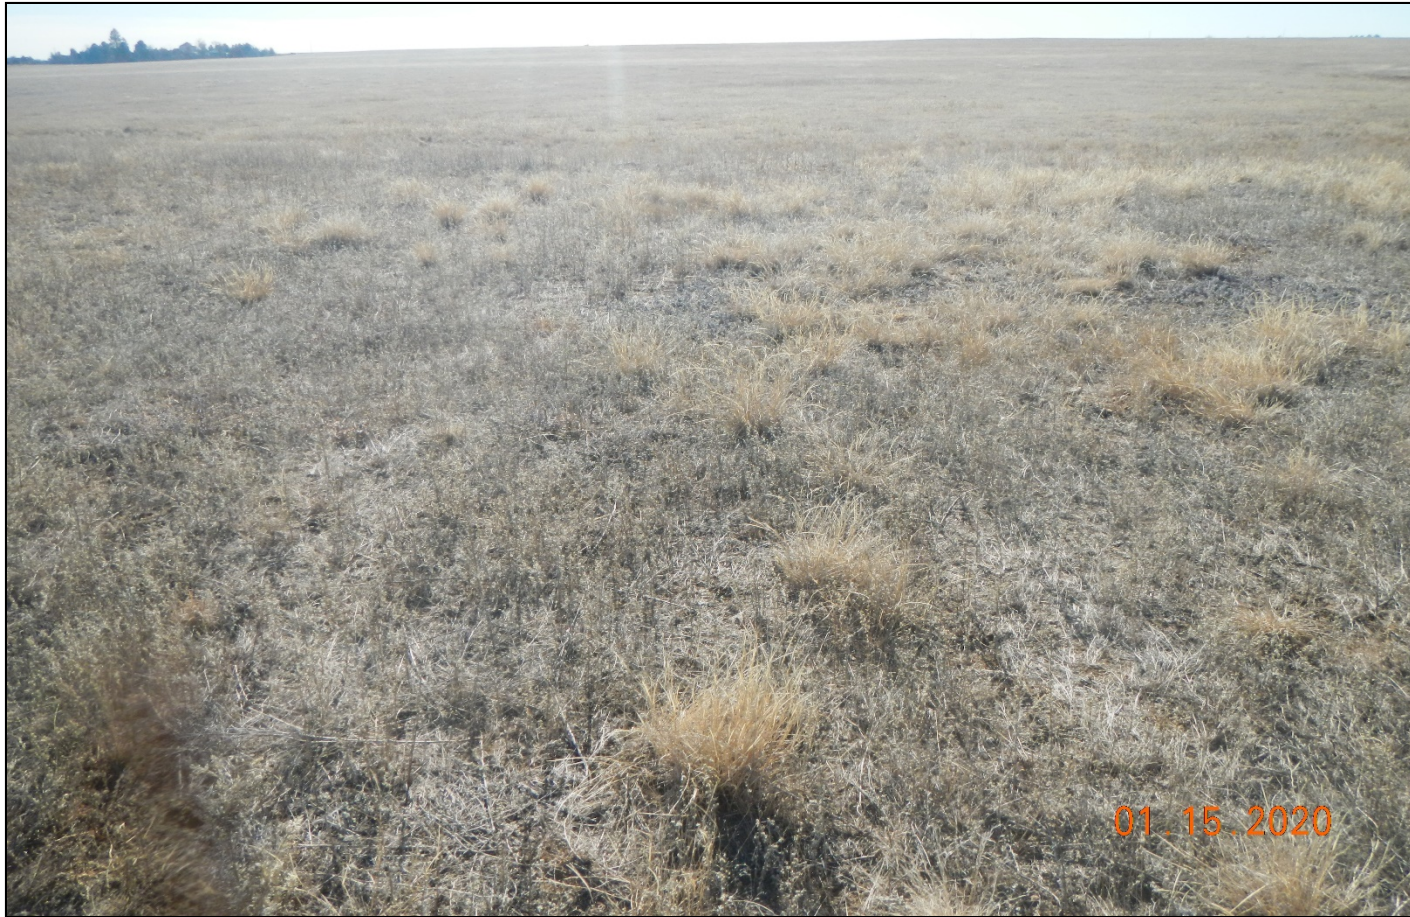
Photo 5. Center of the location facing south.

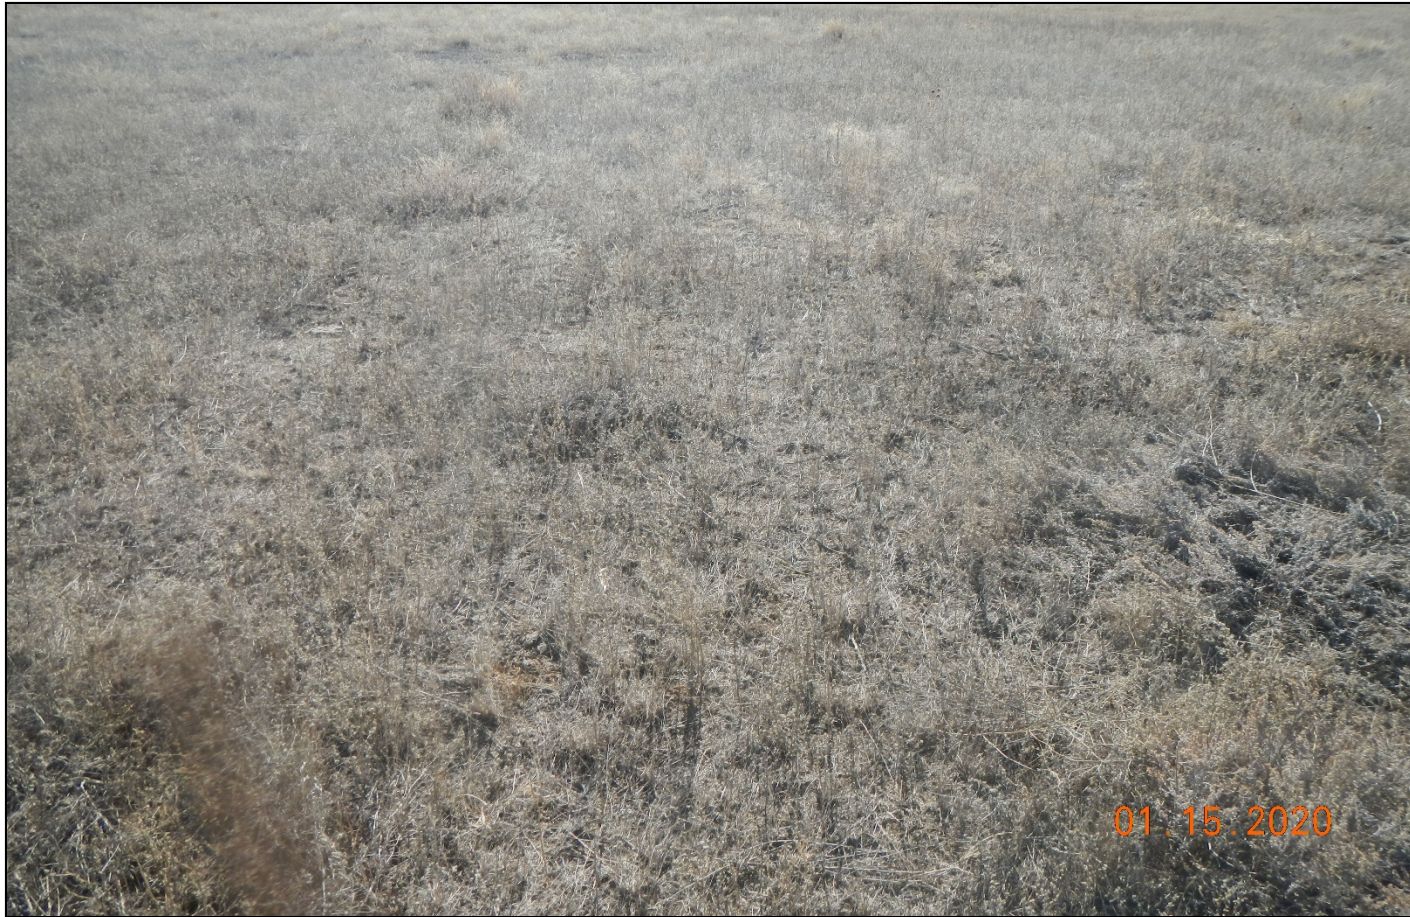
Photo 6. View of groundcover shows predominately undesirable weeds at the location.

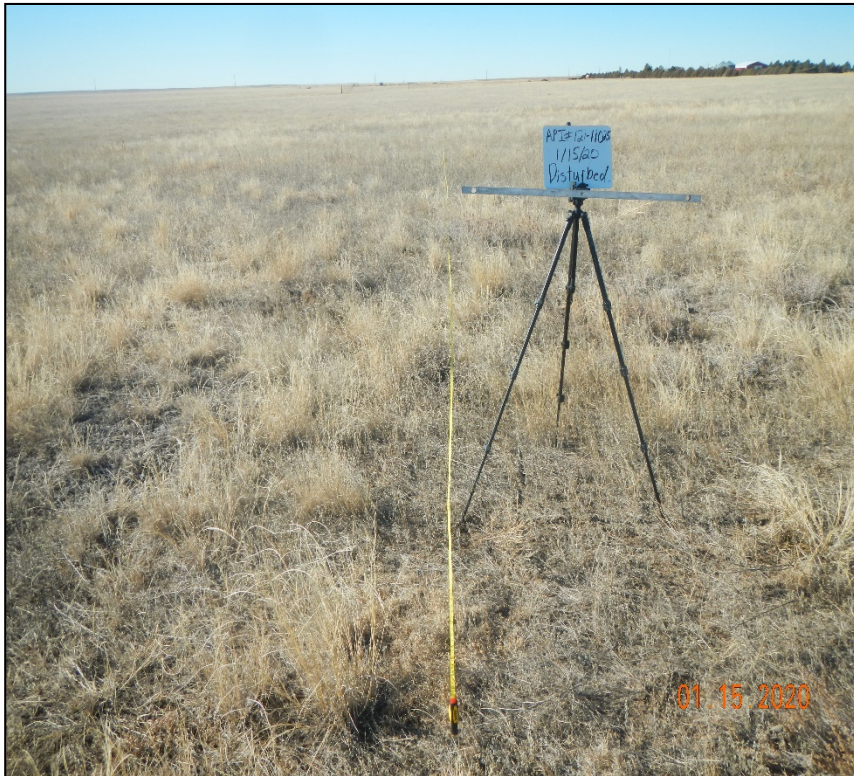
Photo 7. Facing west at the beginning of transect at the disturbed location.

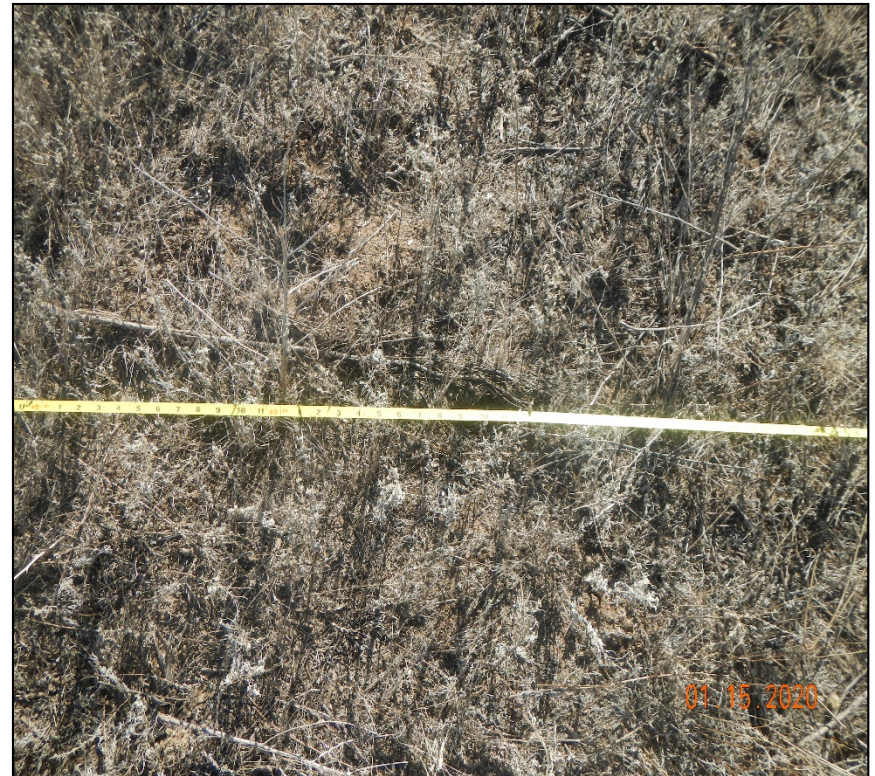
Photo 8. Ground cover at midpoint along the transect at the disturbed location.

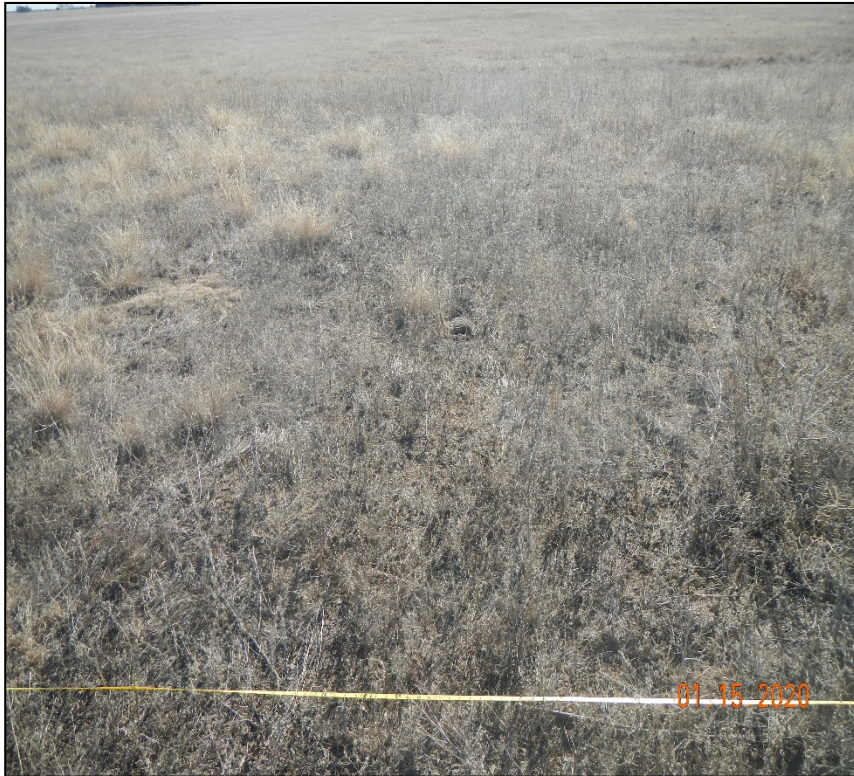
Photo 9. Facing south along the transect at the disturbed location.

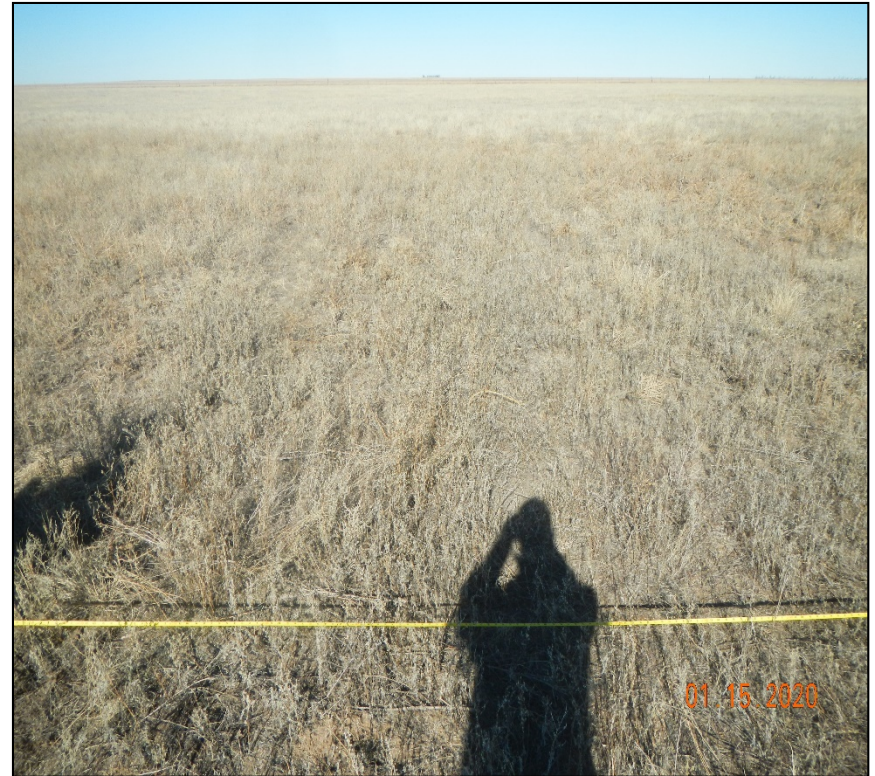
Photo 10. Facing north along the transect at the disturbed location.

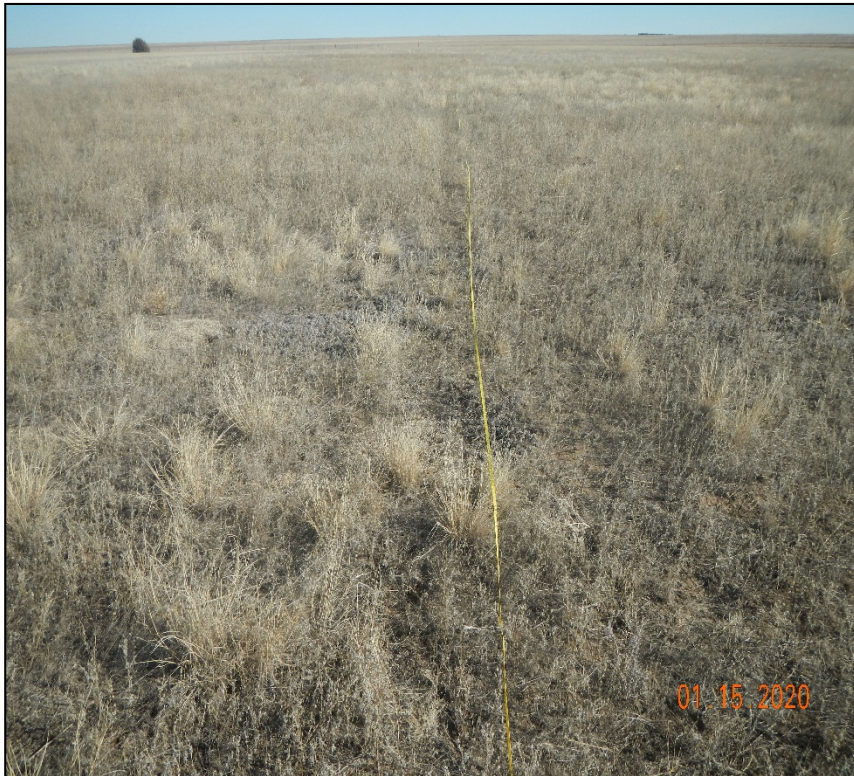
Photo 11. Facing east at the end of the transect at the disturbed location.

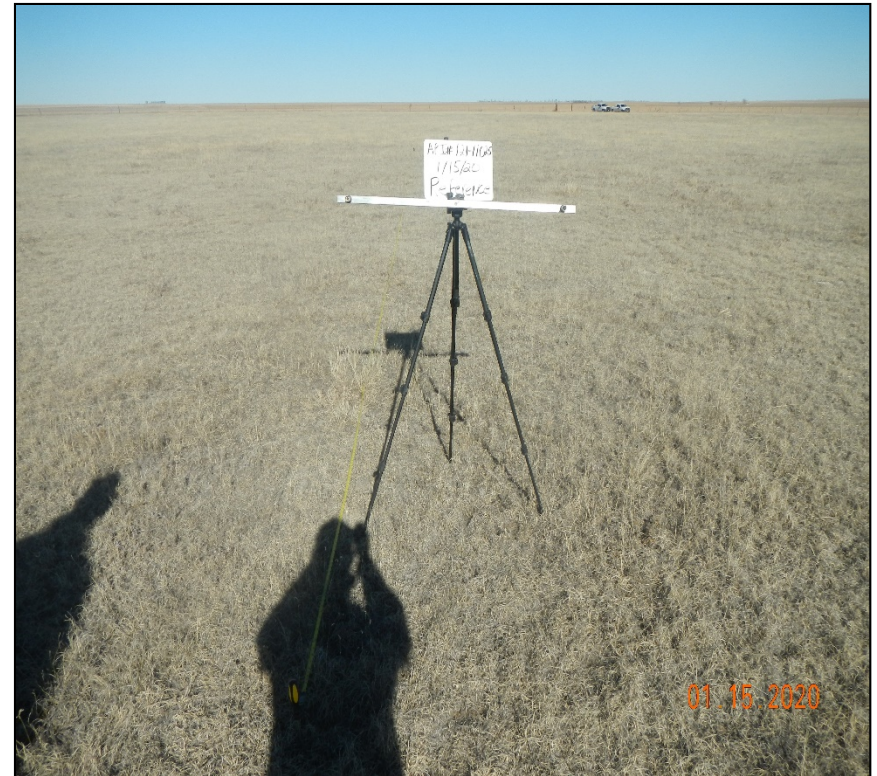
Photo 12. Facing northeast at the beginning of the transect at the undisturbed reference site.

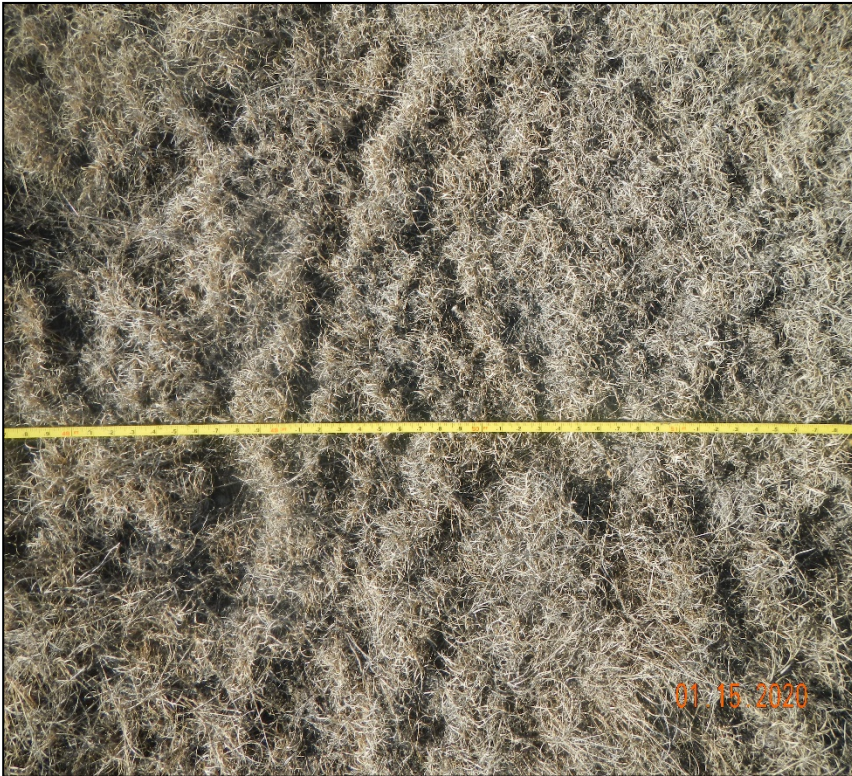
Photo 13. Ground cover at midpoint along the transect at the undisturbed reference site.

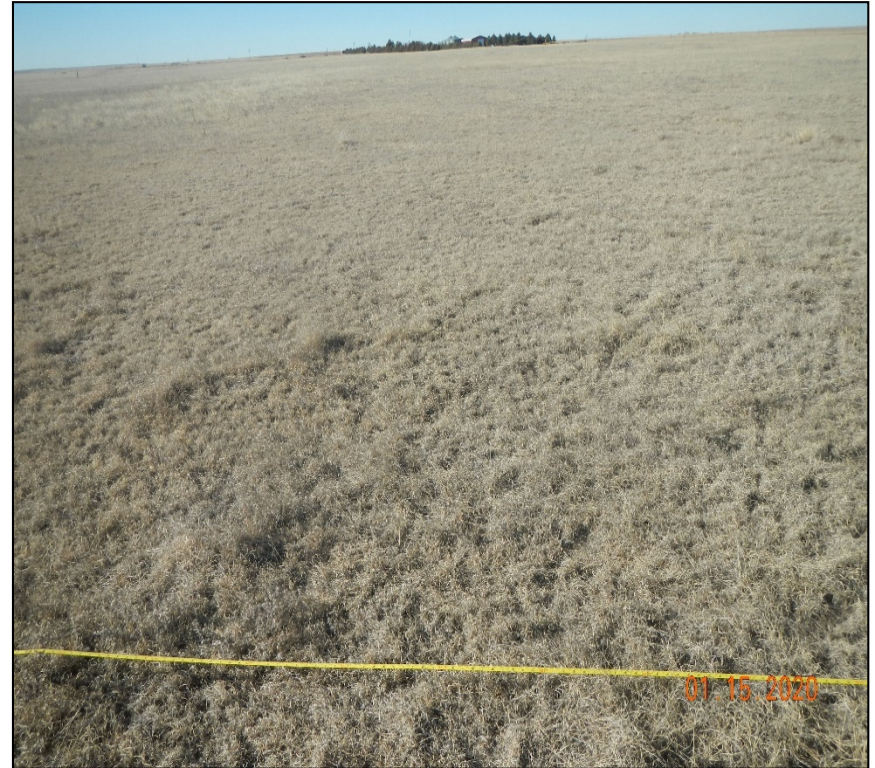
Photo 14. Facing northwest along the transect at the undisturbed reference site.

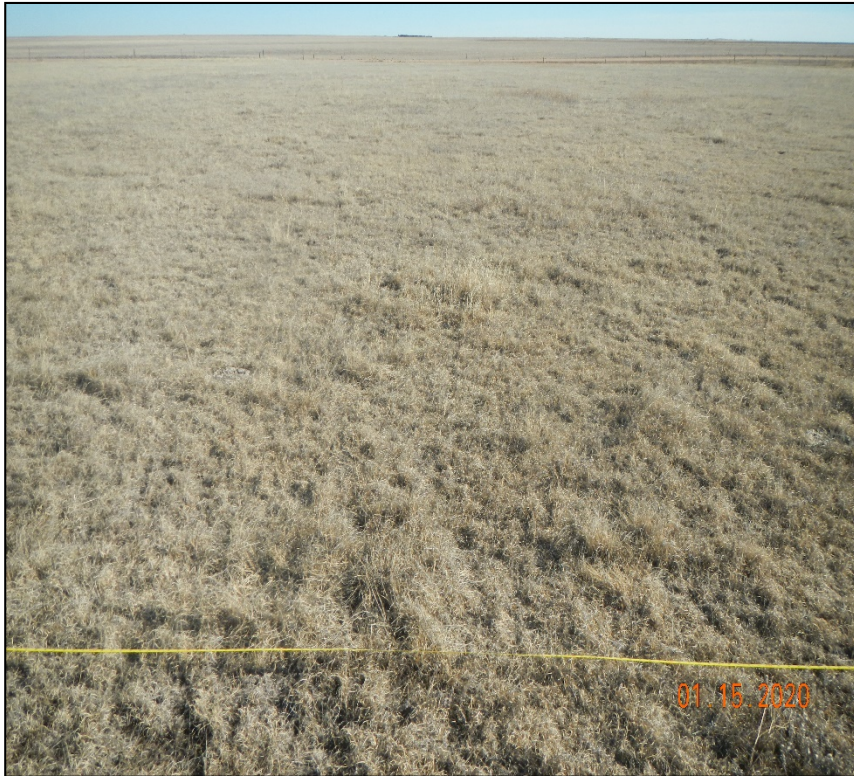
Photo 15. Facing southeast along the transect at the undisturbed reference site.

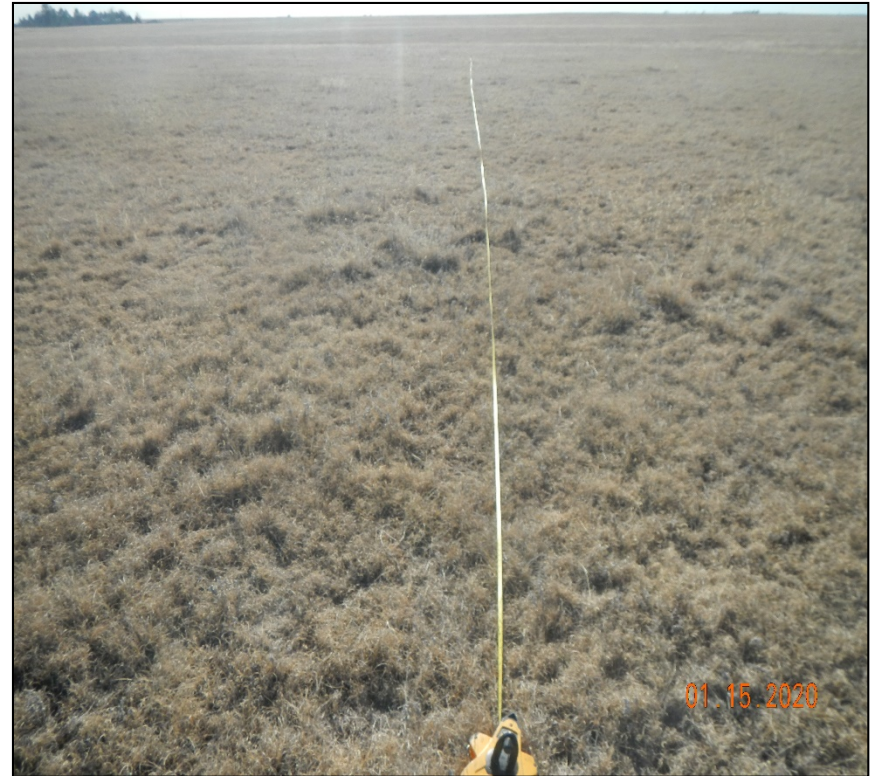
Photo 16. Facing southwest at the end of the transect at the undisturbed reference site.
