Construction and Stormwater Inspection

January 10, 2020

Operator: SRC ENERGY INC- #10311

Location Name: Lincoln State /3-18 Pad

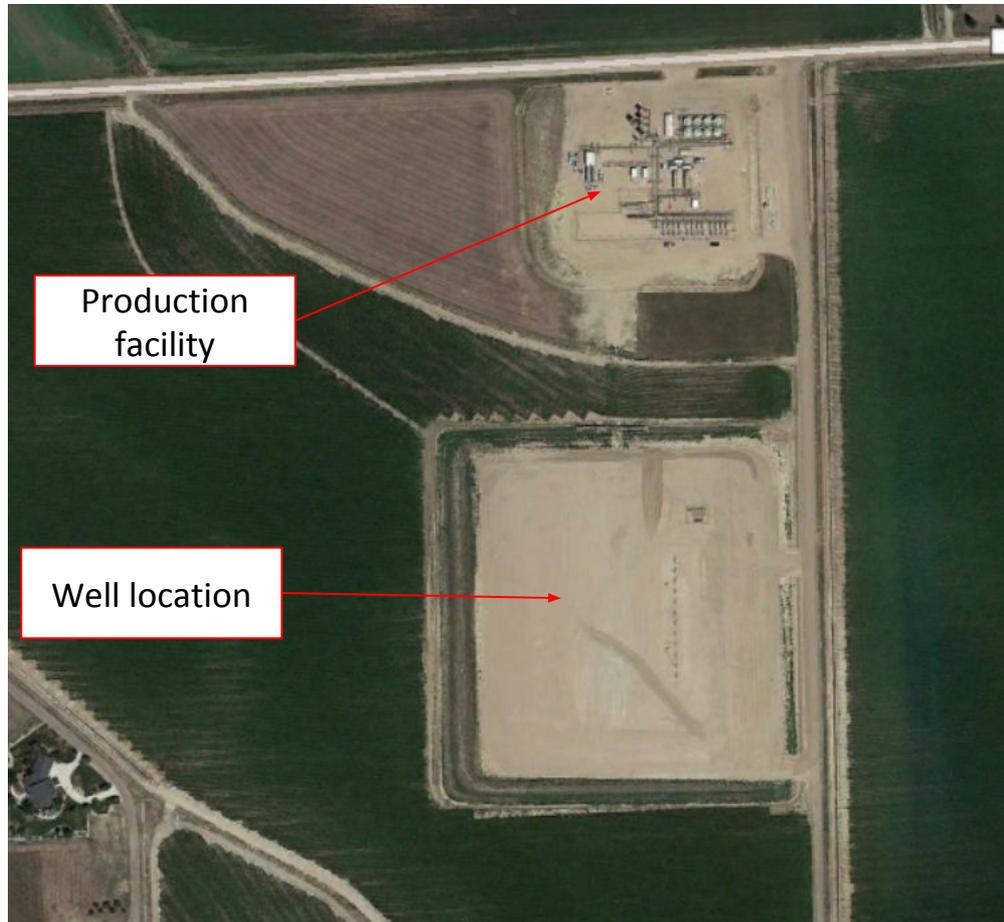
Photo 1. Google Earth aerial imagery taken 7/17/2019. Photo illustrates this location is out of compliance with Rule 1003 for interim reclamation at the well location. Interim reclamation should have been completed by 7/7/2019.

Note: At the time of this inspection on 1/10/2020, interim reclamation had not yet been completed.

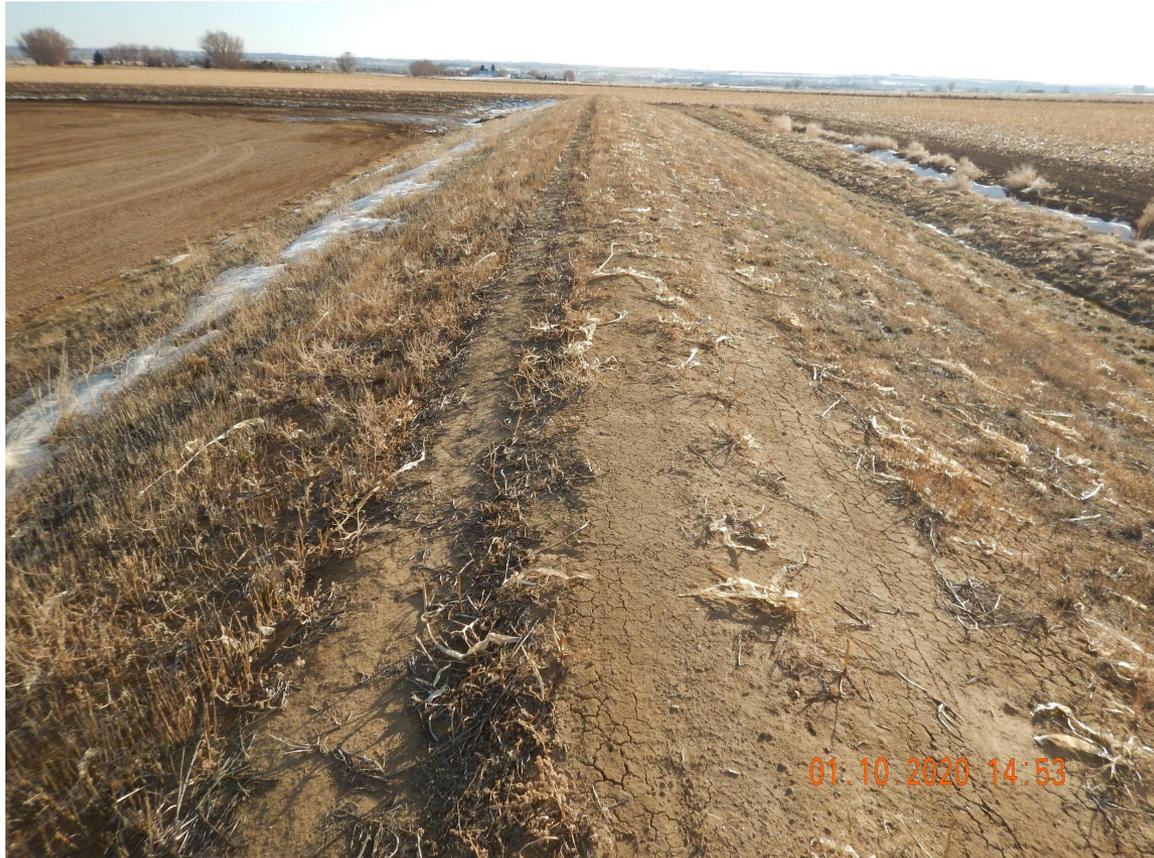
Photo 2. Photo taken from the western topsoil stockpile, facing South. Photo illustrates a topsoil stockpile. Appears the Operator has attempted to seed into the topsoil stockpile. Operator should establish perennial vegetation to ensure compliance with Rule 1002.c.

Note: Operator built this location June 2018. This location is technically out of compliance with Interim Reclamation rules- see Photo 1.

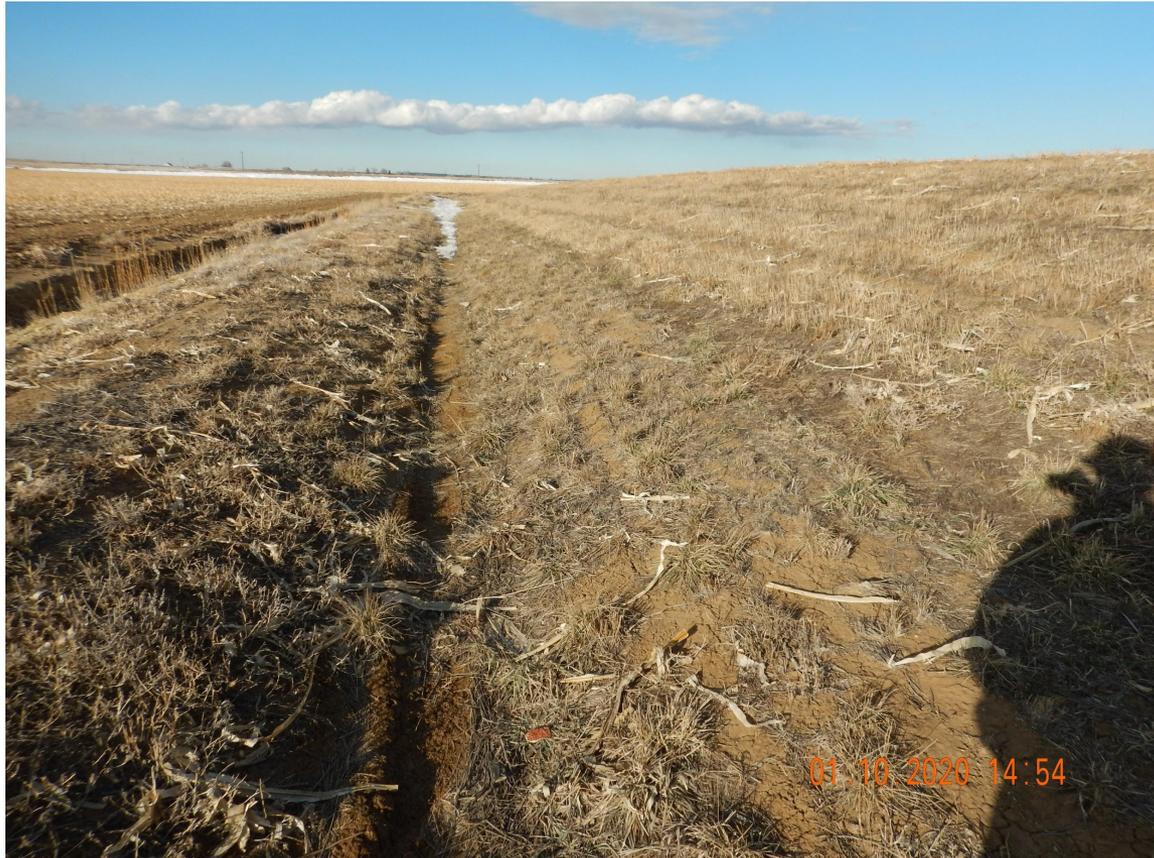
Photo 3. Photo taken from the western perimeter of location, facing North. Photo illustrates the ditch BMP which is directed to a stabilized outlet (sediment trap).

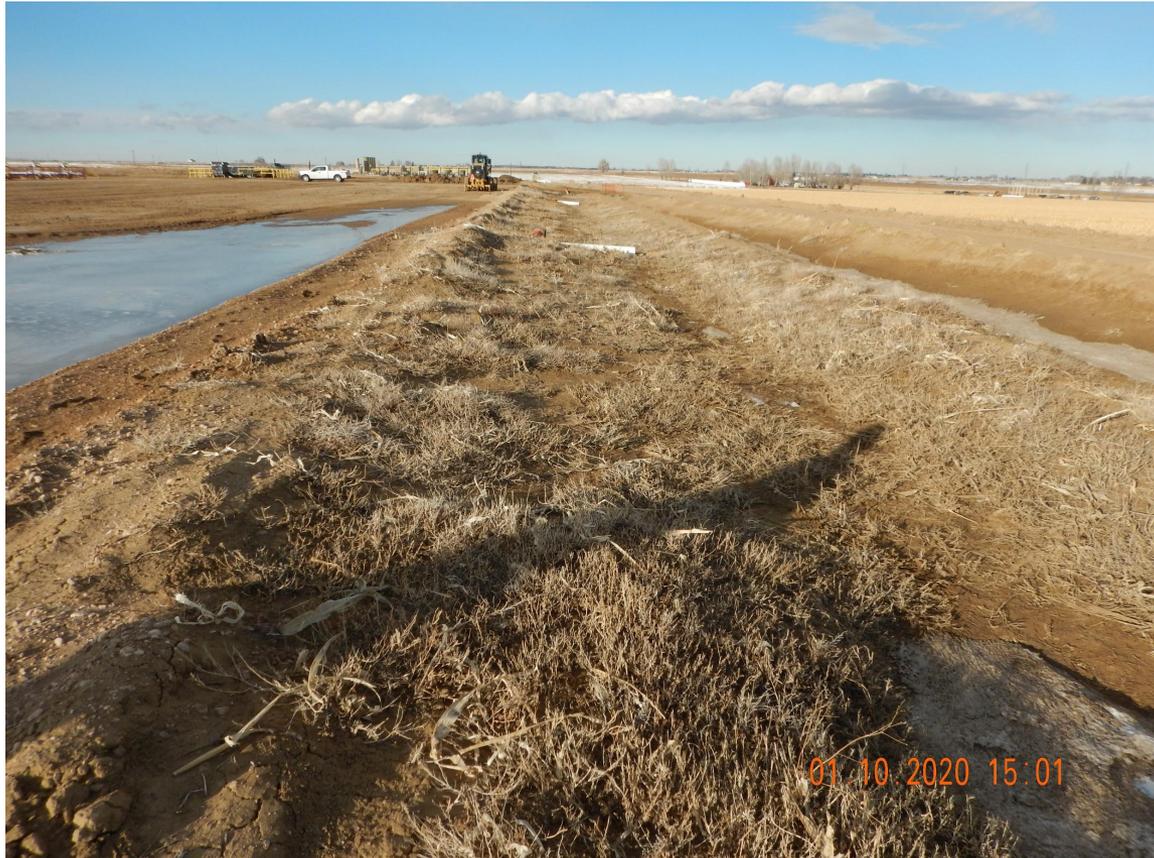
Photo 4. Photo taken from the southeastern perimeter of location, facing North. Photo illustrates the ditch BMP which is directed to a stabilized outlet (sediment trap).

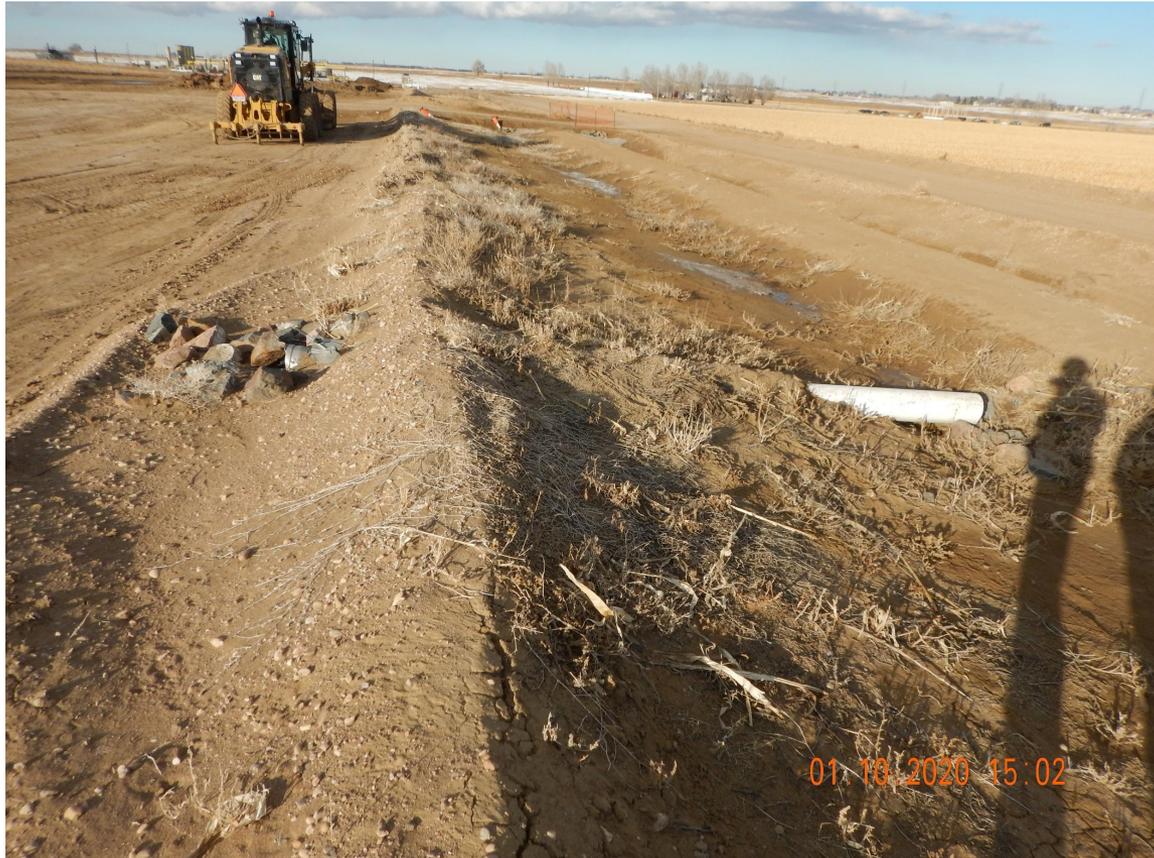
Photo 5. Photo taken from the eastern perimeter of location, facing North. Photo illustrates the ditch BMP which is directed to a stabilized outlet (sediment trap).

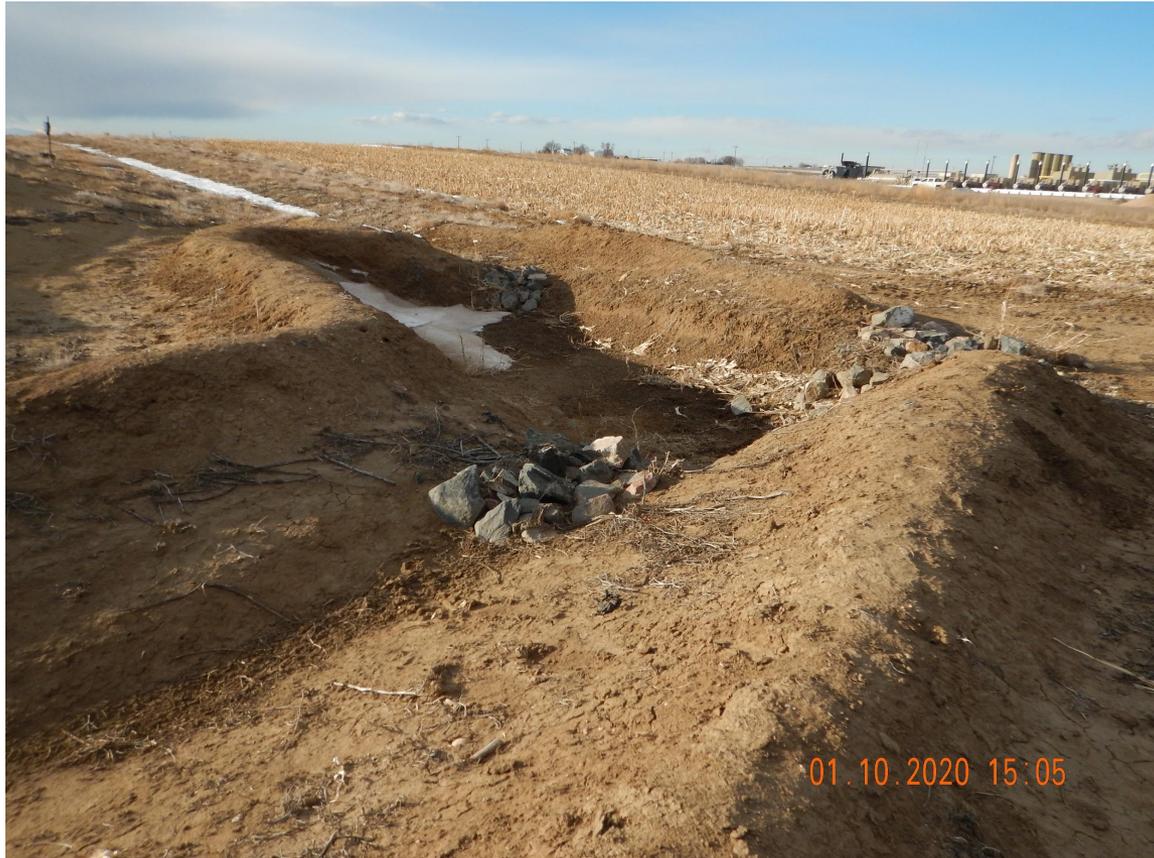
Photo 6. Photo taken from the northeastern perimeter of location, facing Northwest. Photo illustrates the stabilized outlet (sediment trap). Appears to be in proper functioning condition at the time of this inspection.
