Inspection Photos
Location Name: Rocky MTn Fuel CO C #1 & NRC 9-9-15H
Location ID: 317650

COLORADO
Oil & Gas Conservation
Commission
Department of Natural Resources

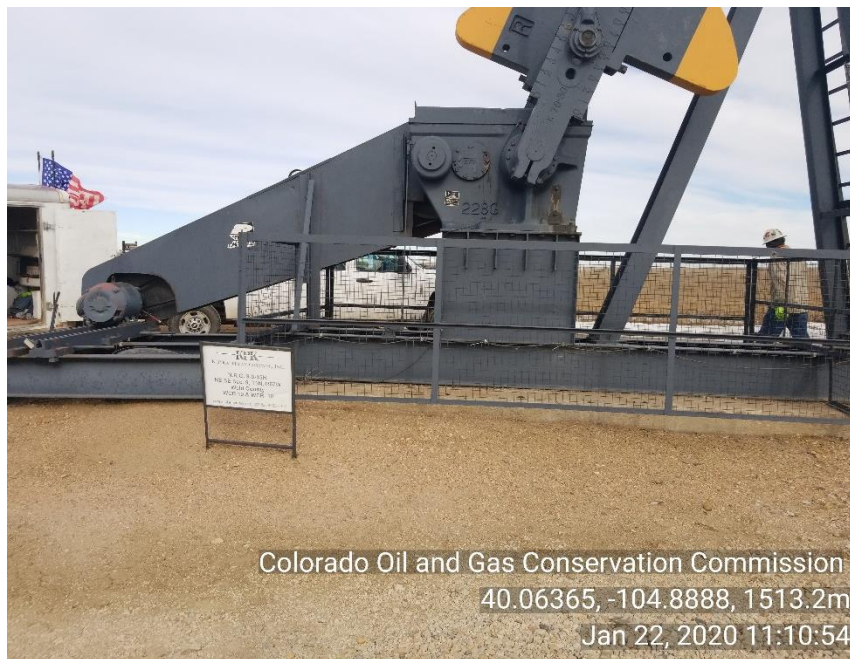
Photo 1 WH sign CO C #1

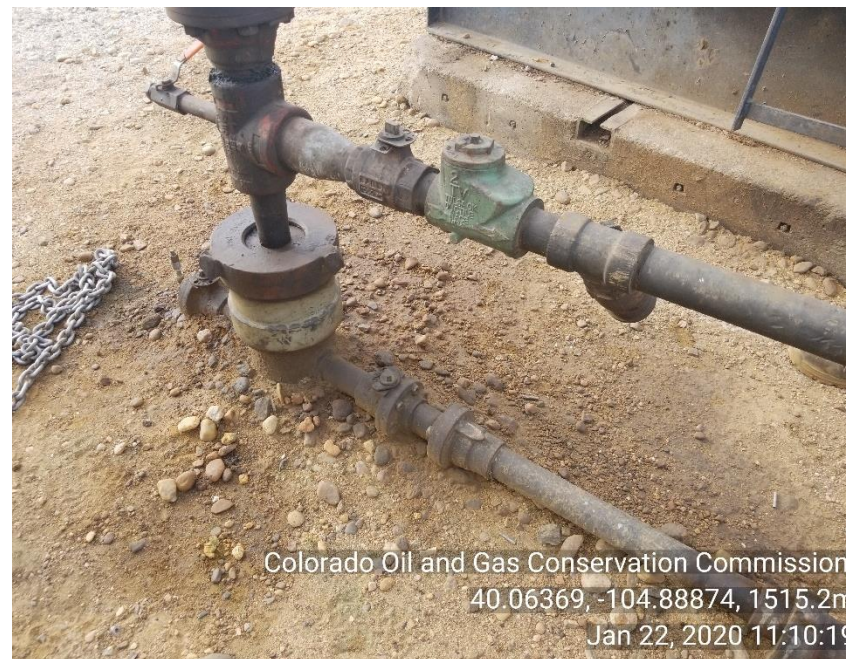
Photo 2 Stained soil around well head CO C #1

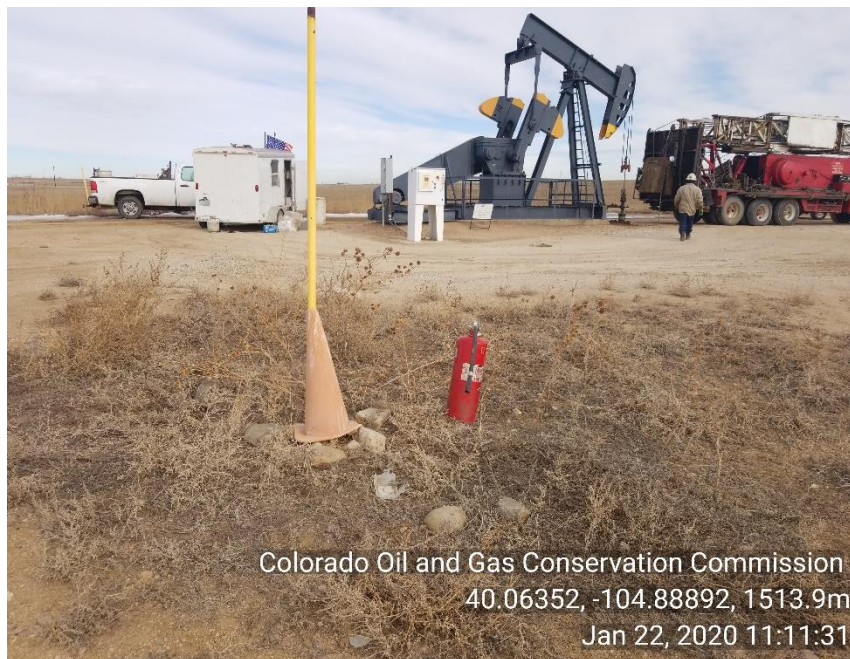
Photo 3 Weeds around Guy line anchor on location

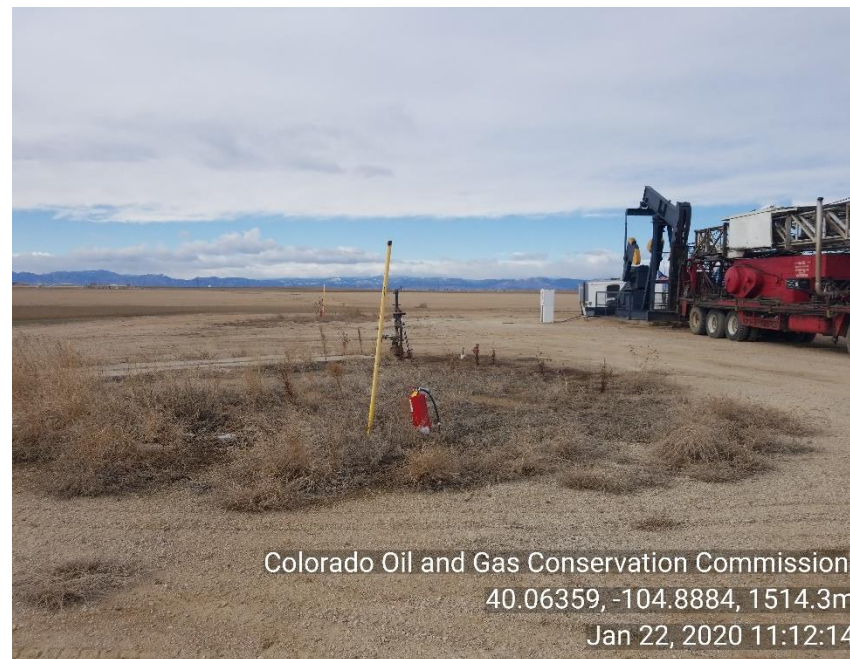
Photo 4 Weeds around Guy line anchor on location

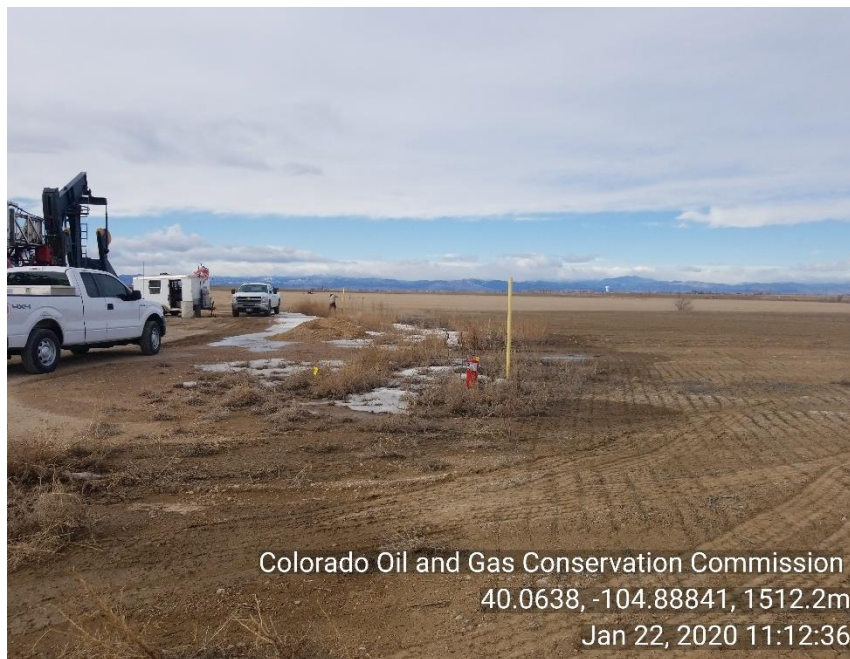
Photo 5 Weeds around Guy line anchor on location

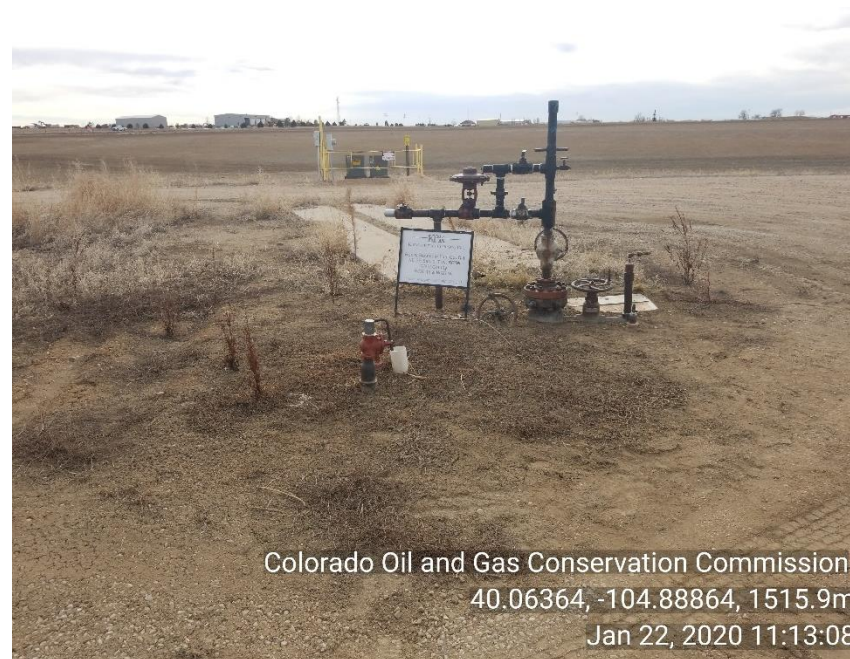
Photo 6 NRC 9-9-15H WH sign. Weeds around well head

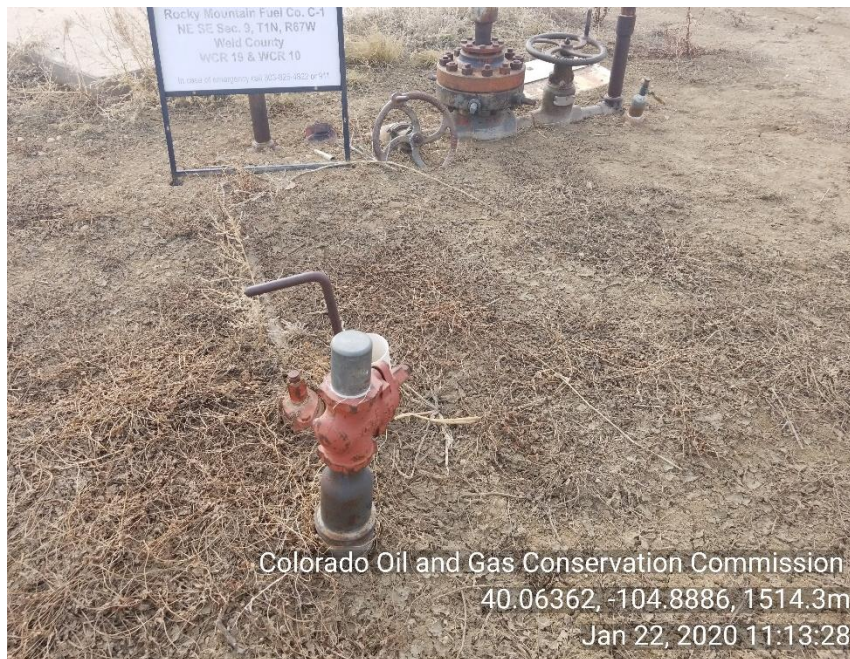
Photo 7 Unmarked unused riser not LOTO

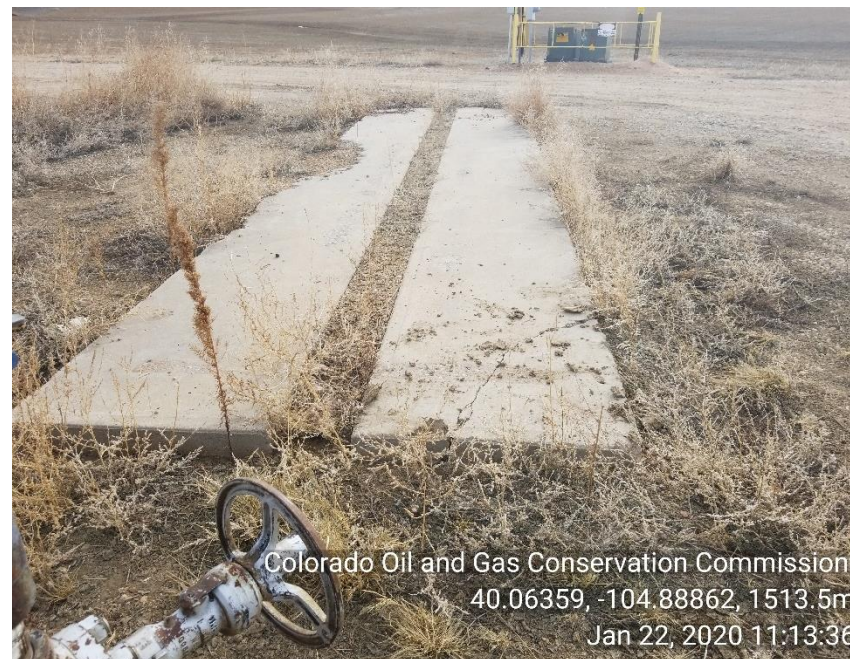
**Photo 8 unused equipment Pumping unit cement base.
Weeds around Well head**

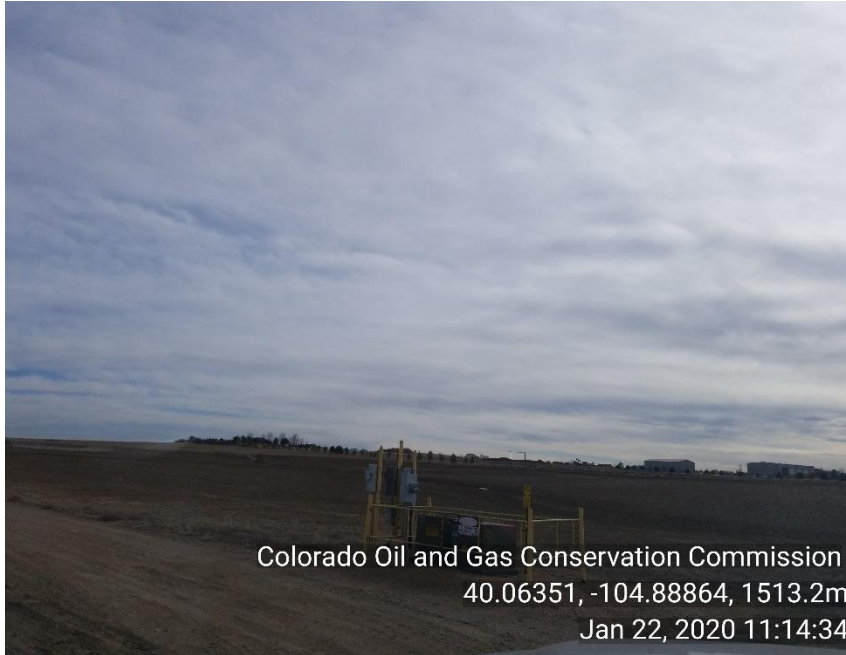
Photo 9 Electric panel

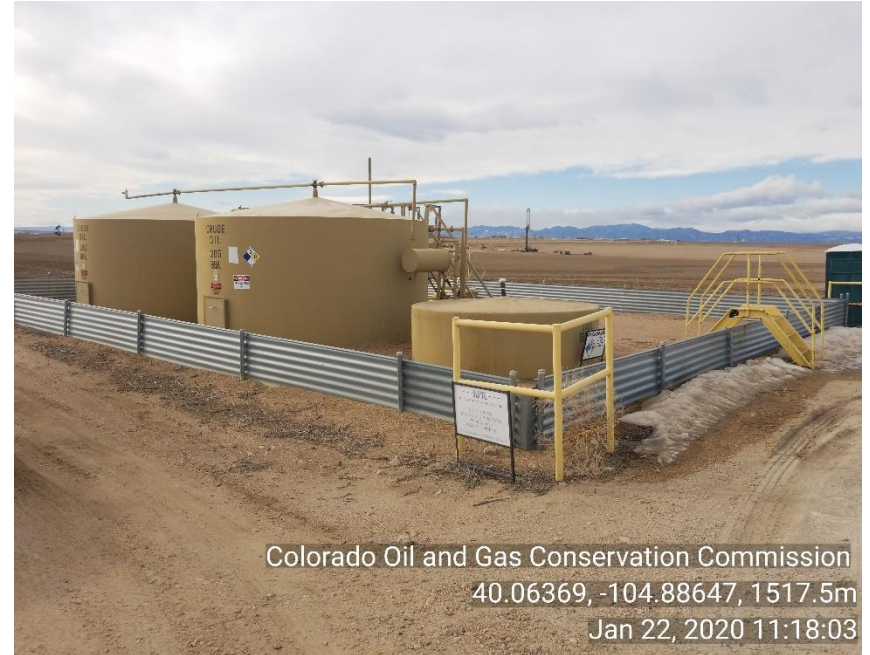
Photo 10 TNK BTRY

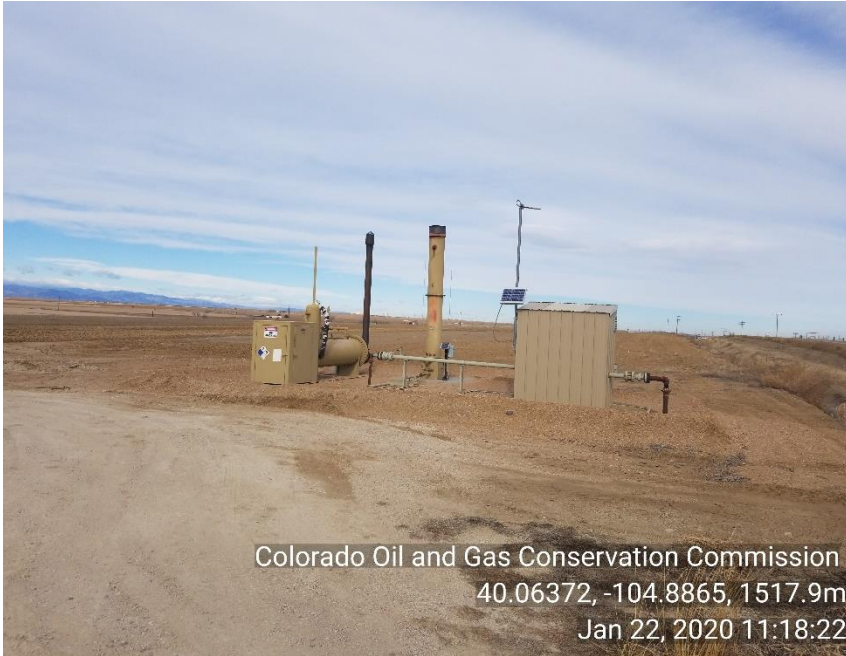
Photo 11 Sep/meter house and ECD

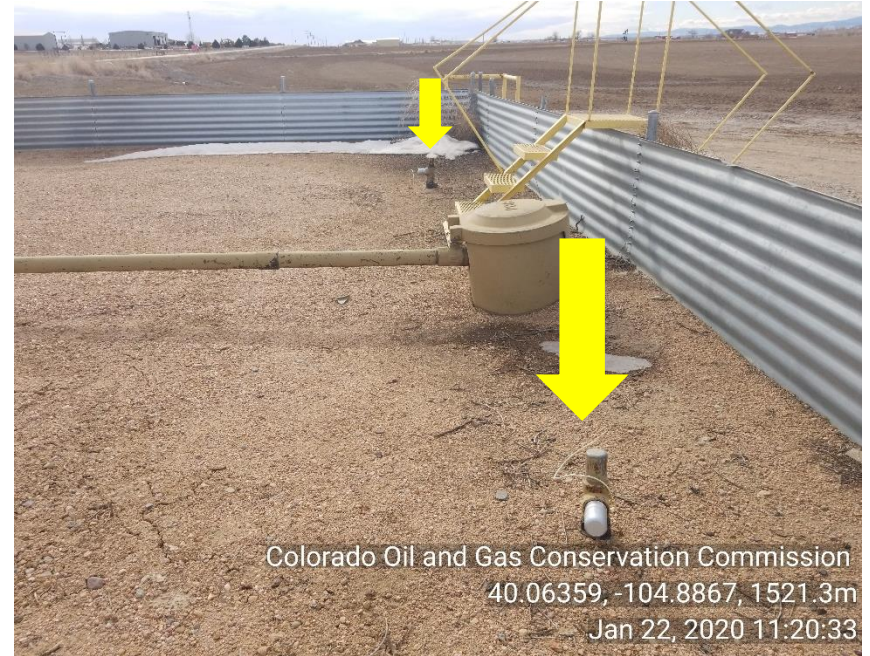
Photo 12 unmarked unused and not loto risers inside crude oil containment.

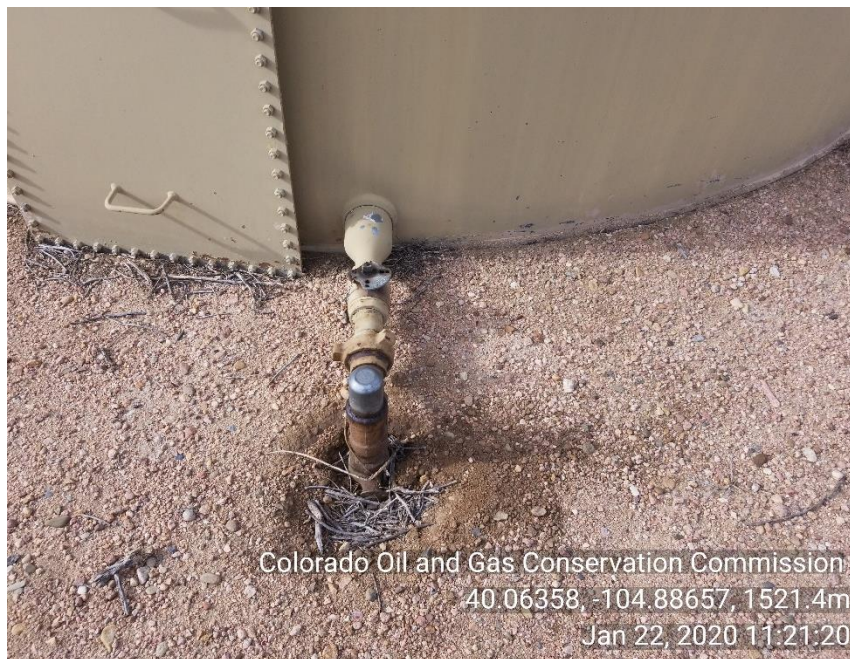
Photo 13 Mechanical issue and stained soil around crude oil tank 2" line

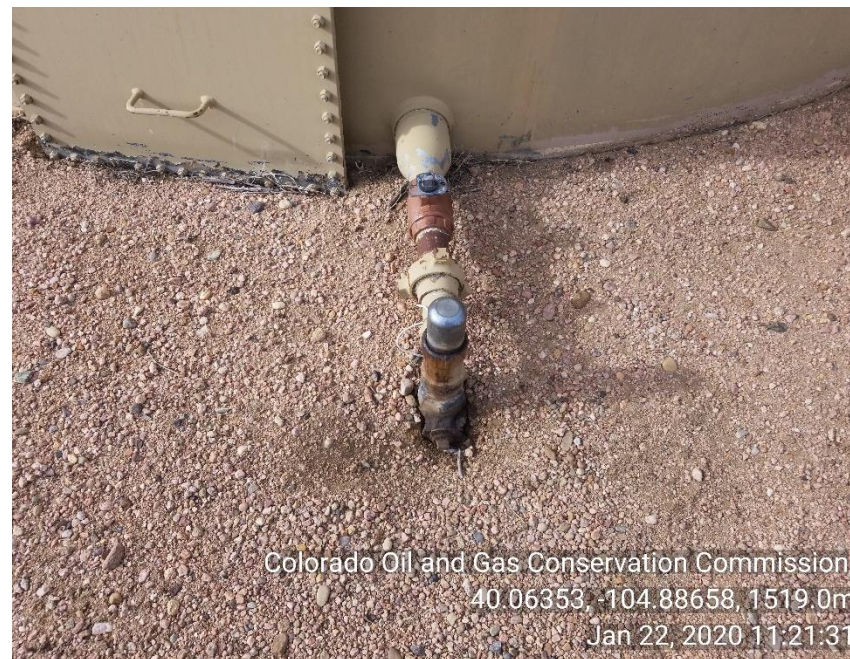
Photo 14 Mechanical issue and stained soil around crude oil tank 2" line

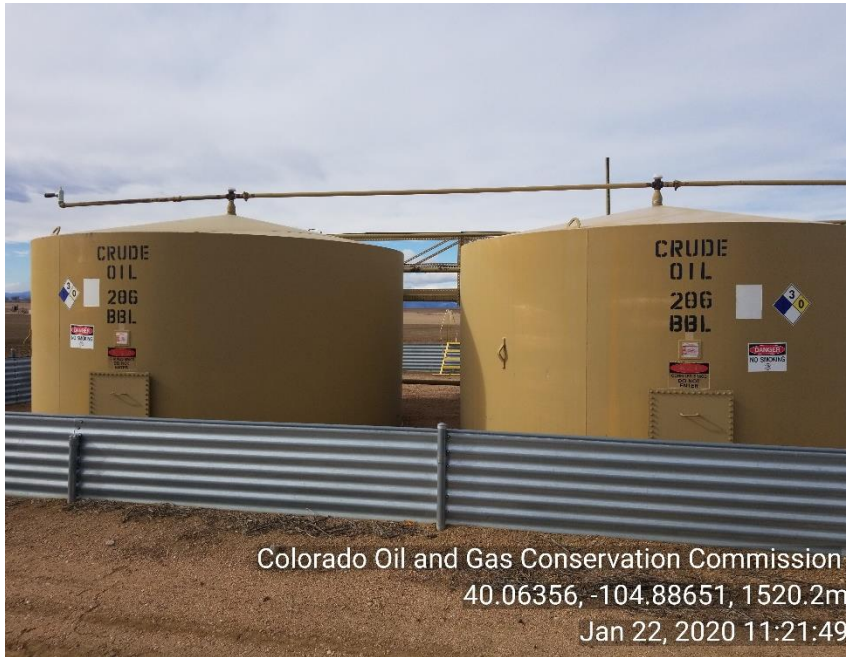
Photo 15 NFPA placards faded need to be replaced.
