Inspection Photos
location 428531
Remediation Projects 14686 & 10268
Inspection Date: 1/7/2020
Photos taken by Kris Neidel

COLORADO
Oil & Gas Conservation
Commission
Department of Natural Resources

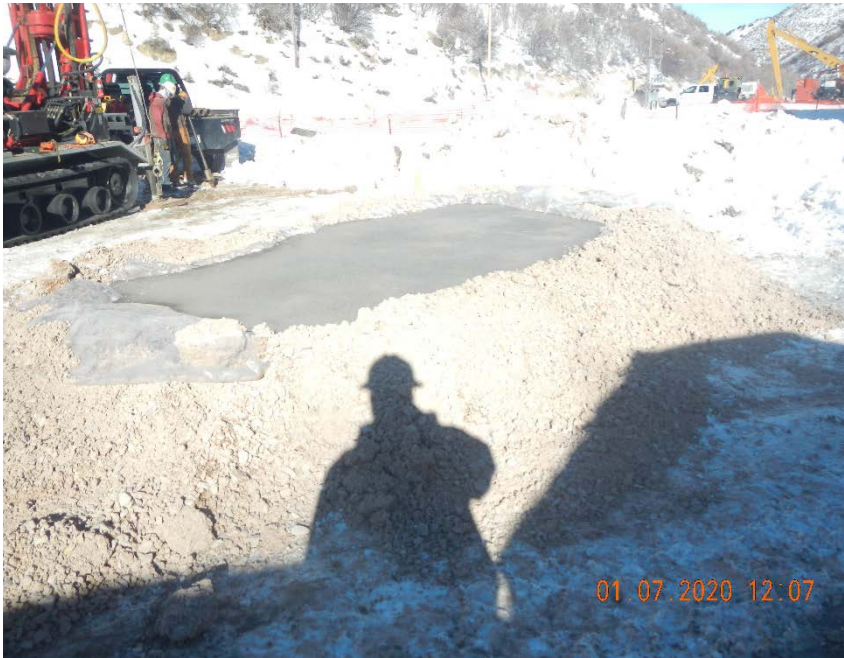
Photo #2 Containment area has material that was hydro-excavated from the top 3-4 feet. There was no observable impact (olfactory or visual) in the holes that were hydrovaced. Weather was below freezing. Wesco should remove fluid and solids as soon as possible.

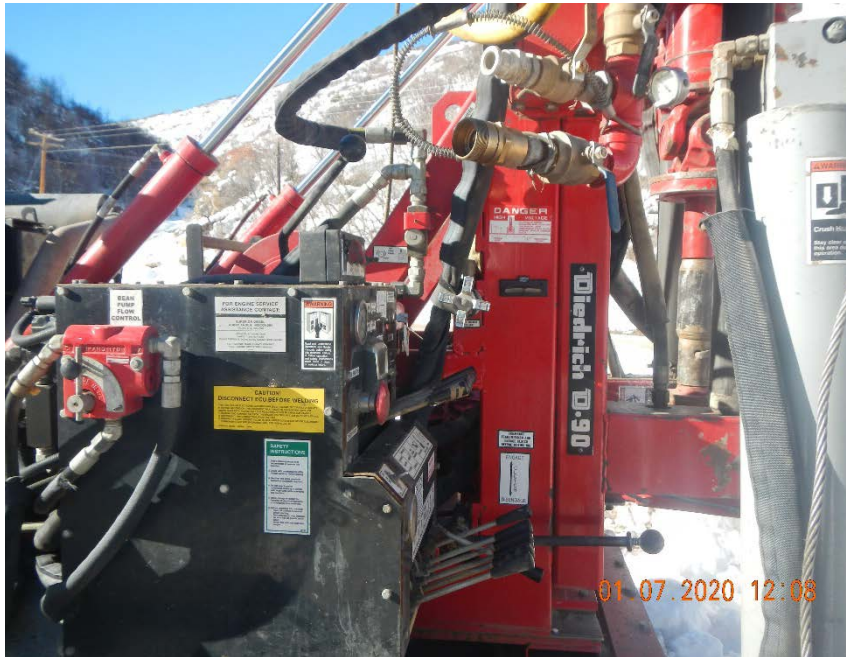
Photo #3 Rig that was used for groundwater investigation.
Diedrich D-90. Rig was owned and operated by HRL Compliance
Solutions Inc.

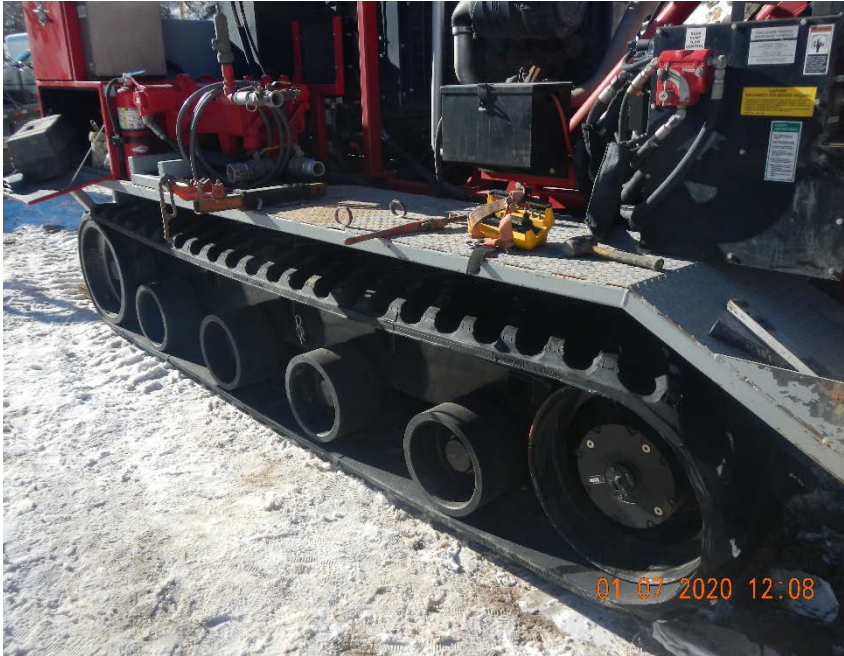
Photo #4 wellhead Rig that was used for groundwater investigation. Diedrich D-90. Rig was owned and operated by HRL Compliance Solutions Inc.

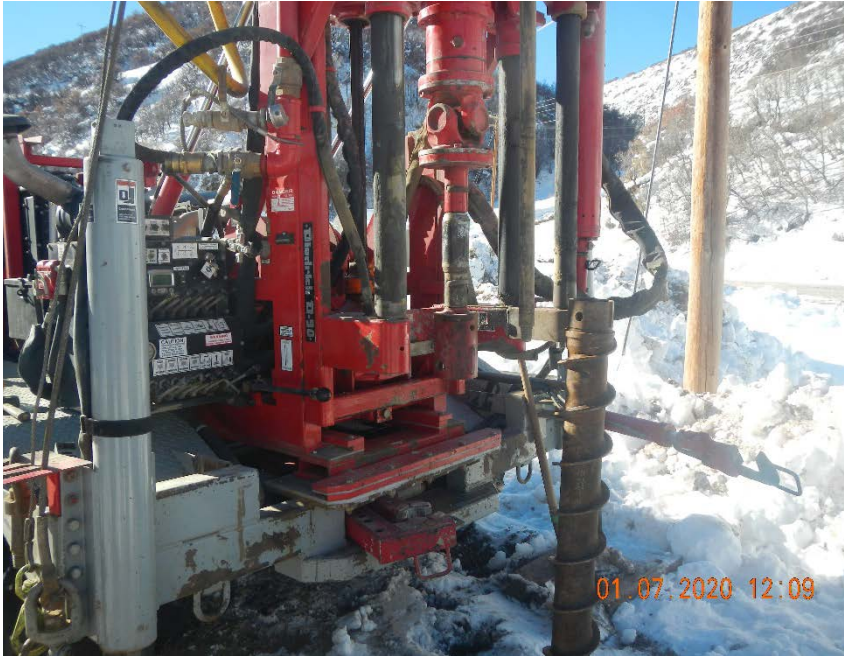
Photo #5 wellhead Rig that was used for groundwater investigation. Diedrich D-90. Rig was owned and operated by HRL Compliance Solutions Inc.

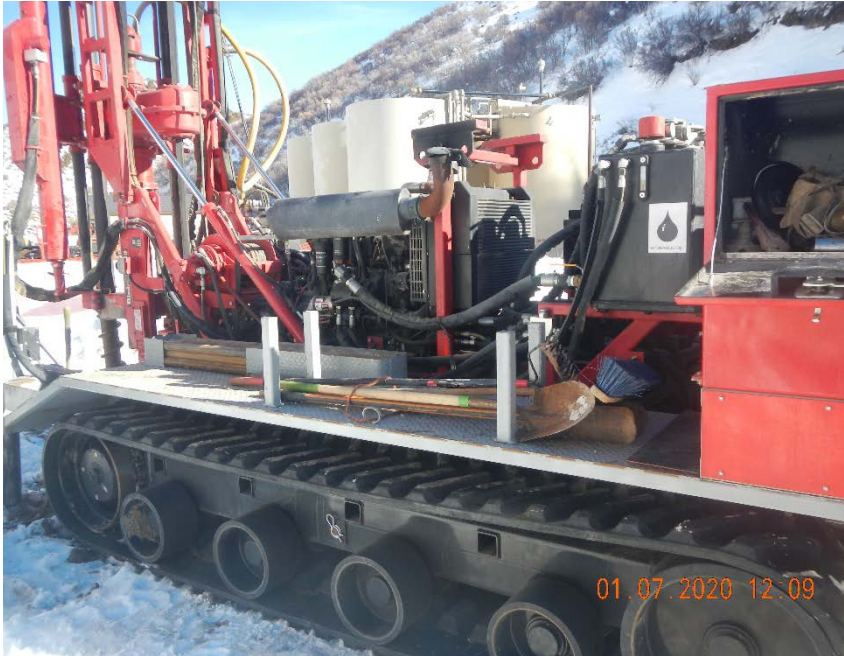
Photo #6 wellhead Rig that was used for groundwater investigation. Diedrich D-90. Rig was owned and operated by HRL Compliance Solutions Inc.

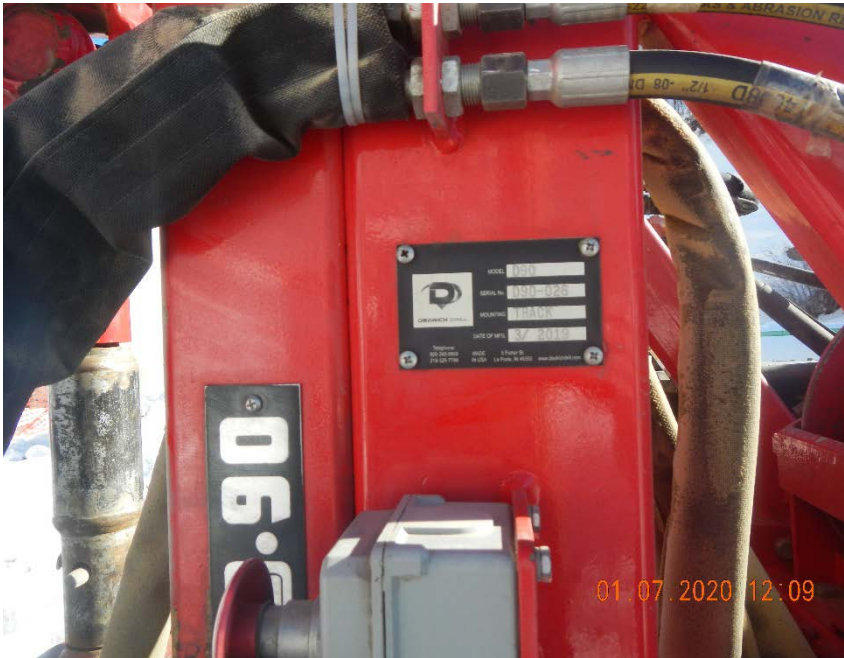
Photo #7 wellhead Rig that was used for groundwater investigation. Diedrich D-90. Rig was owned and operated by HRL Compliance Solutions Inc.

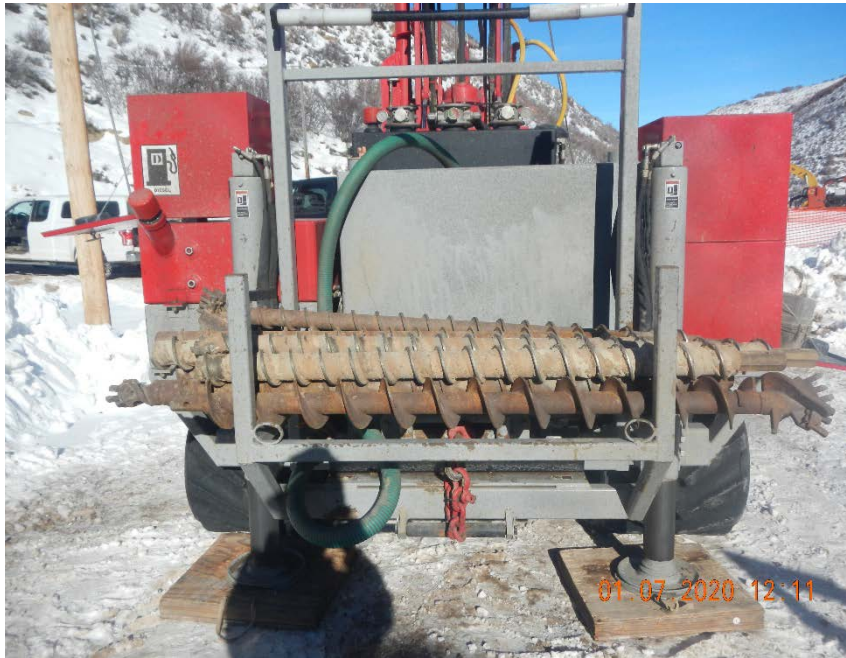
Photo #8 Rig that was used for groundwater investigation.
Diedrich D-90. Rig was owned and operated by HRL Compliance
Solutions Inc.

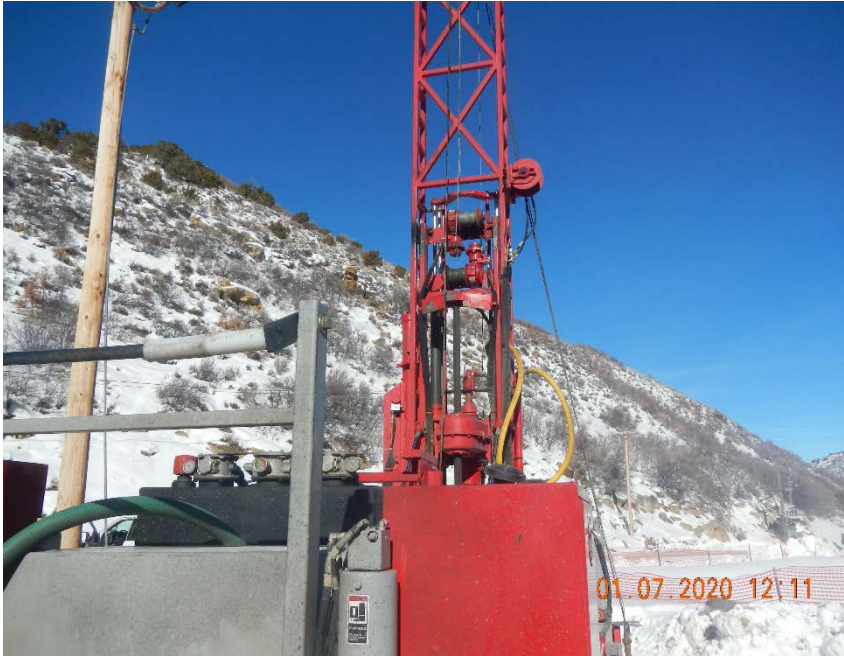
Photo #9 Rig that was used for groundwater investigation.
Diedrich D-90. Rig was owned and operated by HRL Compliance
Solutions Inc.

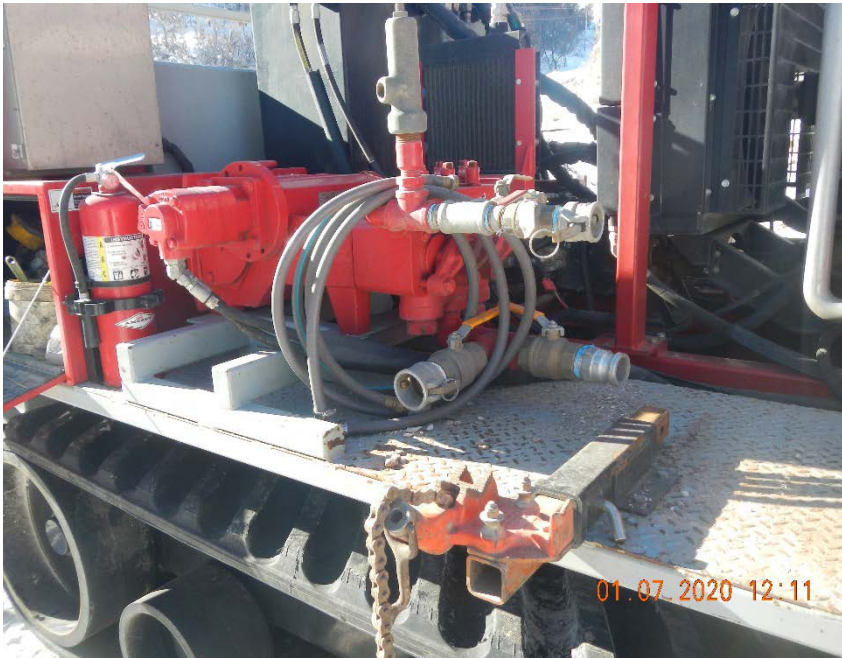
Photo #10 Rig that was used for groundwater investigation. Diedrich D-90. Rig was owned and operated by HRL Compliance Solutions Inc.

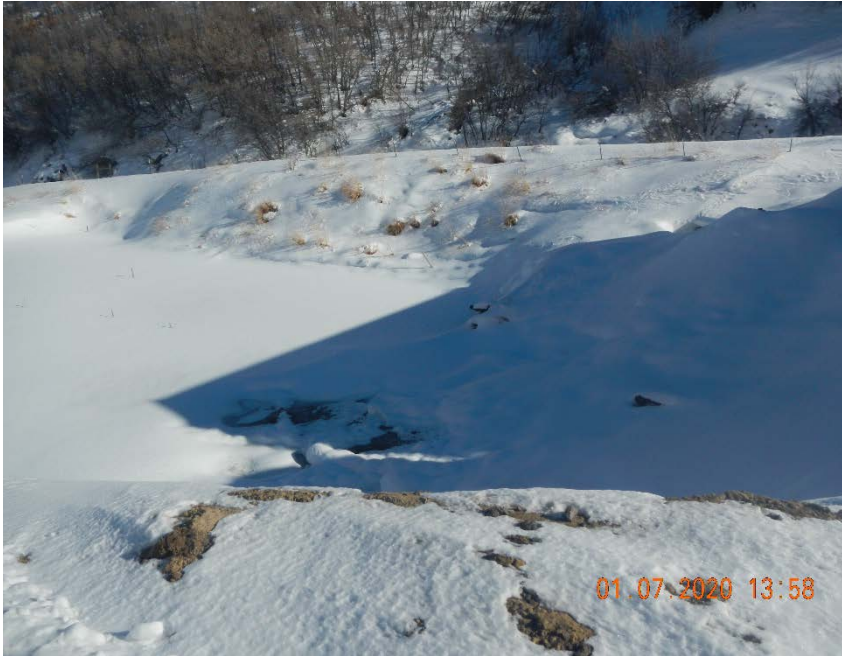
Photo #11 Photo of “emergency Pit 1”. Note: shadow on right of photo is the shop at the maudlin facility. Photo is looking northeast.

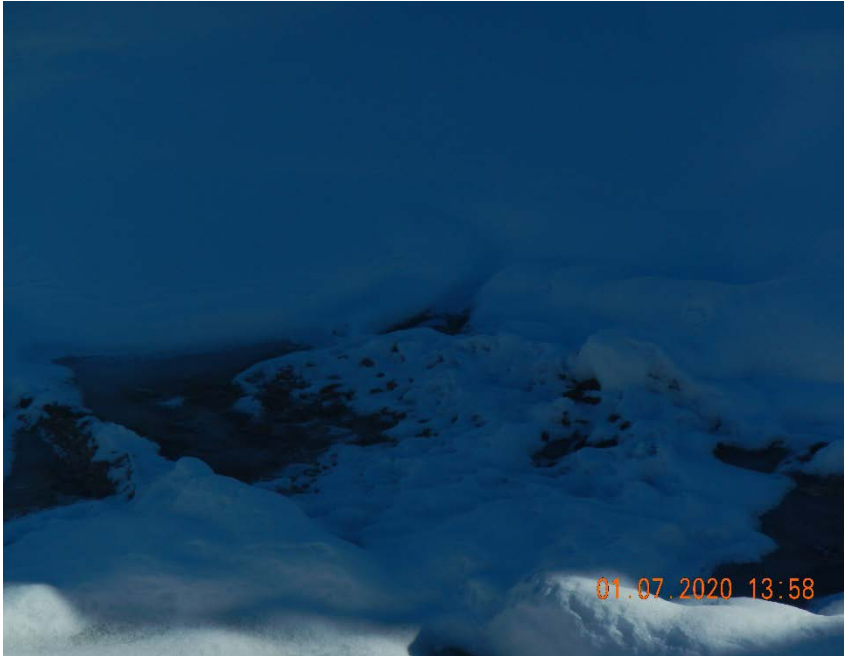
Photo #12 close up of pit bottom. Pit was 98% covered in snow.
NO Hydrocarbon impact was observable in either pit.

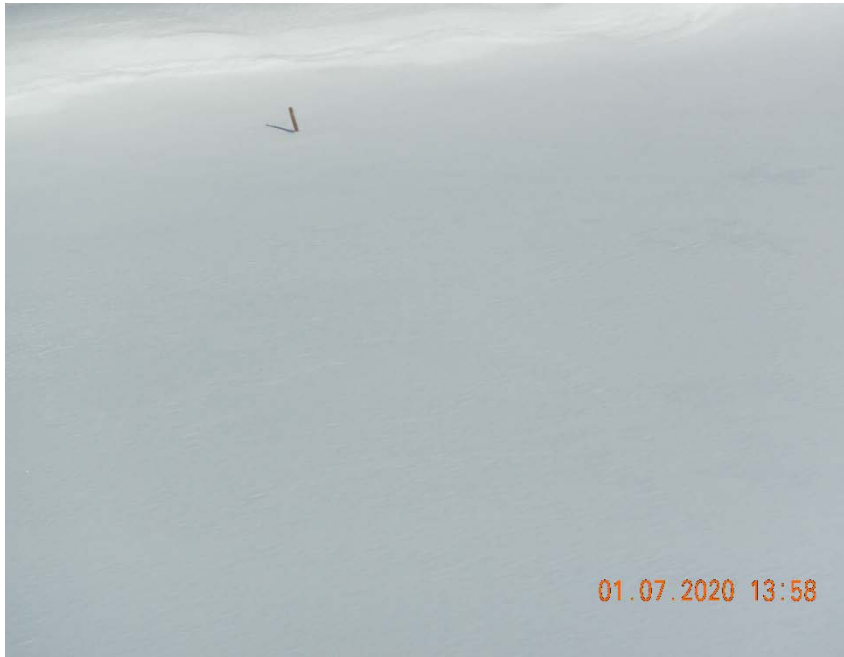
Photo #13 photo of pit, "Emergency Pit #1"

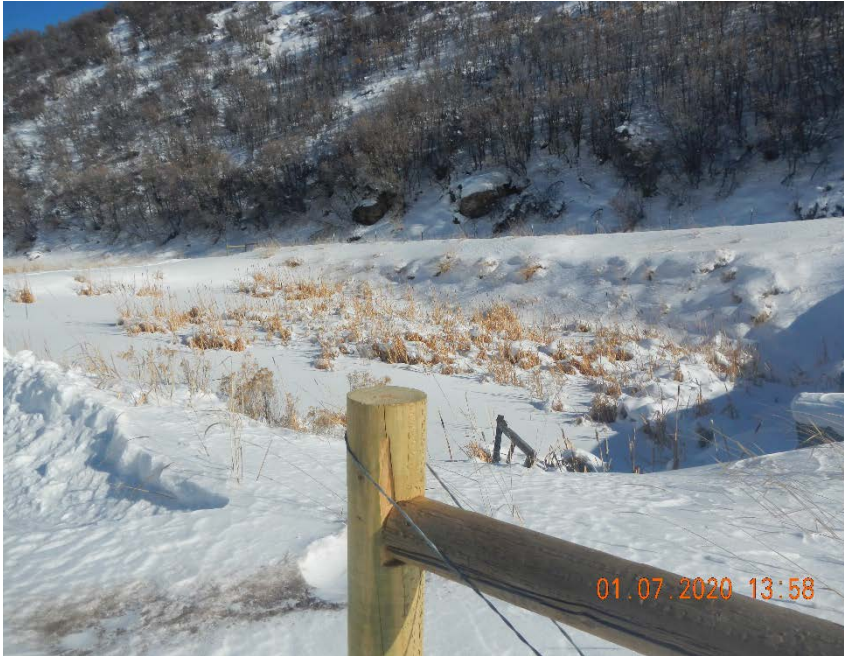
Photo #14 Photo of lower pit, identified by Wesco as “Emergency Pit #2”. Photo taken looking Northeast.

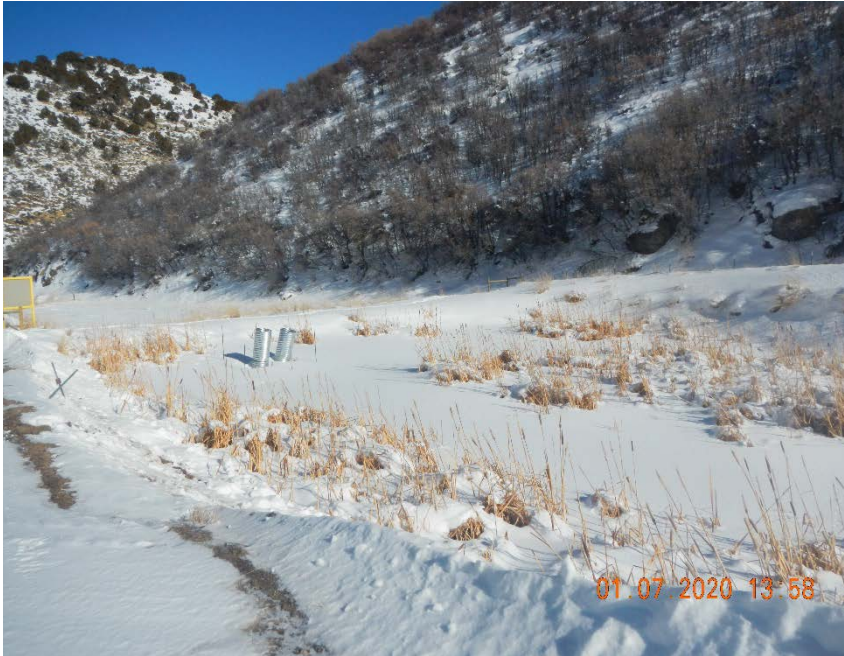
Photo #15 Photo of lower pit, identified by Wesco as “Emergency Pit #2”. Photo taken looking Northeast.

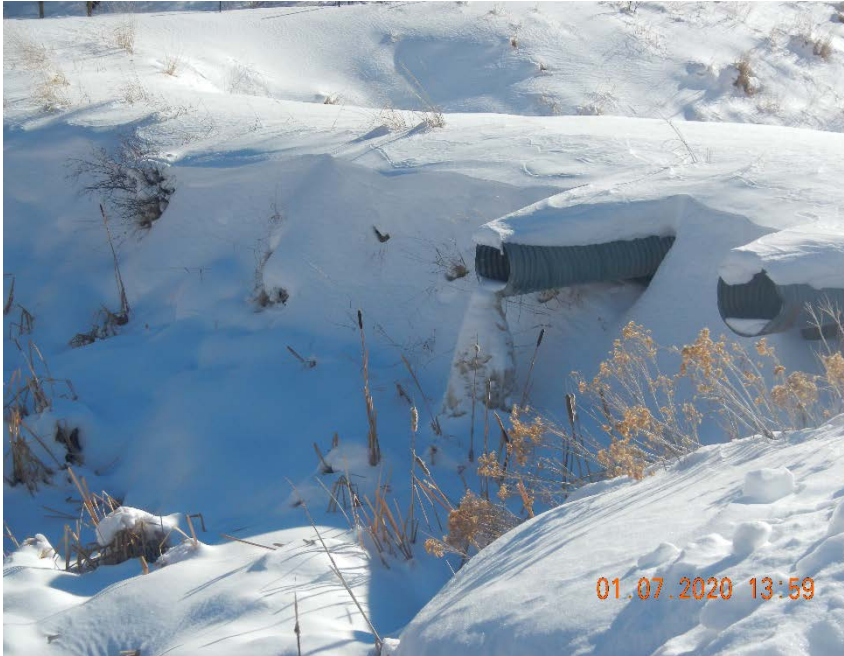
Photo #16 Photo of inlet (culvert) to Emergency Pit #2, from Emergency Pit #1. NO flow was observed. The water level of Pit #1 was more than 2 feet from the culvert.

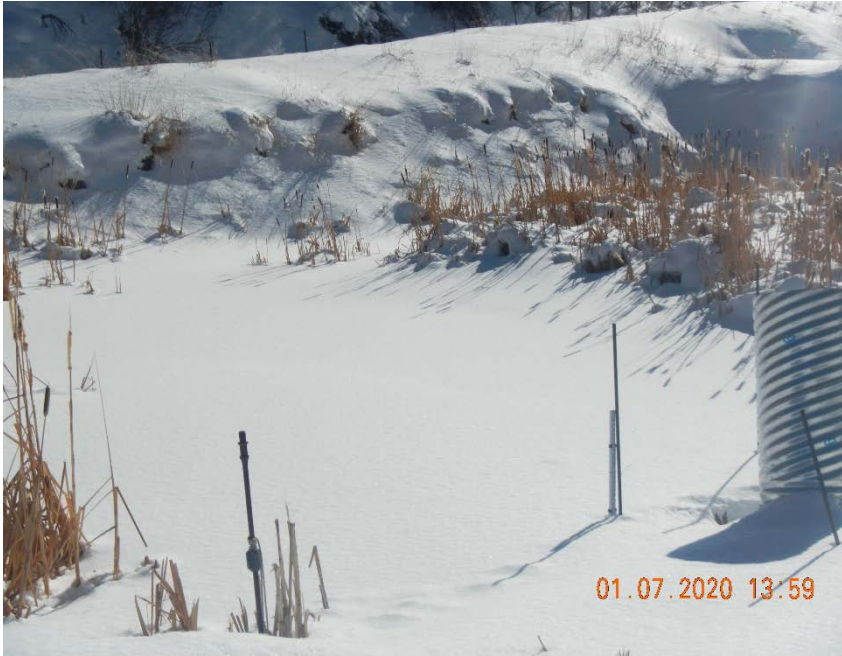
Photo #17 Photo of Emergency Pit #2

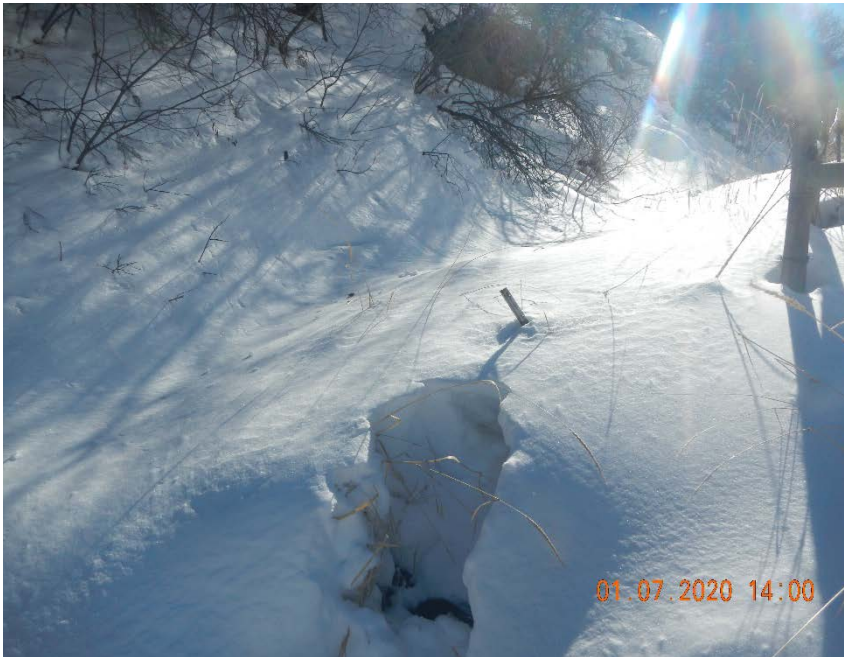
Photo #18 photo of the exit of culvert that Wesco is reporting to be the Straight Gulch diversion that was installed sometime prior to Wesco operating the facility. Photo Data showed lat/long to be 40.287552,-108.024722. No water was observed exiting the culvert. The inlet to the culvert is reported to be near the current water knockout units at the south end of the tank battery facility. The inlet could not be located due to snow.

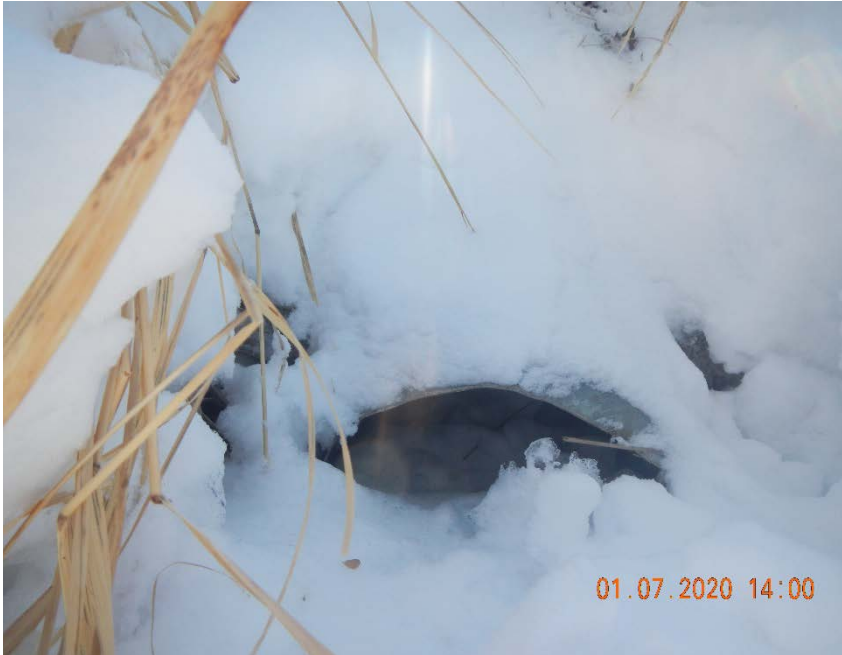
Photo #19 Close up of possible Straight Gulch Diversion culvert.
Exit was recorded by camera as 40.287542, -108.024710.

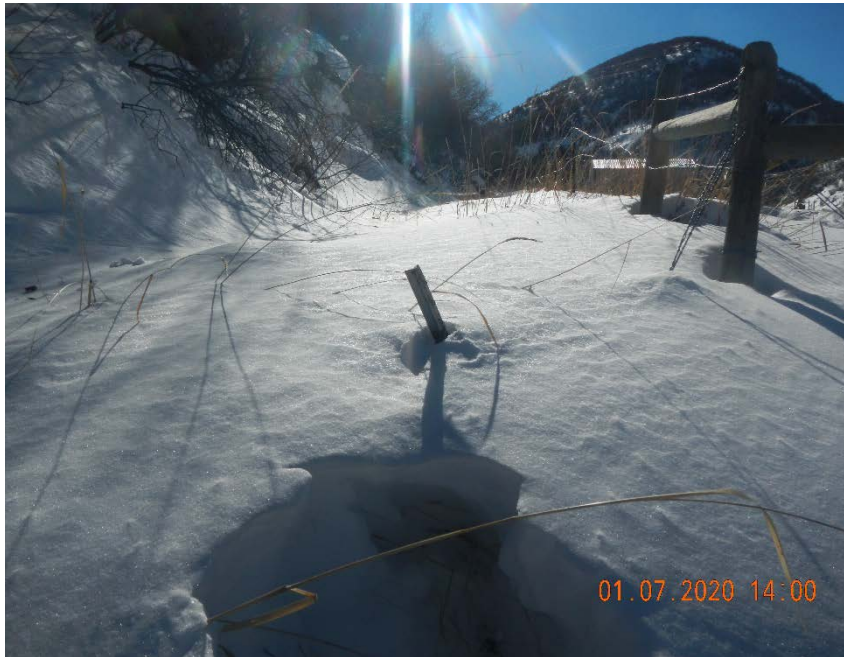
Photo #20 Culvert discharge, looking south-southwest. A buried culvert was observed in potholes that were hydrovaced between the mountain (to the east) and the tank battery (to the west). The observed discharge appears to be in line with the observed culvert in potholes.

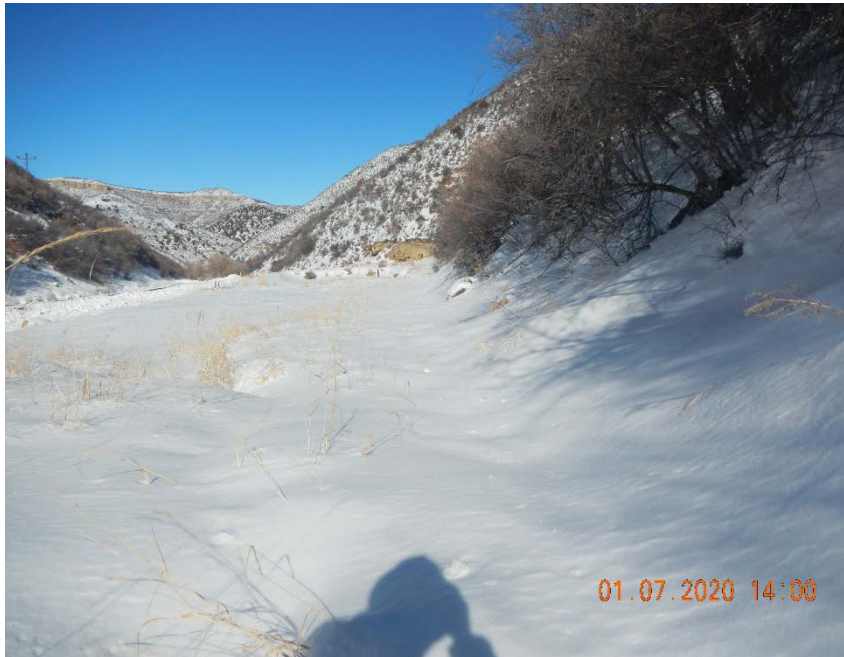
Photo #21 Photo looking downgrade from culvert discharge.

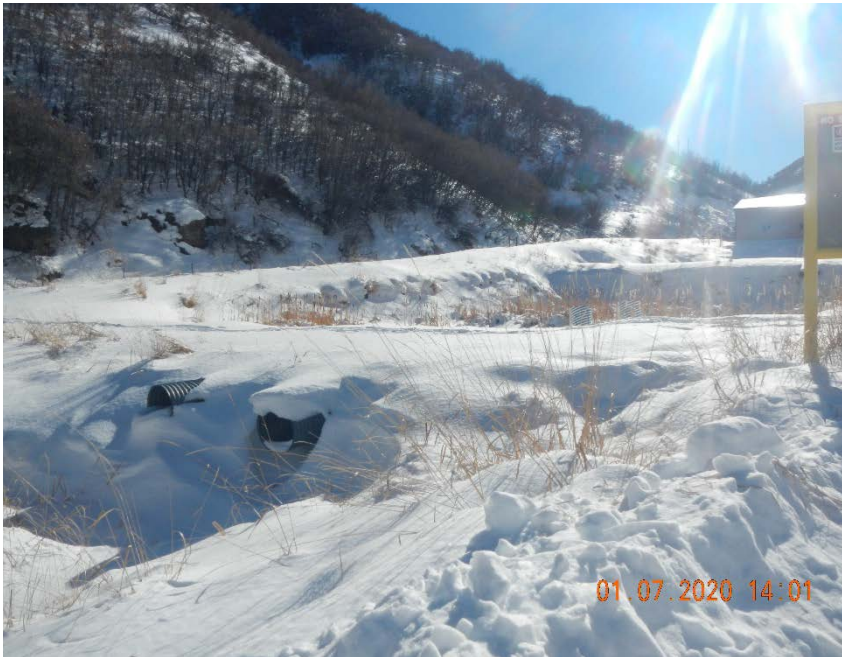
Photo #22 Photo of Emergency Pit #2 discharge.

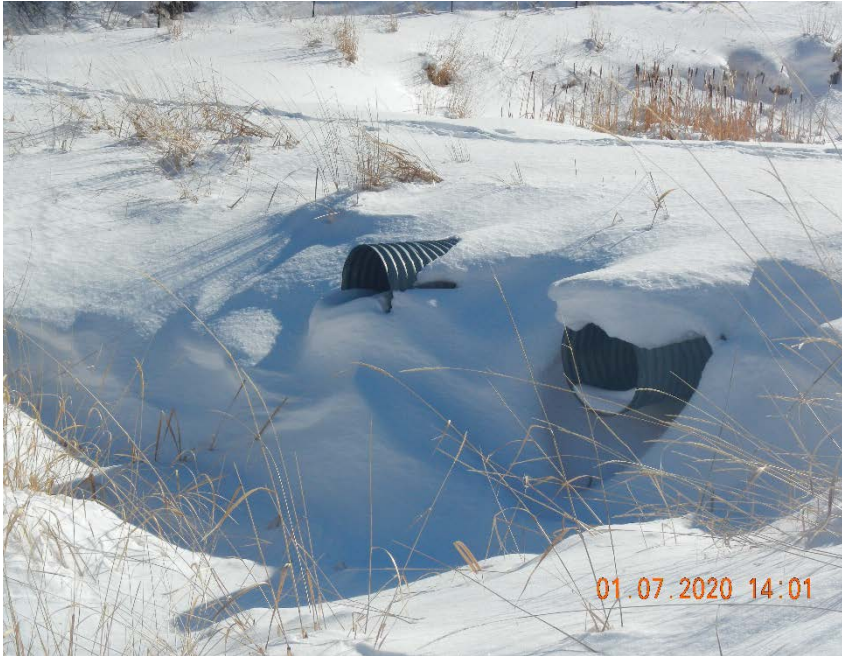
Photo #23 Photo of Emergency Pit #2 discharge.

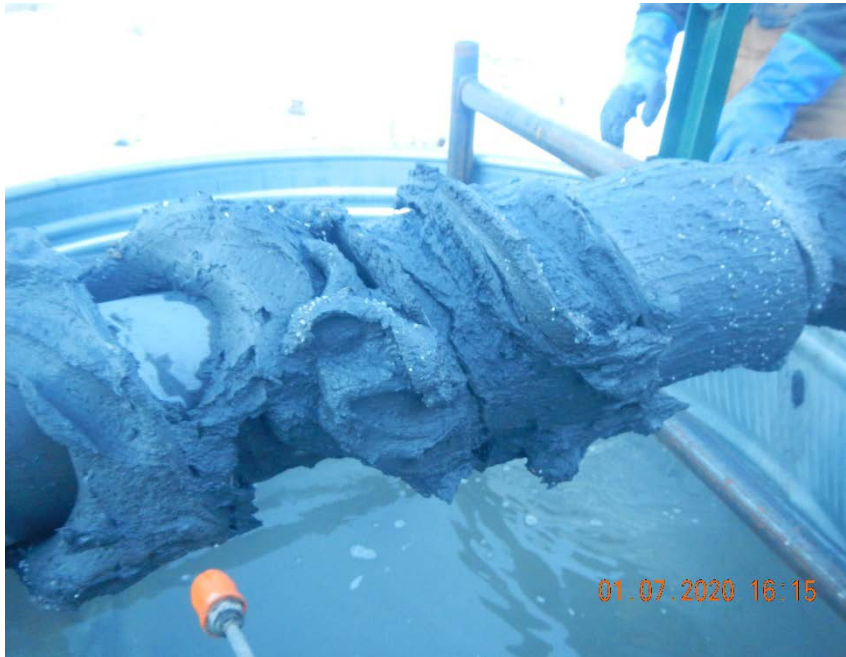
Photo #24 Cleaning of auger bit. Note: kiddie pool catchment basin.

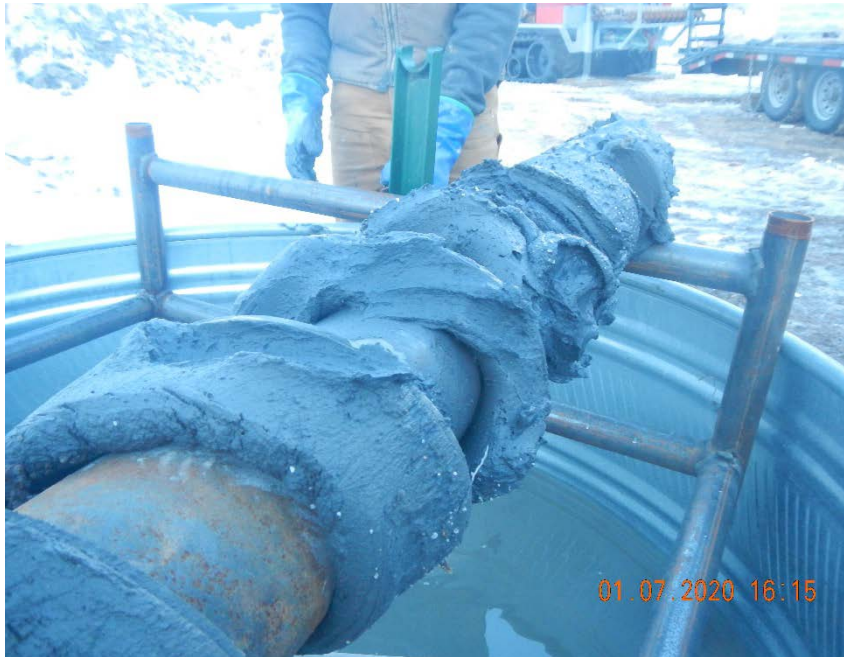
Photo #25 Cleaning of auger bit. Note: kiddie pool catchment basin.
