Inspection Photos

API: 05-043-06207

Operator: JAVERNICK OIL

Inspection Date: 1/23/2020

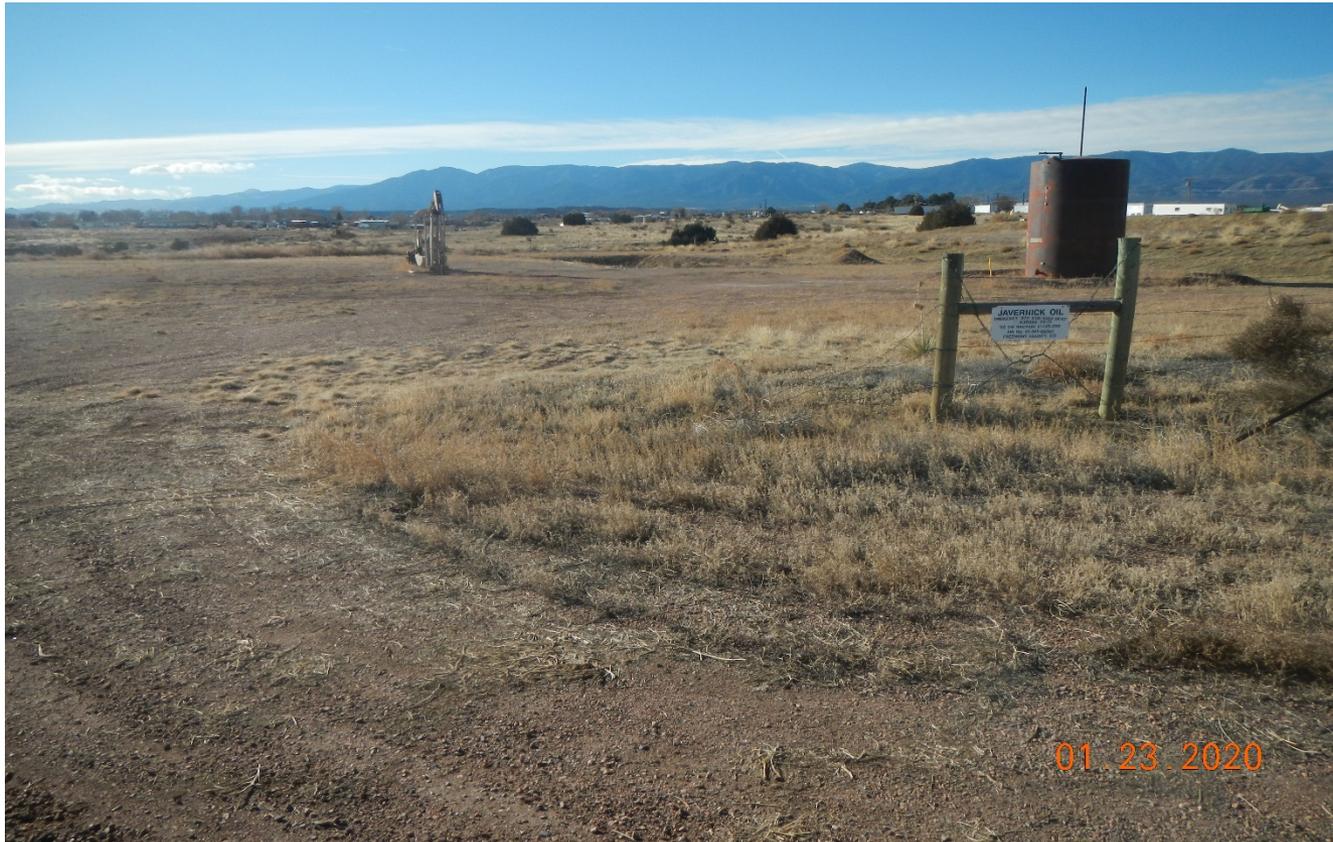
Photo 1. Facing south toward the location. Well sign is posted at the fence H brace.

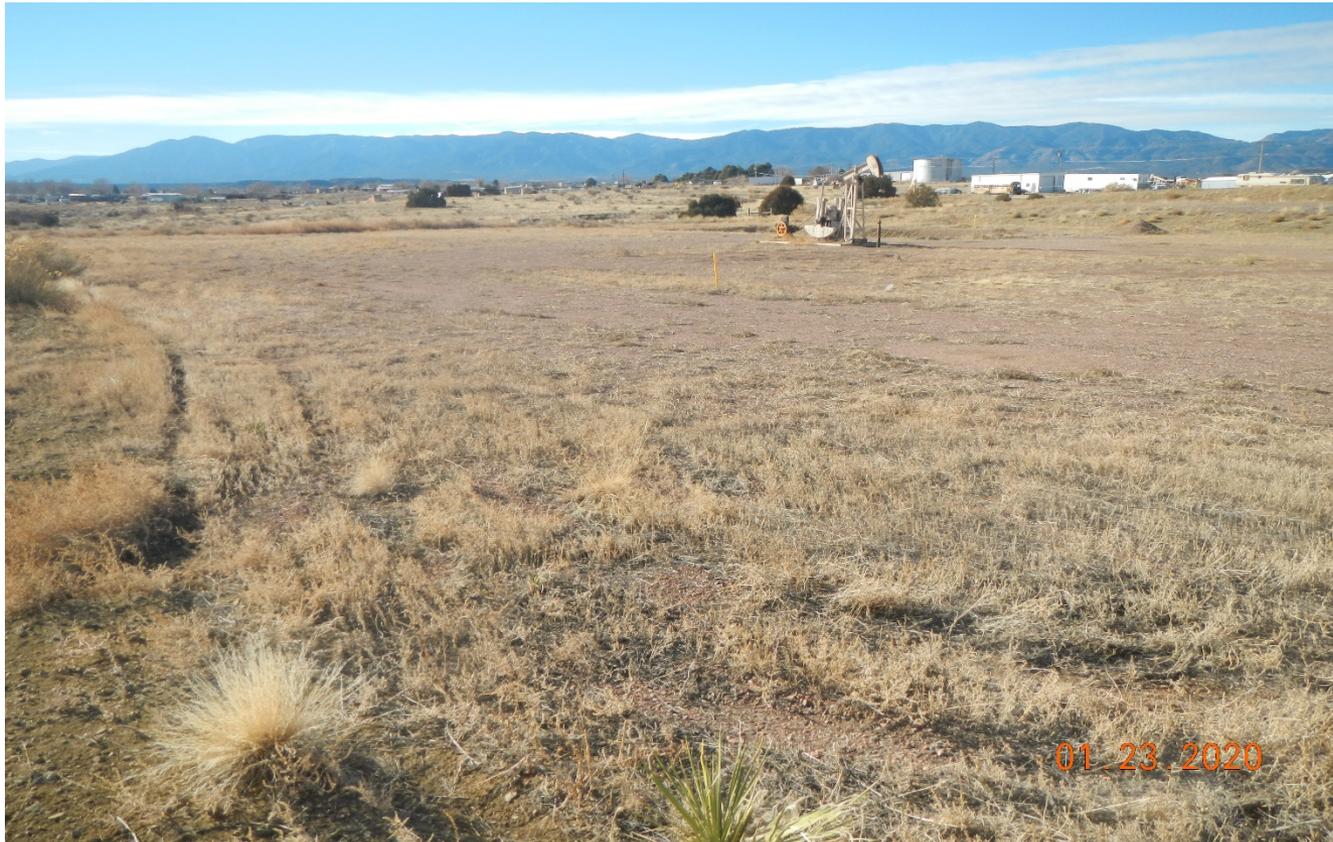
Photo 2. Facing southwest toward the location. Interim reclamation has not been performed at this location. Unused areas of the location must be reclaimed.

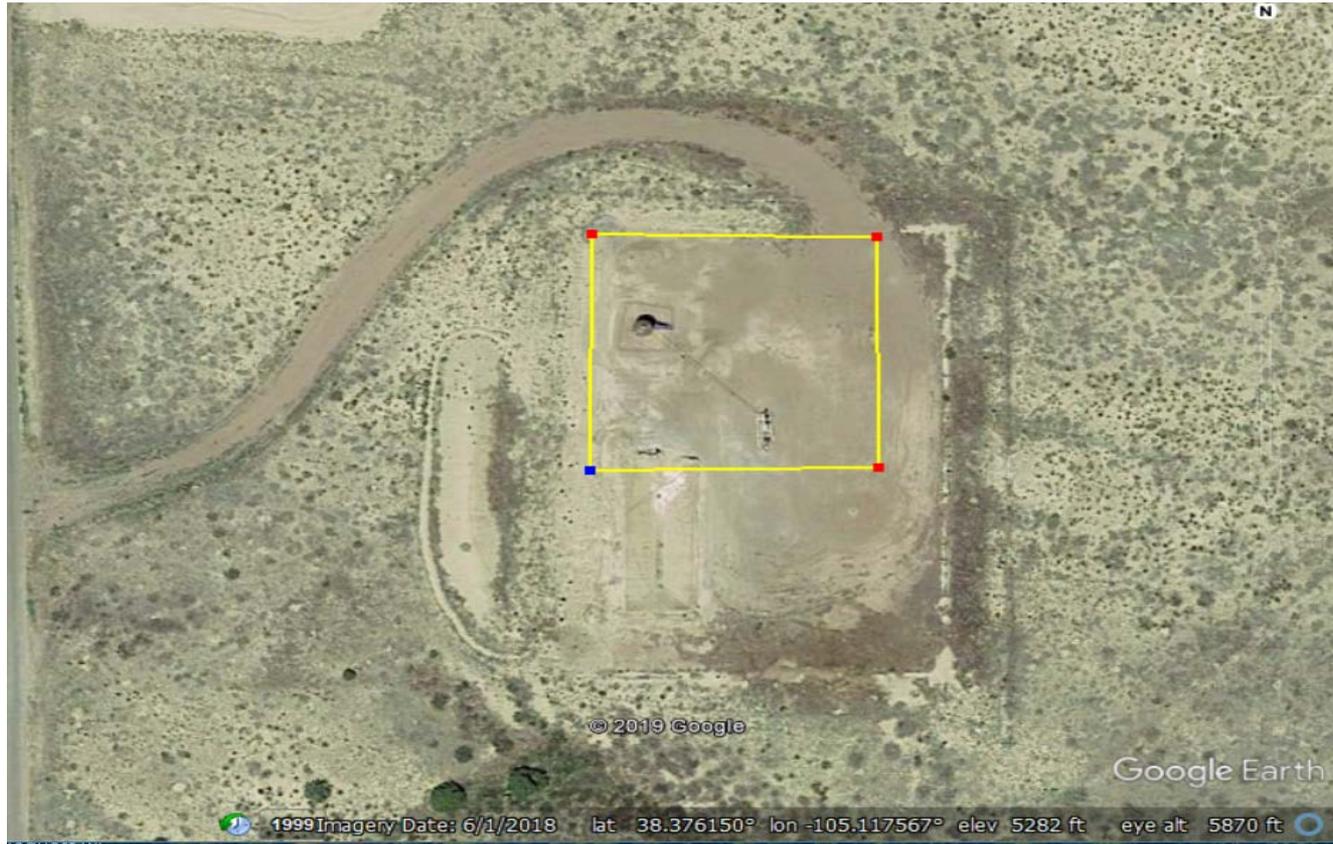
Photo 3. Aerial image shows the location and the outline shows approximately the size of the location it should be reduced to. Unused areas of the location must be reclaimed.

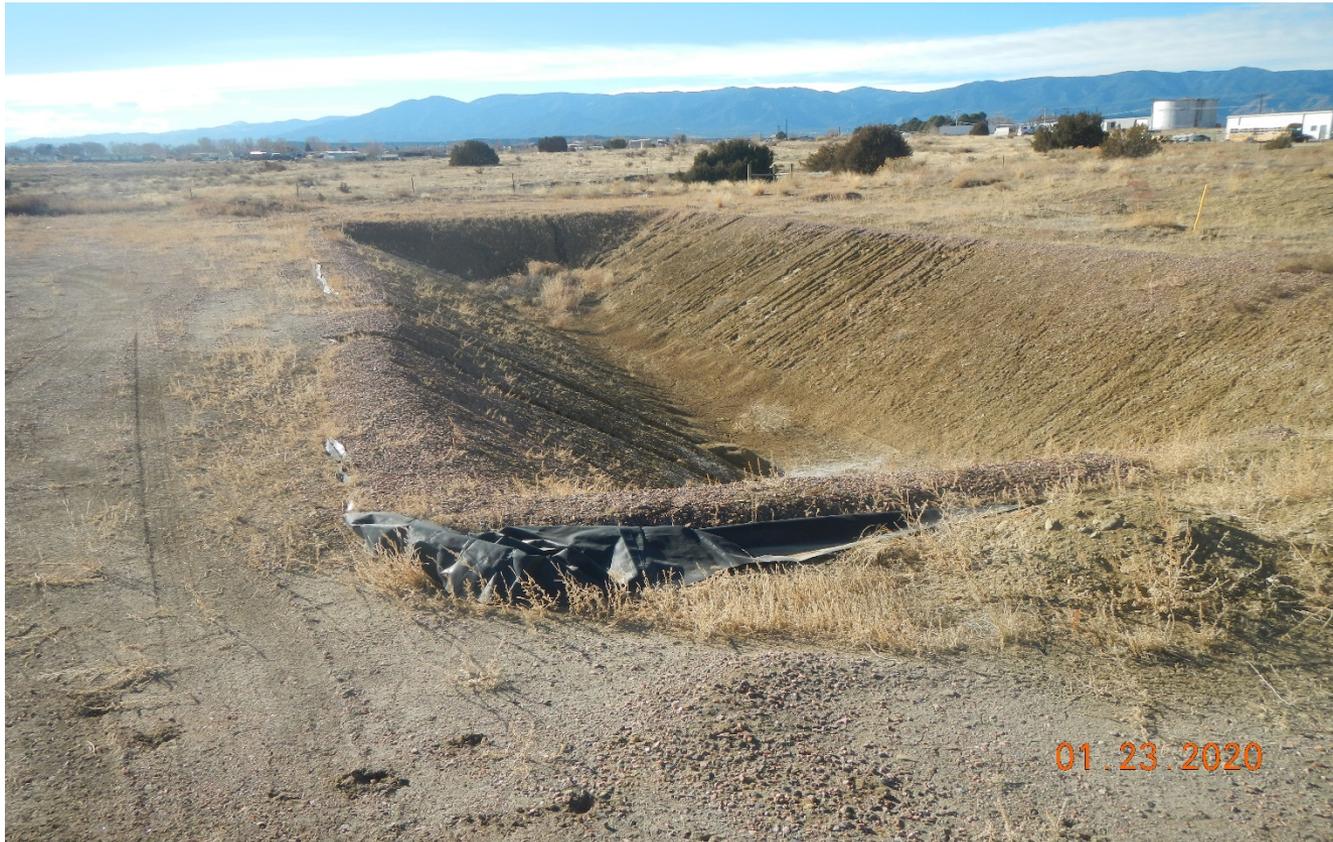
Photo 4. The drilling pit has not been closed and reclaimed as required.

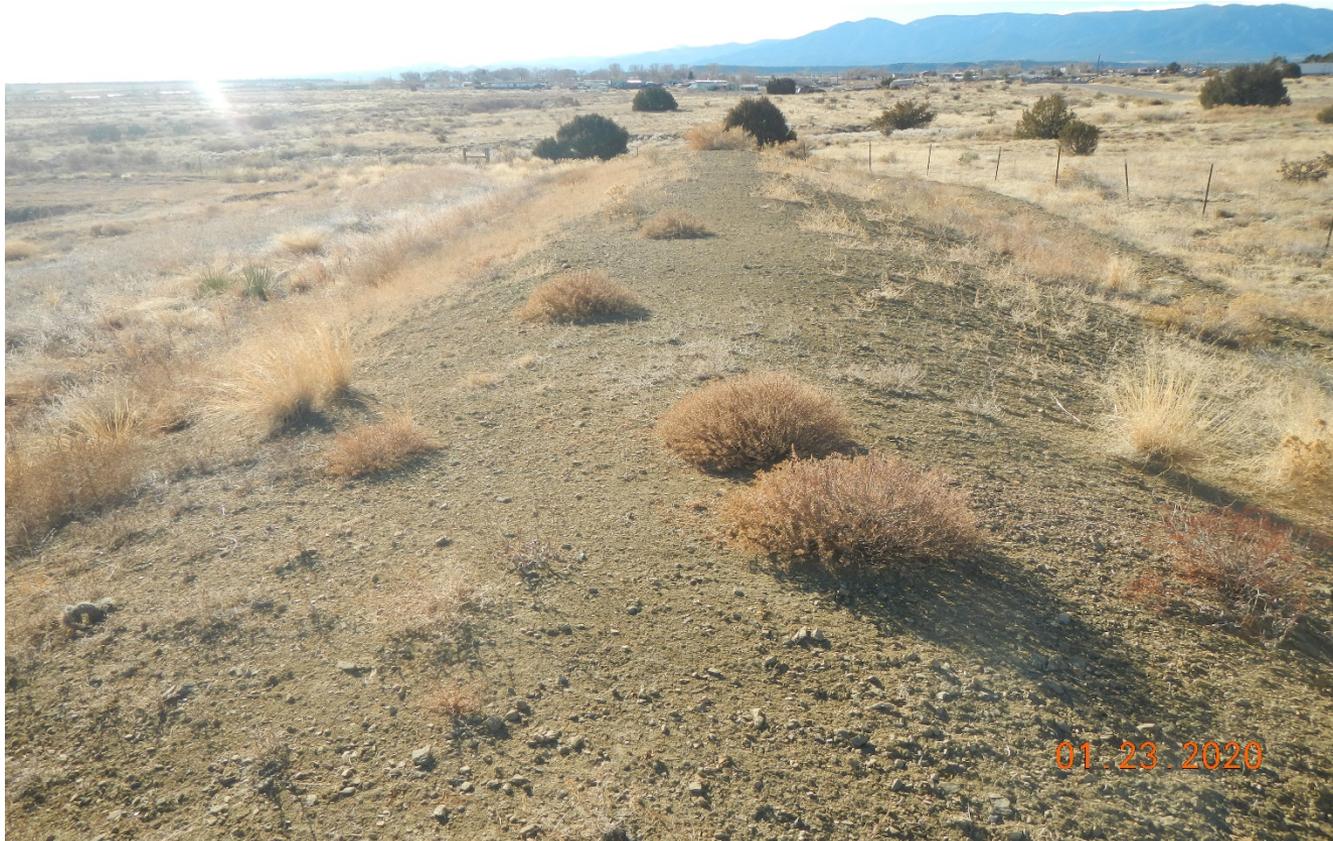
Photo 5. The topsoil pile at the west side of the location is bare and not stabilized. Part of the topsoil needs to be used for interim reclamation.

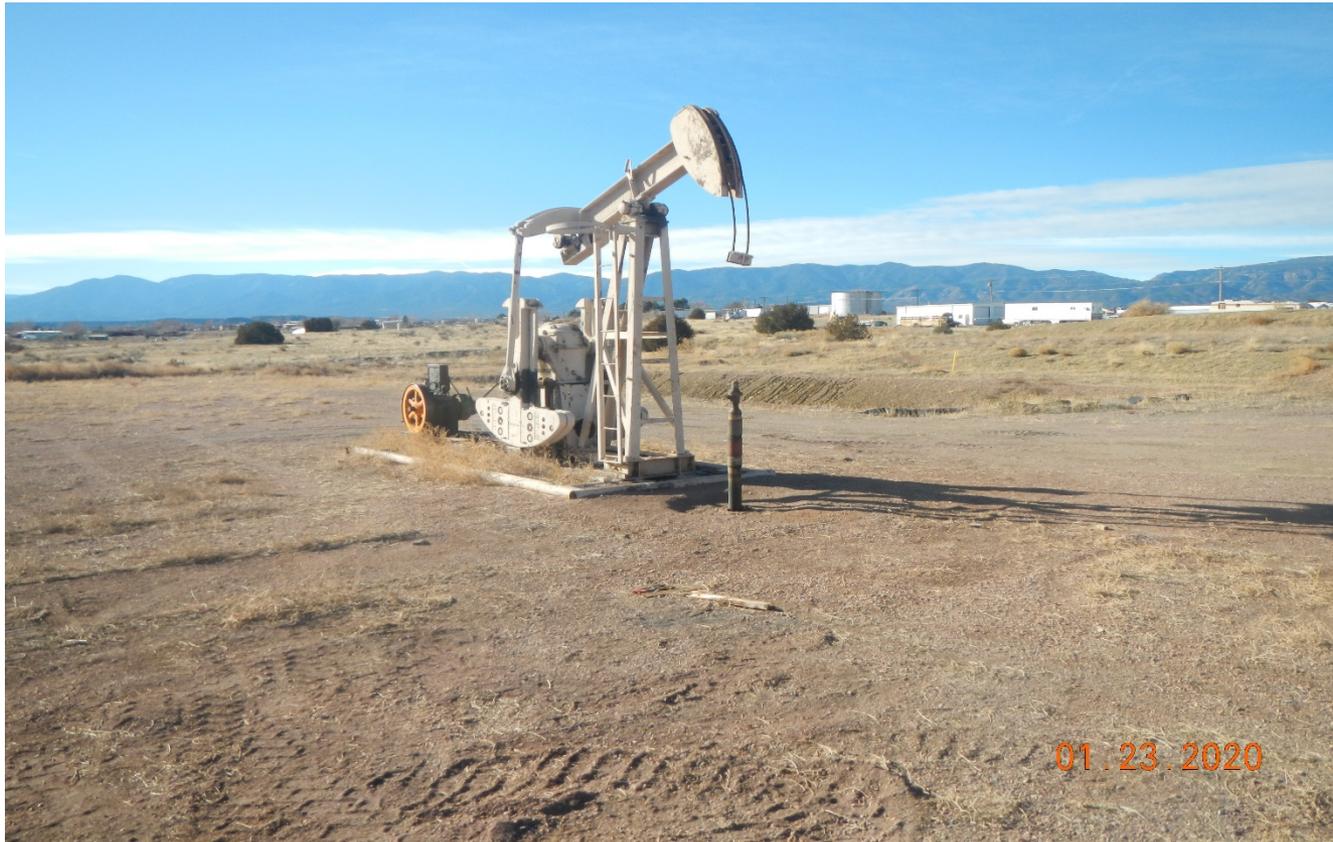
Photo 6. The pumpjack appears to be disconnected. Well status appears to be shut in.

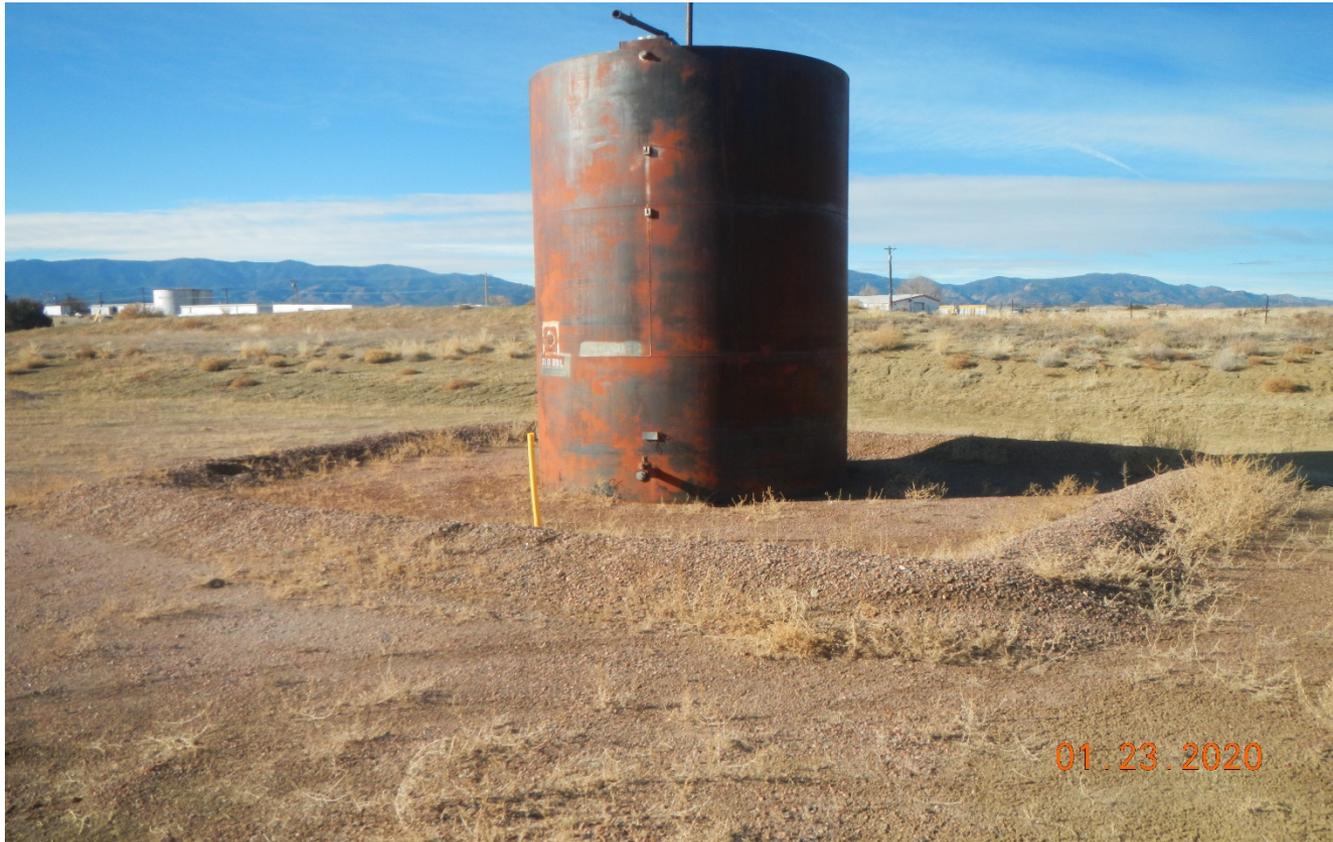
Photo 7. The tank does not have the required labeling.
