Inspection Photos

Operator: Catamount Energy
Location/API #: 067-10019
Date: 1-22-2020

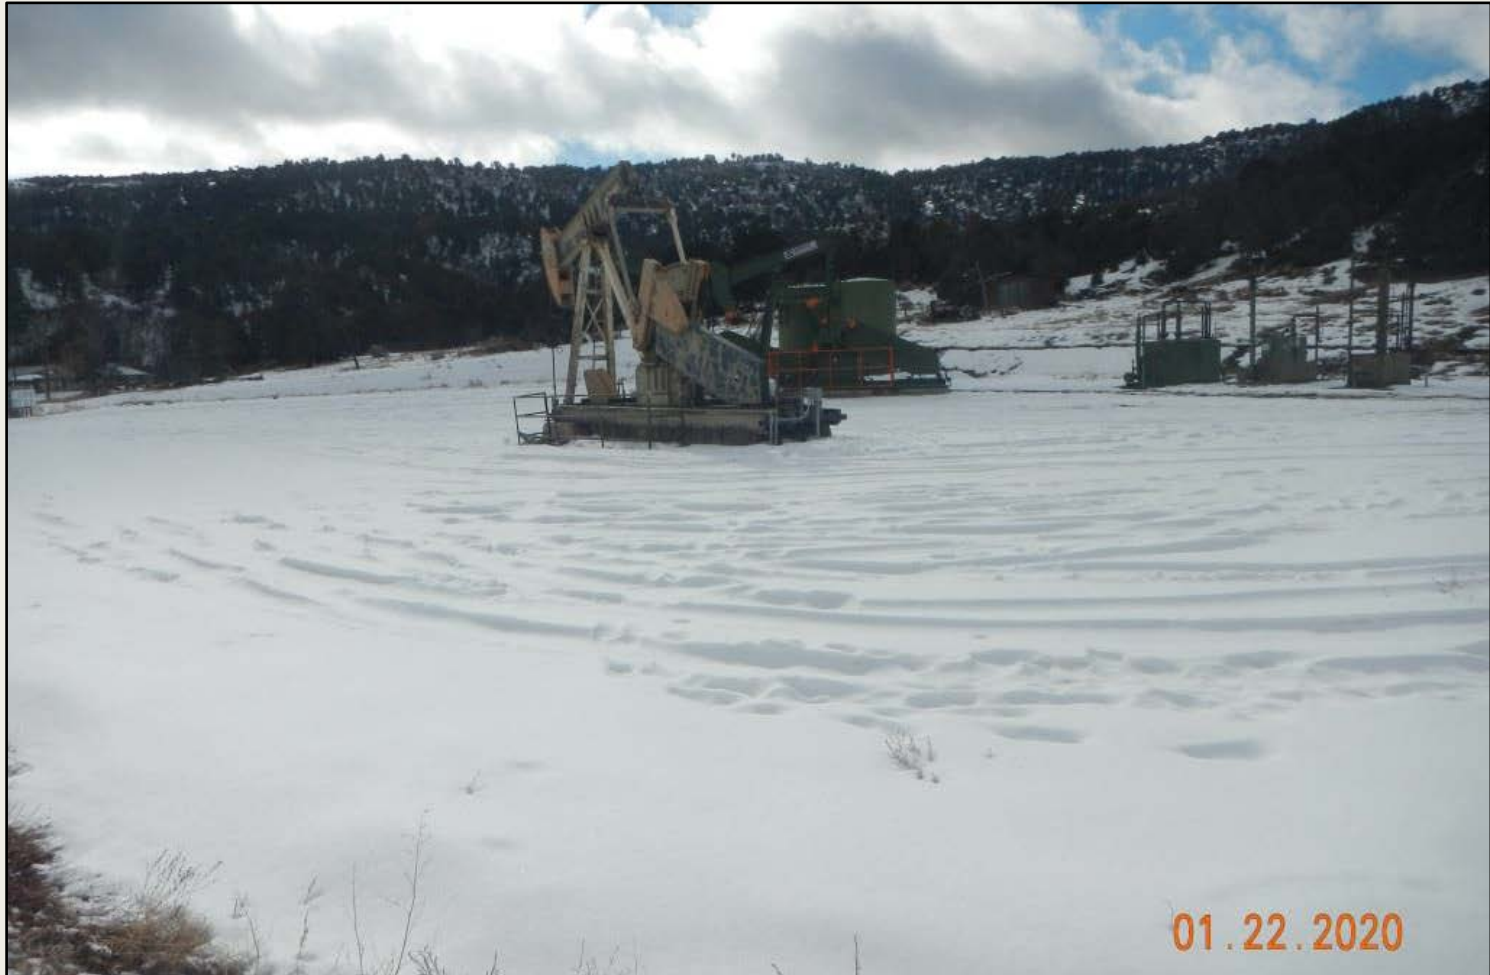
Photo 1. View of the project area from the northeastern corner facing center.

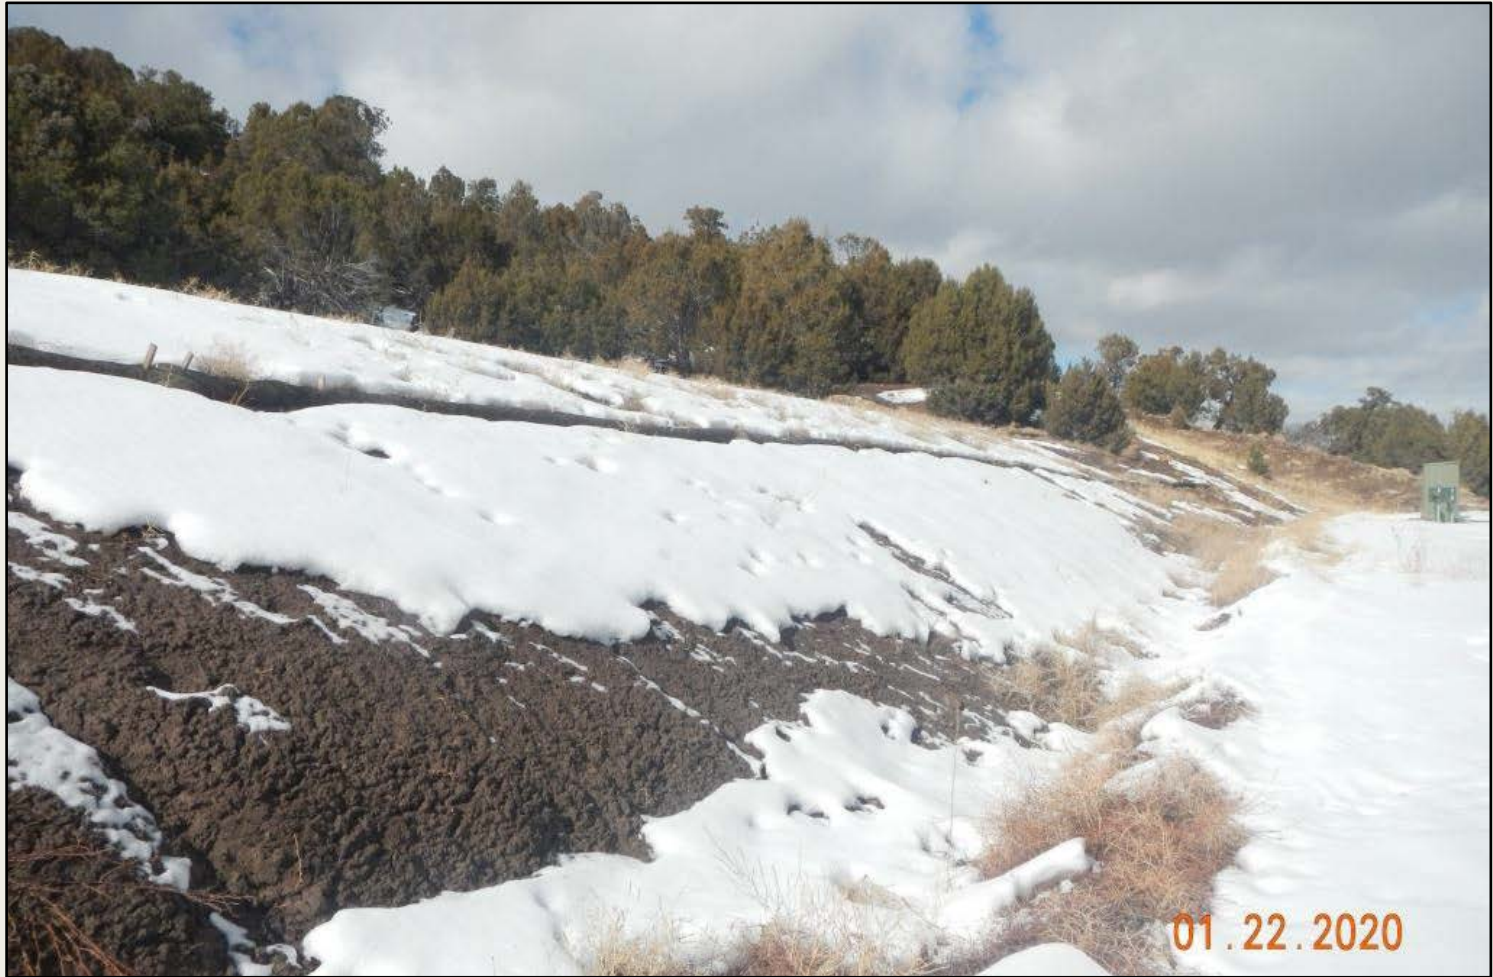
Photo 2. View of the western cut-slope from the western edge facing northward.

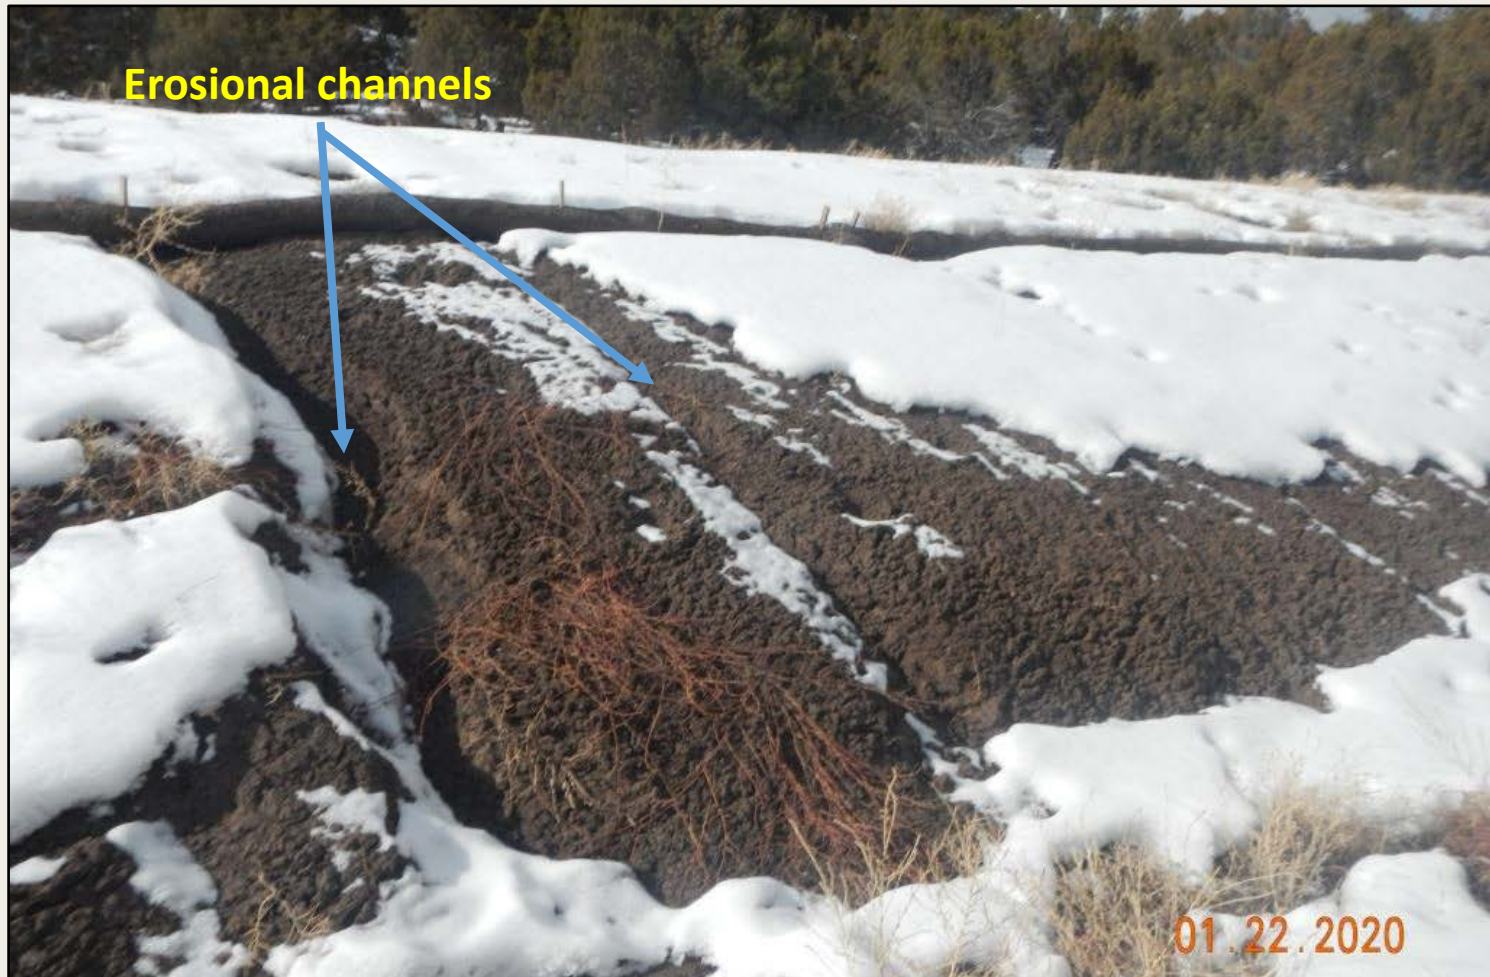
Photo 3. View of erosional channels that remain in the western project area.

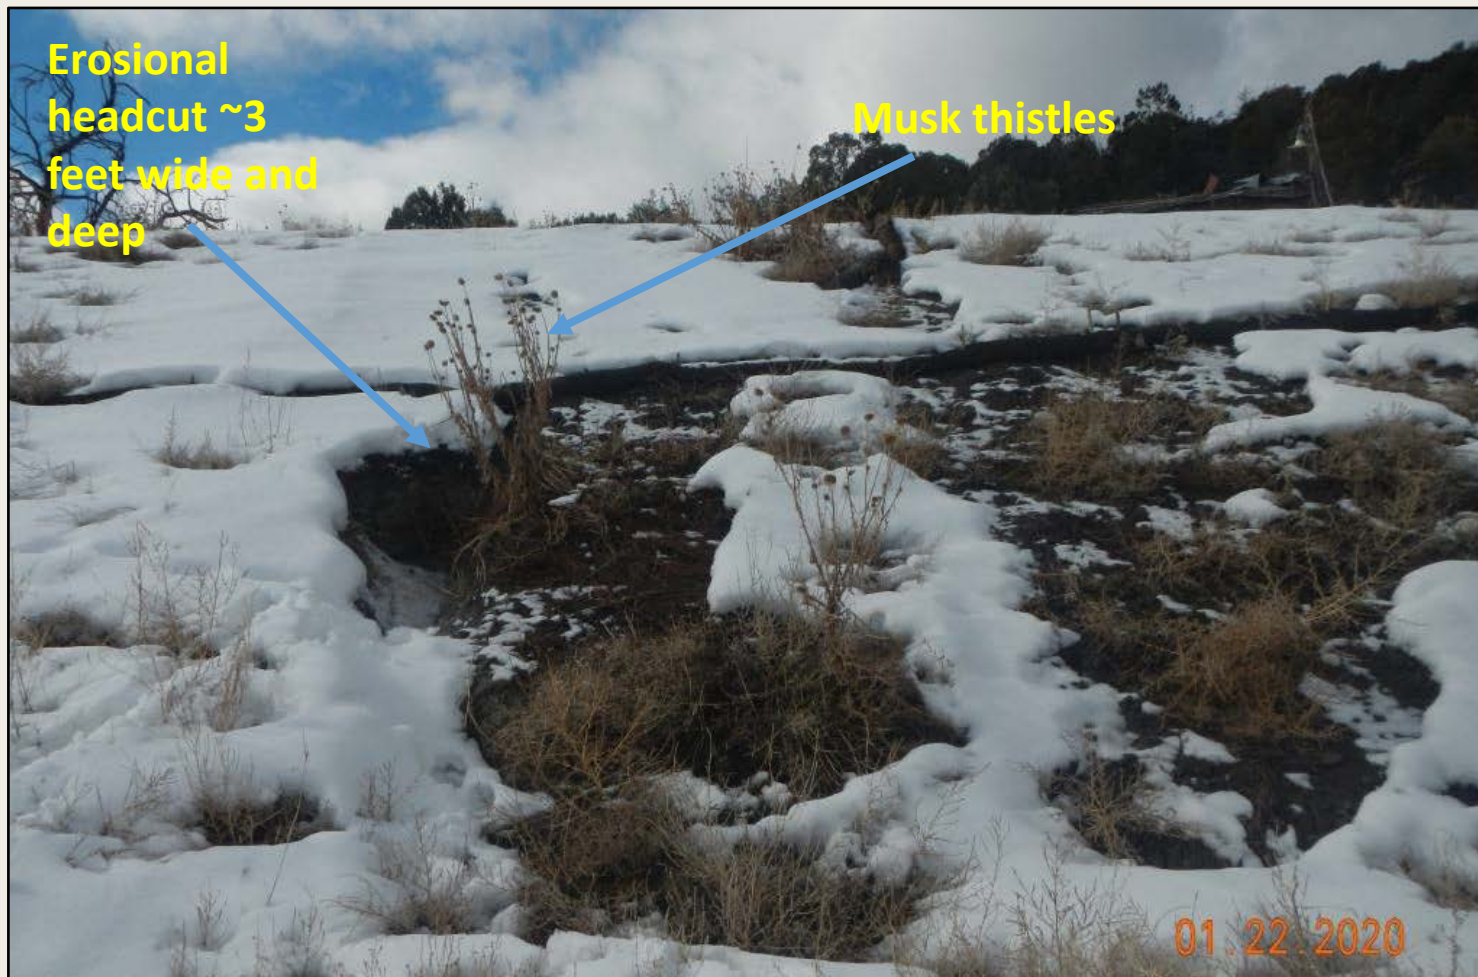
Photo 4. View of erosional channel that remains on the southwestern project area.

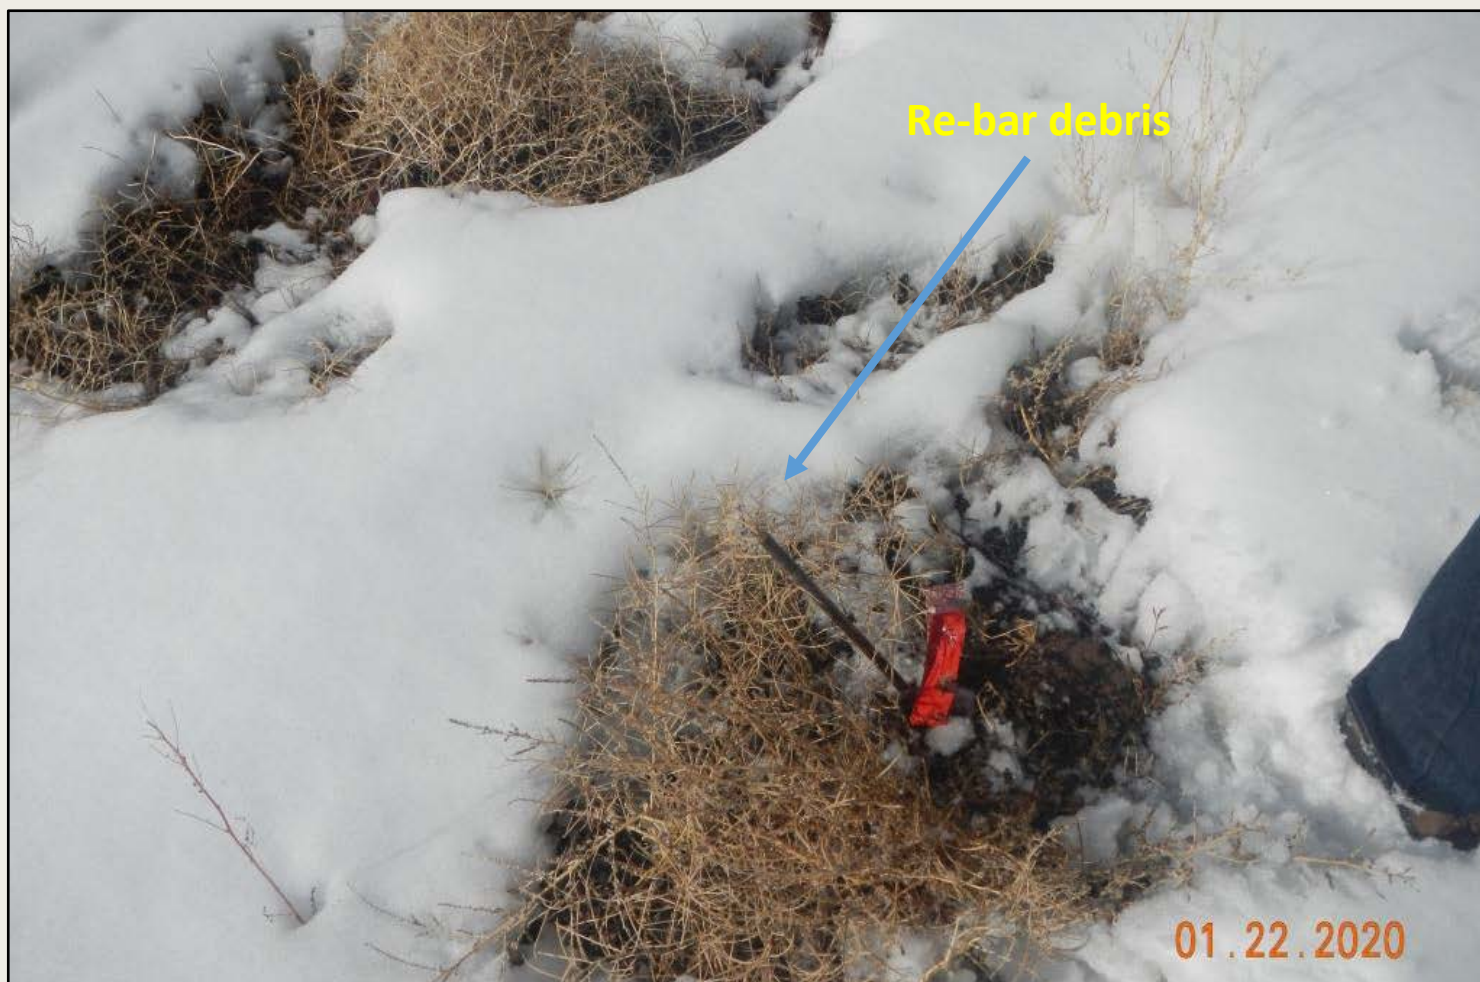
Photo 5. View of metal debris within the southwestern project area.

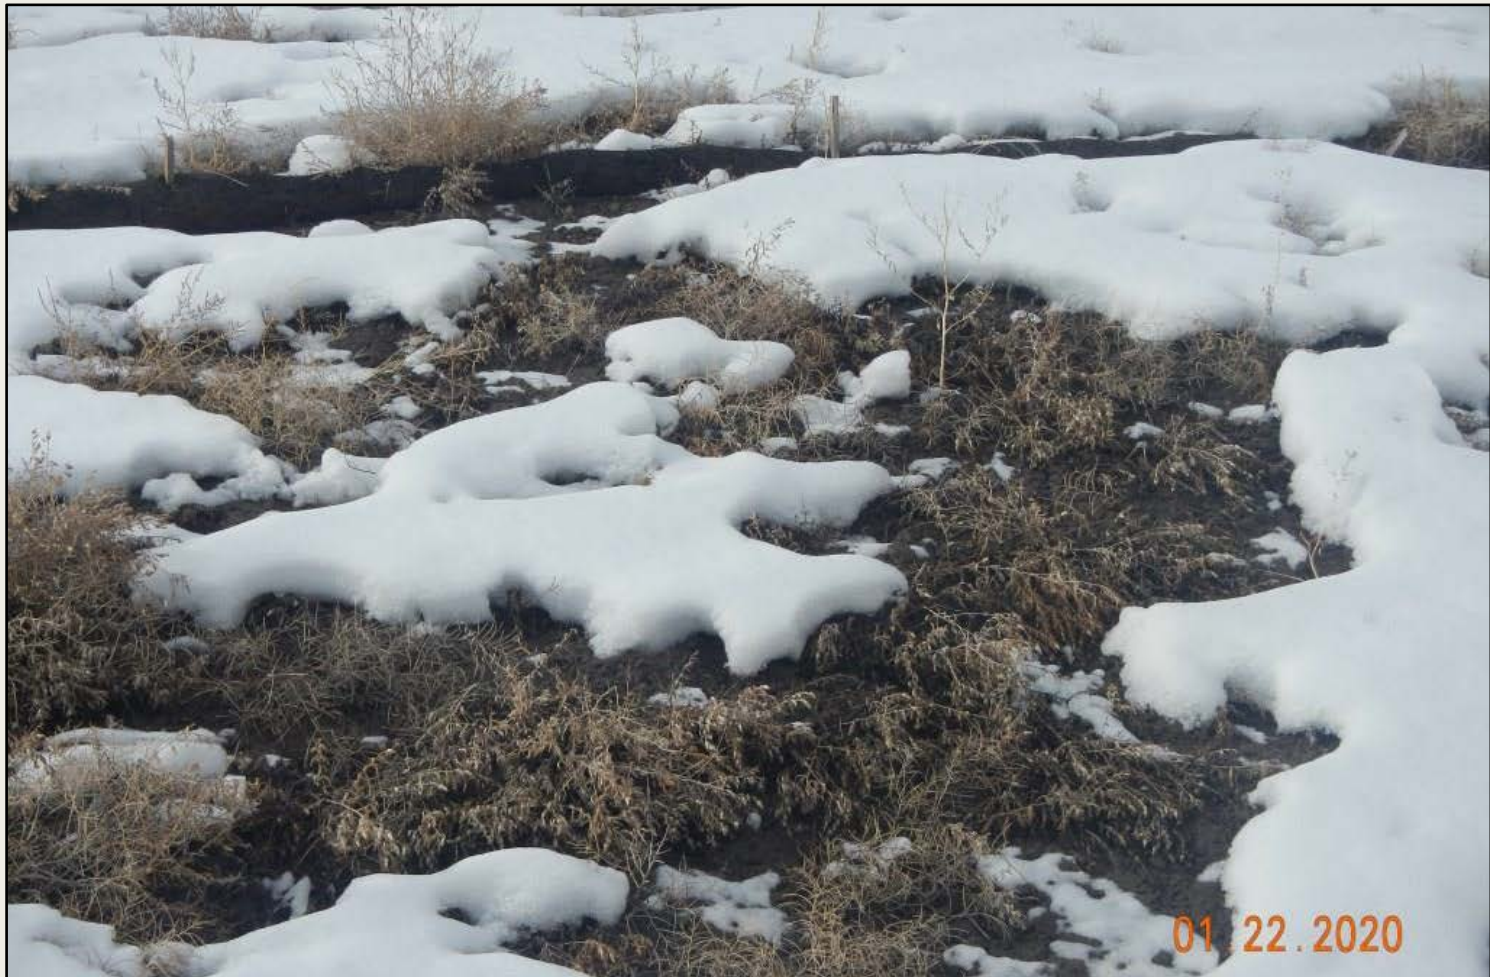
Photo 6. View of Russian knapweed in the western project area.
