Inspection Photos

API: 05-043-06219

Operator: AUSCO PETROLEUM INC

Inspection Date: 1/23/2020

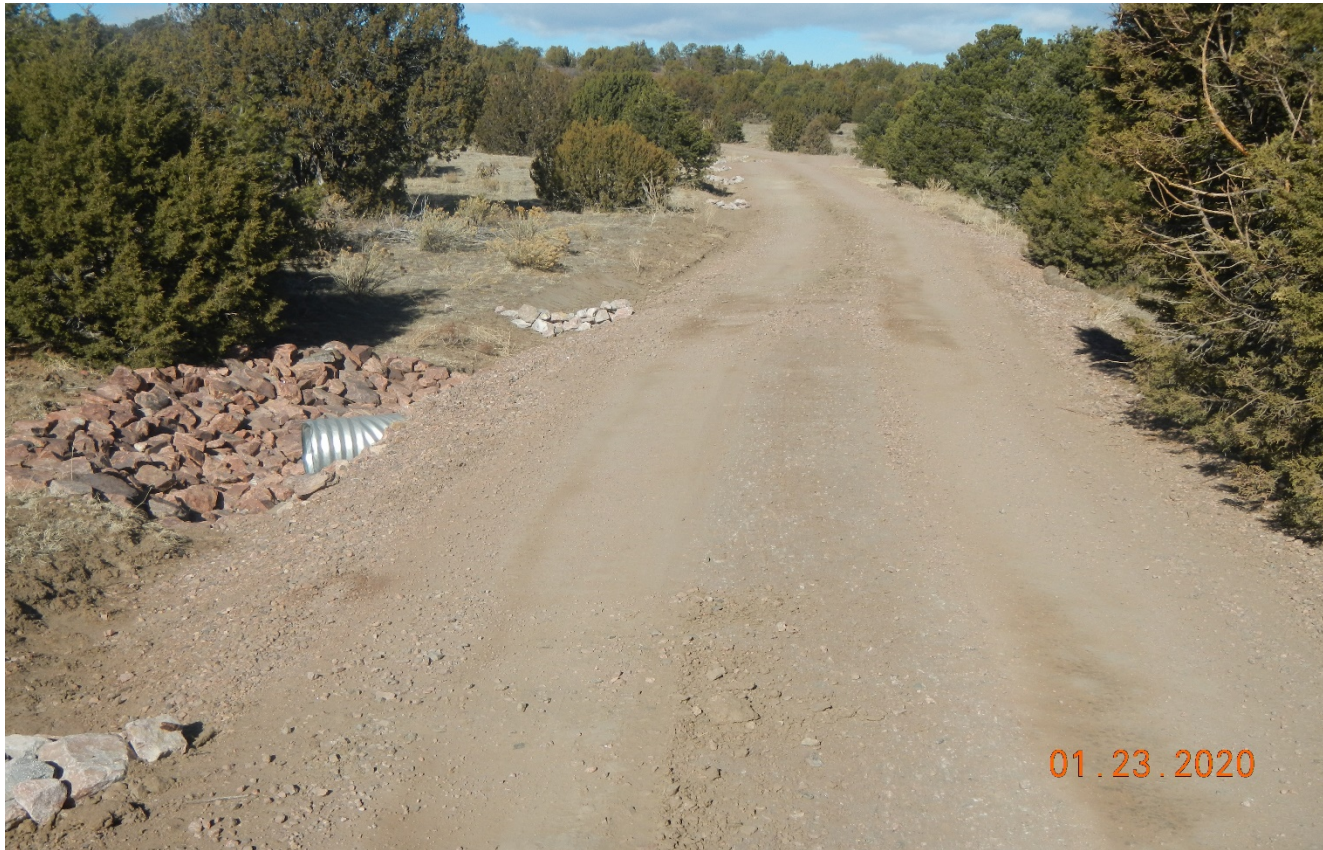
Photo 1. Facing northwest along the access road. Stormwater controls appear to be maintained.

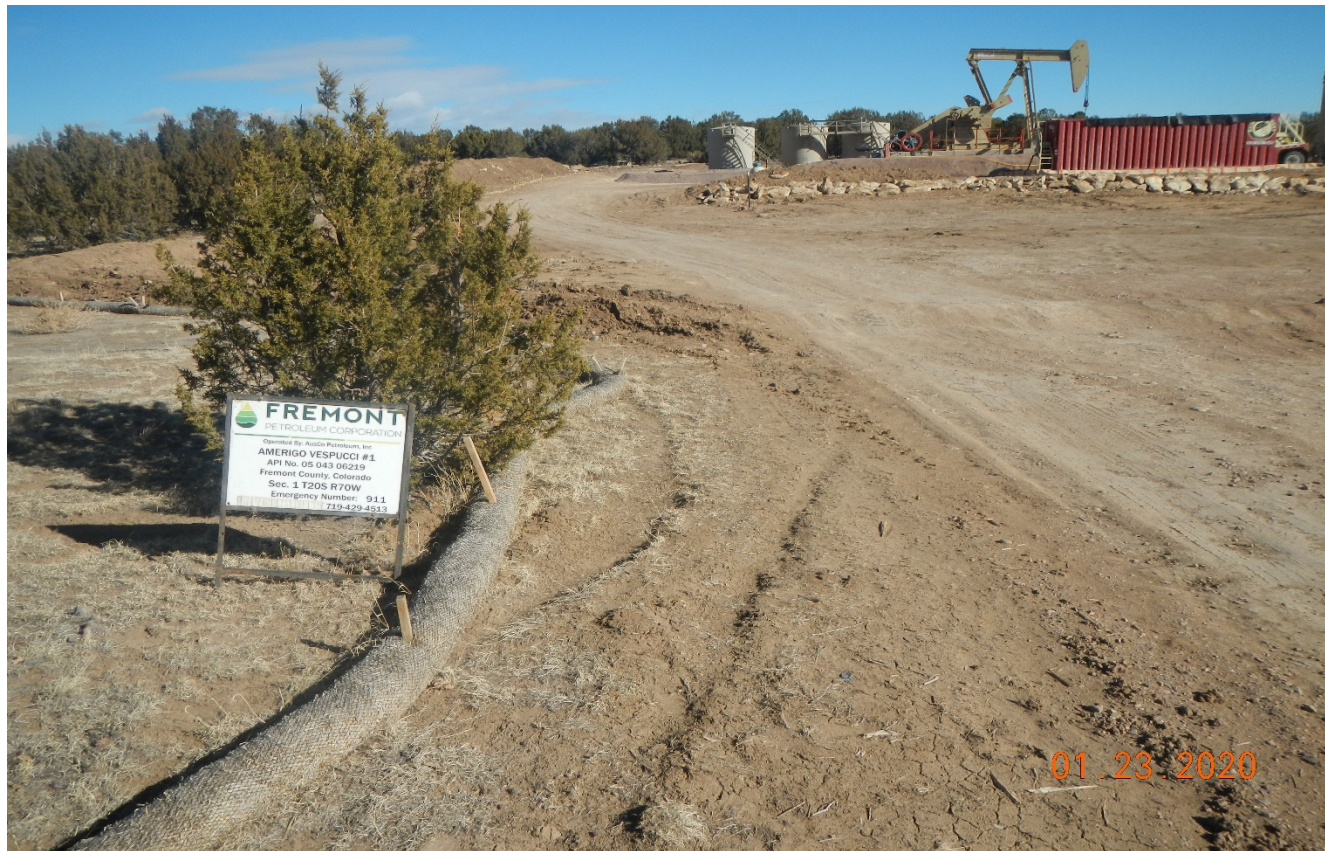
Photo 2. Facing north toward the location. Well sign is posted.

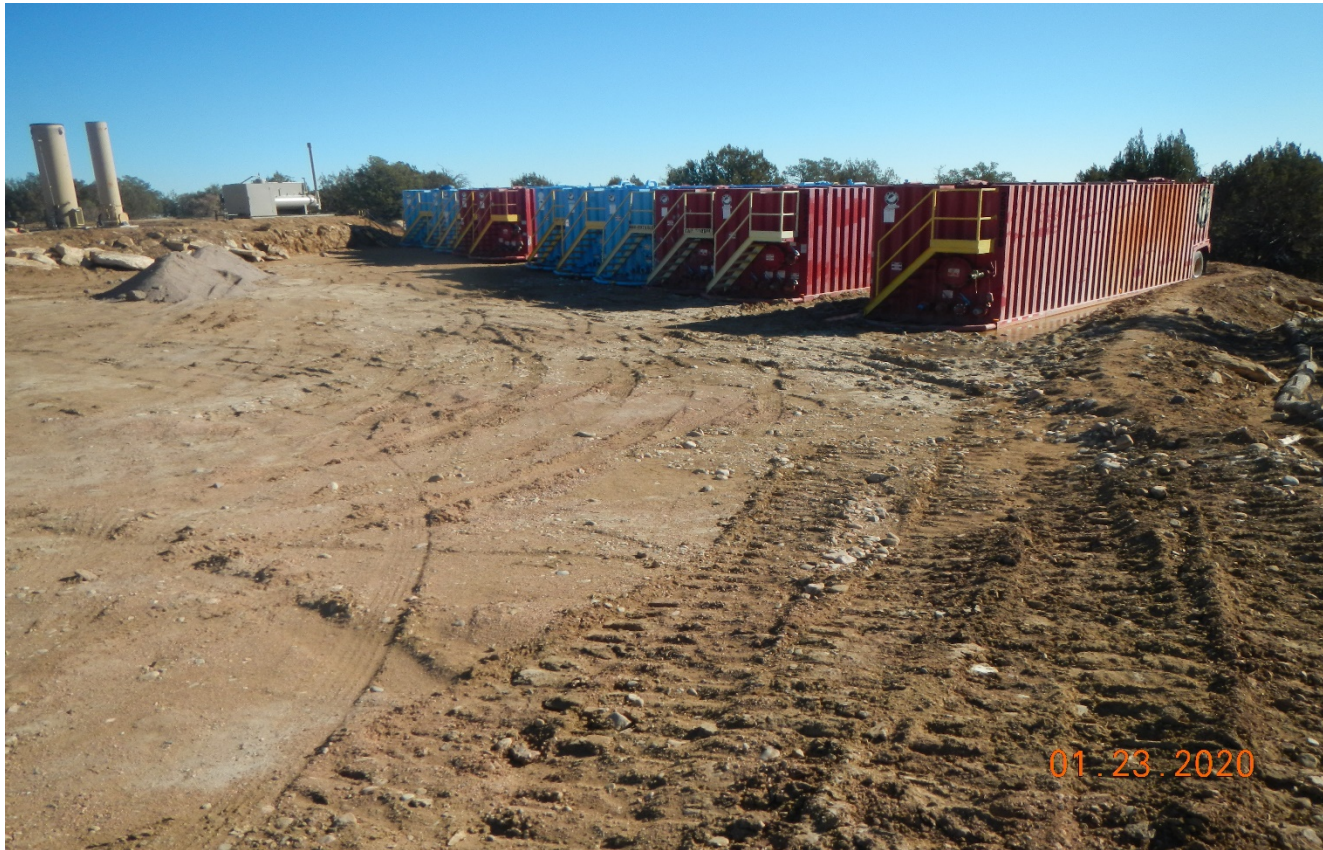
Photo 3. Facing northeast at the location. There is 11 frac tanks staged at this location. The tanks need to be removed so interim reclamation can be performed.

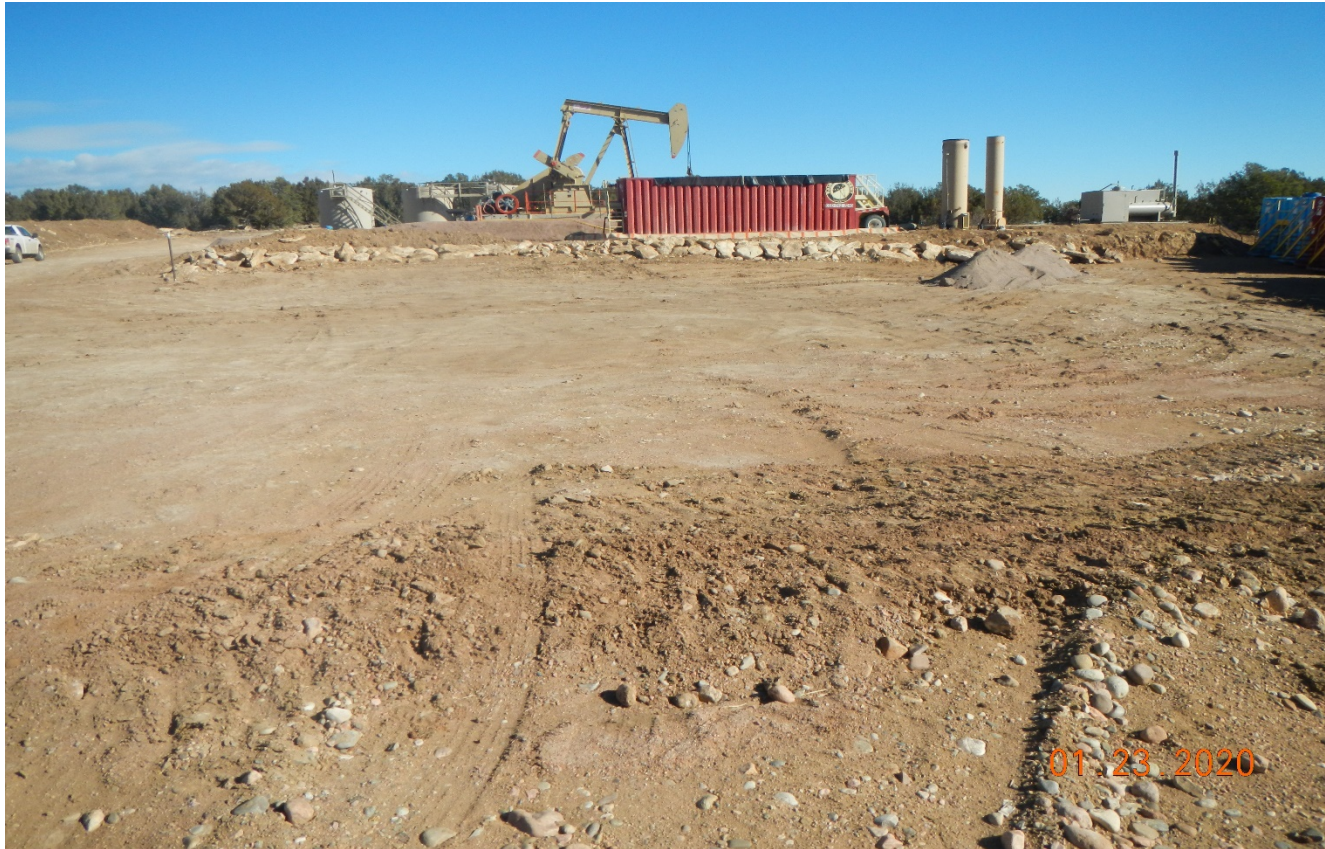
Photo 4. Facing north toward the location. Interim reclamation has not been performed. Unused areas must be reclaimed.

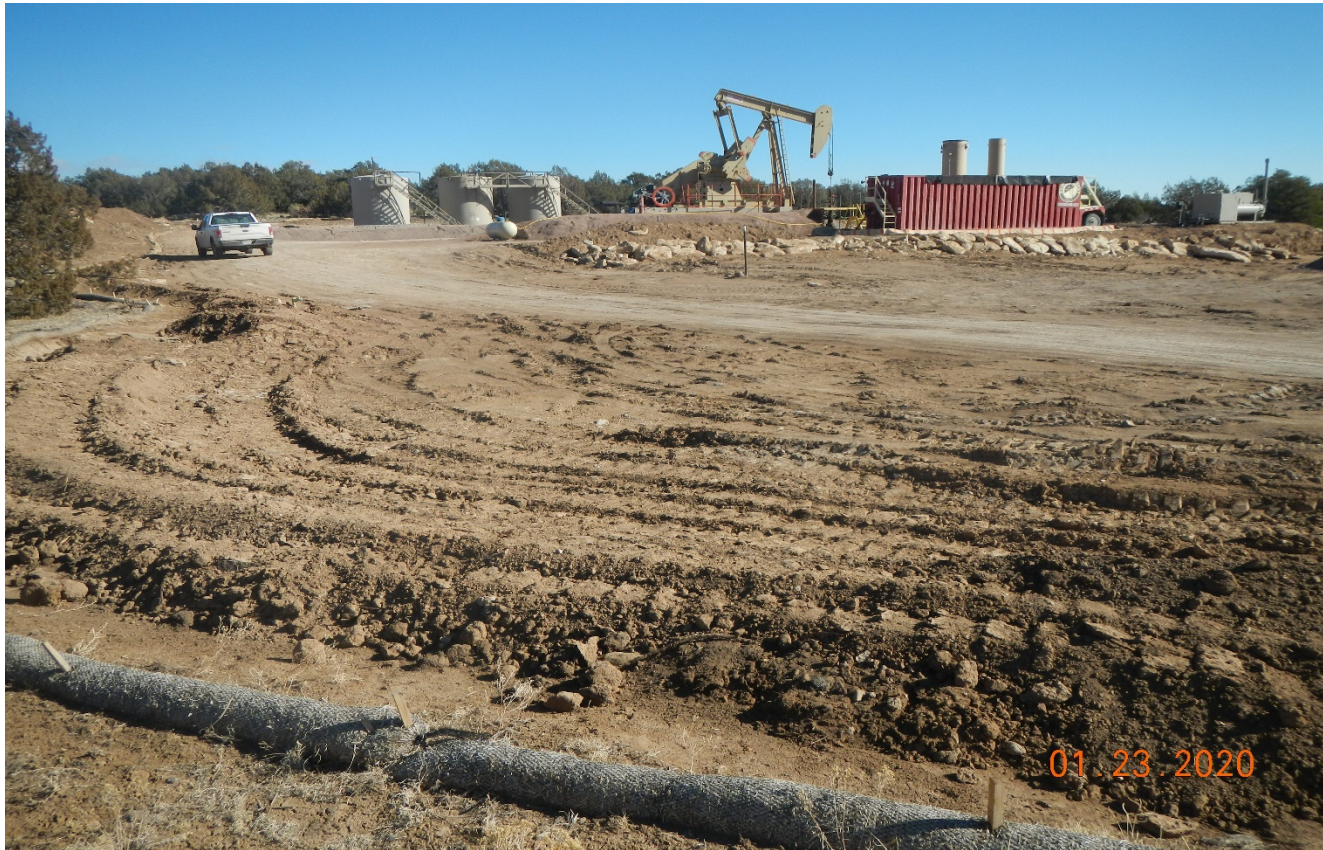
Photo 5. West side of the location facing northeast. Unused areas of the location must be reclaimed. Disturbed soils are susceptible to erosion.

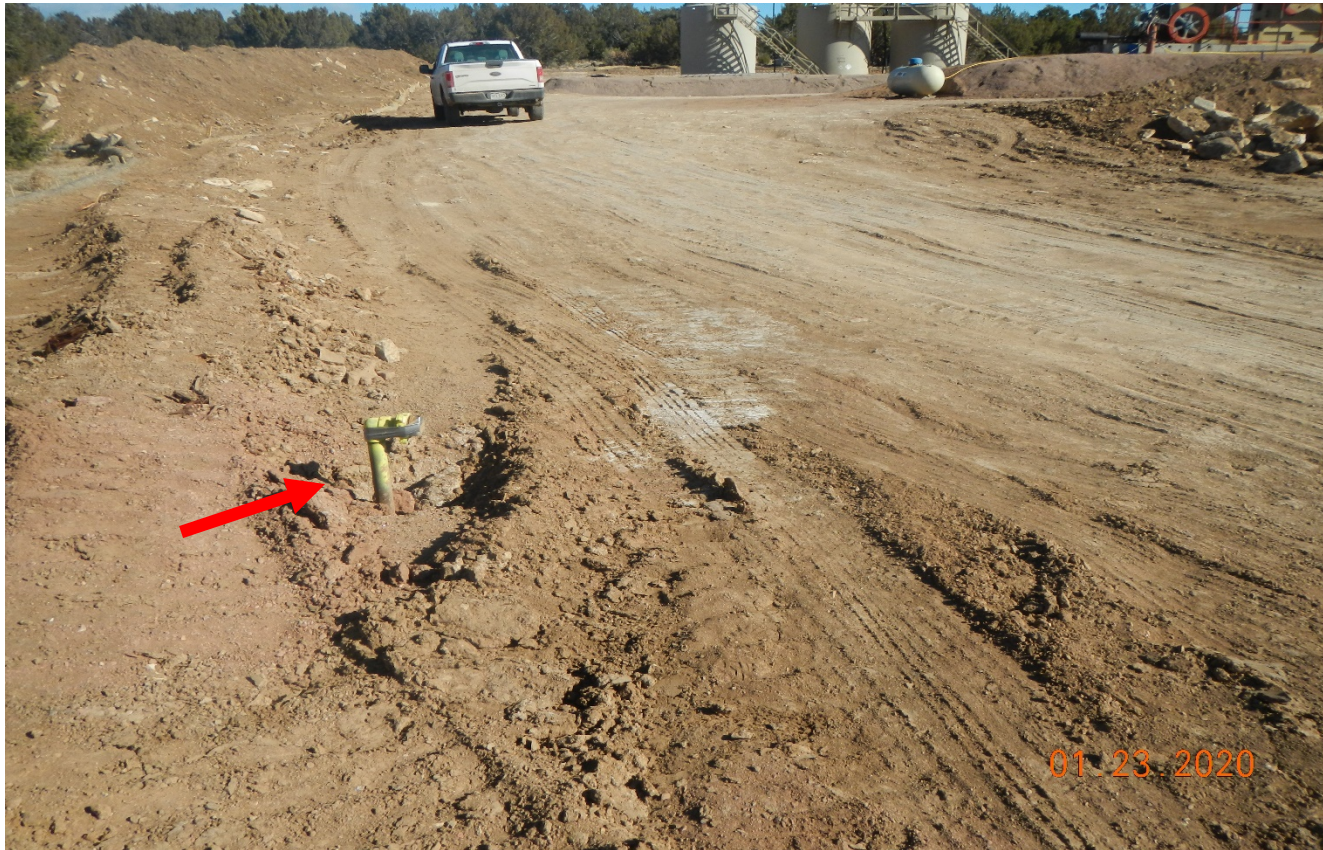
Photo 6. There is a pipe riser at west side that is not clearly visible or protected.

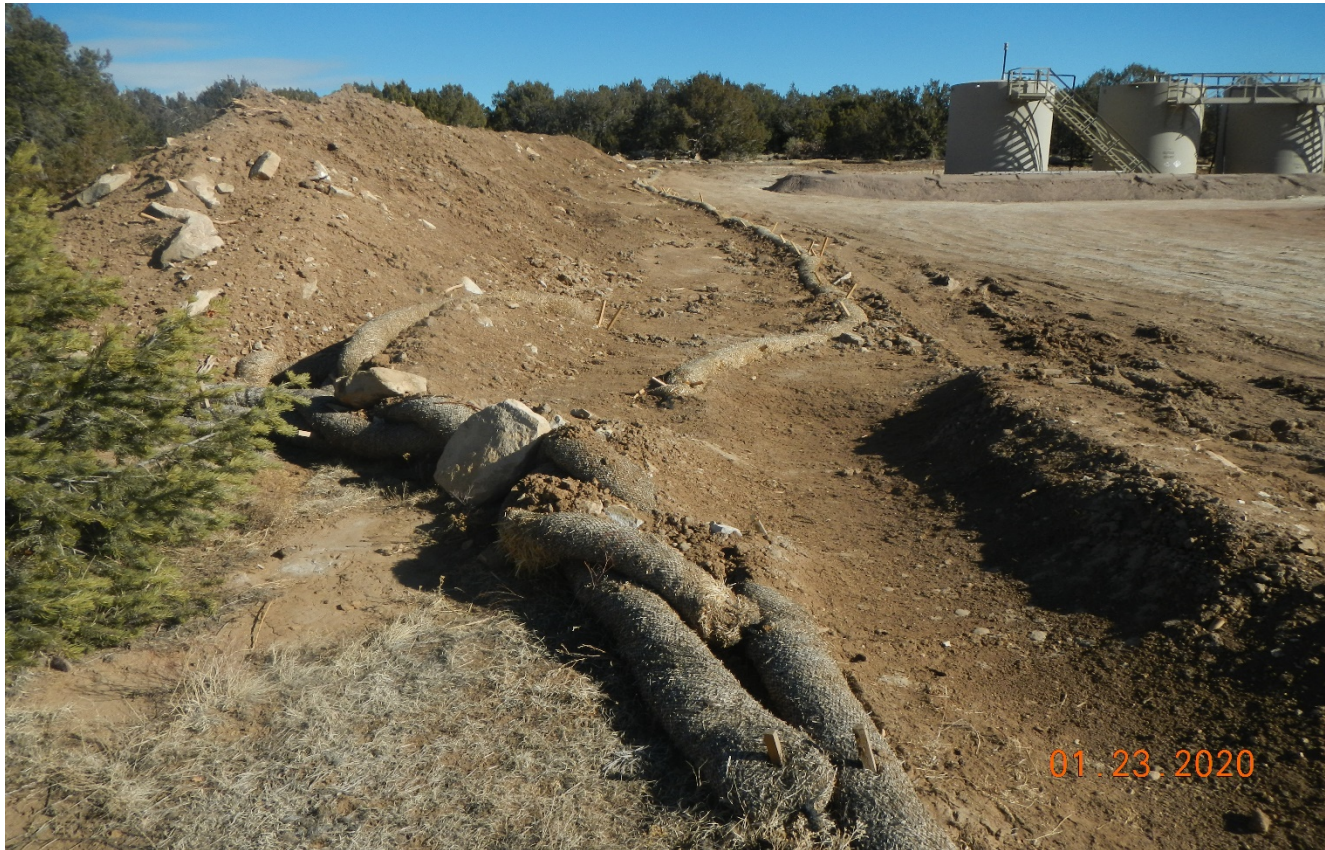
Photo 7. Wattle are displaced in areas around the location. BMP's must be maintained at all times.

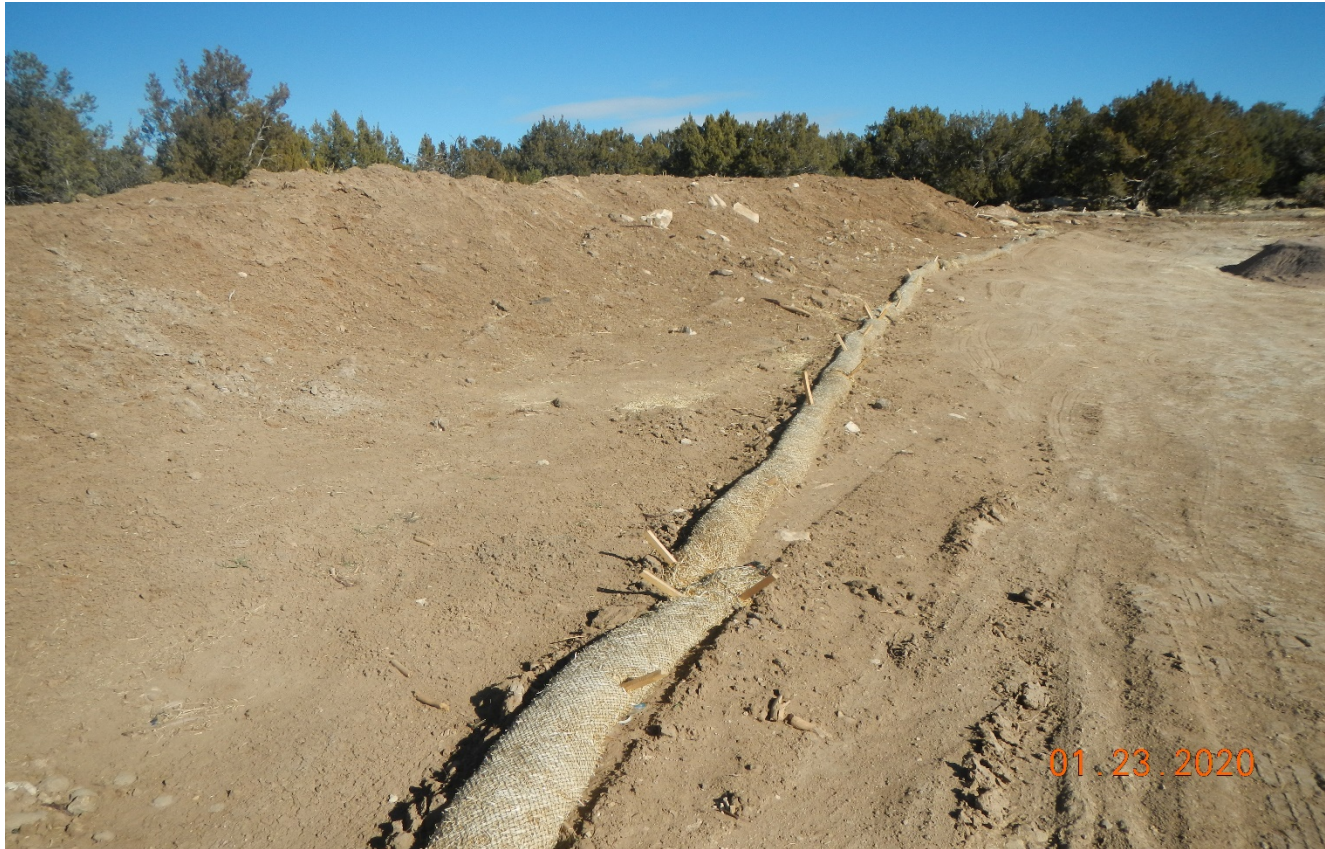
Photo 8. Topsoil pile at west side of the location. The topsoil pile is not stabilized and protected. A portion of the topsoil will need to be used for interim reclamation. The remaining portion must be seeded and stabilized.

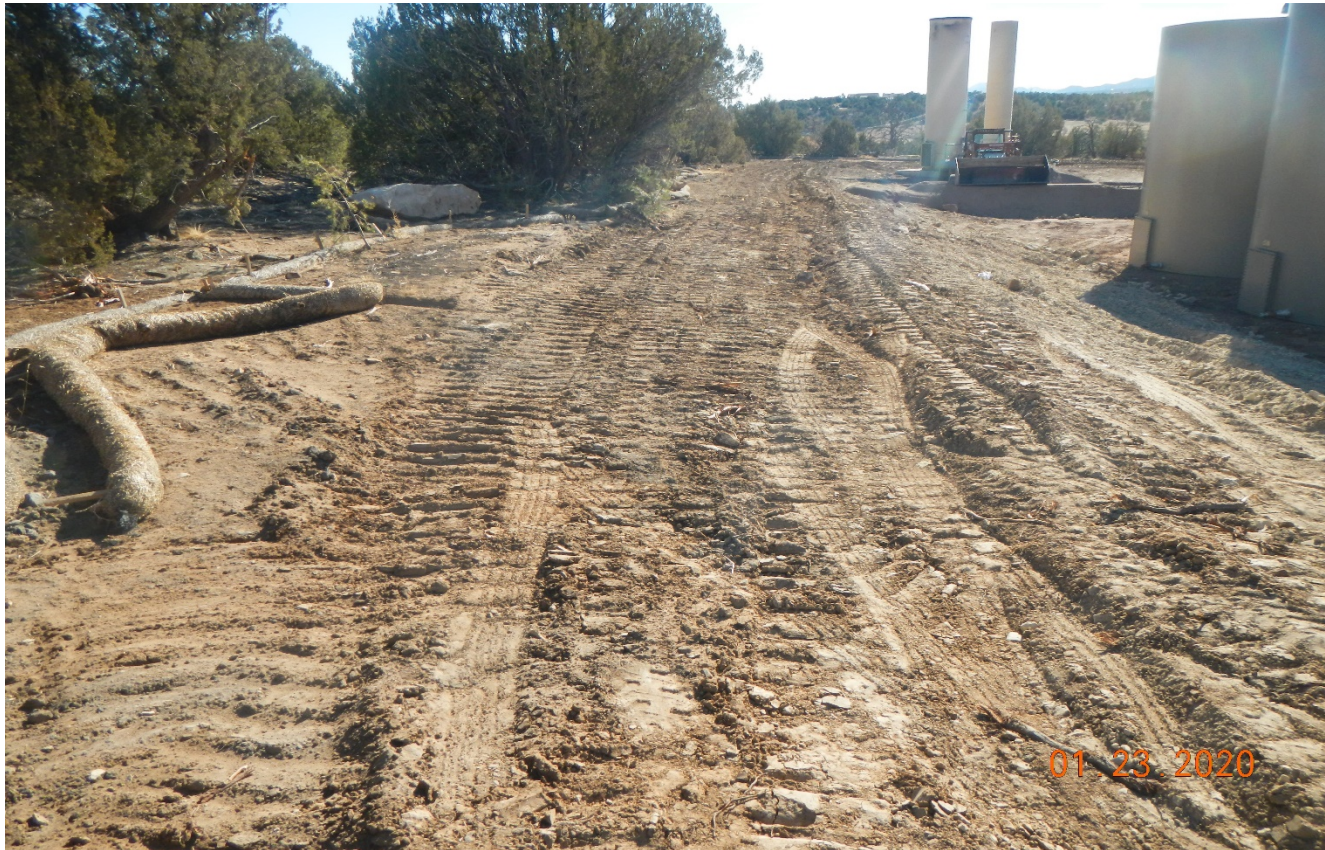
Photo 9. North side of the location facing east. The wattles are displaced and disturbed soils are not stabilized.

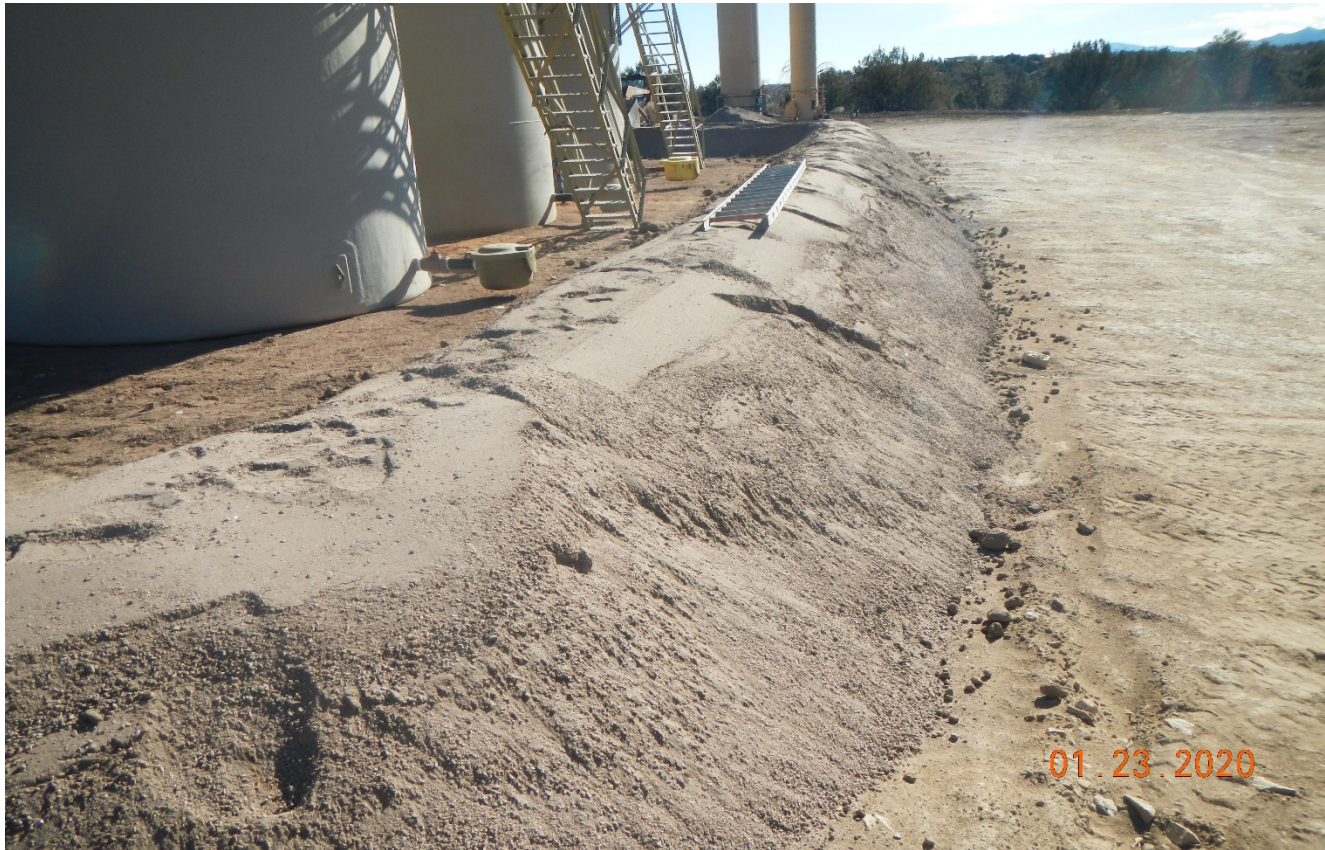
Photo 10. The berms around the tank battery are not compacted.

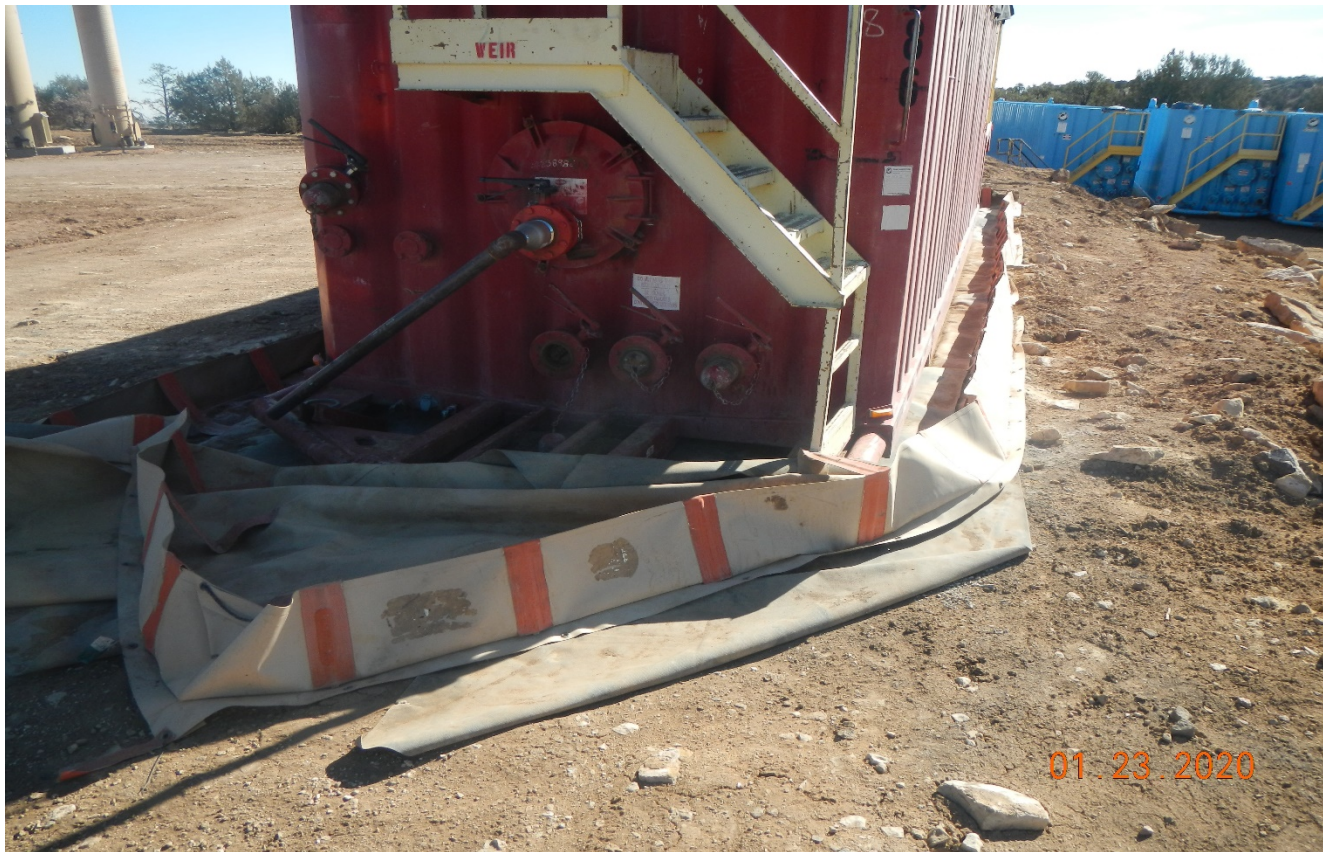
Photo 11. The secondary containment around the tank is not adequate to contain spill.

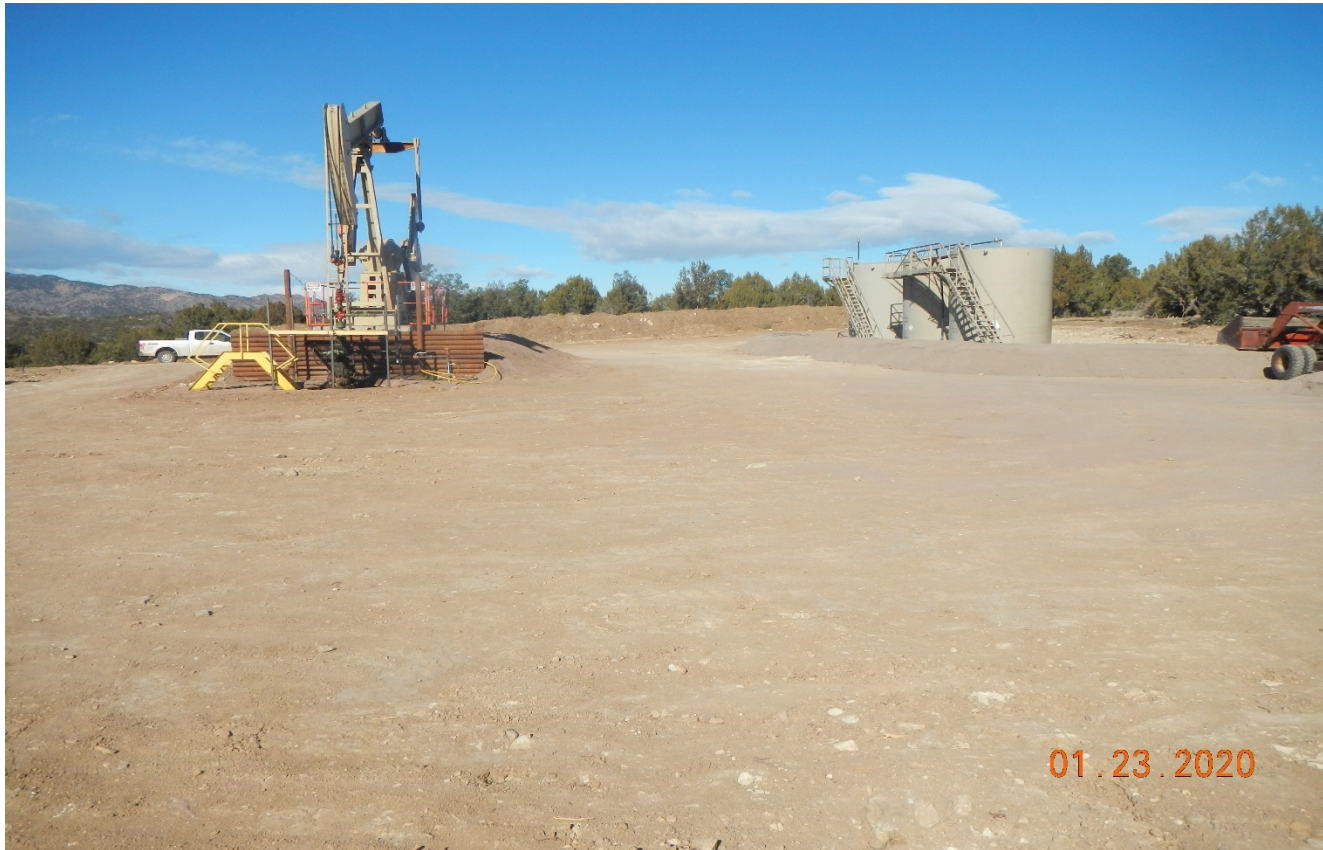
Photo 12. East side of the location facing west.

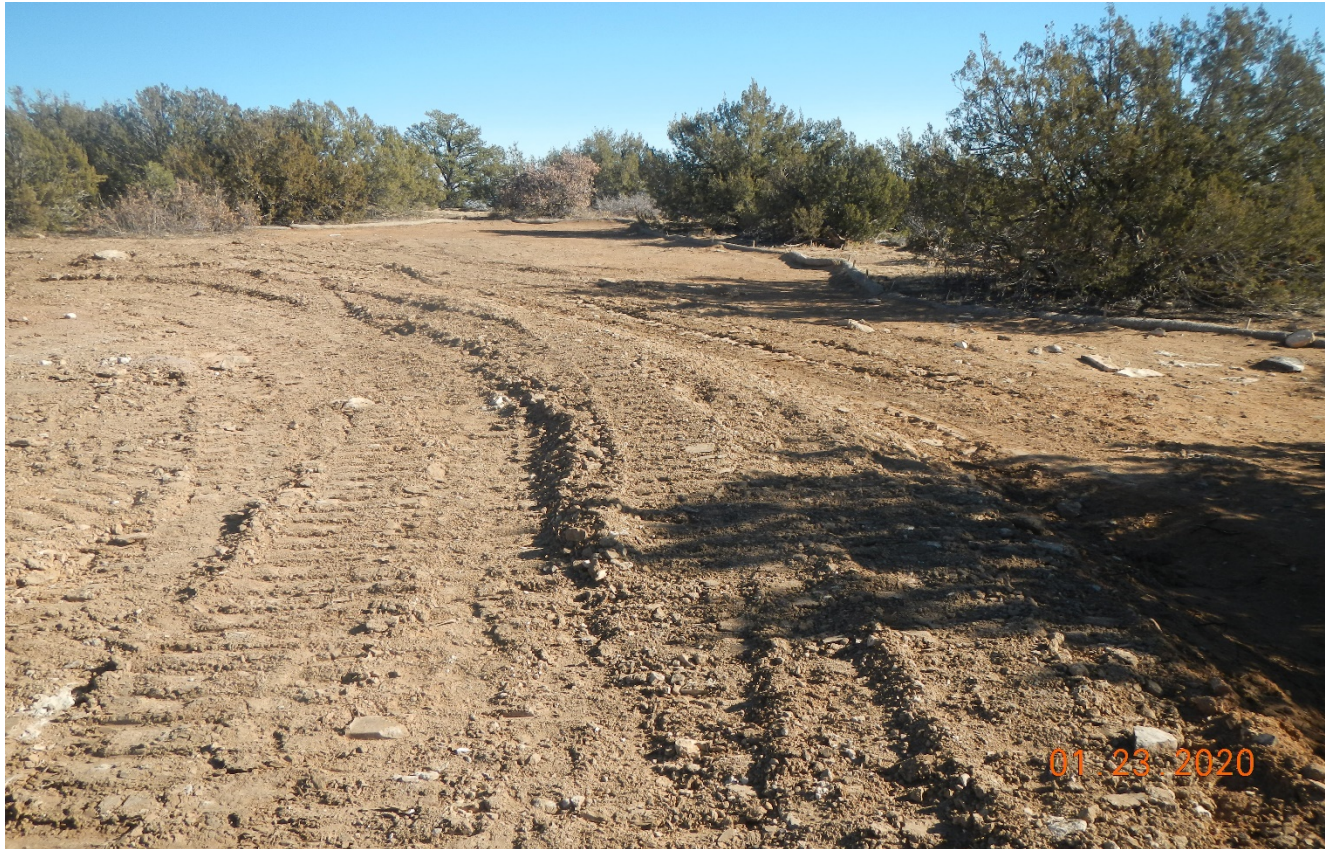
Photo 13. Facing toward northeast area of the location. The disturbed soils are susceptible to erosion.

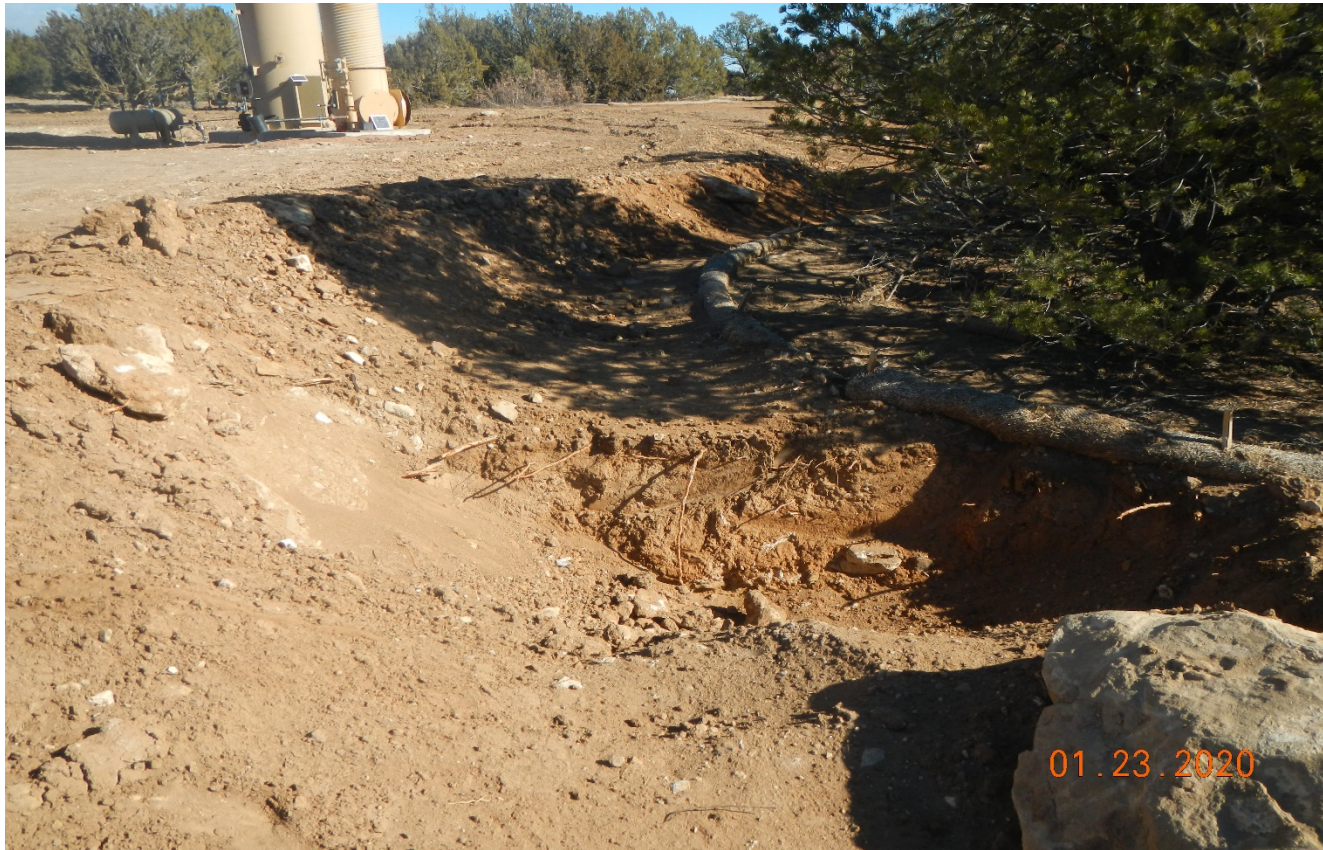
Photo 14. There is a hole at the east side of location which may be an incomplete sediment trap. BMP's must be implemented in accordance with good engineering practice and must be maintained at all times.

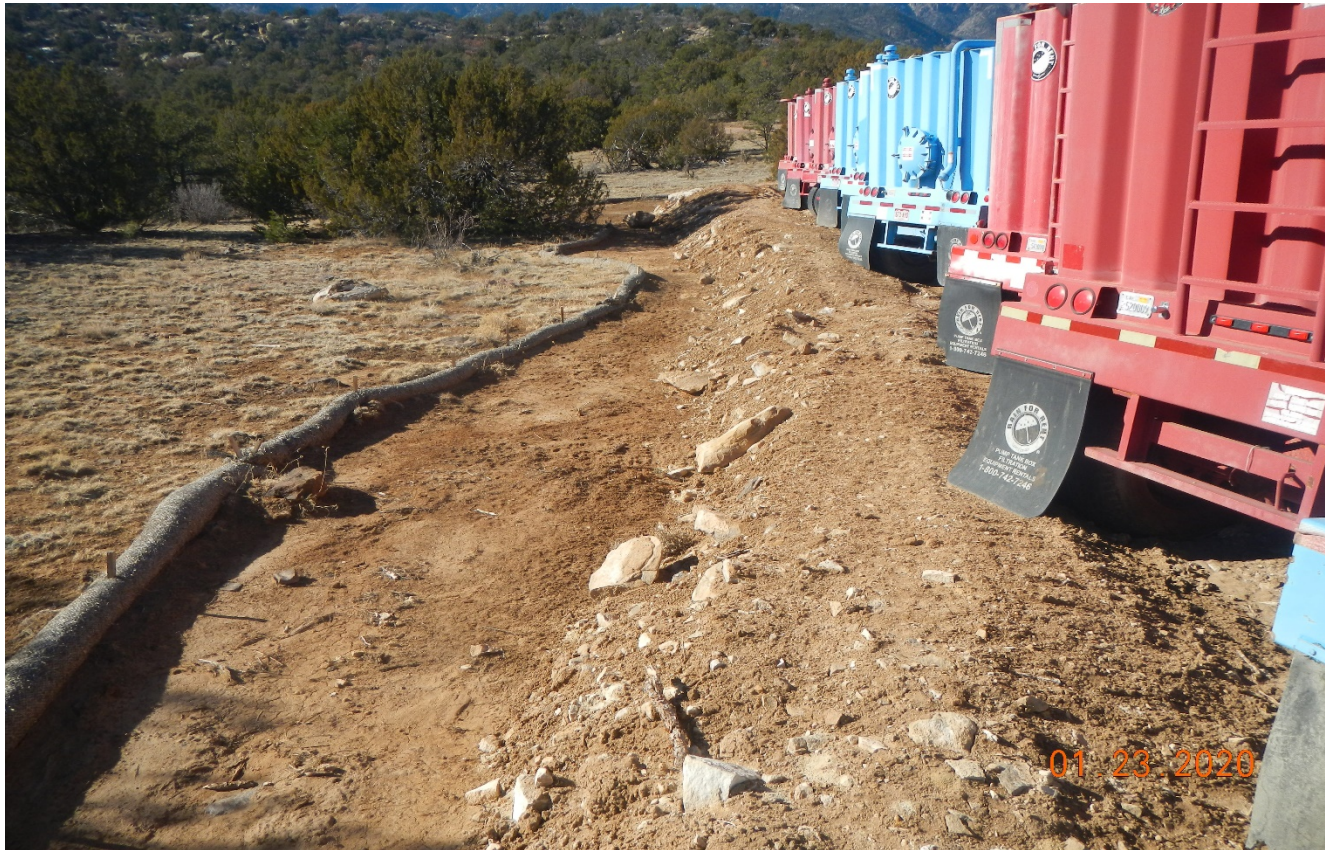
Photo 15. There are wattles installed around the southeast perimeter however stormwater will run down hill along the wattles.

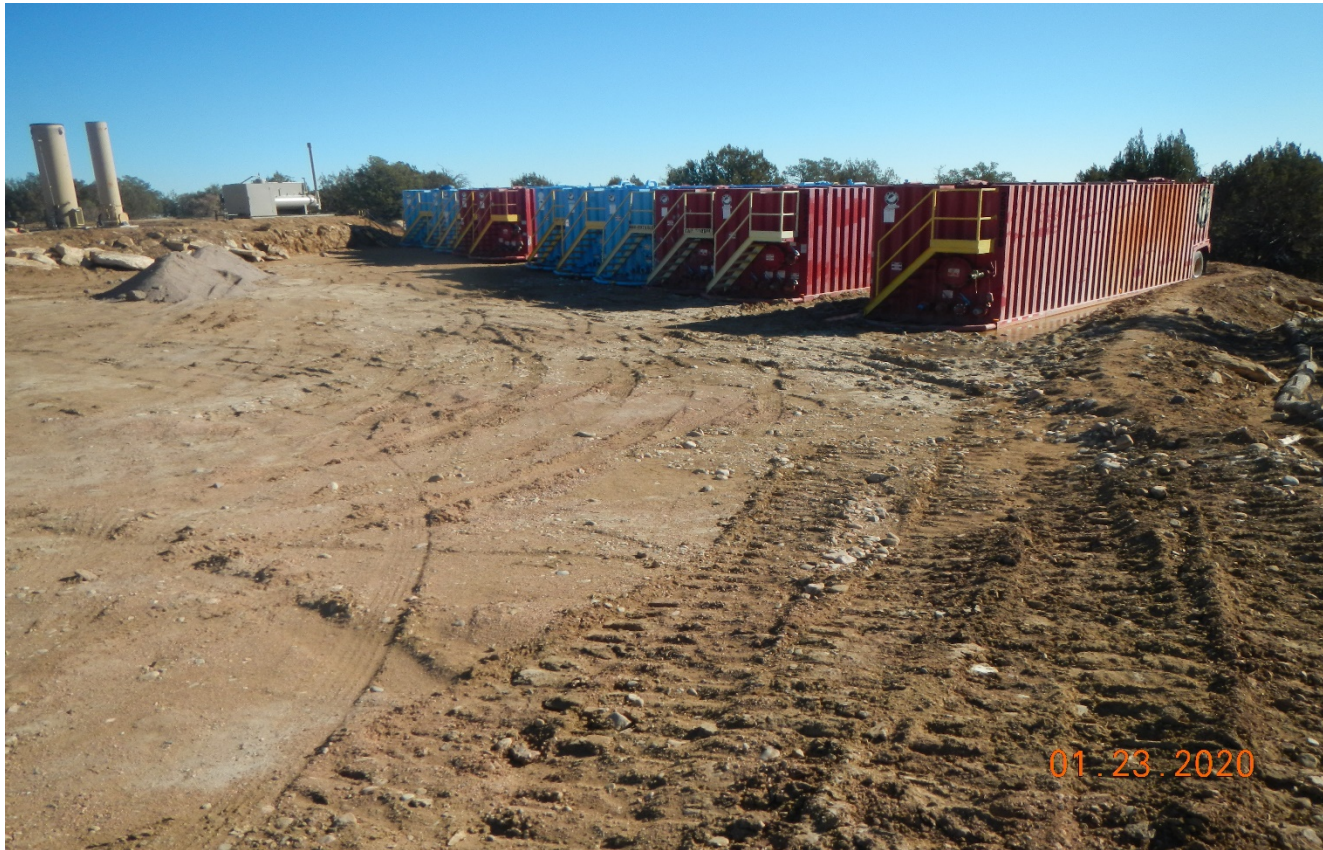
Photo 16. Facing northeast at the location. The tanks need to be removed so interim reclamation can be performed. This area needs to be recontoured and reclaimed.
