**Inspection Photos**  
**Operator: Catamount Energy**  
**Location/API #: 067-07911**  
**Date: 1-22-2020**

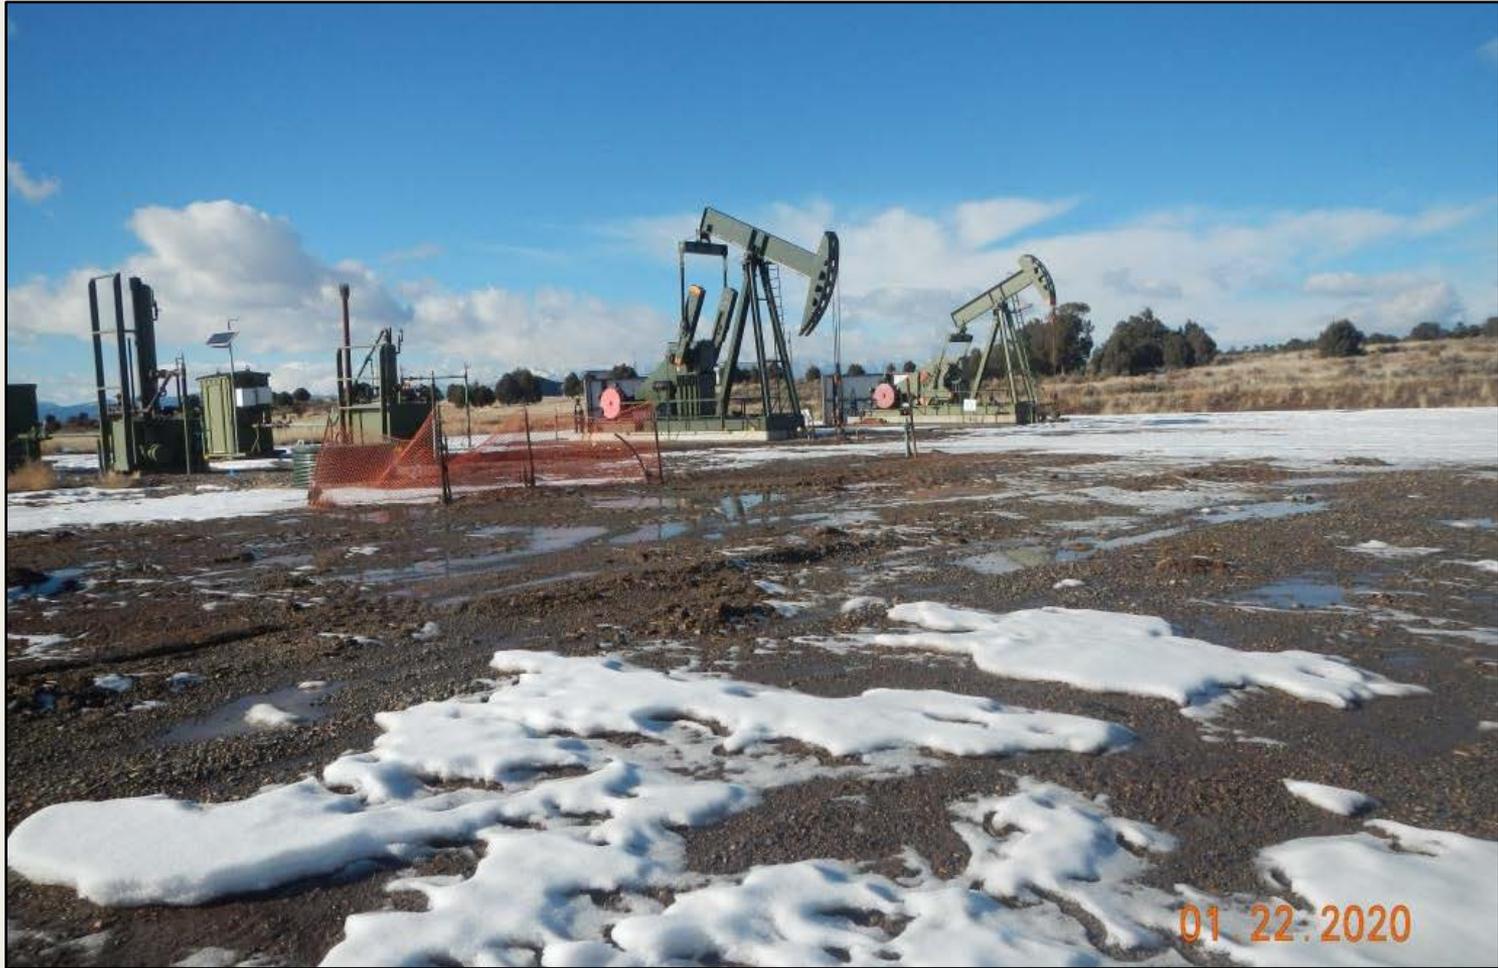
Photo 1. View of the project area from the southeastern corner facing center. Producing well in foreground is mapped on plugged well pad south of producing pad. Documentation needs to be fixed.

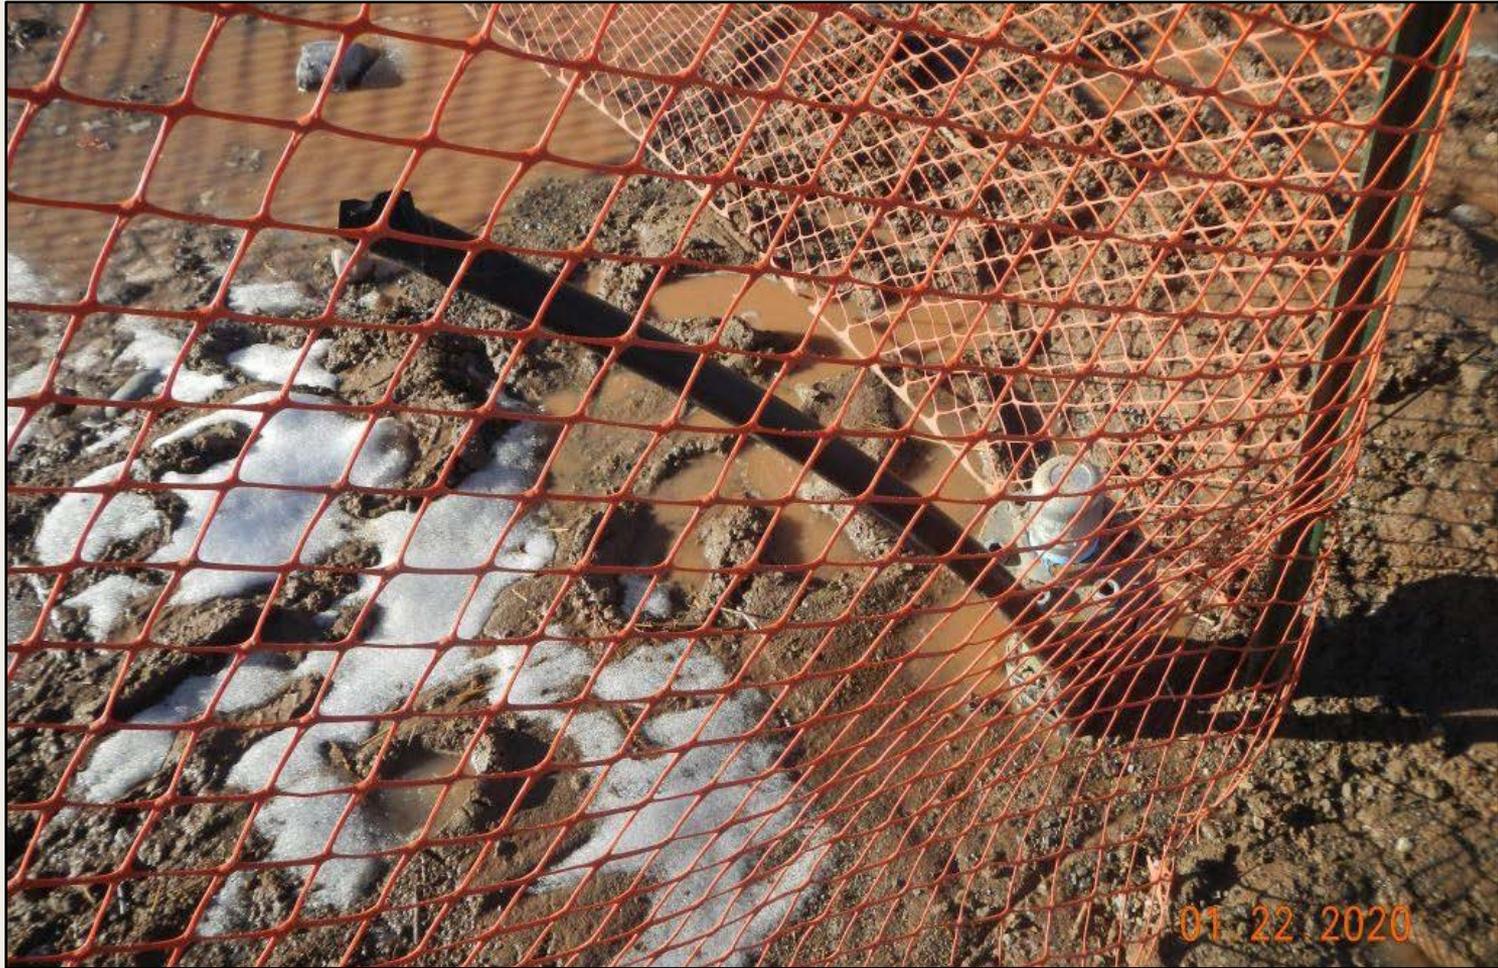
Photo 2. View of riser within the southern project area.

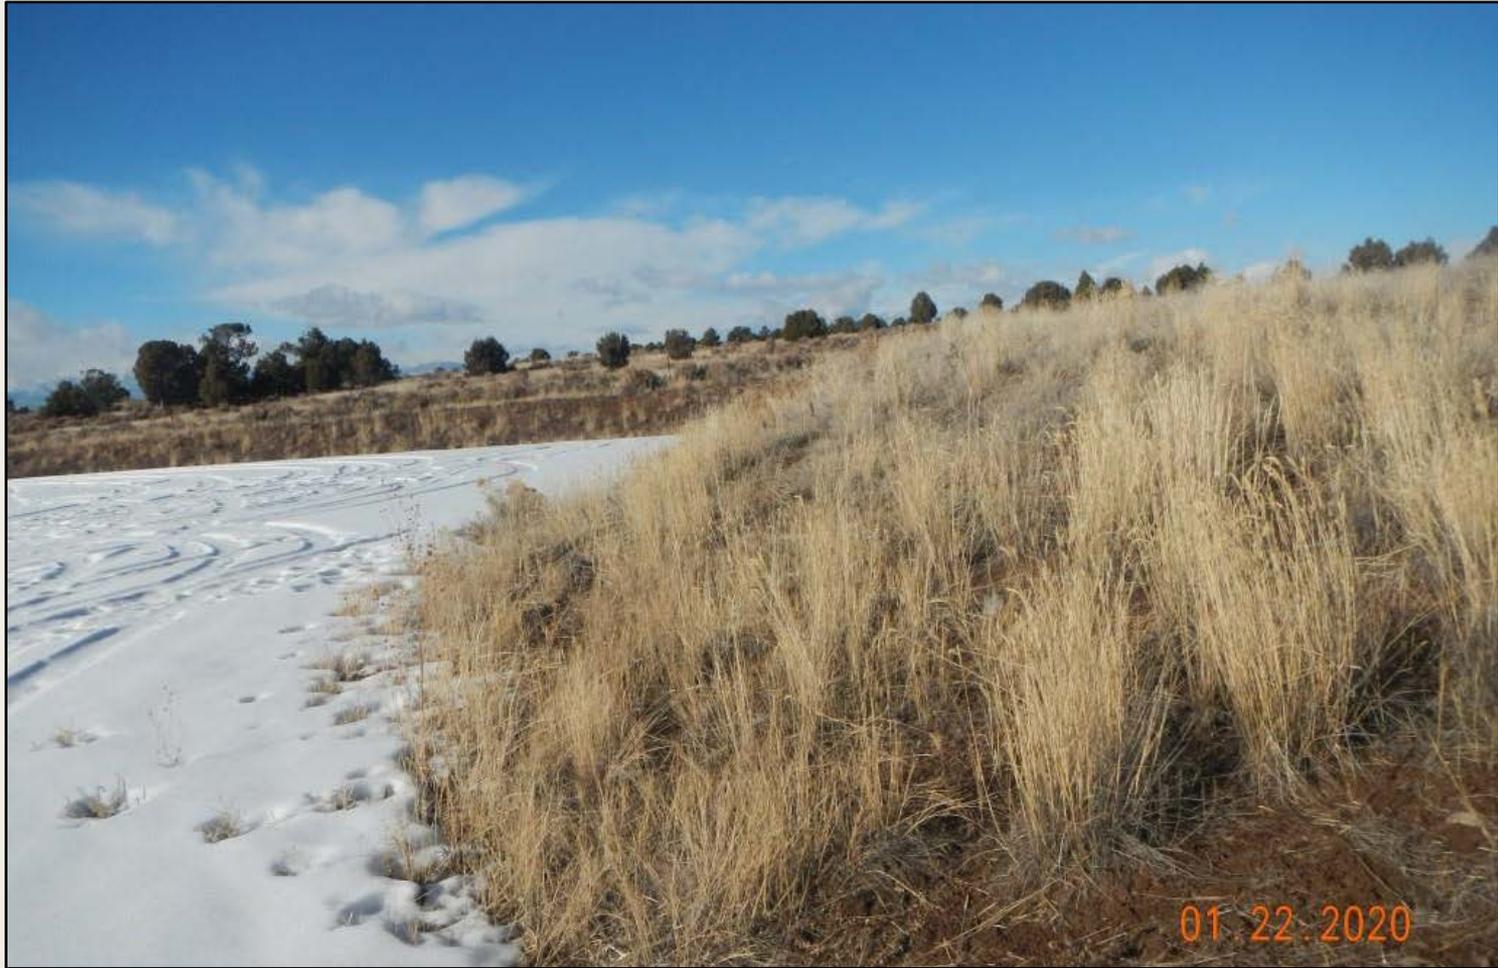
Photo 3. View of the eastern project area from the southeastern portion facing northward. Although snow covered, it is apparent that revegetation is progressing with grasses such as crested wheatgrass and western wheatgrass.
