Inspection Photos
Operator: Catamount Energy
Location/API #: 067-05455
Date: 1-22-2020

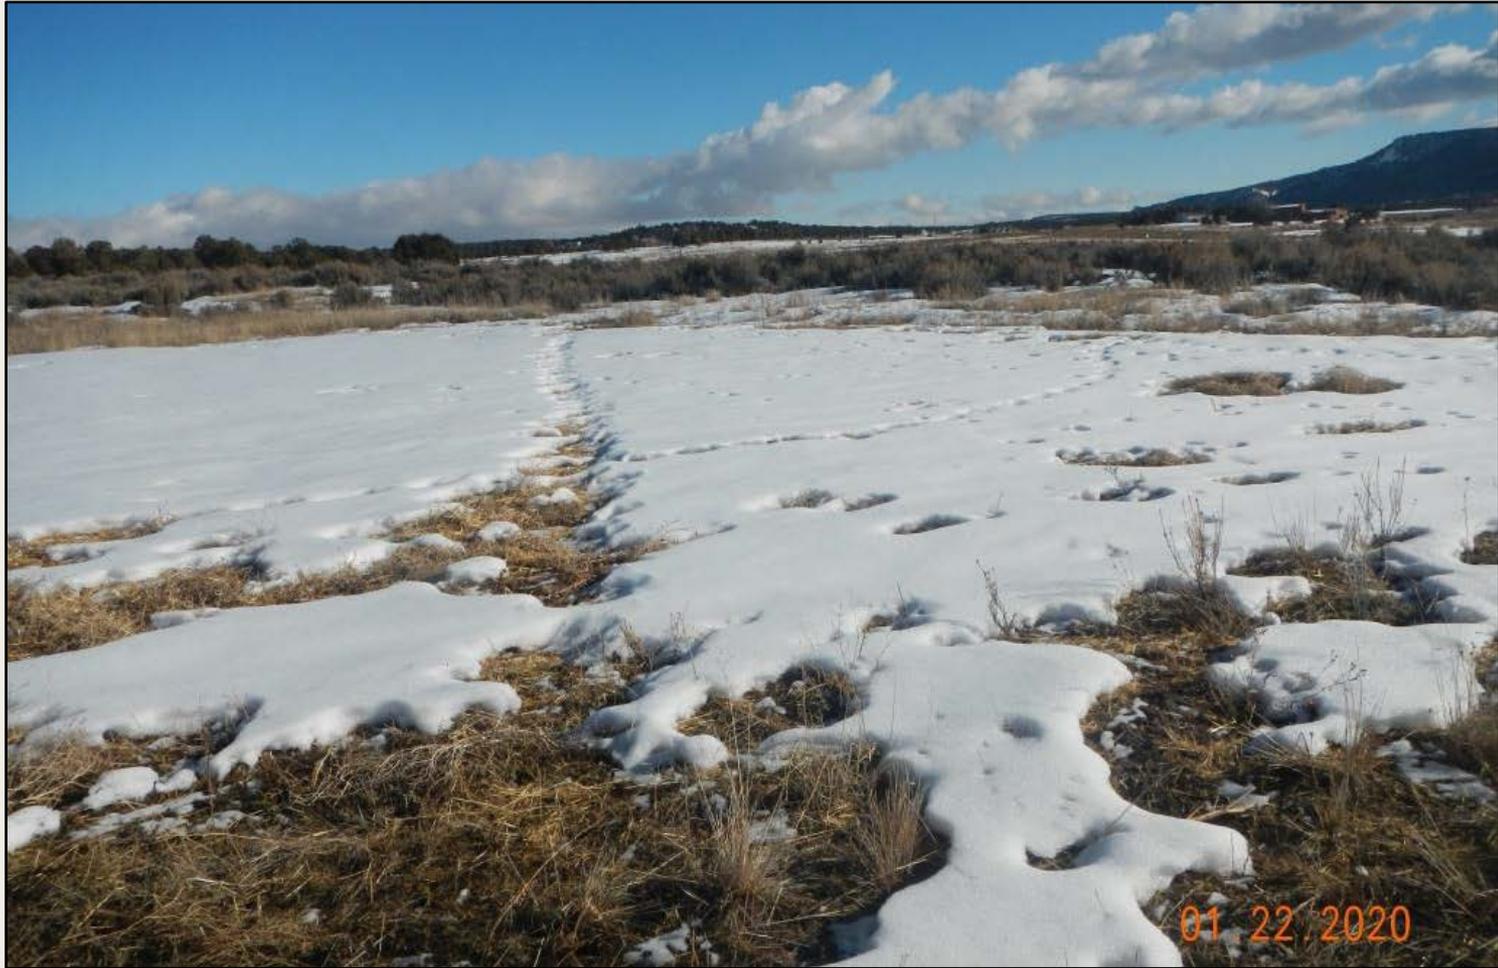
Photo 1. View of the project area from the northern edge facing southward. It appears that reclamation is initiated. Straw mulch observed beneath snow.

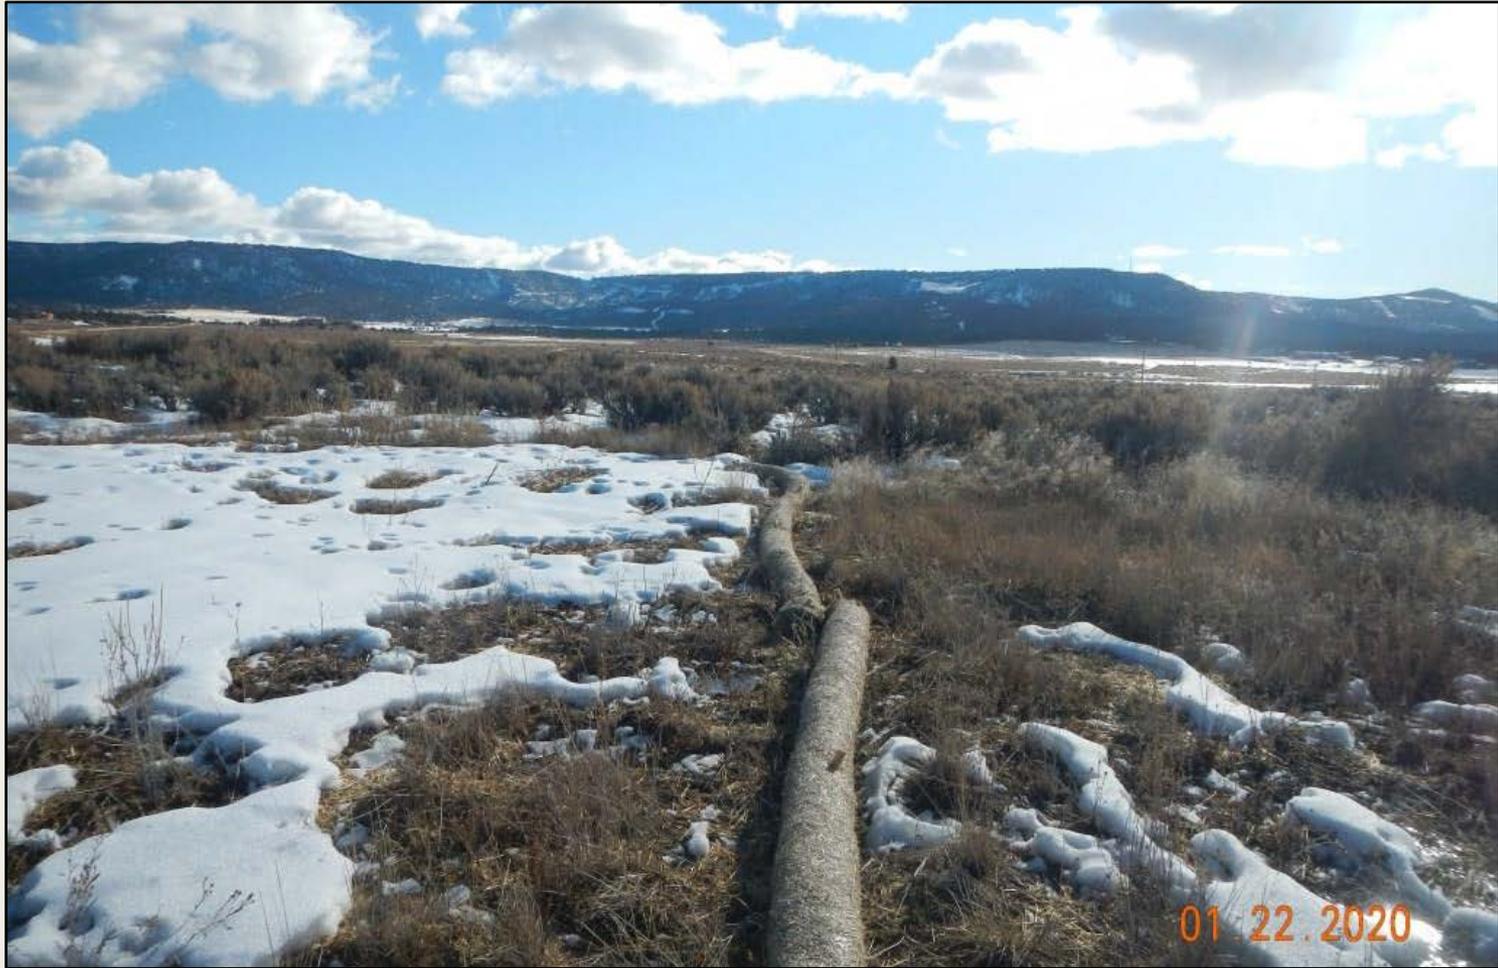
Photo 2. View of wattles placed along the western edge of the project area.

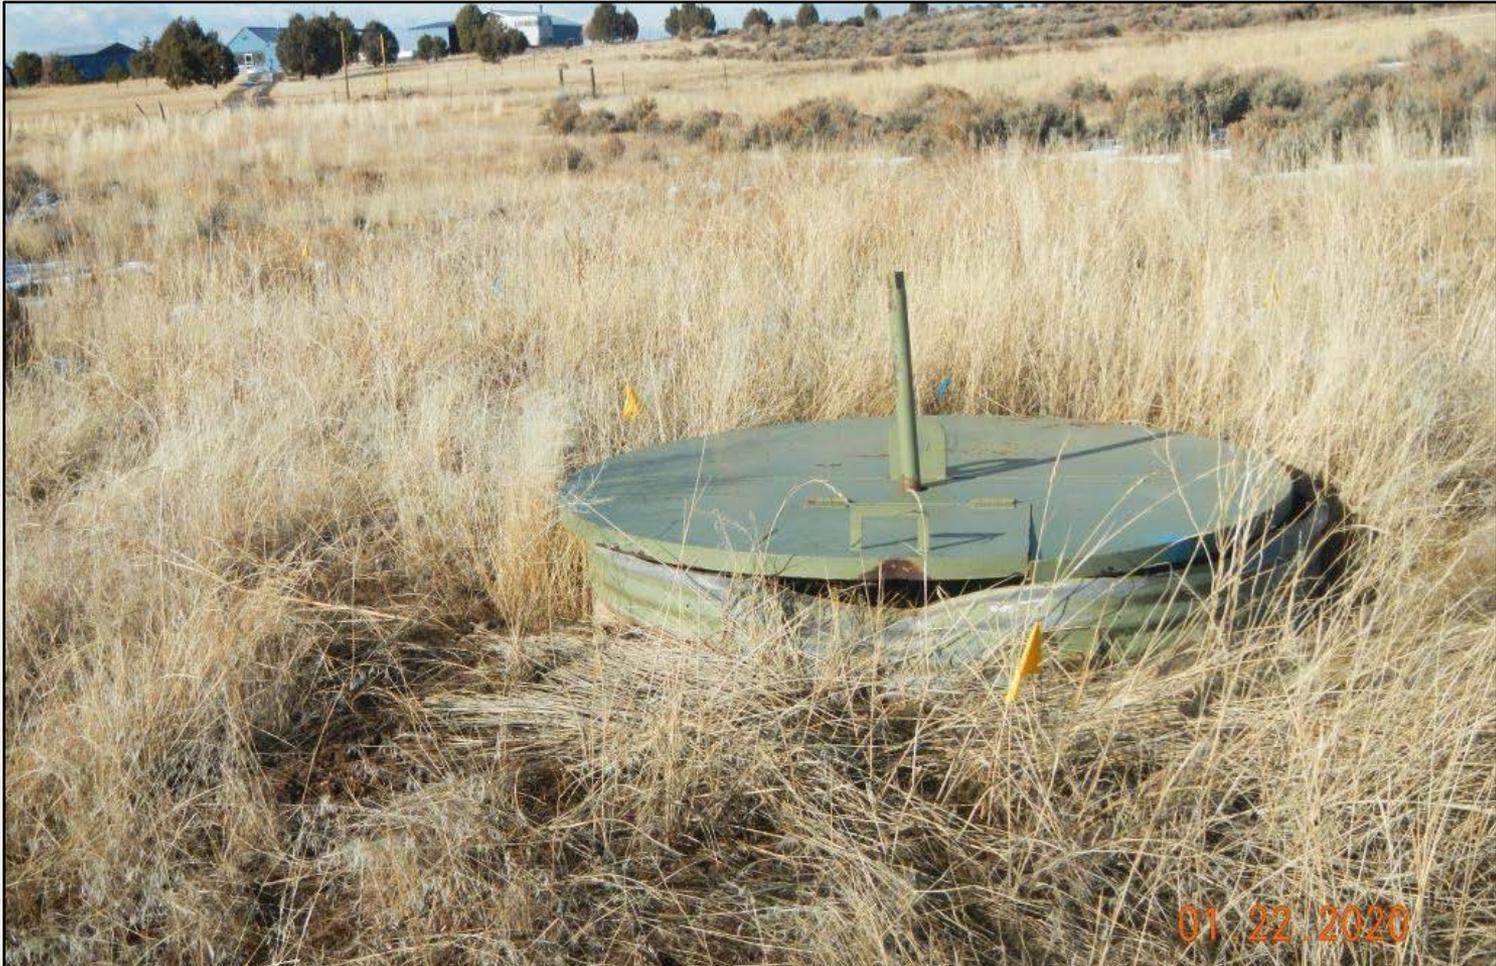
Photo 3. View of unused equipment that remains in the northwestern project area.

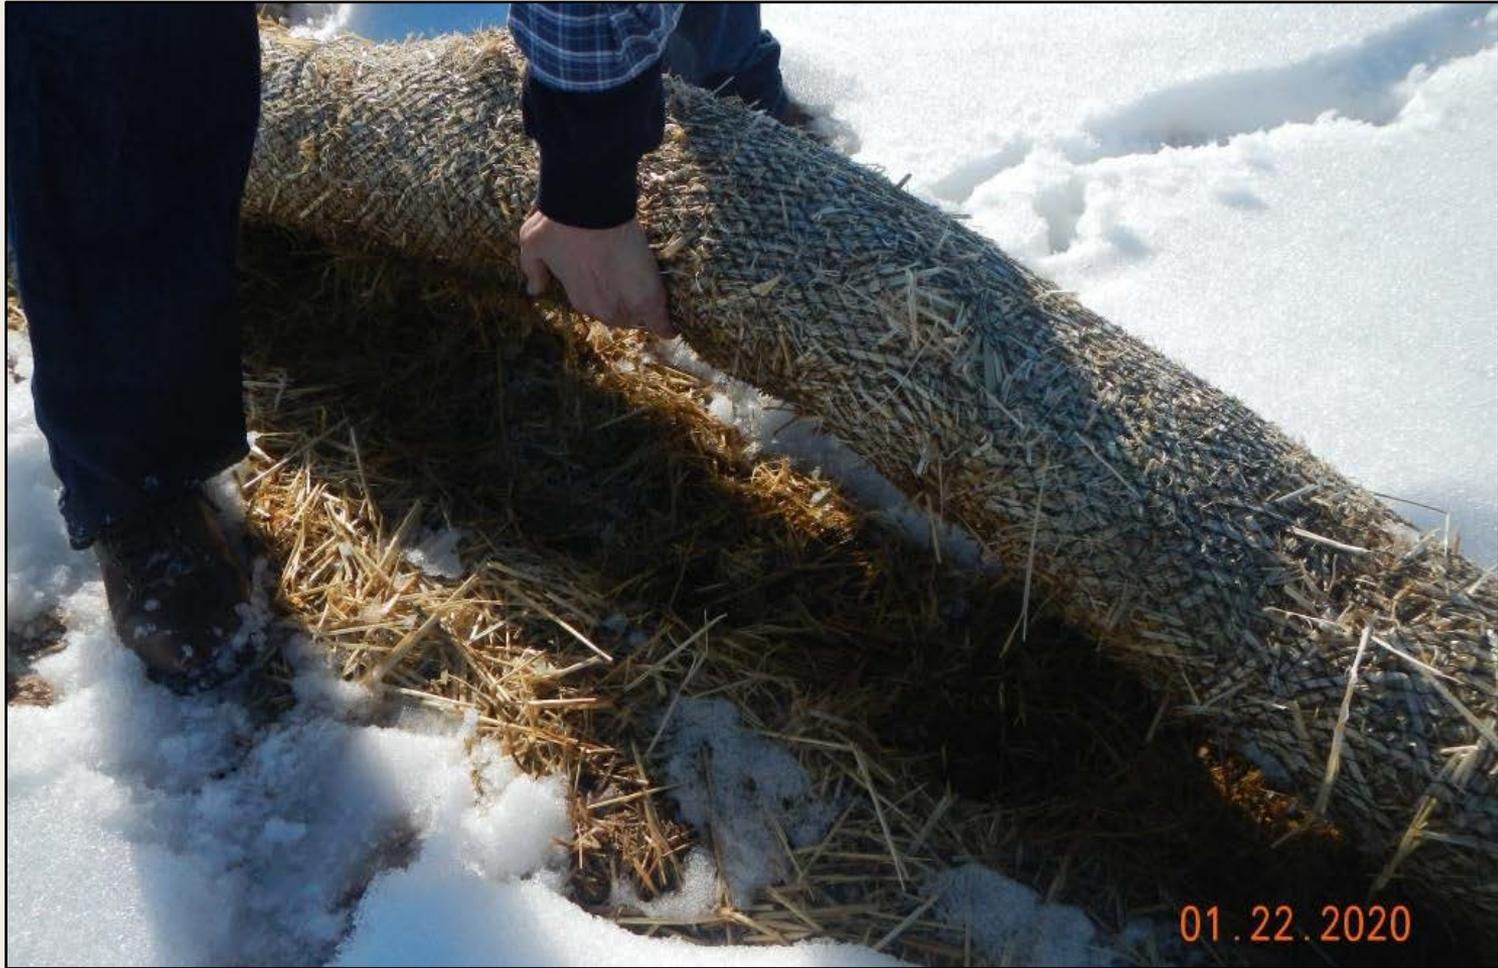
Photo 4. View of area beneath wattle that shows that wattle is not properly trenched within the soil.
