Inspection Photos
Operator: Catamount Energy
Location/API #: 067-09346
Date: 1-22-2020

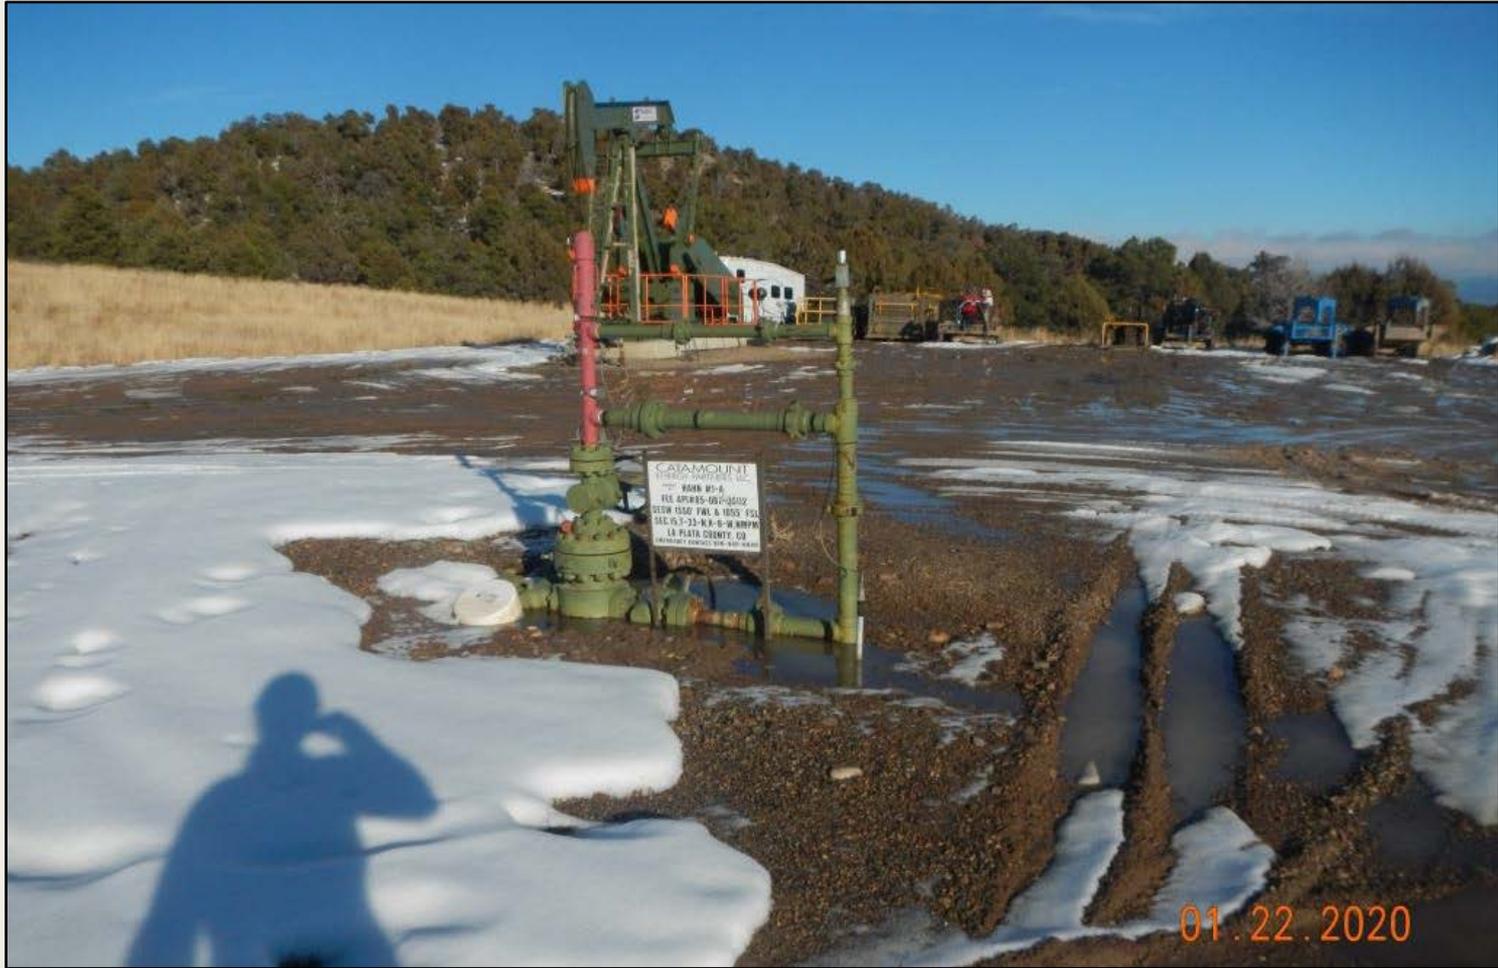
Photo 1. View of the project area from the wellhead facing eastward.

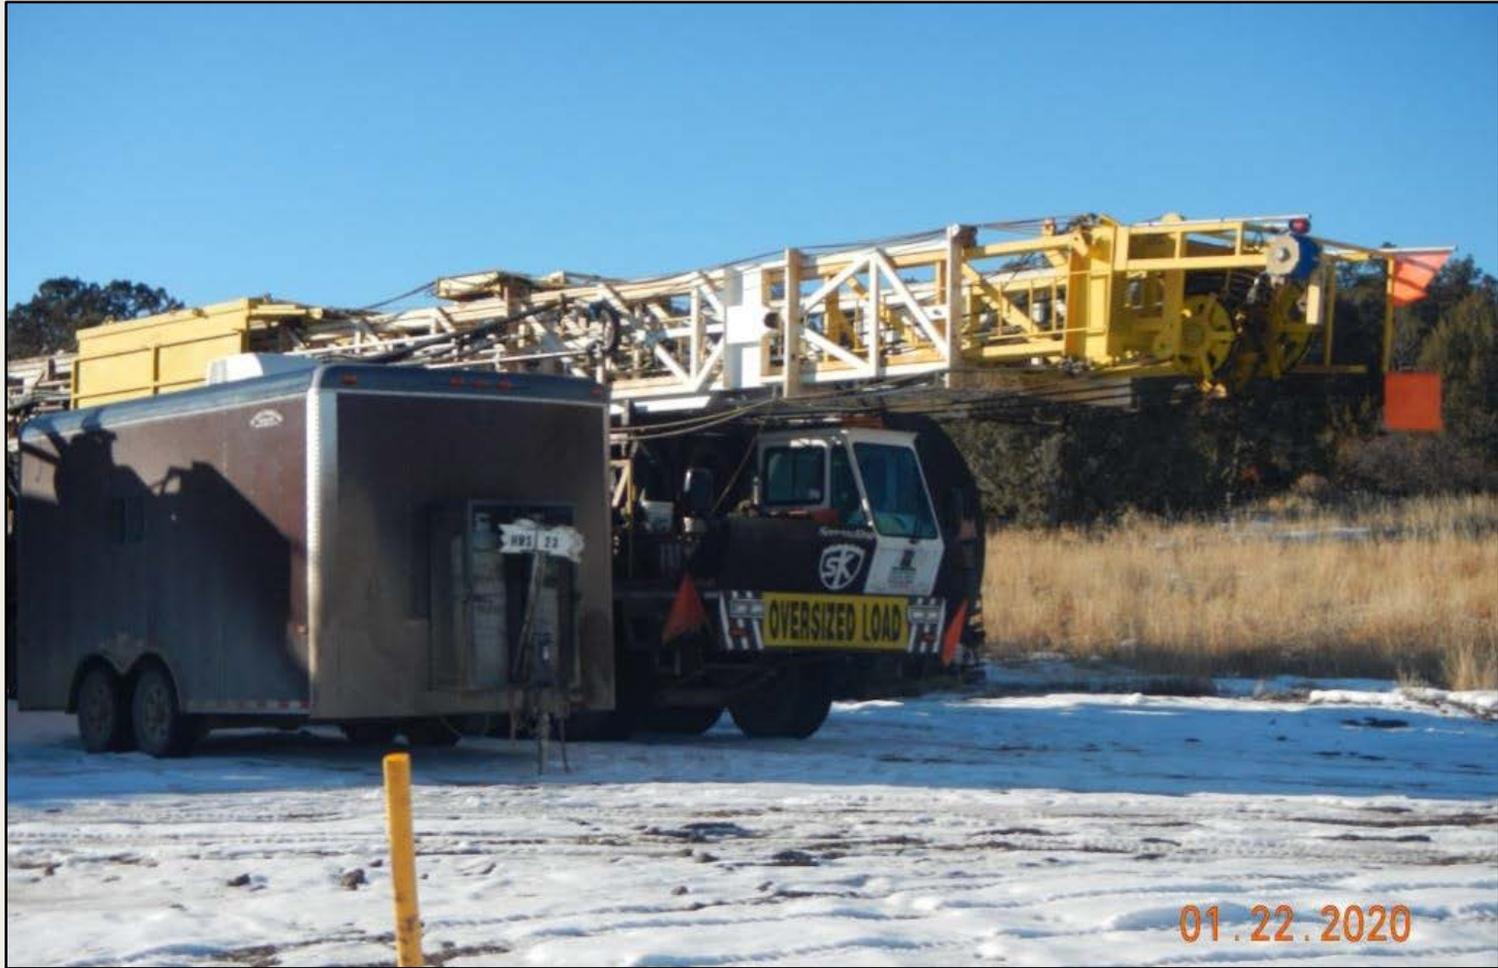
Photo 2. View of unused equipment within the northwestern project area.

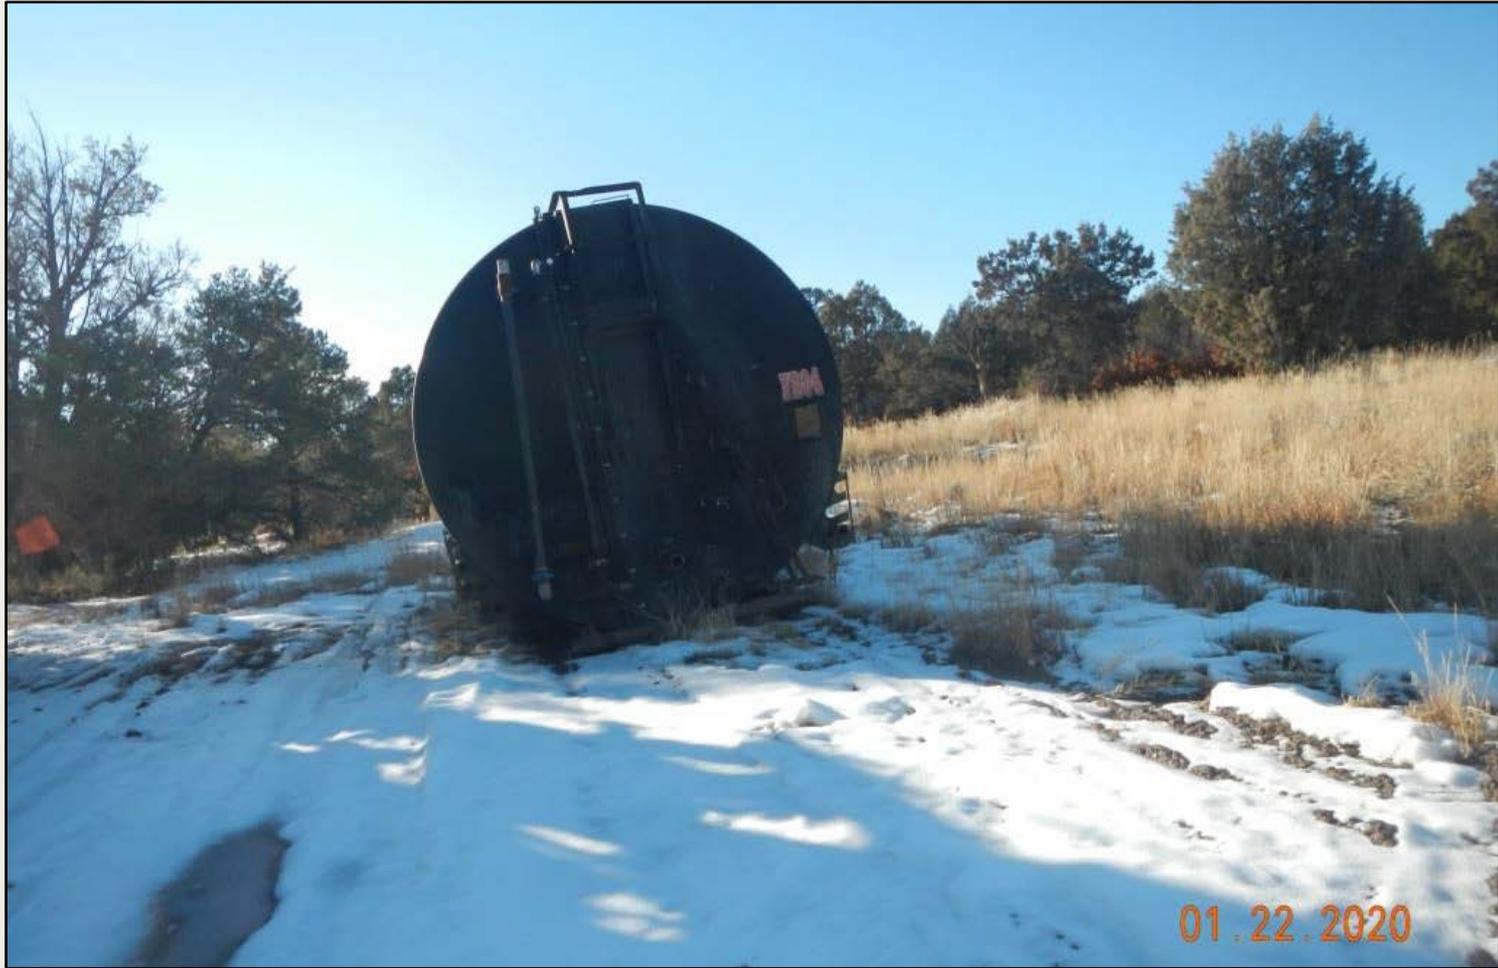
Photo 3. View of unused tank stored within the northwestern project area.

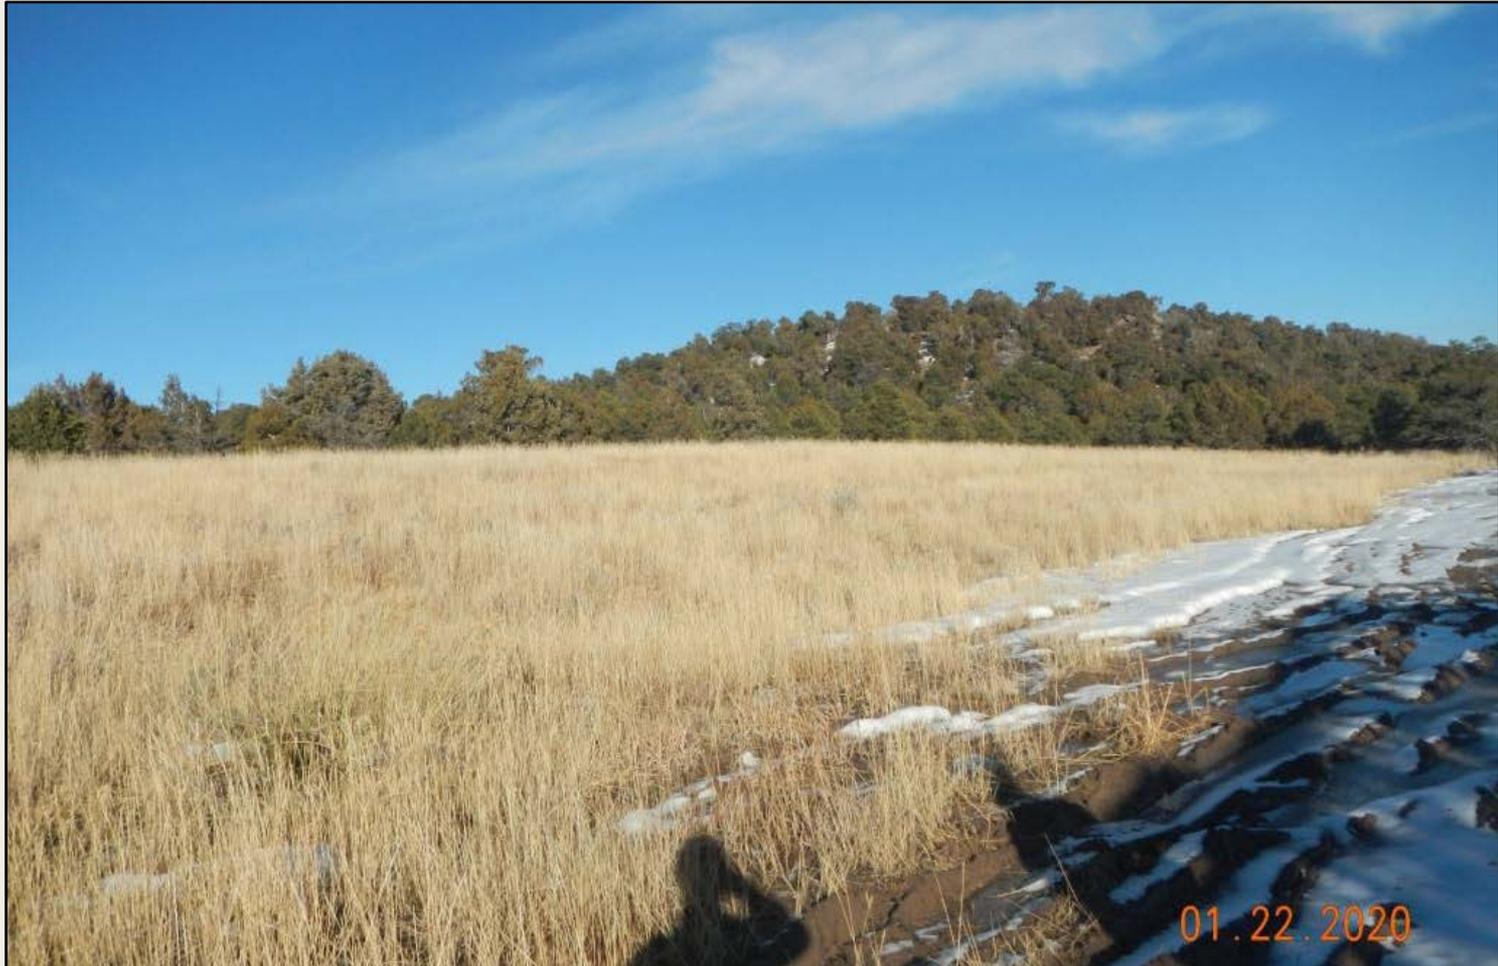
Photo 4. View of the northern project area from the northwestern edge facing eastward. Revegetation is progressing within the northern project area.

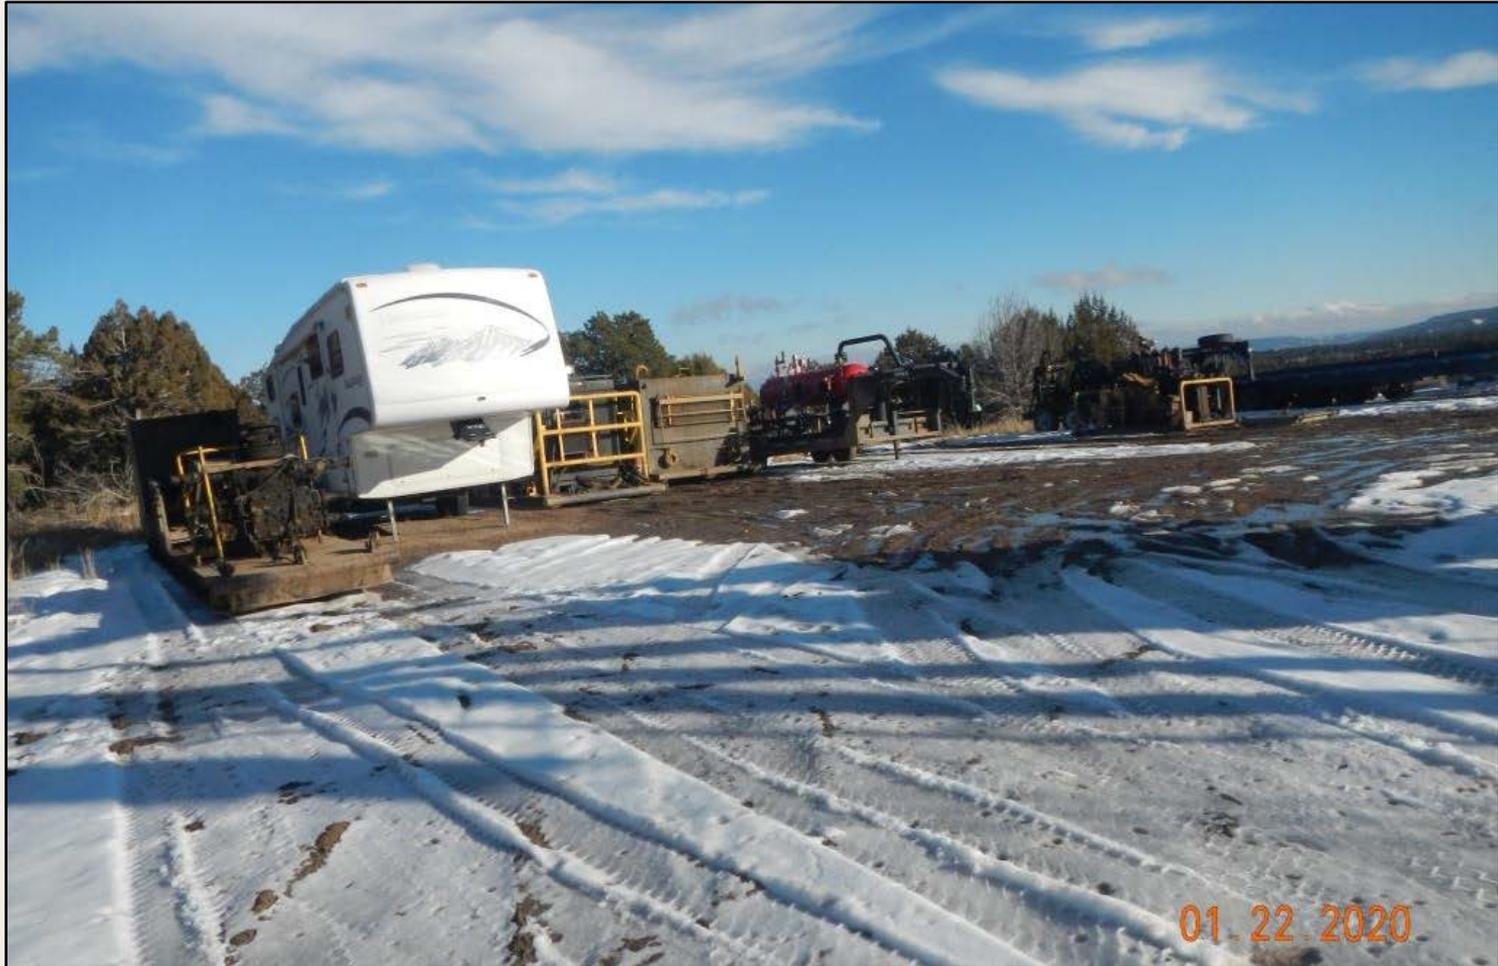
Photo 5. View of unused equipment stored within the eastern project area.

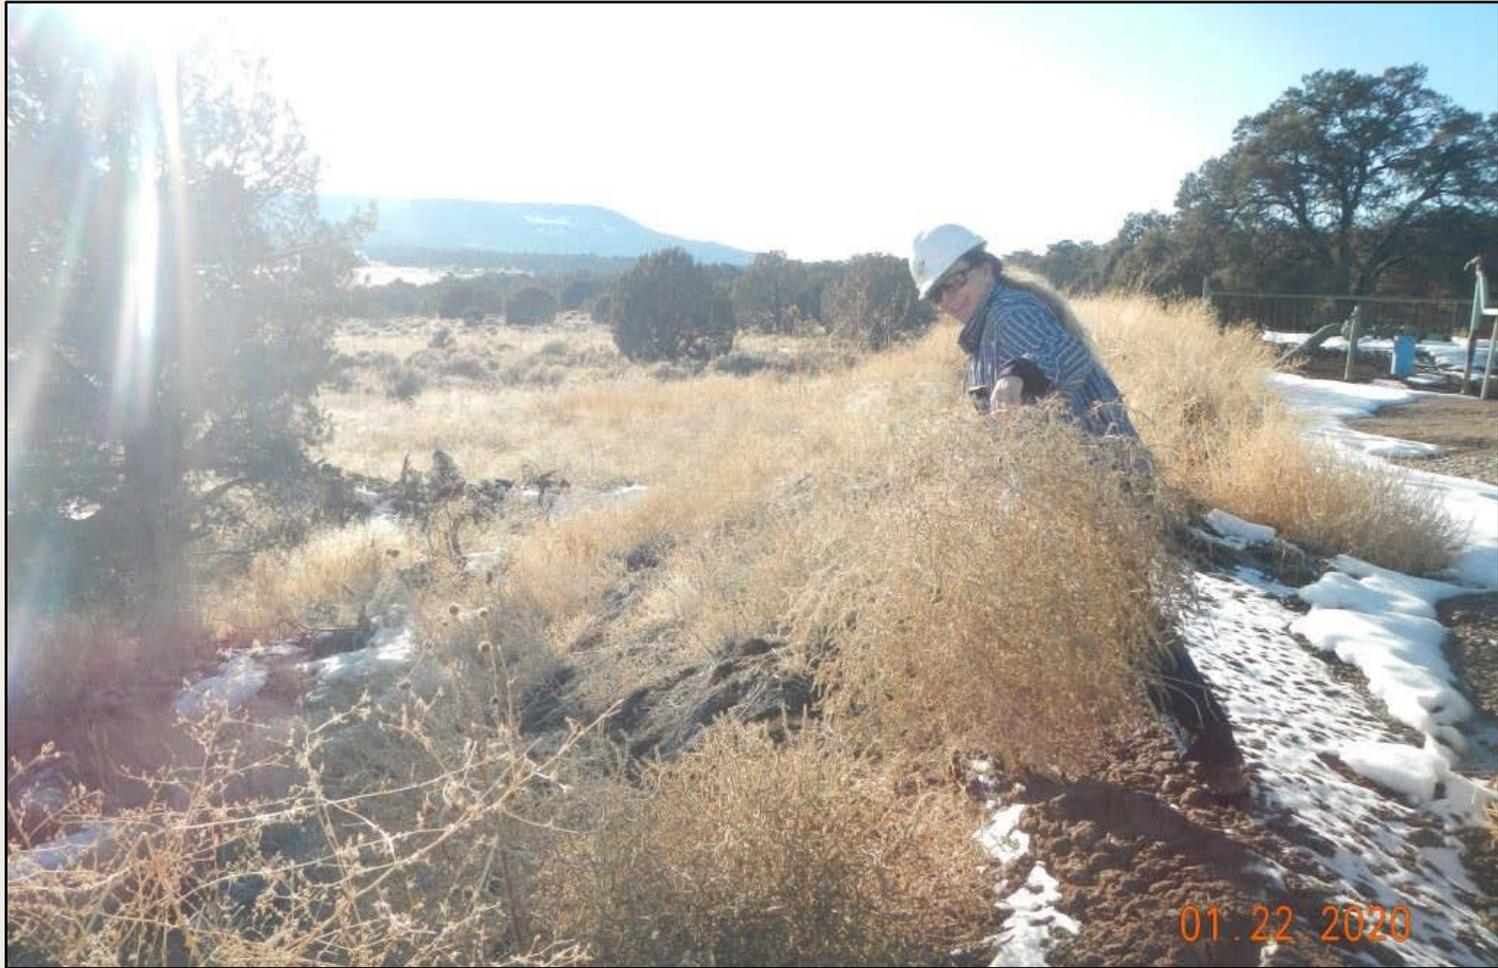
Photo 6. View of Russian thistle debris within the southern project area. Needs to be removed and properly disposed of.

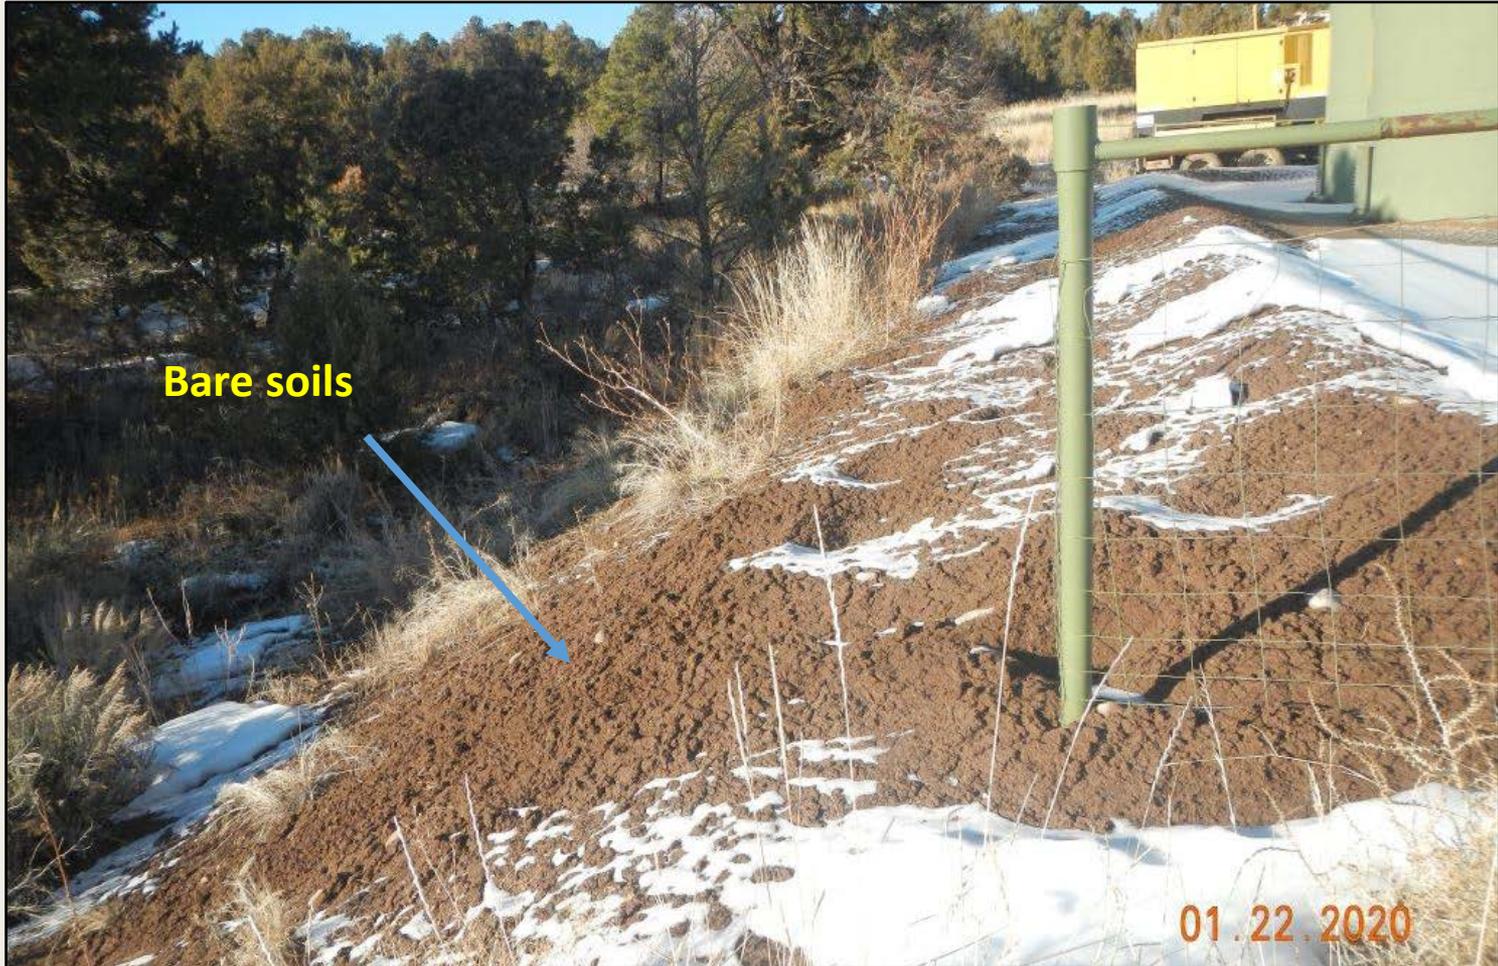
Photo 7. View of bare soils within the southwestern project area. Erosion controls are needed to stabilize bare soils here.
