Douglas Creek Unit 38
API: 05-103-09316
Inspection: 679707135

COLORADO
Oil & Gas Conservation
Commission
Department of Natural Resources

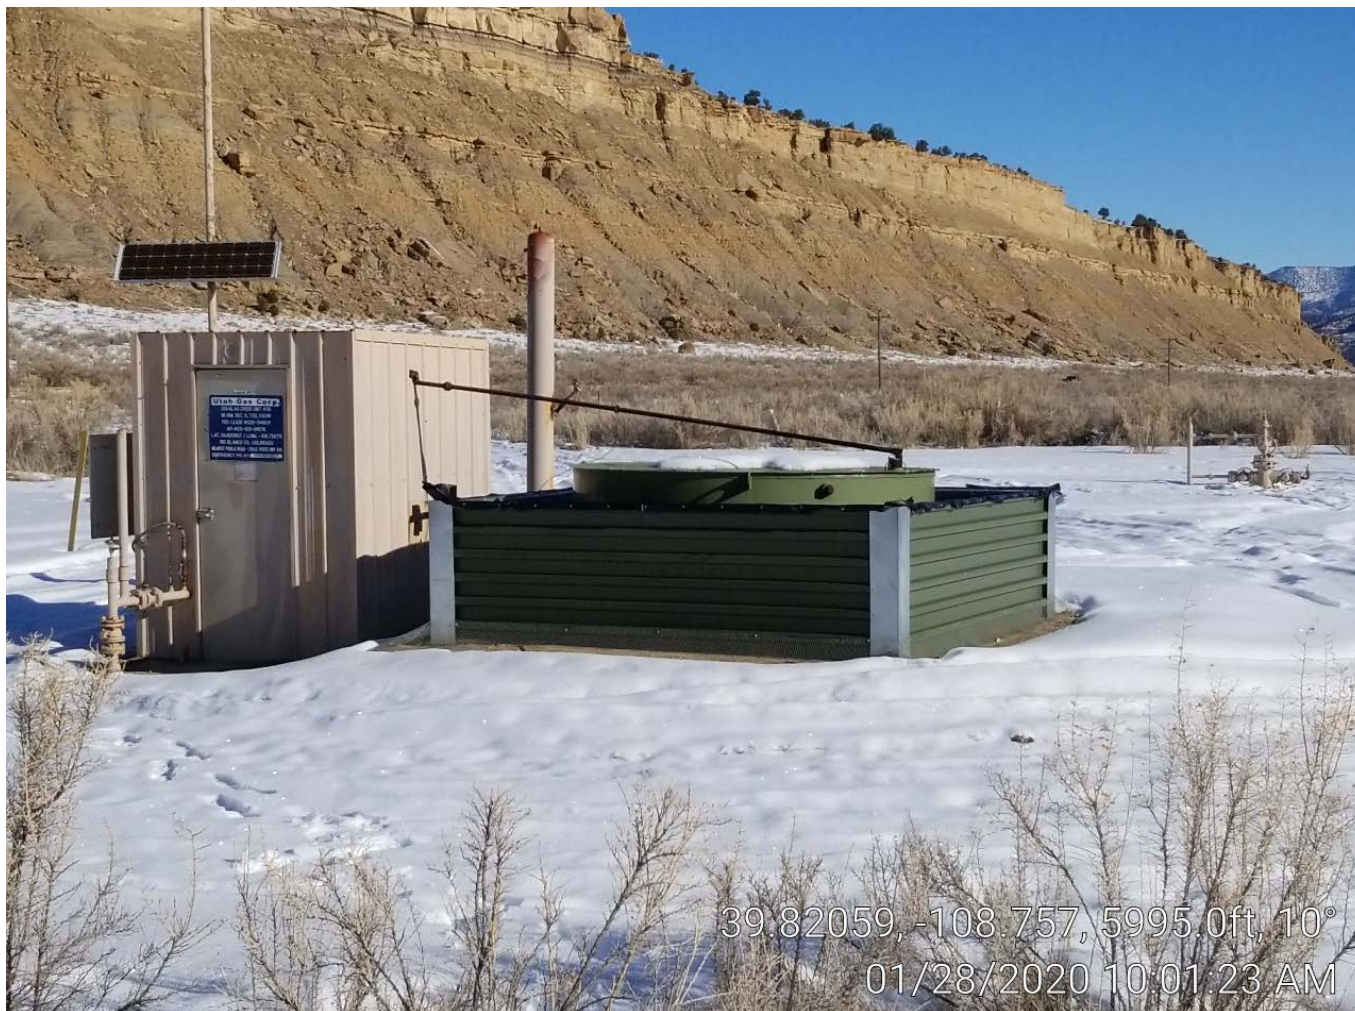
Photo 1. Location.

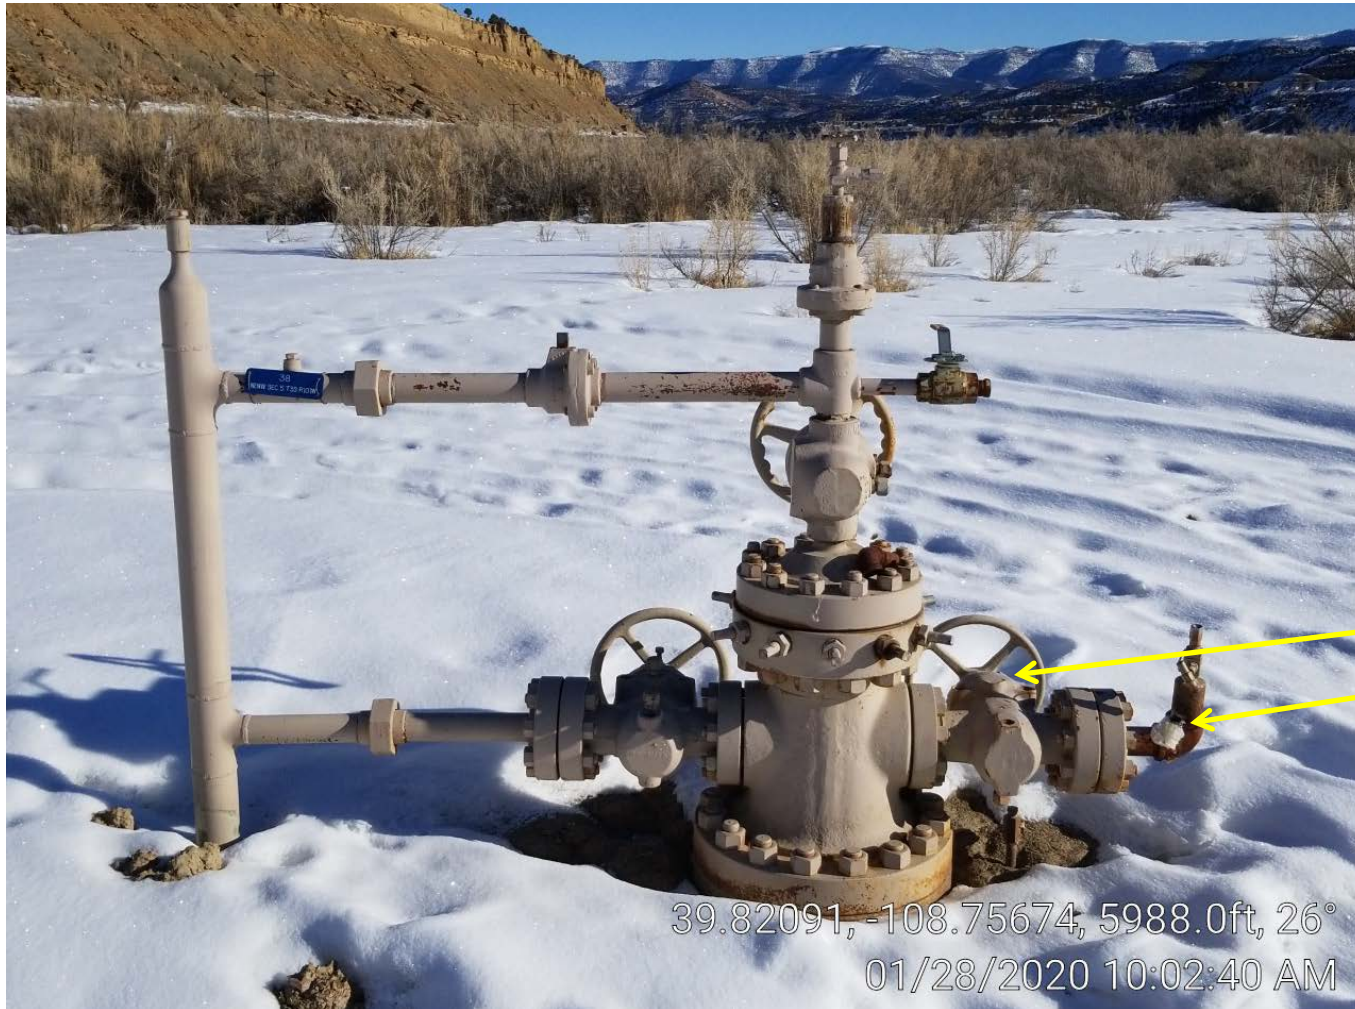
Gas
leaks

Photo 2. Well head.

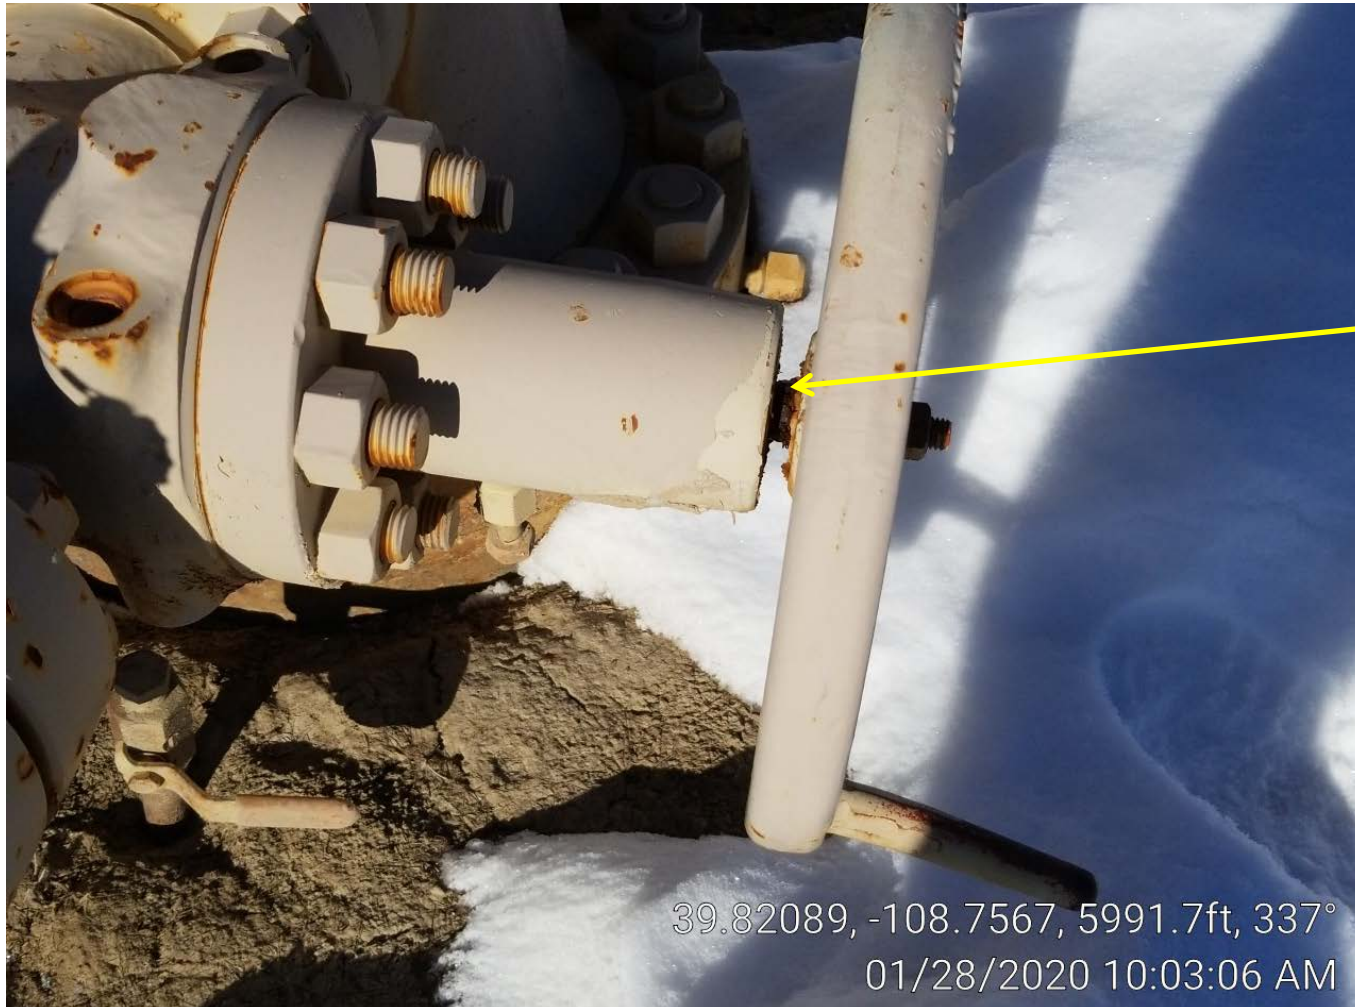
Gas
leak

Photo 3. Casing valve.

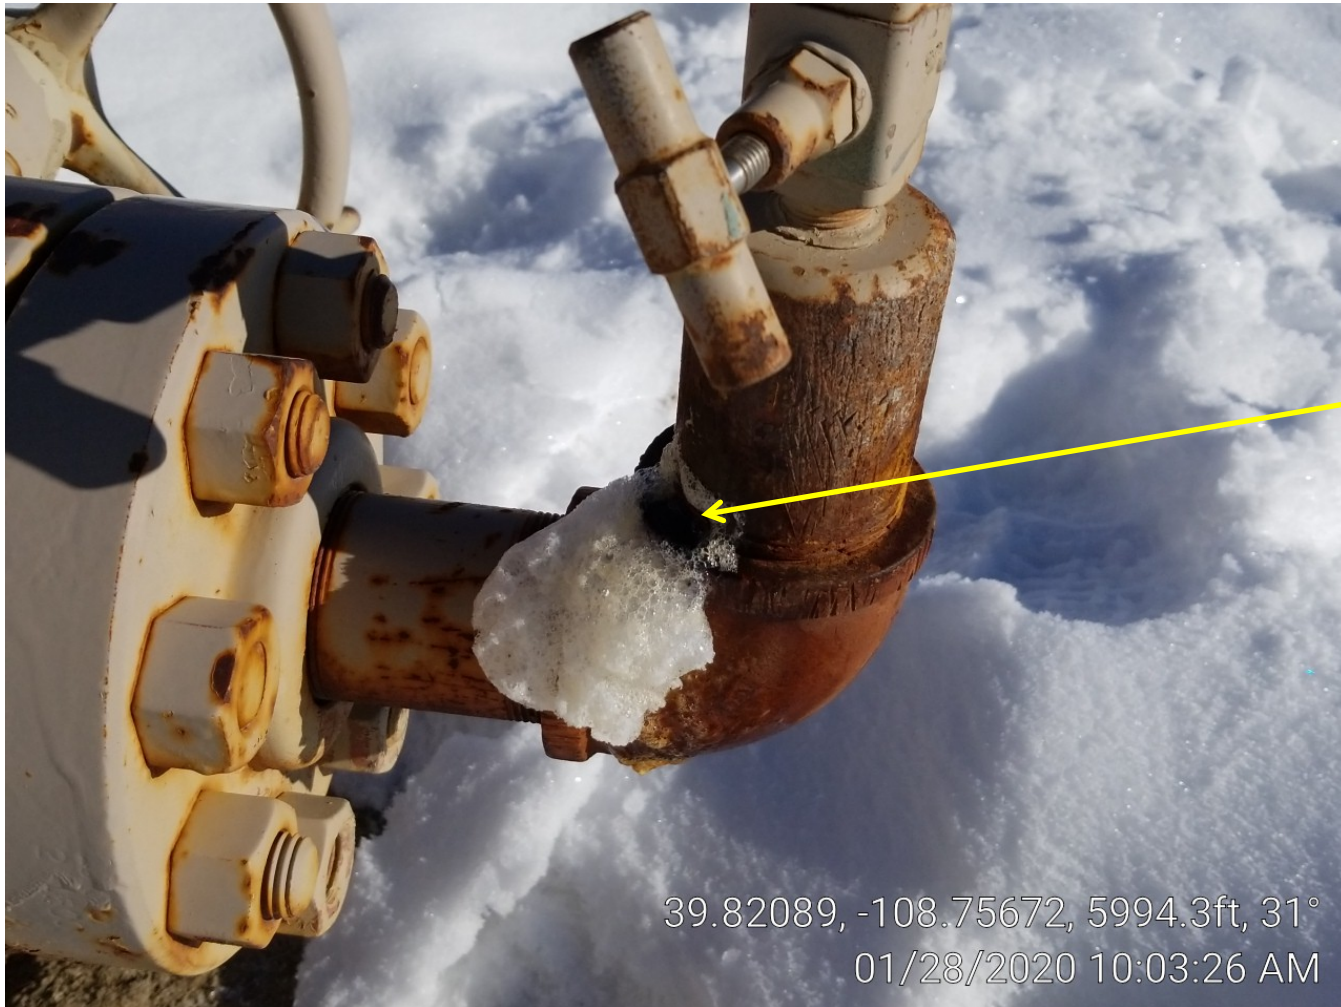
Photo 4. Casing fitting.
