Inspection Photos
Location Name: ESTER (OWP) #1
API: 05-067-06232

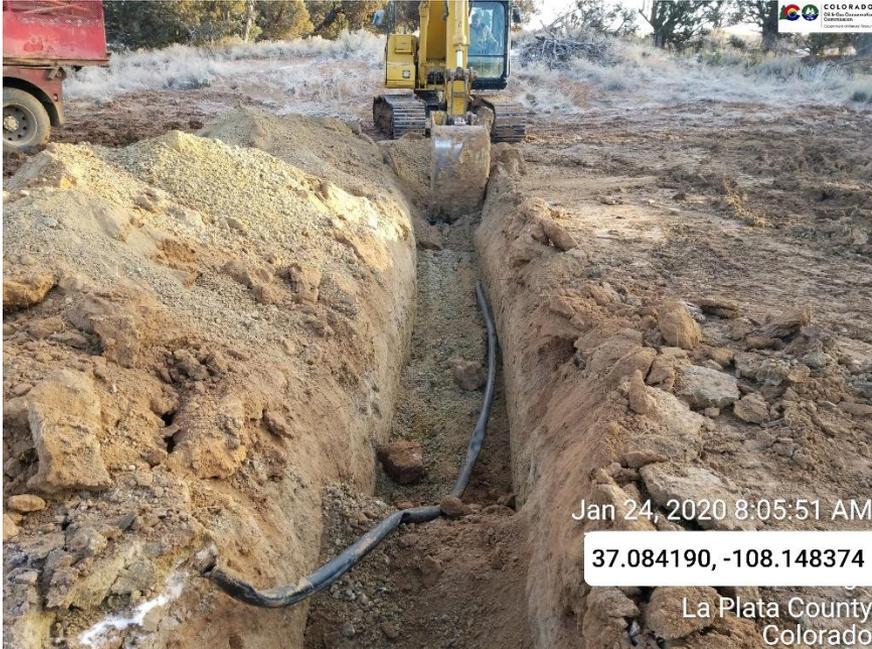
PVC flowline located.

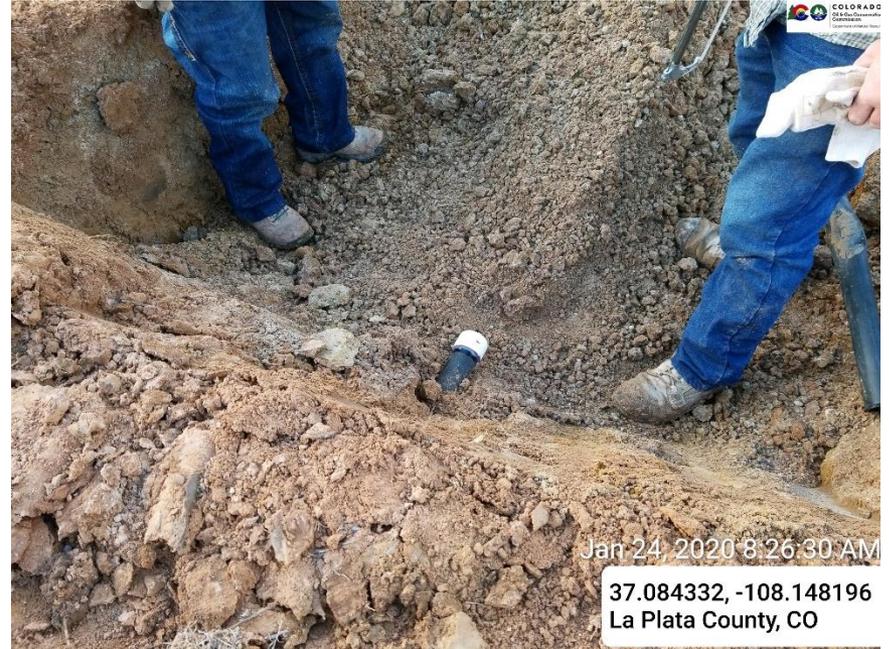
PVC flowline cut and capped.

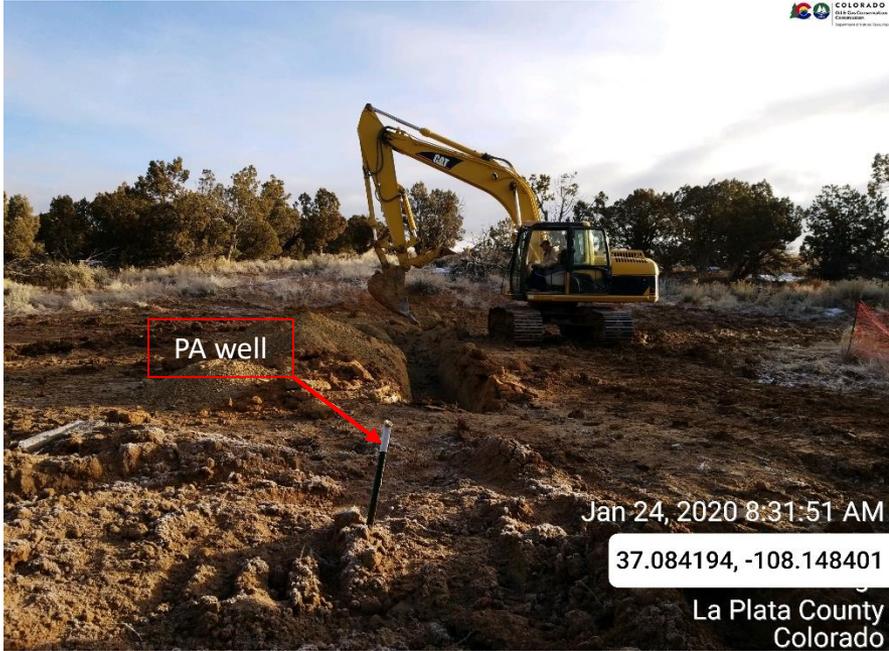
Trench backfilled.

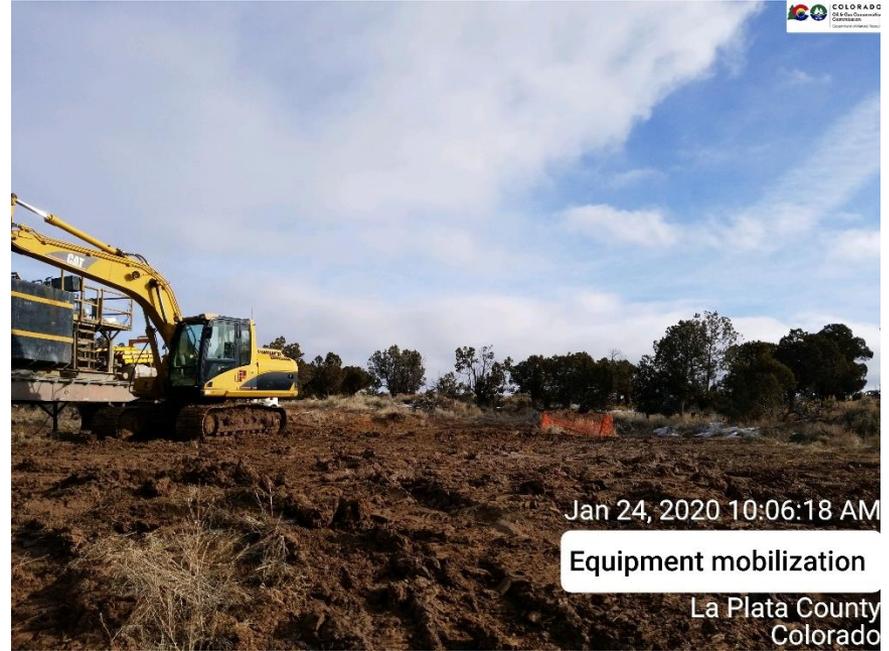
Equipment mobilization.
