Pit Status Evaluation Form

Pit Name: WAILES 1	Facility ID: 114407
Current Status: Unknown	Status Date: 9/23/1999
Current Operator: MACEY & MERSHON OIL INC / 52225	
Updated Operator:	
Form 15 Pit Permit Doc #:	Permit Date:
Related Facilities: WAILES #1 (API 05-009-08210, Facility ID 202805, Loc ID 320141)

County: ADAMS			
Township: 2S	Range: 63W	Section: 8	QQ: NESE
Original Latitude/ Longitude: 39.888462 / -104.453977			
Updated Latitude/ Longitude: /			
Basis for Location Change:

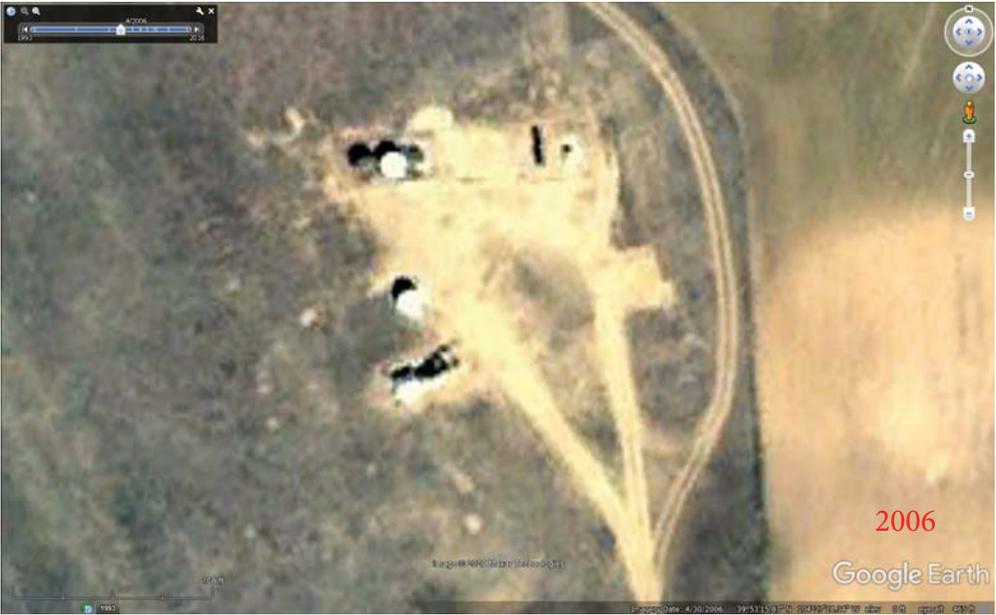
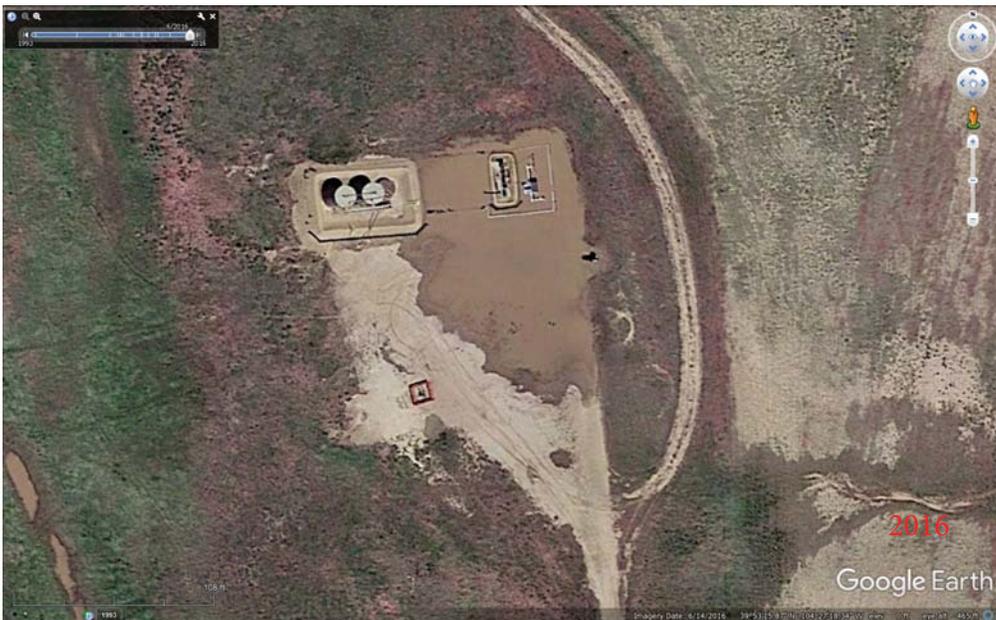
| <input checked="" type="checkbox"/> Aerial Photo Verification (photos attached) | |

No evidence of a pit on location.

Based on records review there is no evidence that there was a pit on location; field inspections and pit inventory report documents a concrete produced water vault then fiberglass tank on location. Pit status has been changed to closed.
