# Inspection Photos

API: 05-071-08351

Operator: TIMBER CREEK OPERATING

Inspection Date: 1/30/2020

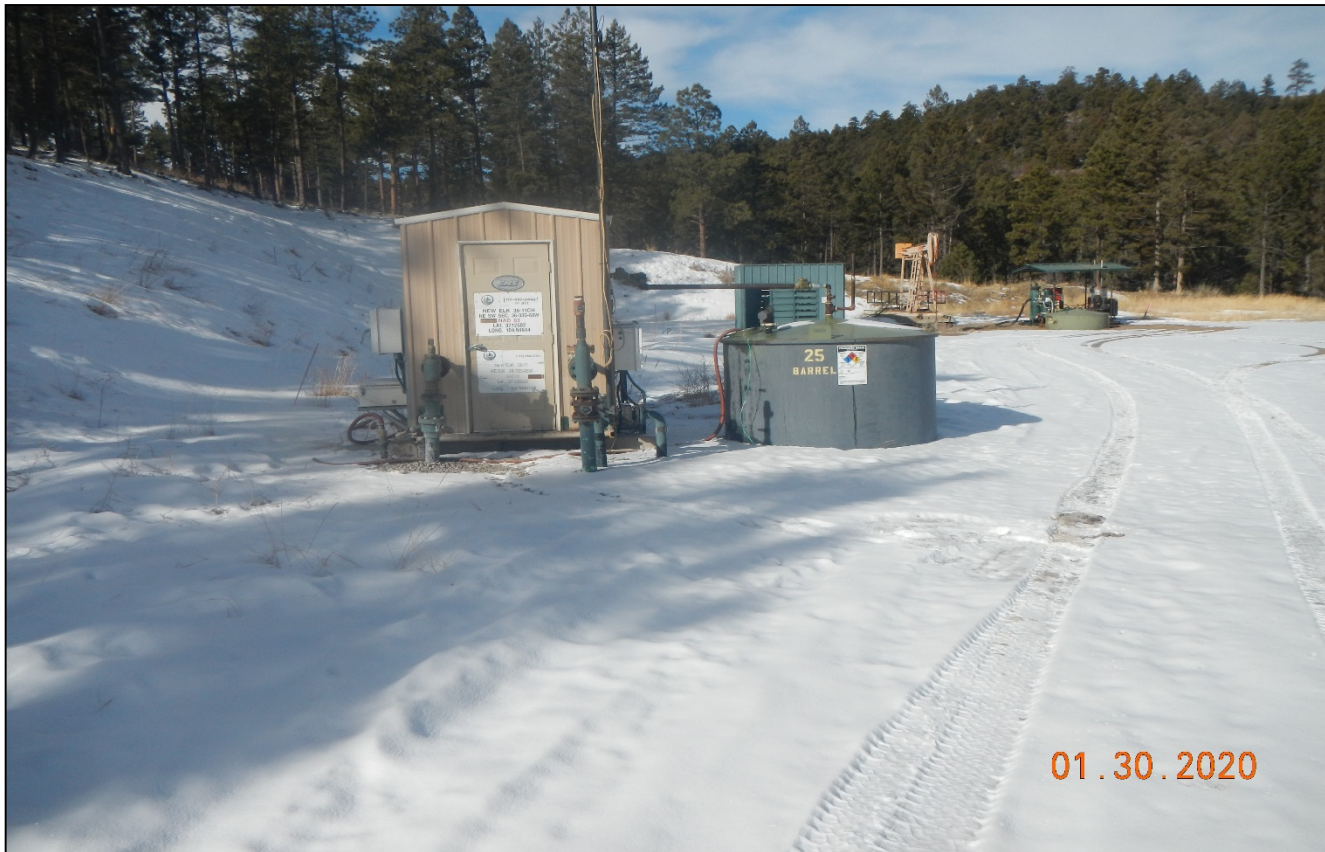
**Photo 1.** Facing west toward the location.

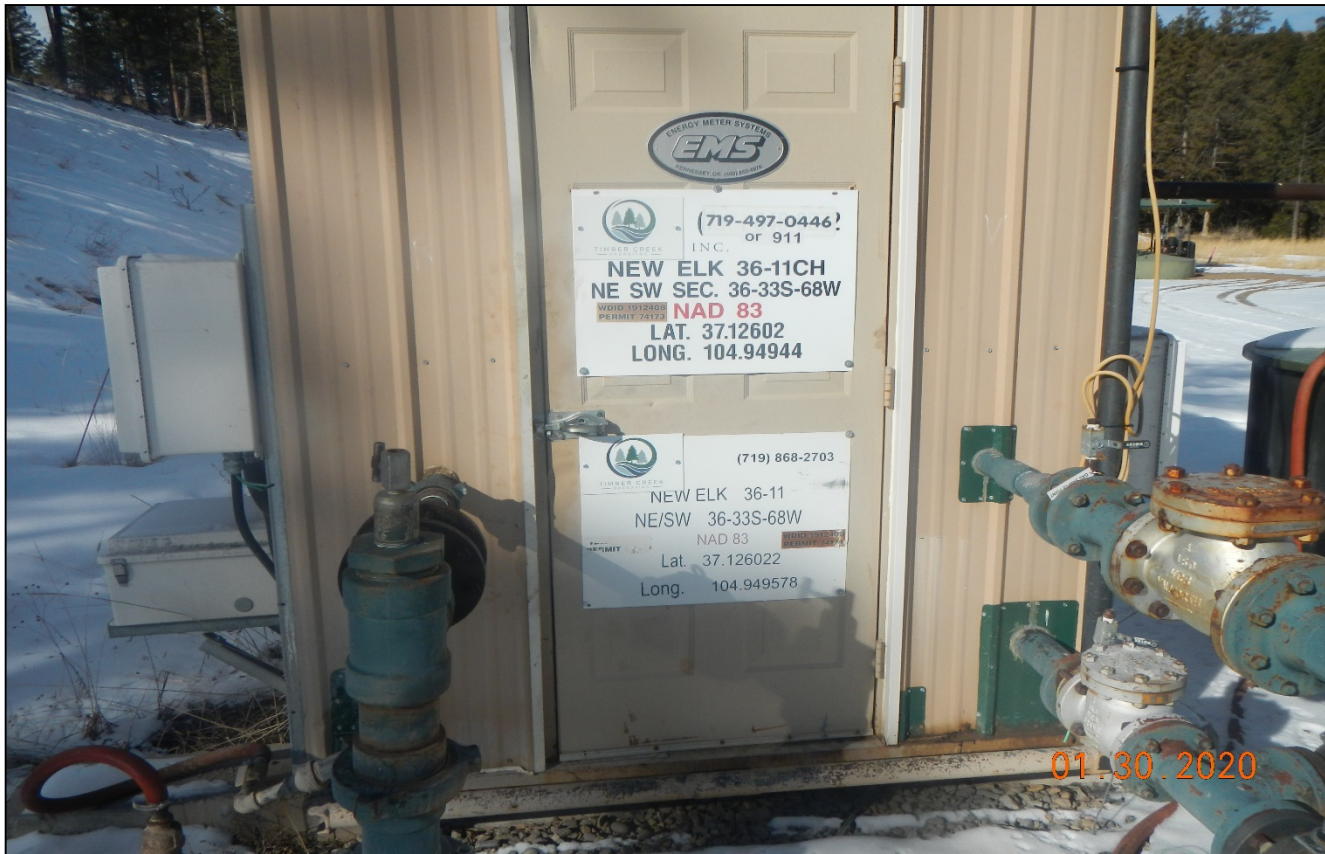
**Photo 2.** Well sign is posted at meter house.

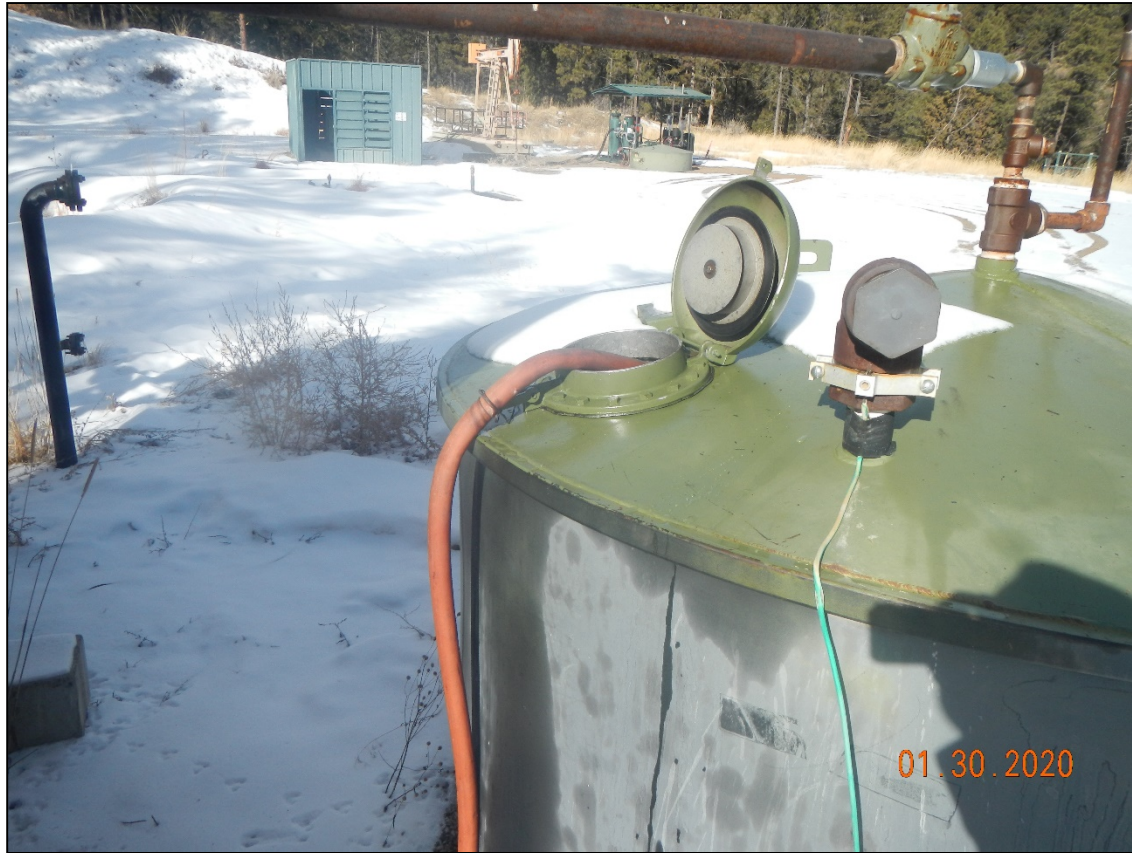
**Photo 3.** The lid is open on the tank. There are signs of spillage out of the tank.

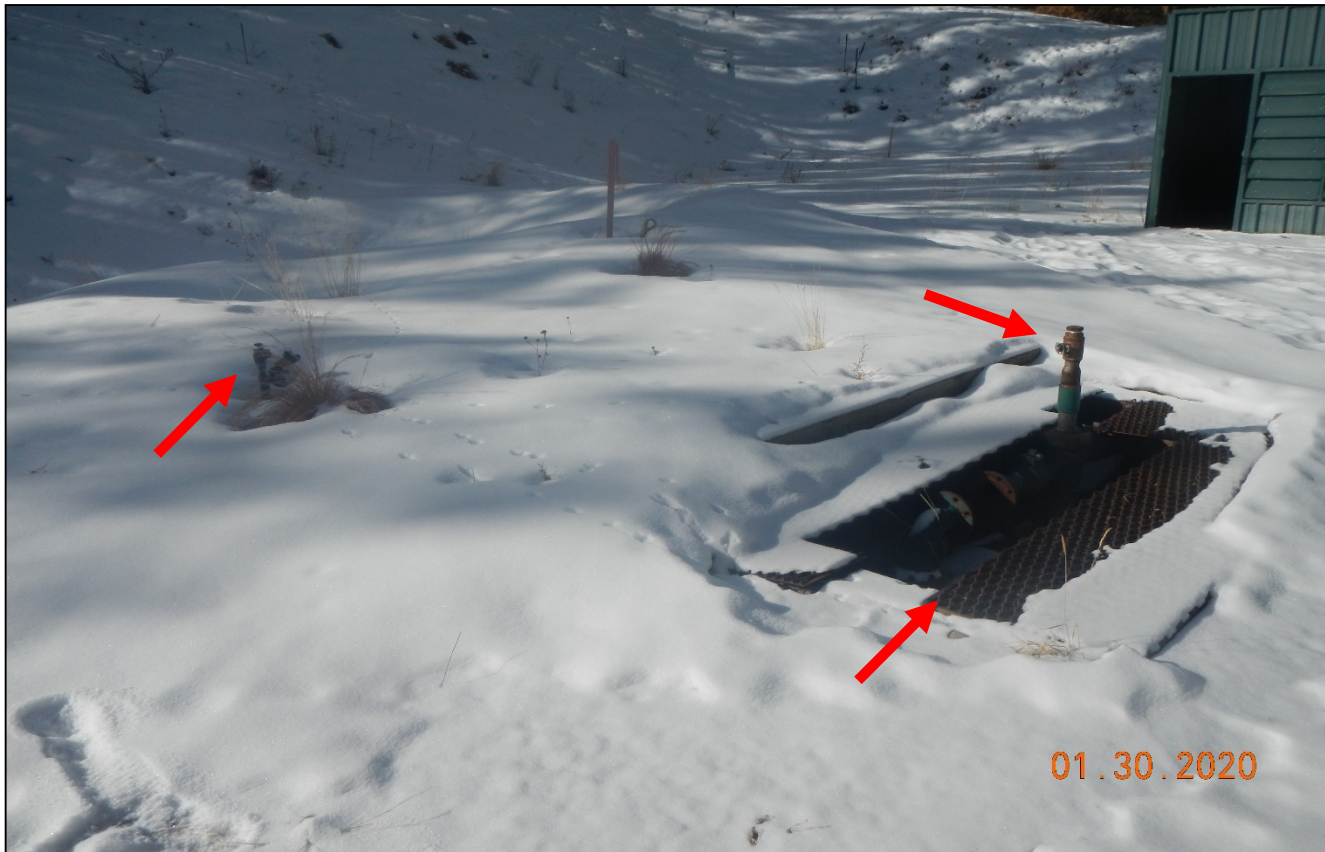
**Photo 4.** There is pipe riser with no LO/TO and clearly visible . The steel covers need to be placed to avoid entry.

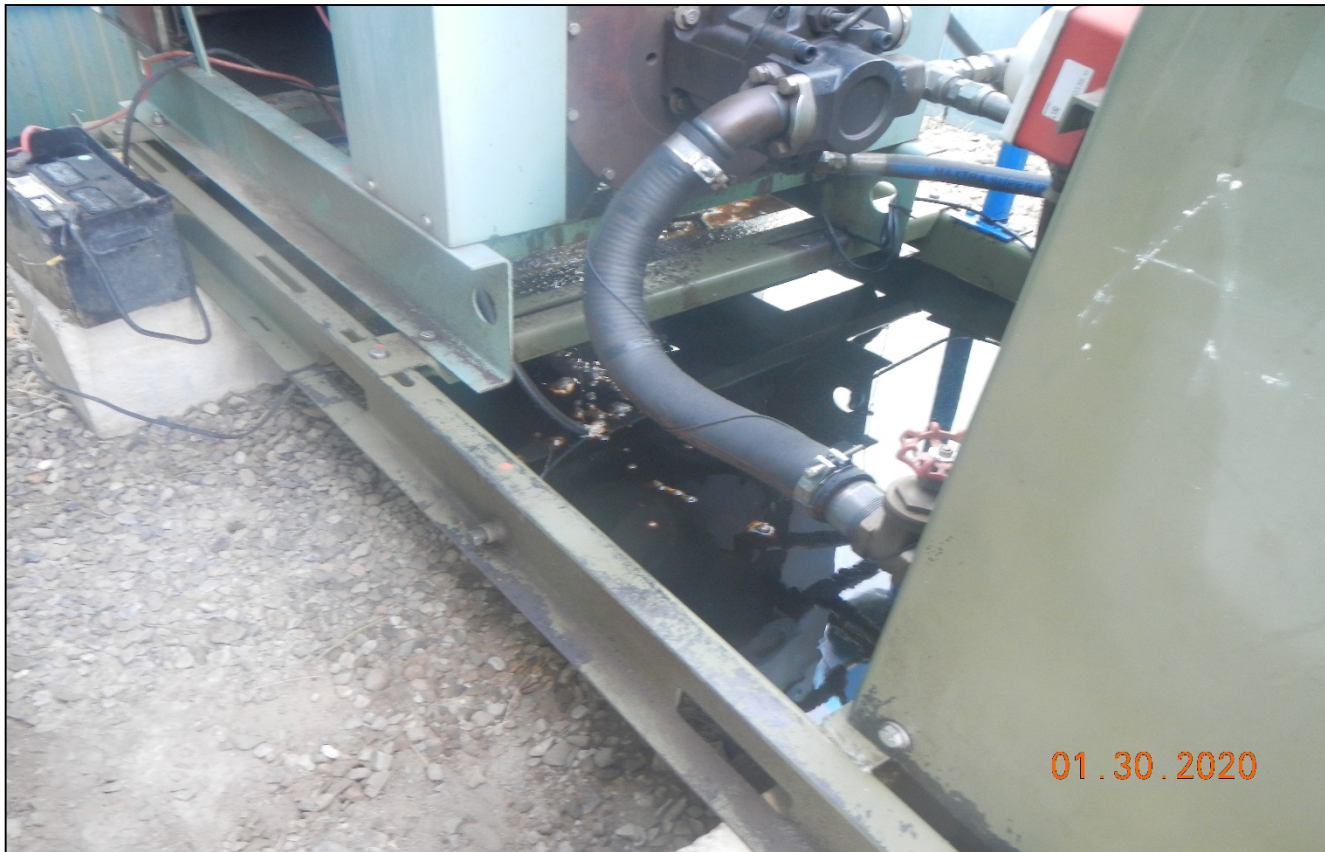
**Photo 5.** There is oily waste in the engine skid.

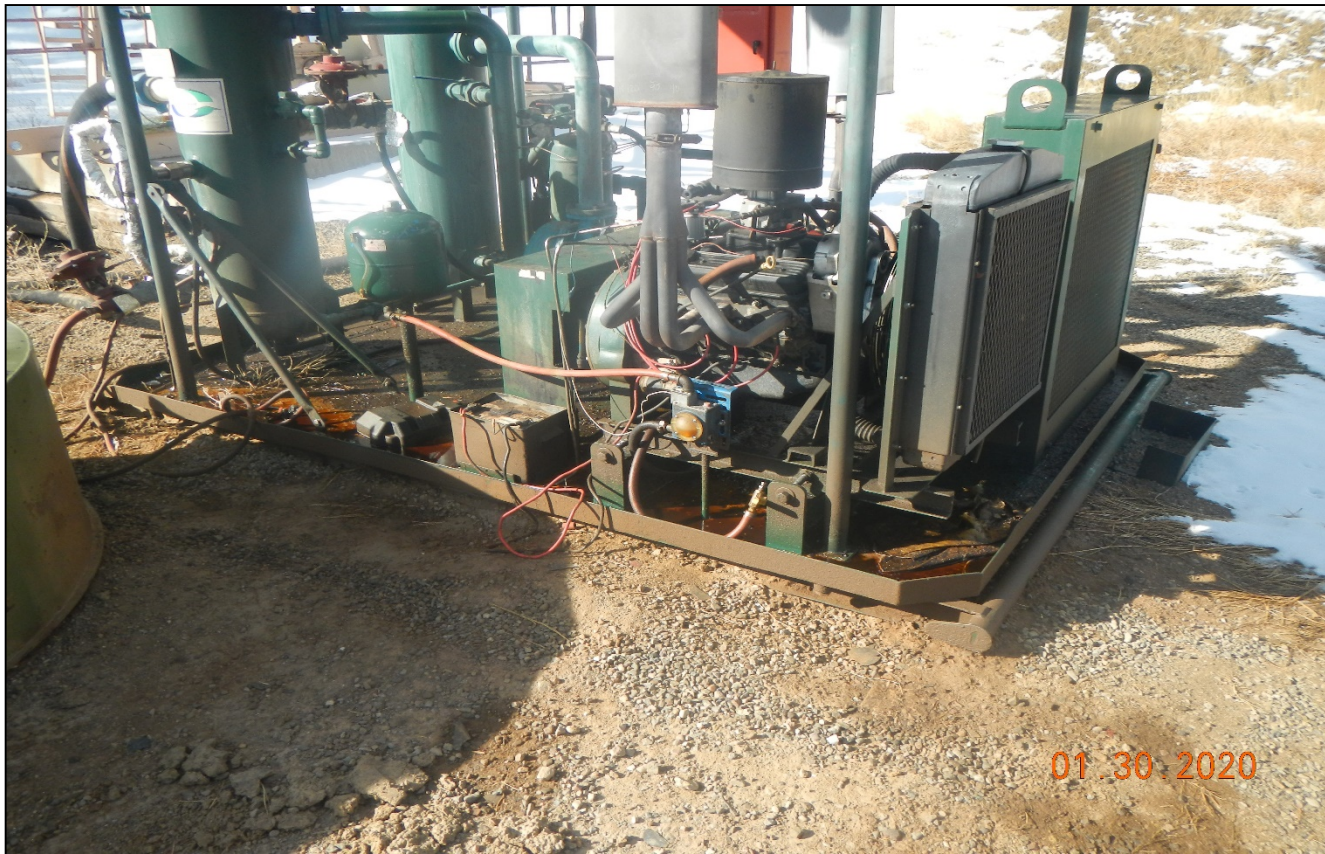
**Photo 6.** There is oily waste at the engine skid at the separator.

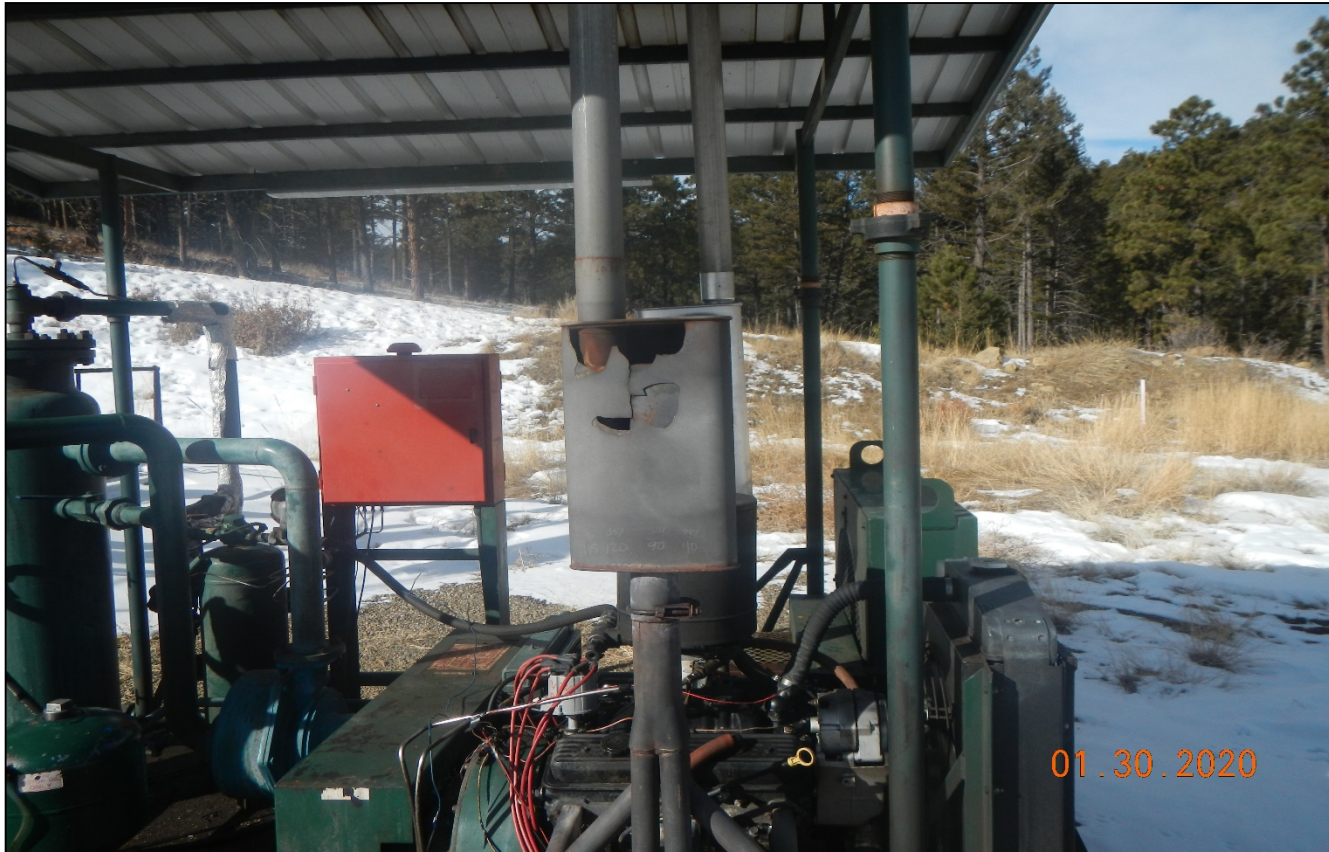
**Photo 7.** The muffler on the engine is broke apart causing the engine to be very loud. Needs to be maintained in good mechanical condition.
