**Inspection Photos**  
**Location Name: Candelaria 33-5 FEE 10U #3**  
**API: 05-007-06215**

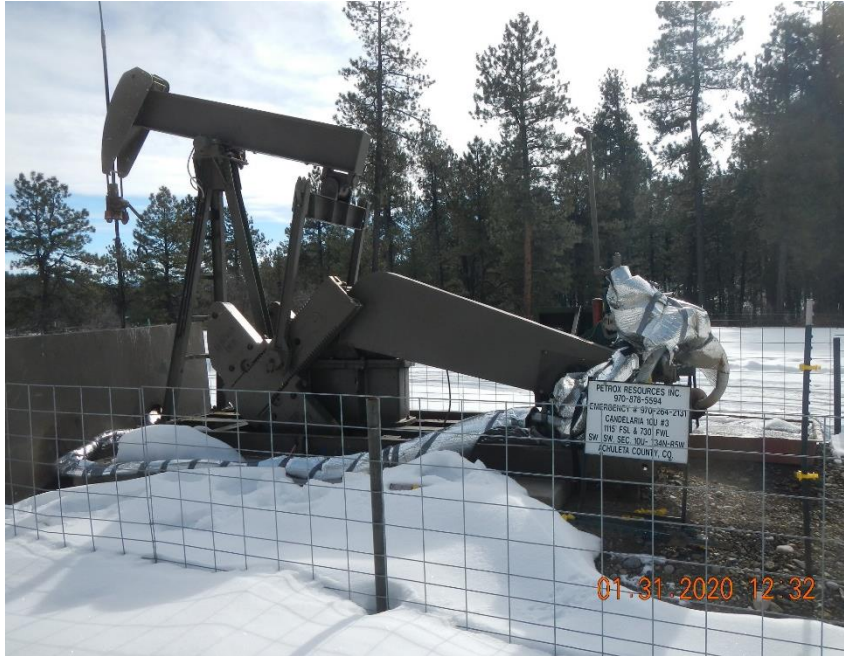
**Candelaria 33-5 FEE 10U #3 pump jack.**

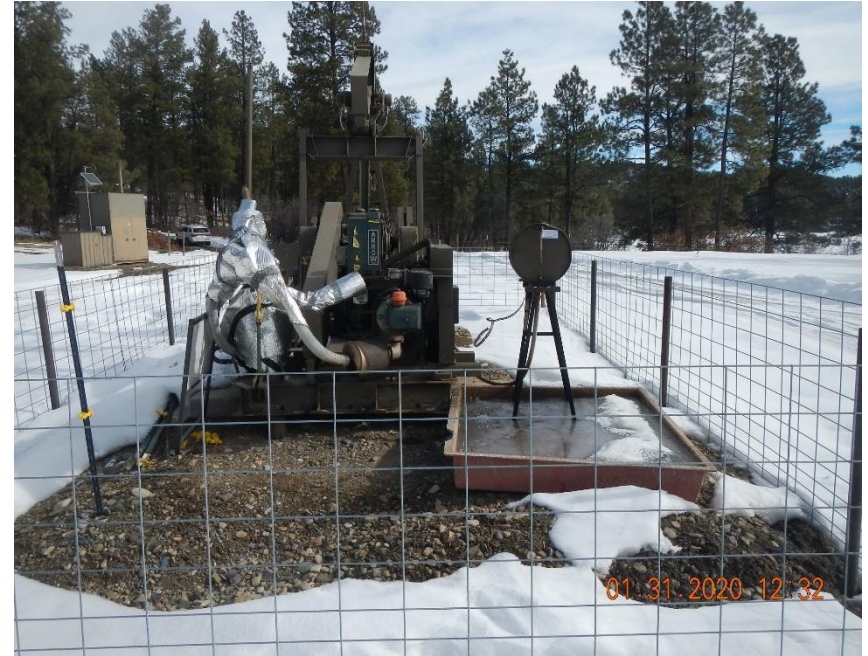
**Secondary containment for lube oil container is almost full of ice.**

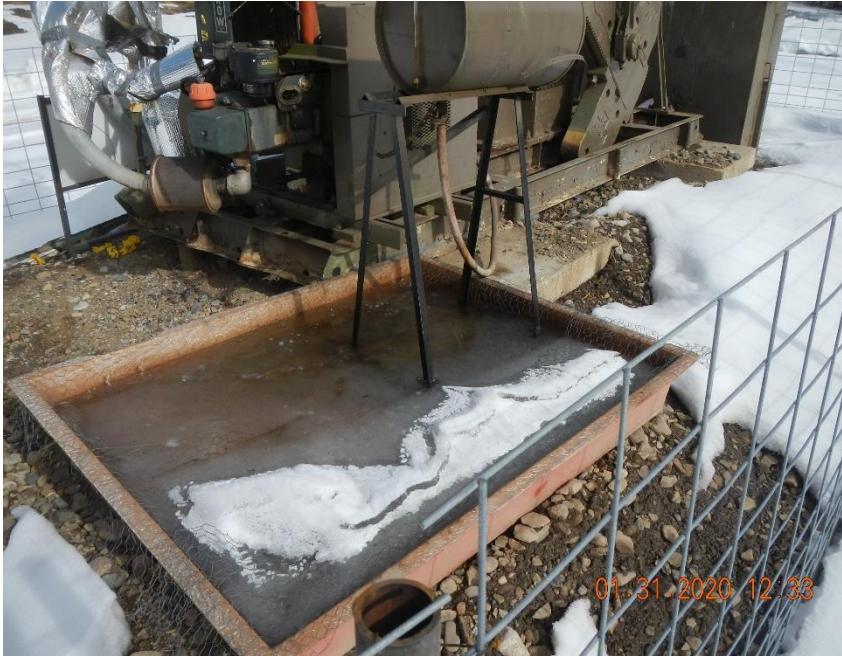
**Inadequate secondary containment for lube oil container.**

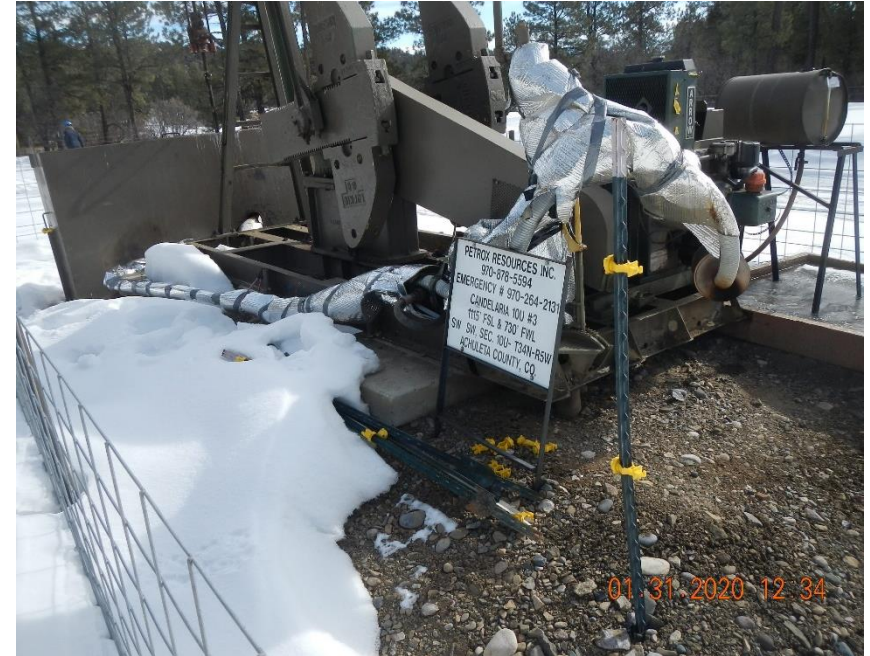
**Fencing supplies stored near pump jack.**
