**RE:** Request to Remove Equipment from Location  
Shields Marie 2 6 2 Gas Well (API# 0506707929)

Inspection Date: <u>12/18/2019</u> Submitted Date: <u>12/19/2019</u> Document Number: <u>693901235</u>
<b>FIELD INSPECTION FORM</b>

**Inspection Photos**  
**Operator: Hilcorp Energy**  
**Location/API #: 067-07929**  
**Date: 12-18-2019**

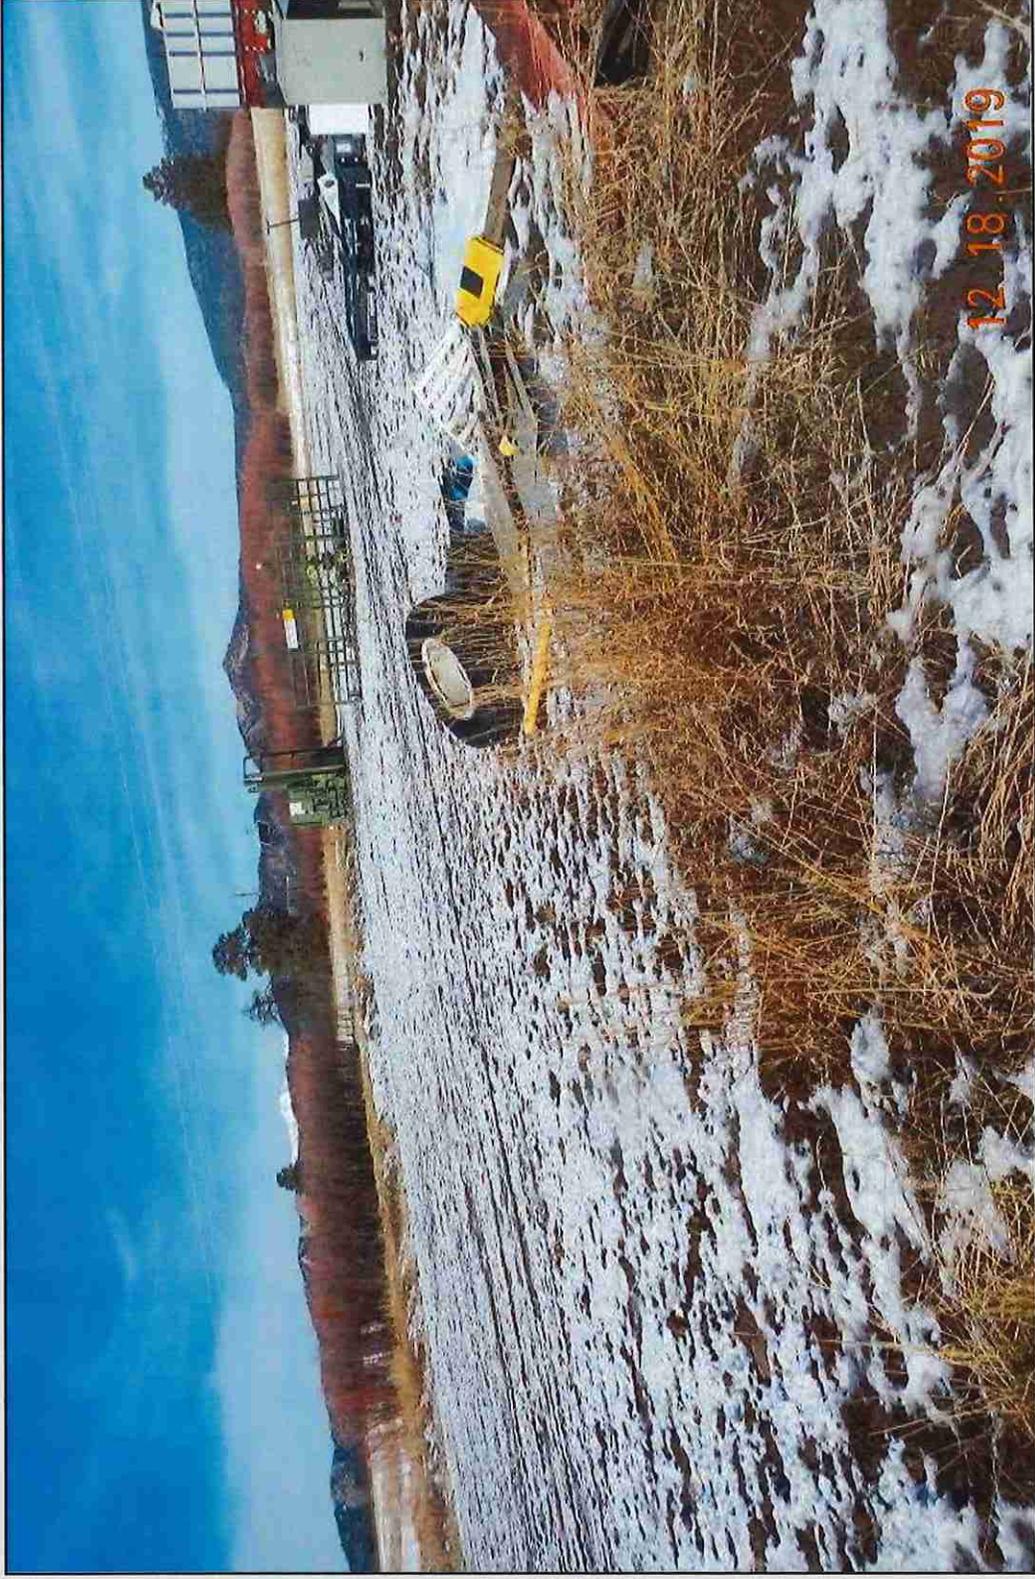
Photo 1. View of the project area from the southeastern corner facing center.

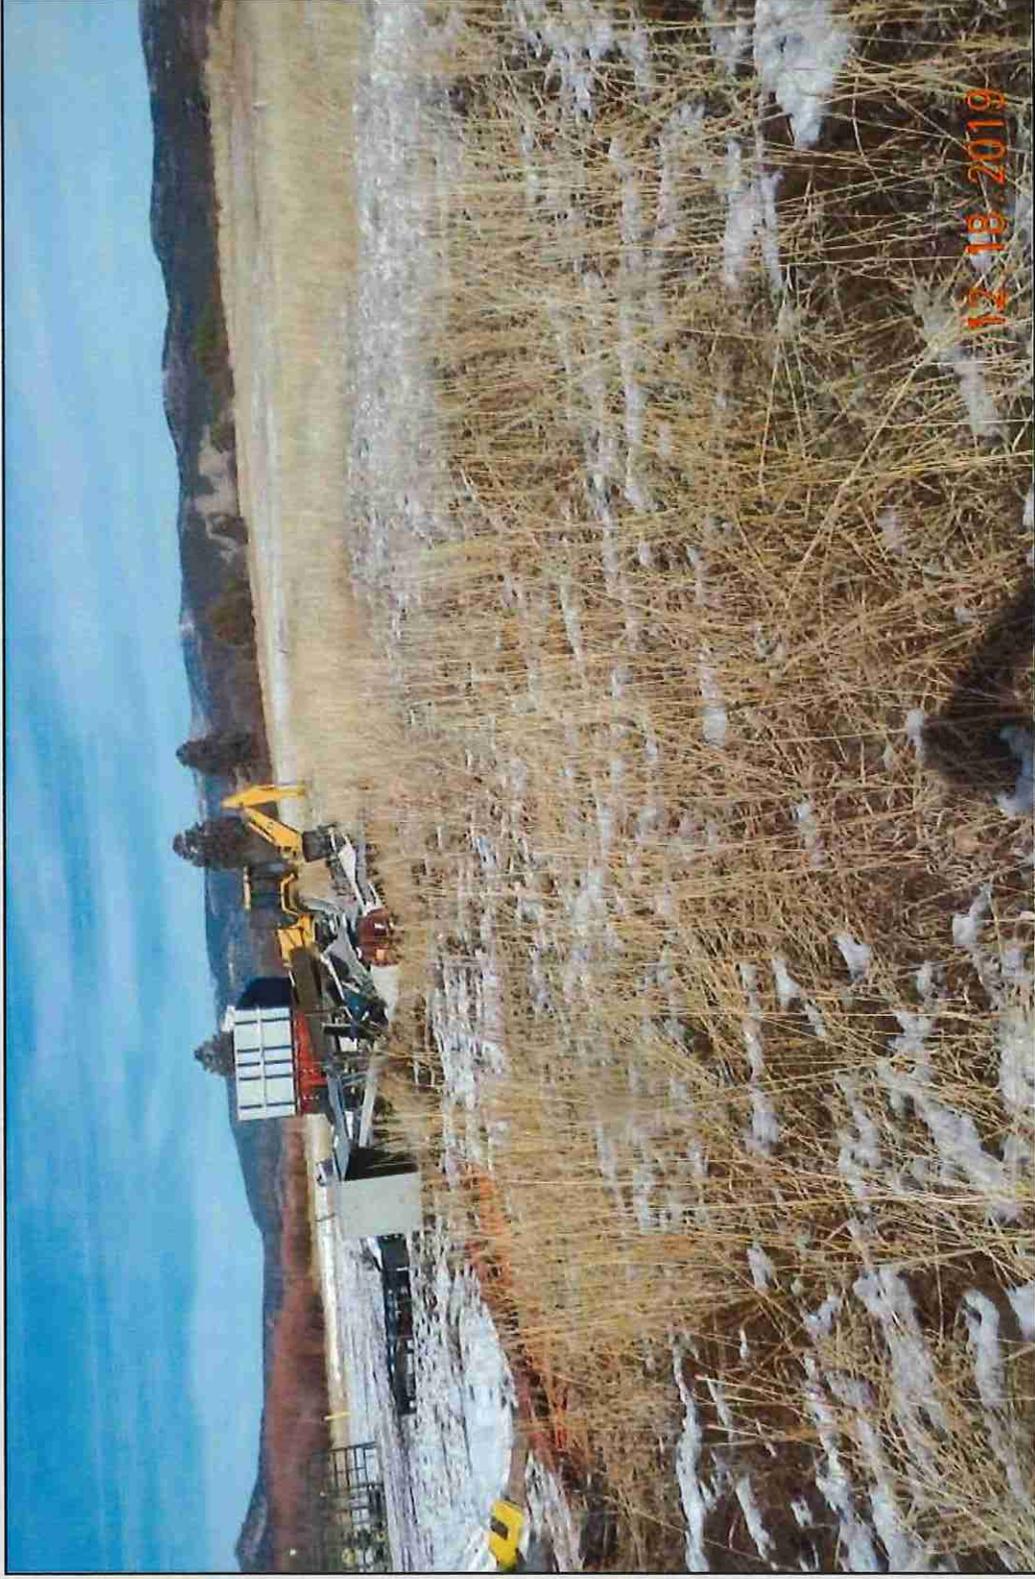
Comment **Waste and debris observed within the eastern project area.**

Comment **Unused equipment observed within the project area.**

Photo 2. View of the eastern fill slope from the southeastern corner facing northward. Location is partially snow covered at this time. Revegetation is in a dormant vegetative condition, and largely comprised of smooth brome, western wheatgrass, and sand dropseed. Junk, debris, and unused equipment stored within the eastern project area.

Corrective Action **Remove and properly dispose of waste nad debris.**

Corrective Action **Remove and properly store unused equipment.**

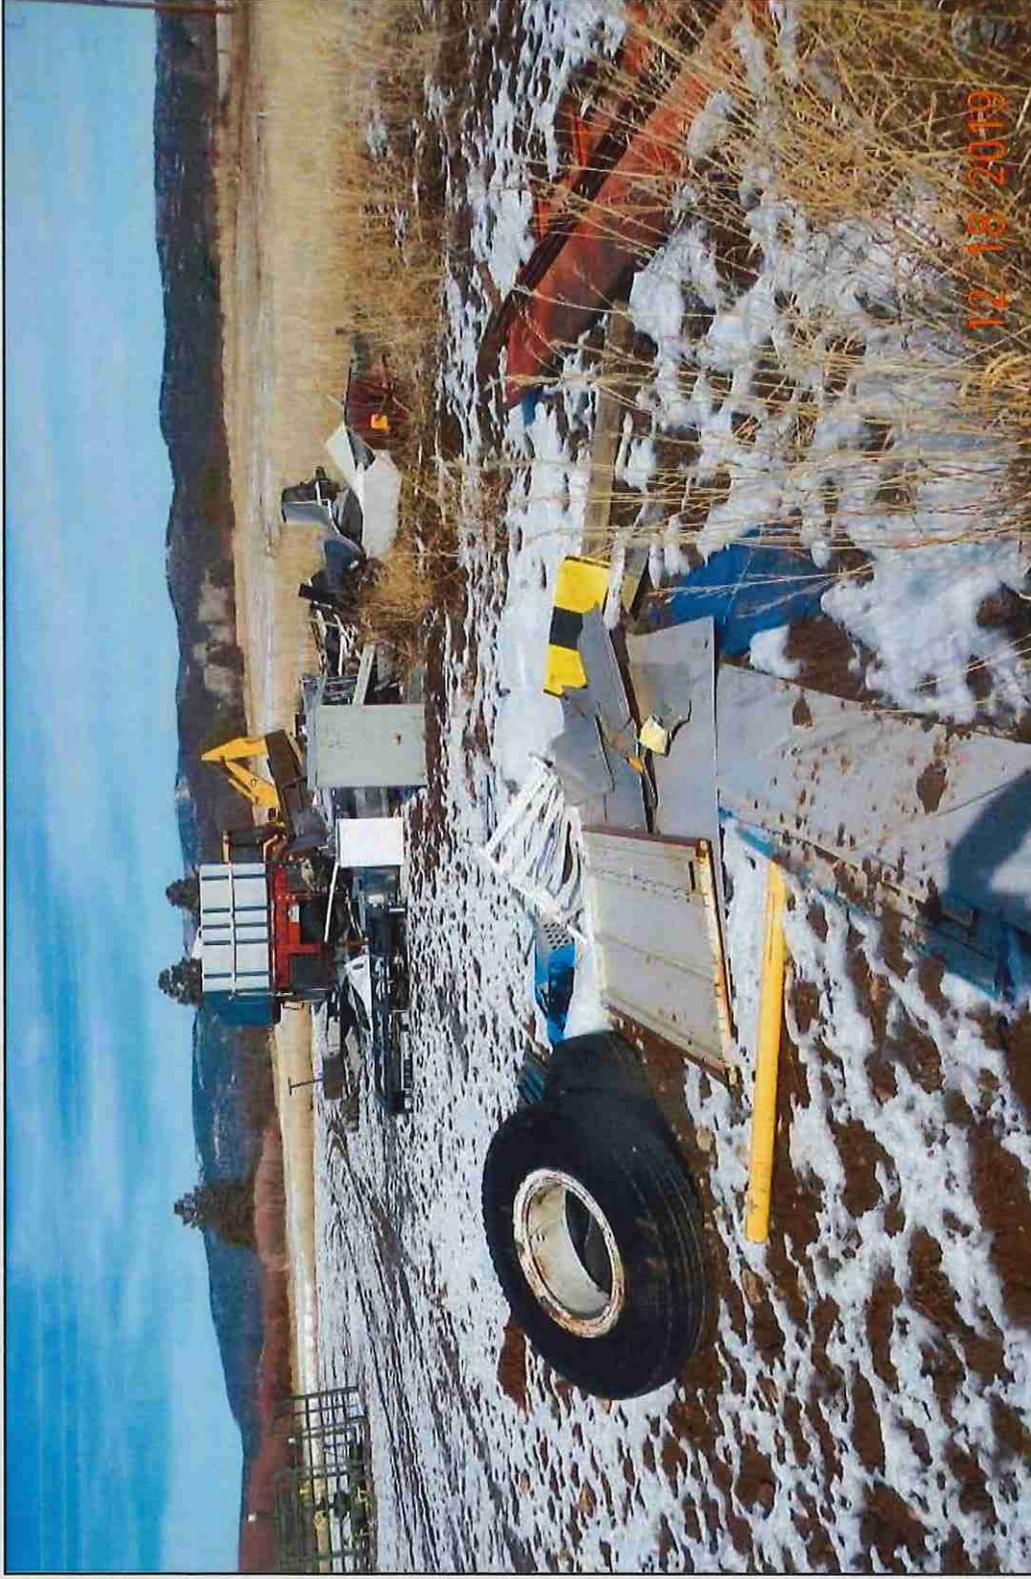
Photo 3. View of unused equipment, junk, and debris in the eastern project area; needs to be removed.

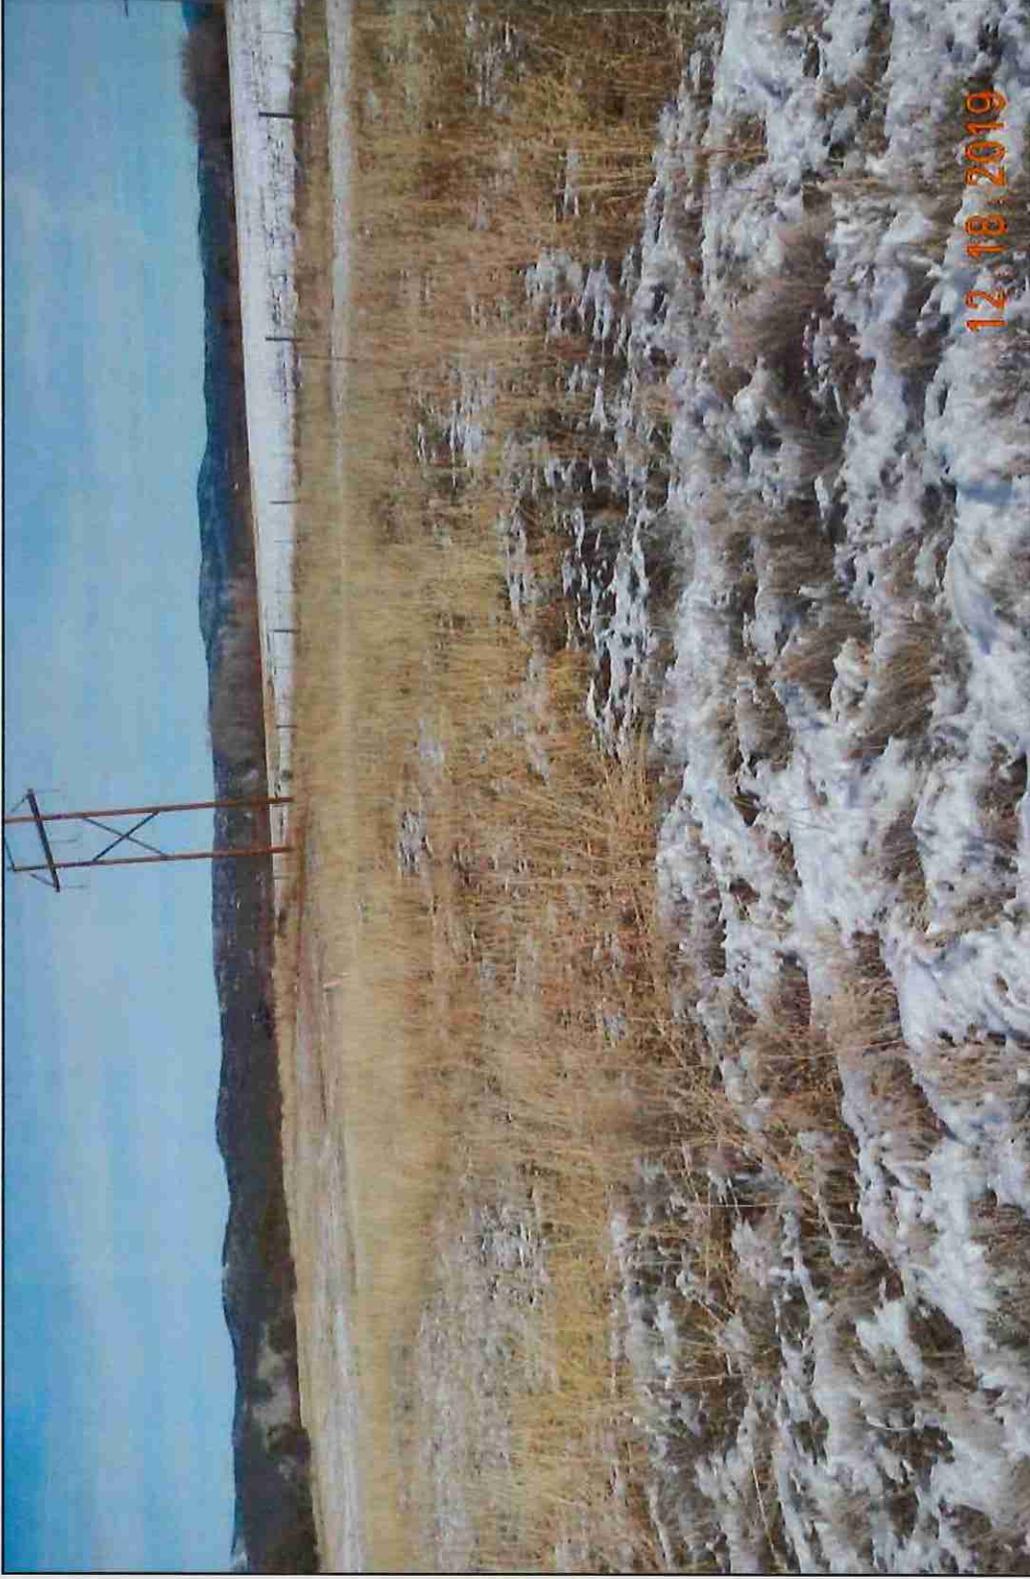
Photo 4. View of reference area comprised grass field, largely comprised of smooth brome in dormant vegetative condition.
