Inspection Photos
Location Name: State of Colorado "P" #1
Location ID:319692

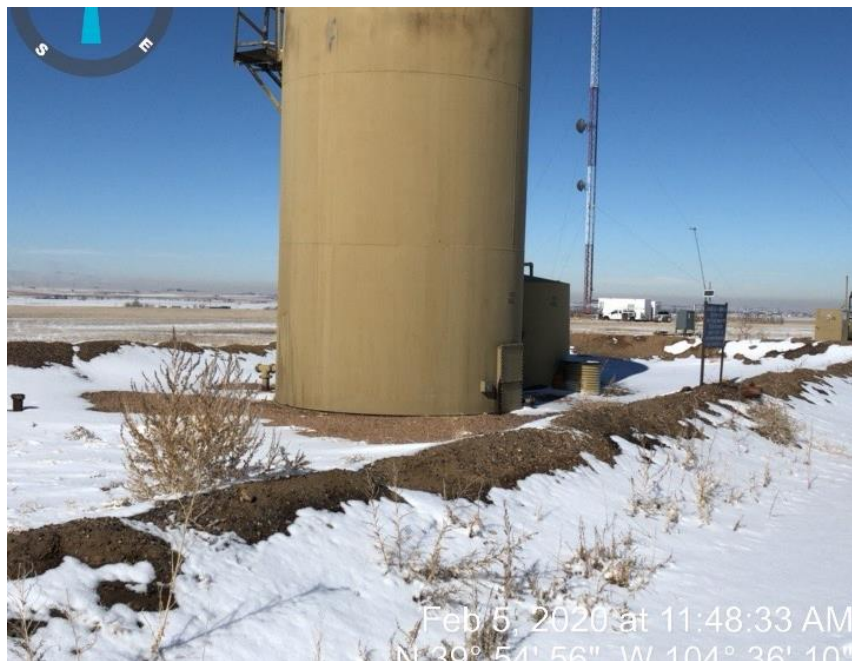
Photo #1 tanks and debris

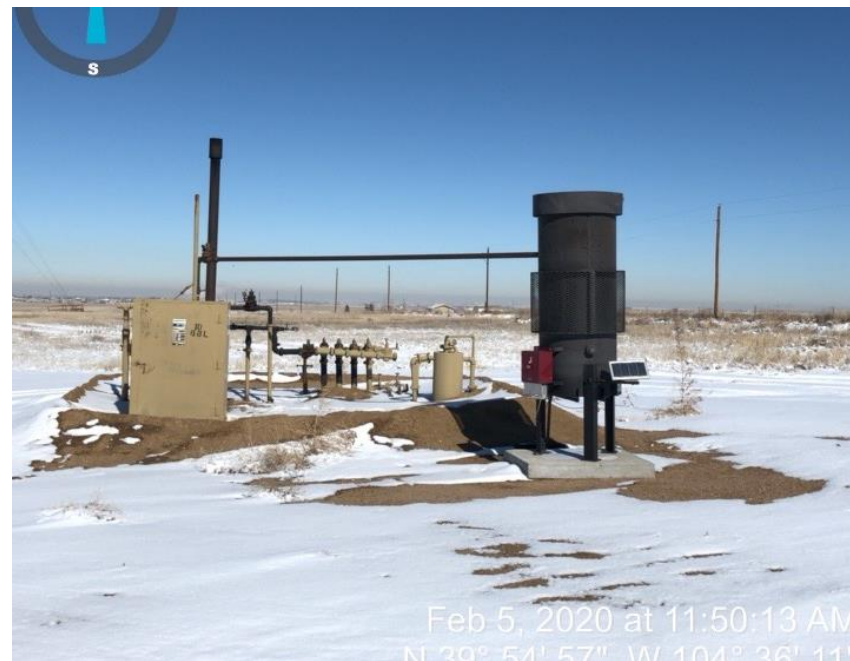
Photo #2 separator and combustor

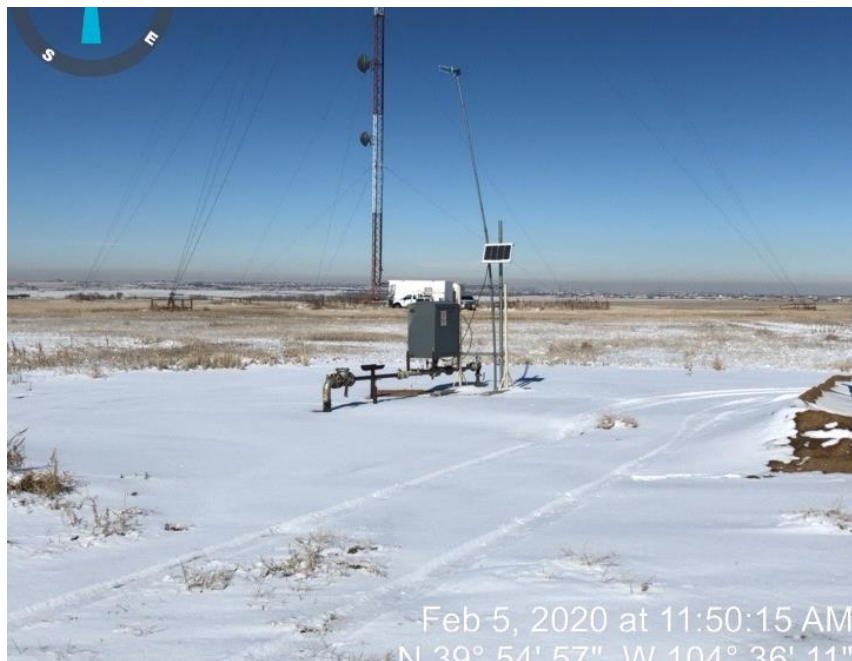
Photo #3 meter run and RTU

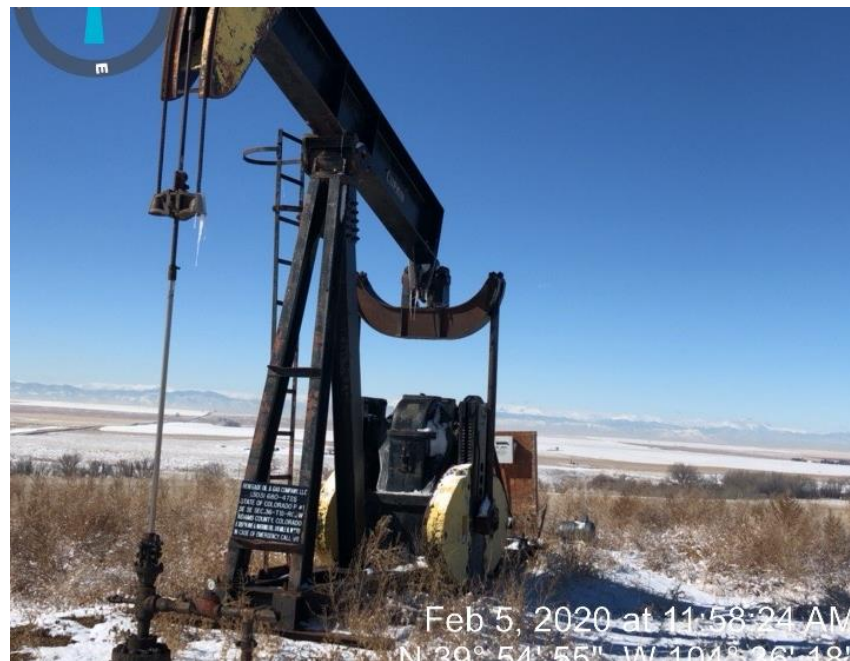
Photo #4 pumpjack

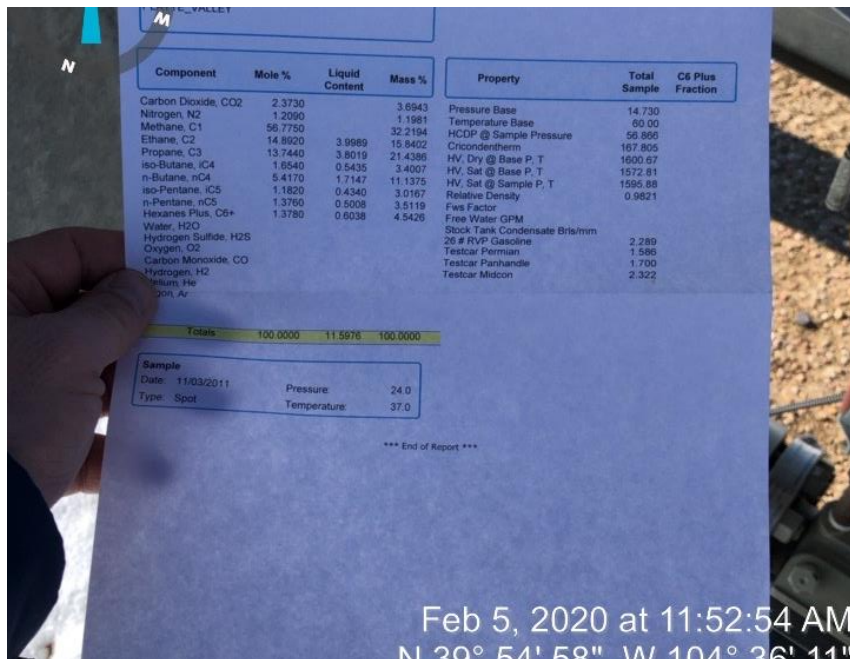
Photo #5 meter out of calibration

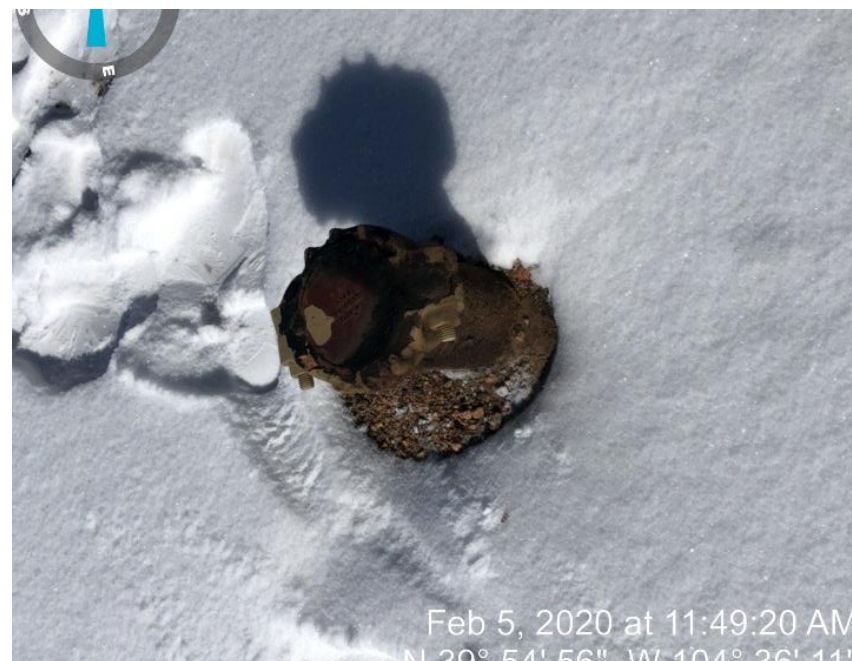
Photo #6 unmarked riser south of crude tank

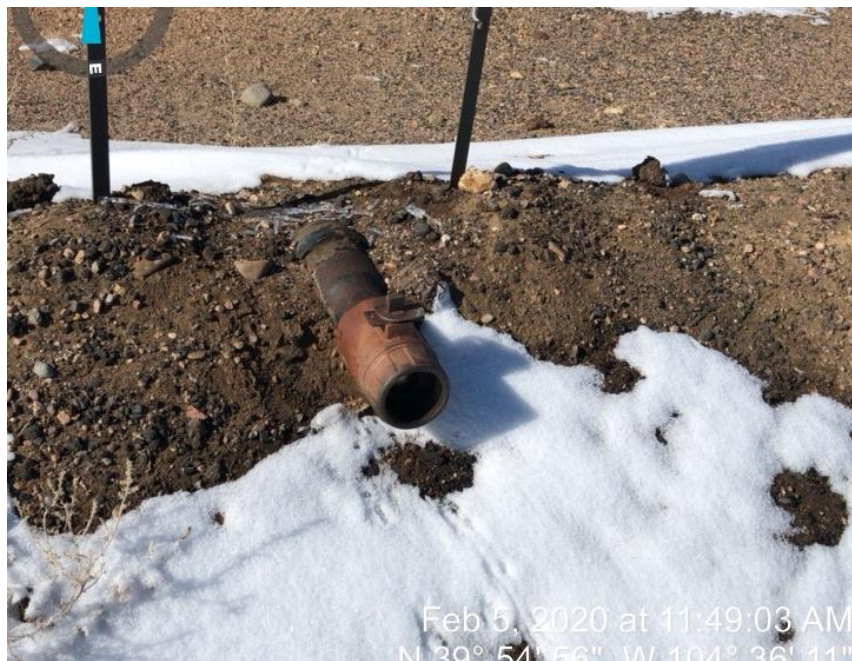
Photo #7 load off line with no bull plug

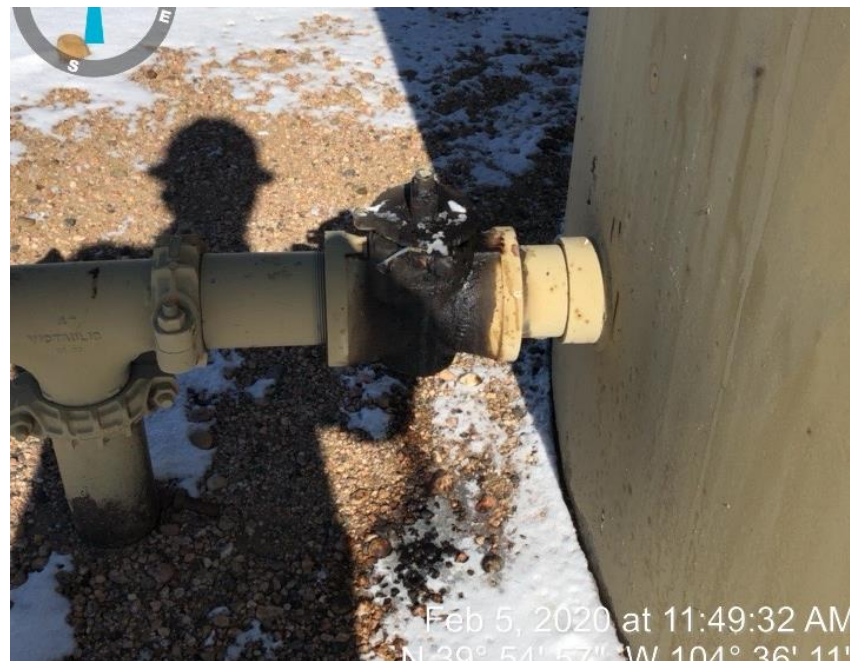
Photo #8 leaking valve and stained soil

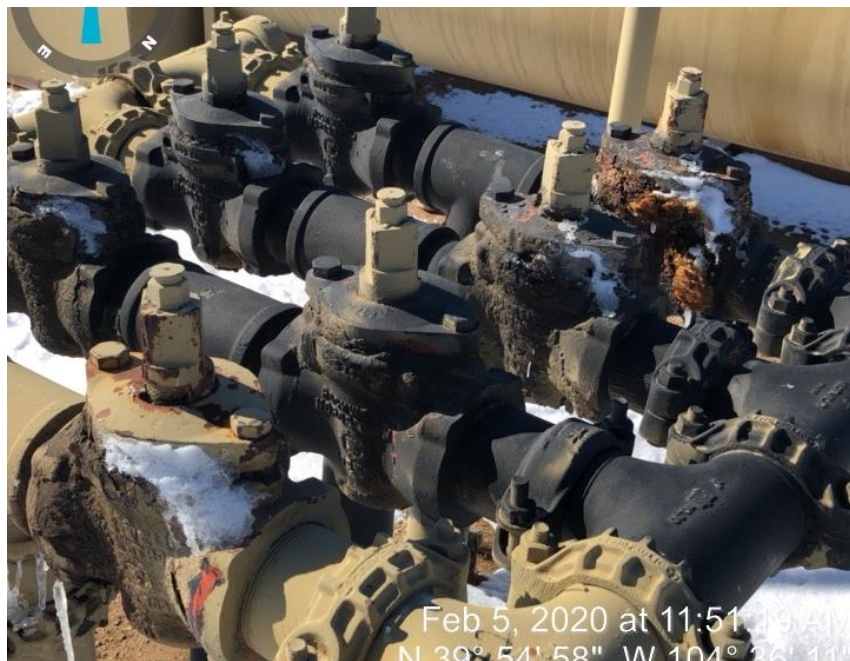
Photo #9 leaking valves

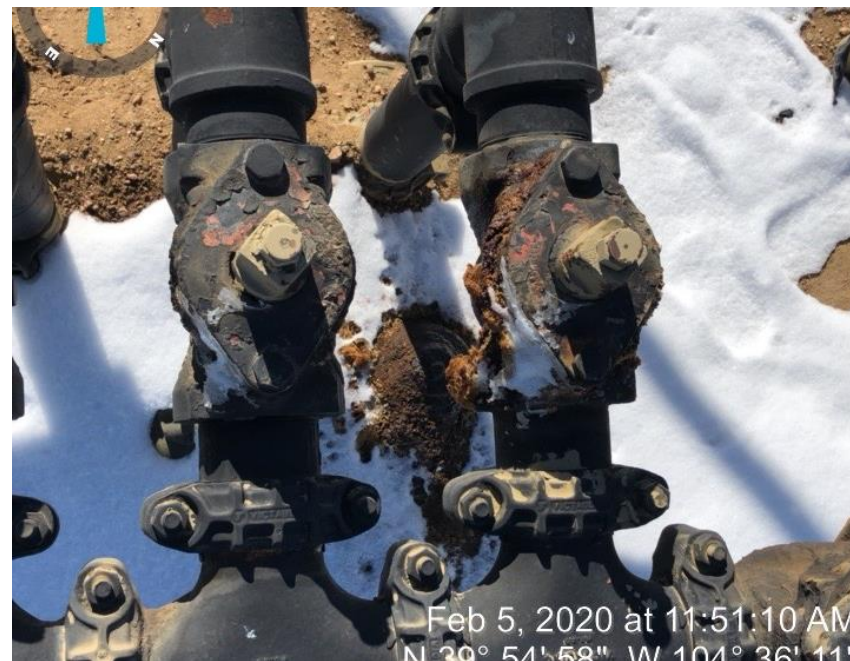
Photo #10 stained soil

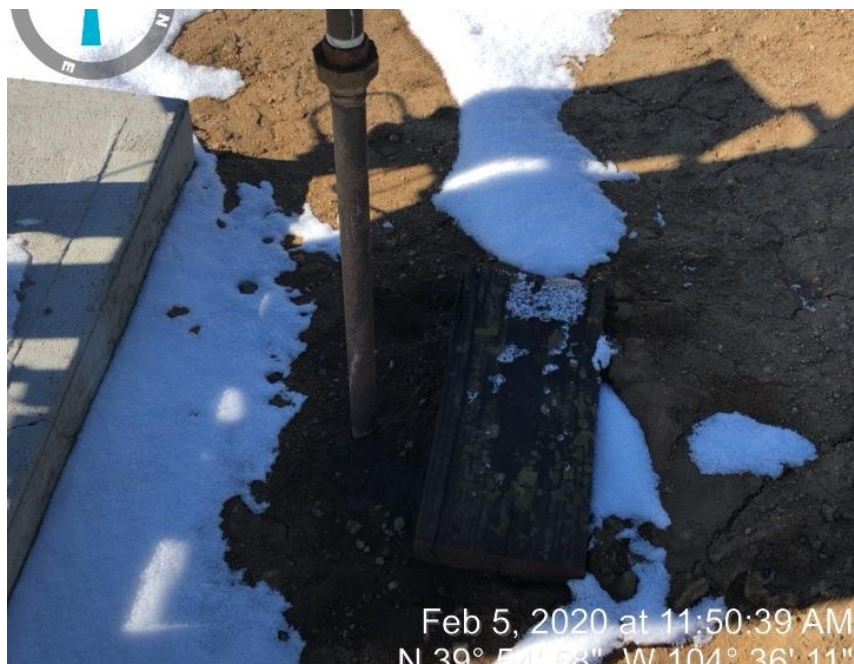
Photo #11 stained soil by combustor

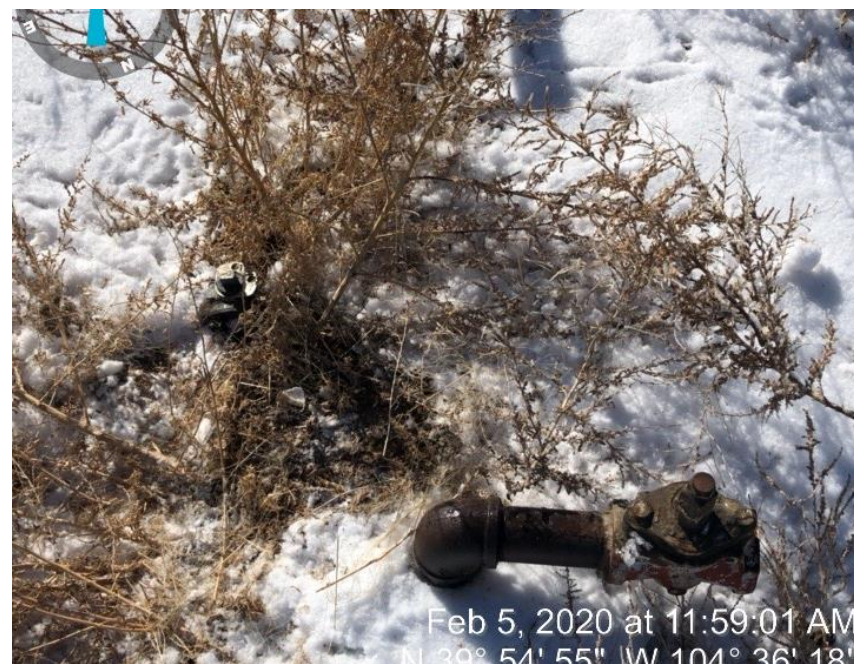
Photo #12 unmarked risers by pumpjack

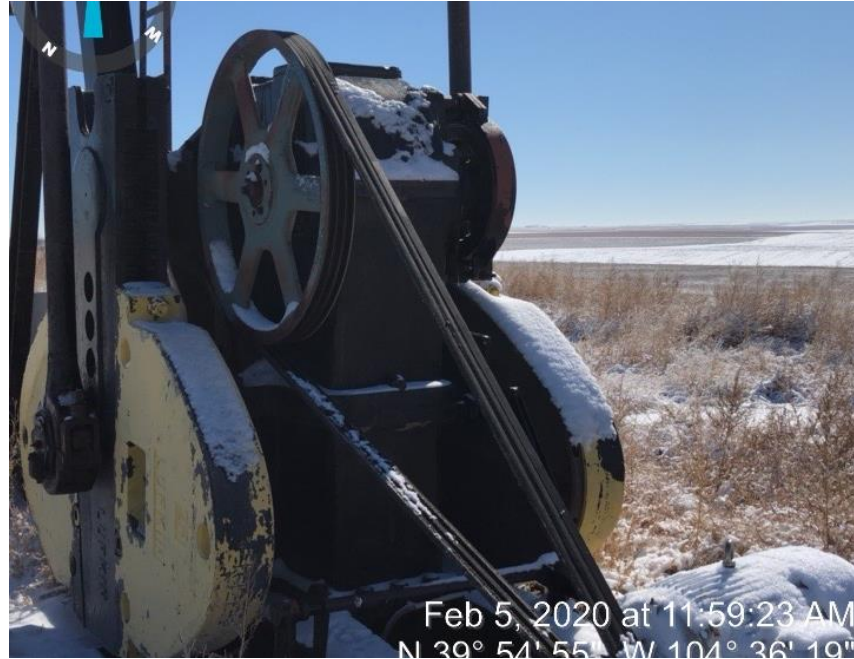
Photo #13 safety equipment not in place on pumpjack
