Inspection Photos
Location Name: Anschutz Windmill
Location ID: 424573

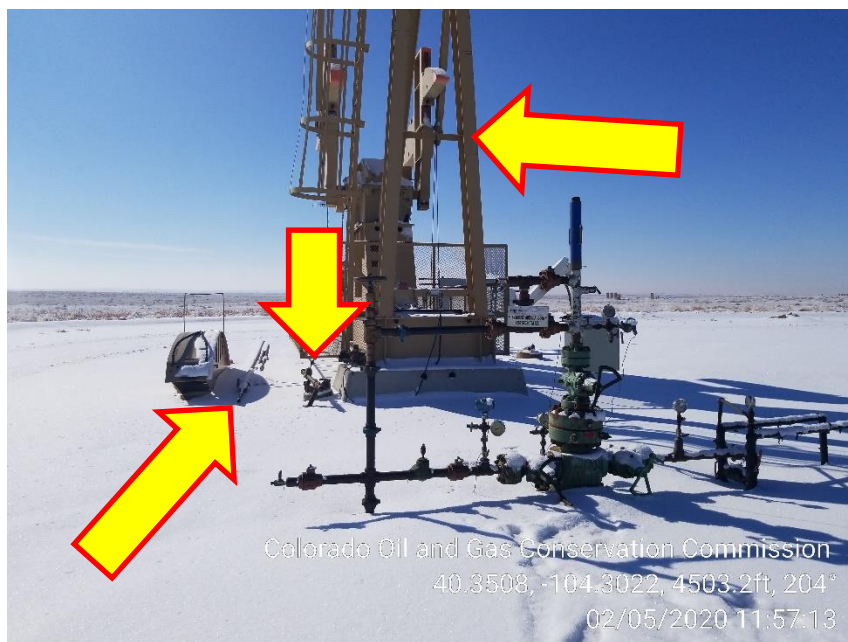
Photo 1 – Wellhead, Unused wellhead parts, polish rod and Pumping Unit

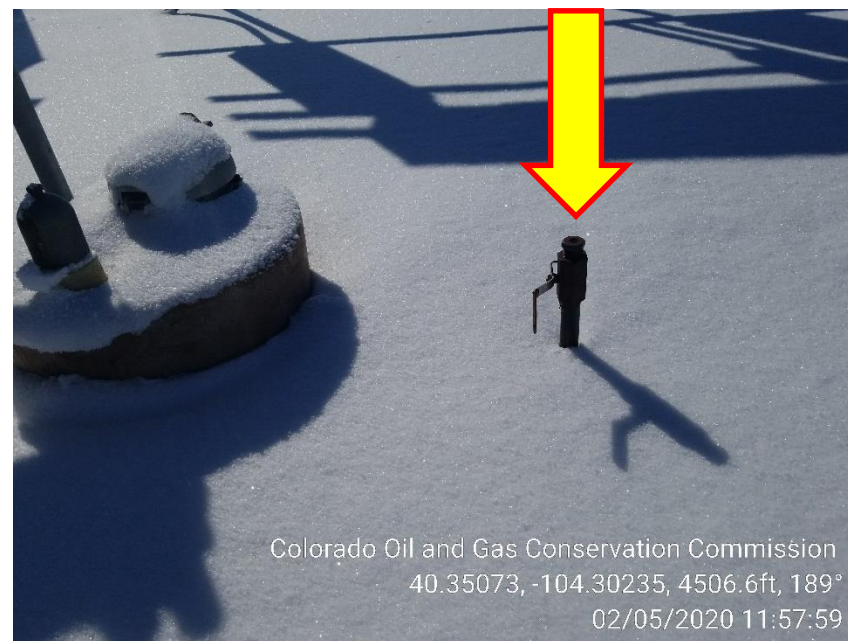
Photo 2 – Unmarked Riser

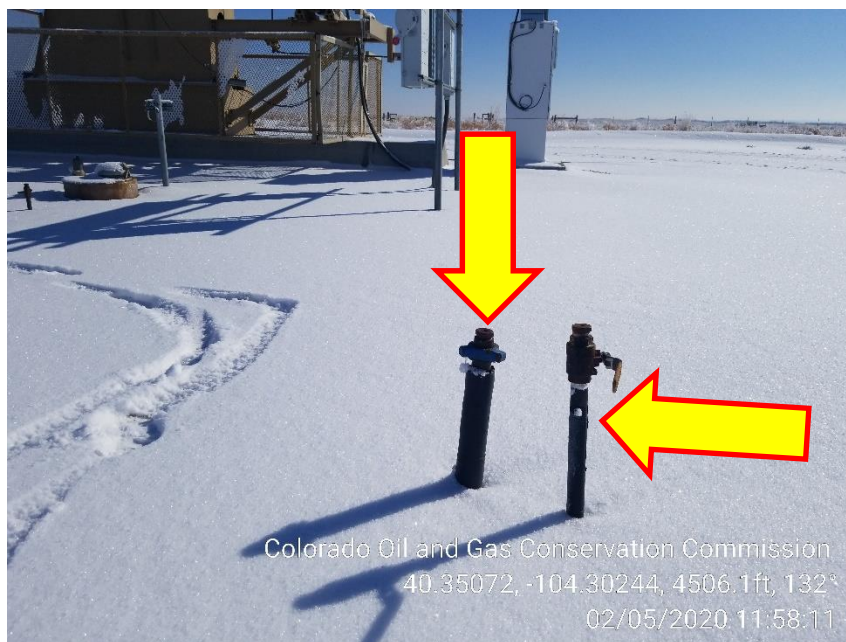
Photo 3 – Unmarked Risers

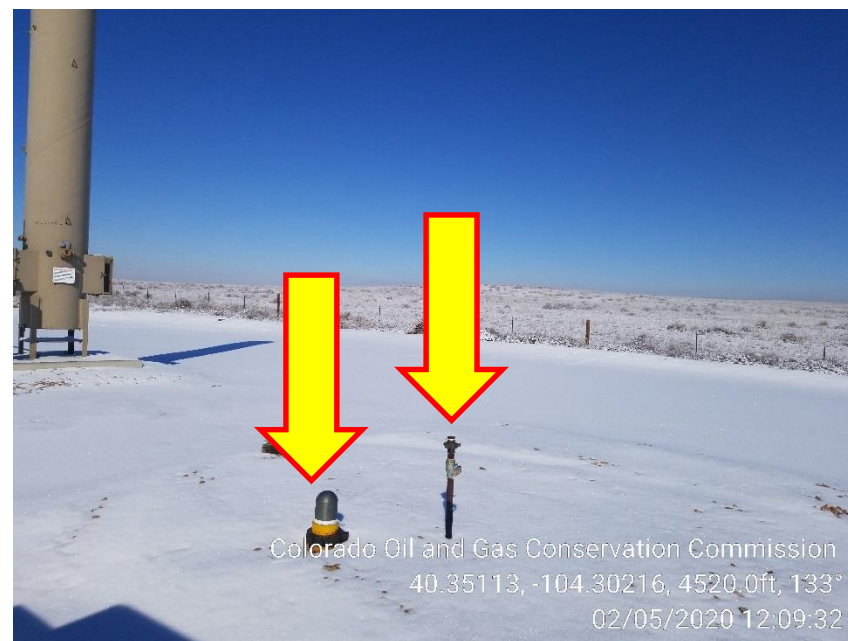
Photo 4 – Unmarked Riser, south of ECD
