Inspection Photos  
Operator: BP America  
Location #: 333635  
Date: 1-31-2020

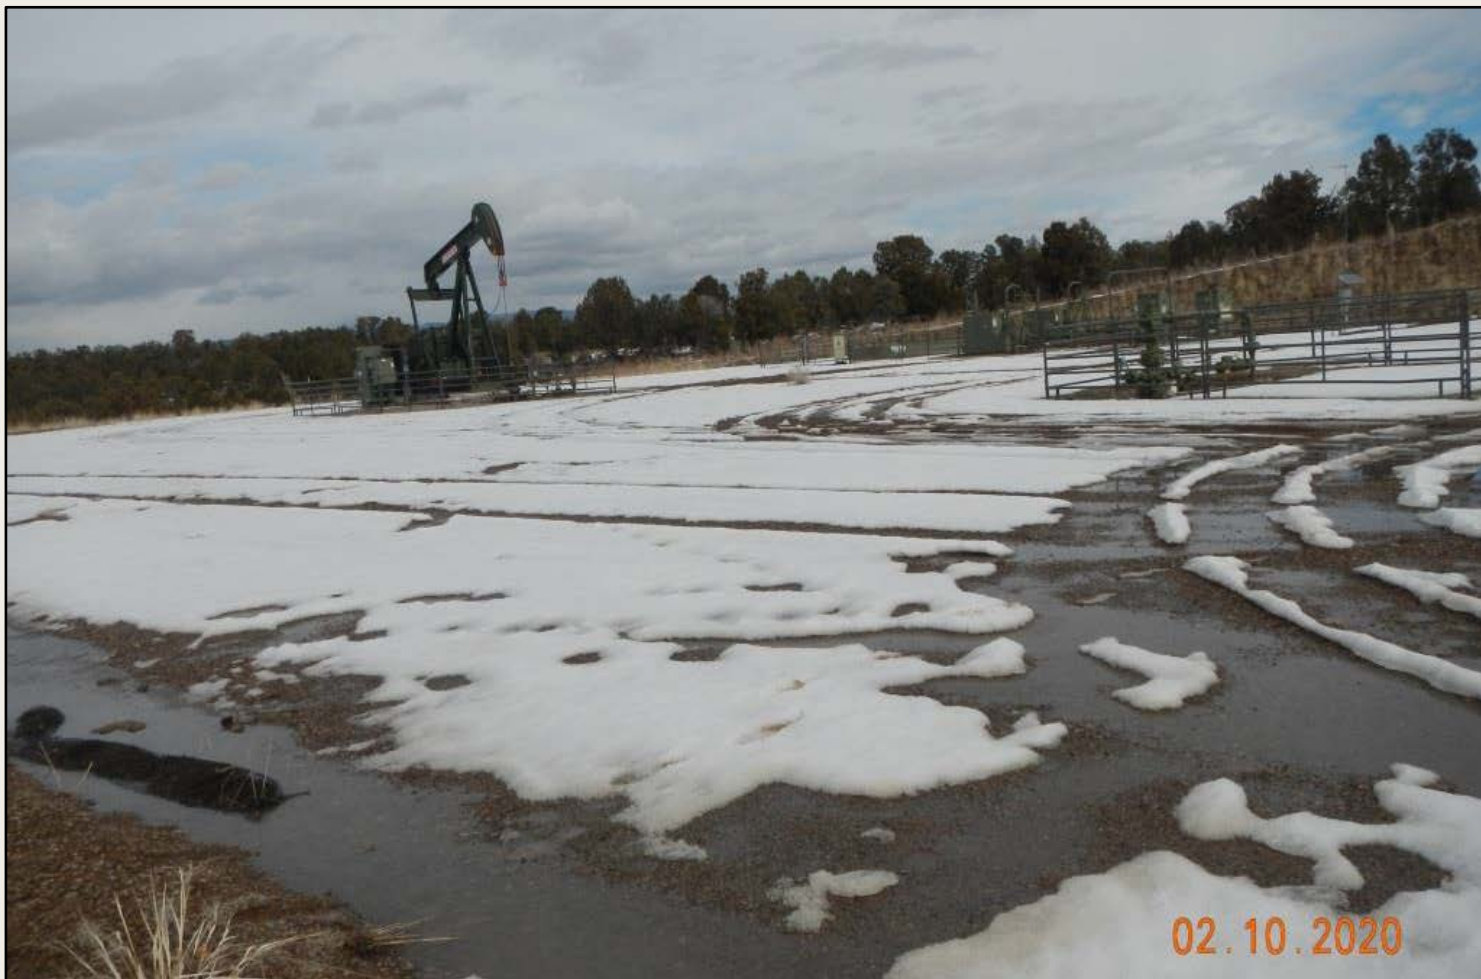
Photo 1. View of the project area from the southwestern corner facing center.

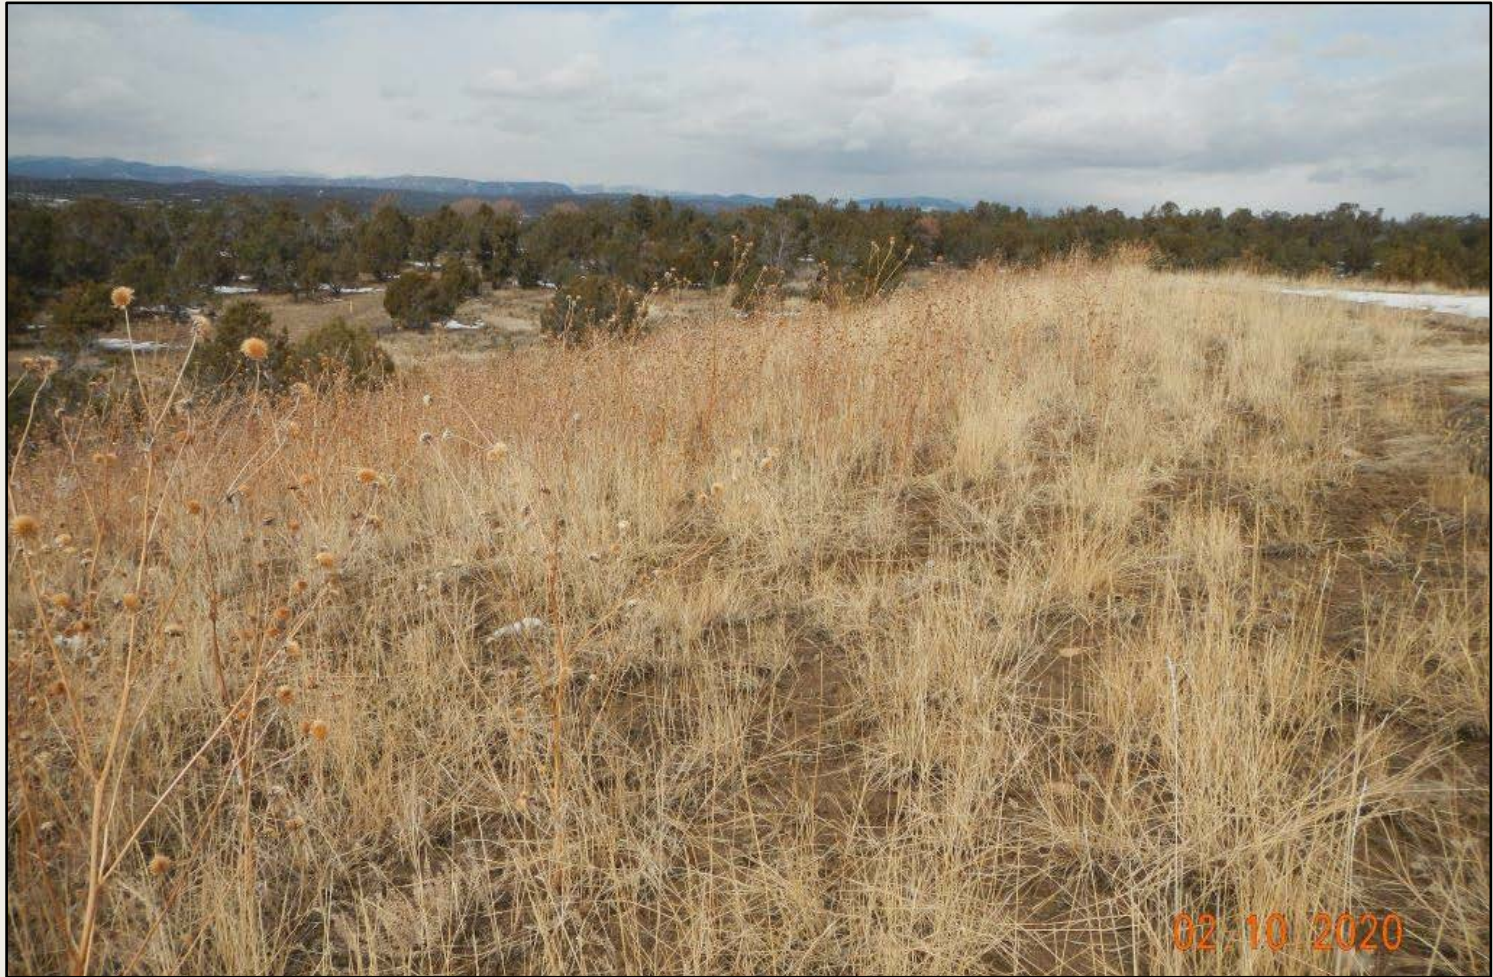
Photo 2. View of the western project area from the southwestern corner facing northward. Vegetation is largely in a dormant condition at this time with perennial grasses such as crested wheatgrass, western wheatgrass, and intermediate wheatgrass.

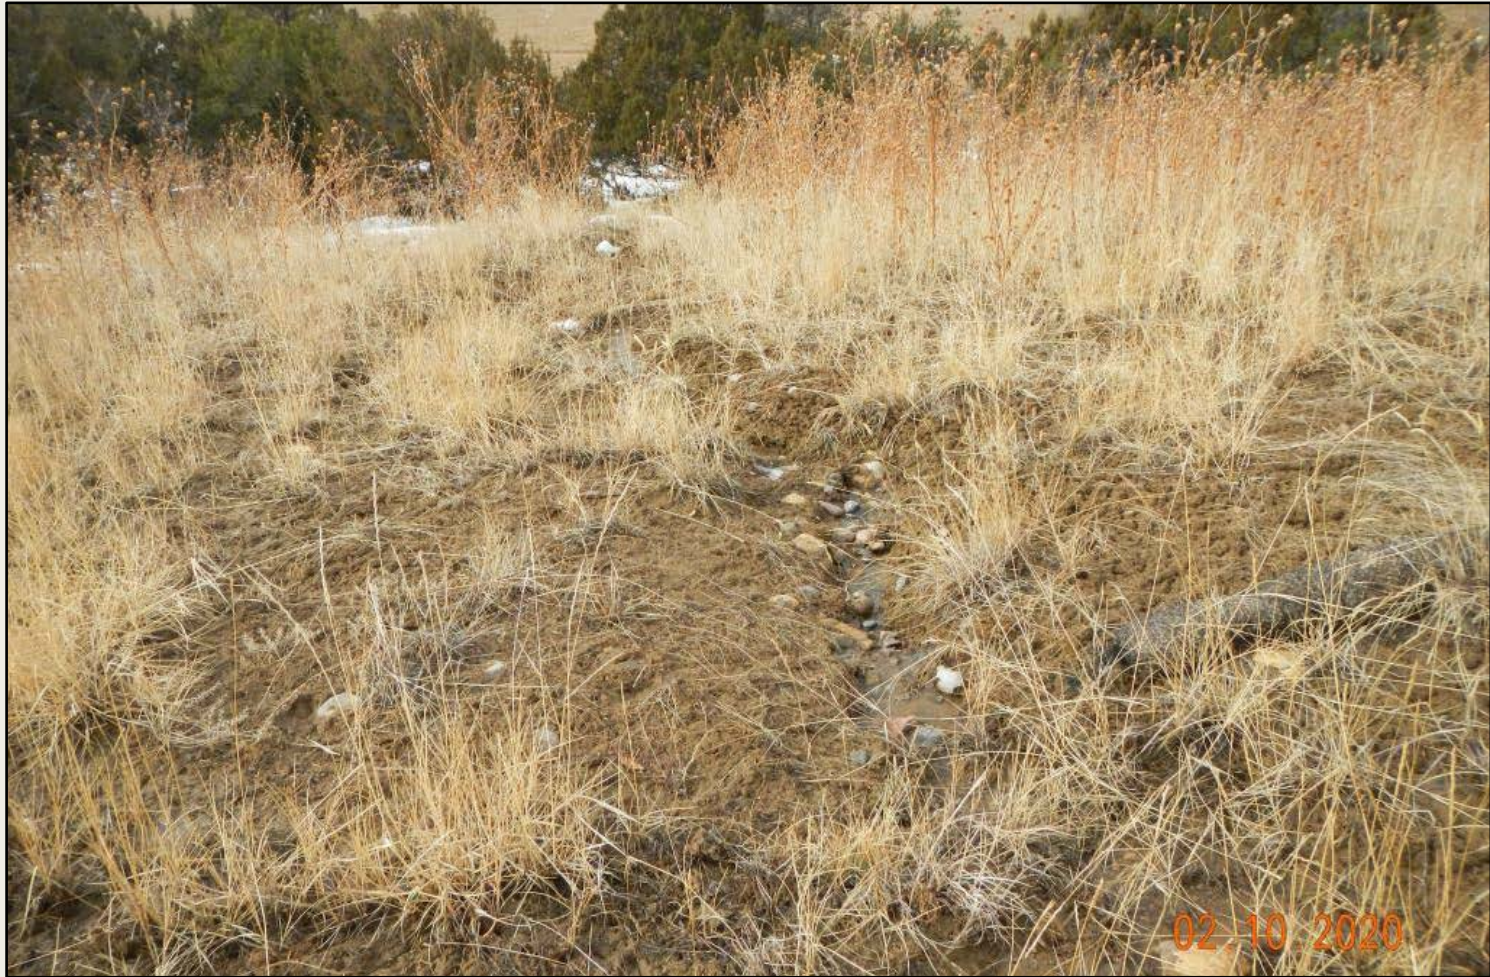
Photo 3. View of area within the western fill slope where snow melt is actively flowing off of the well pad, creating an erosional channel. Wattle is not functioning and is not an adequate BMP in this area.

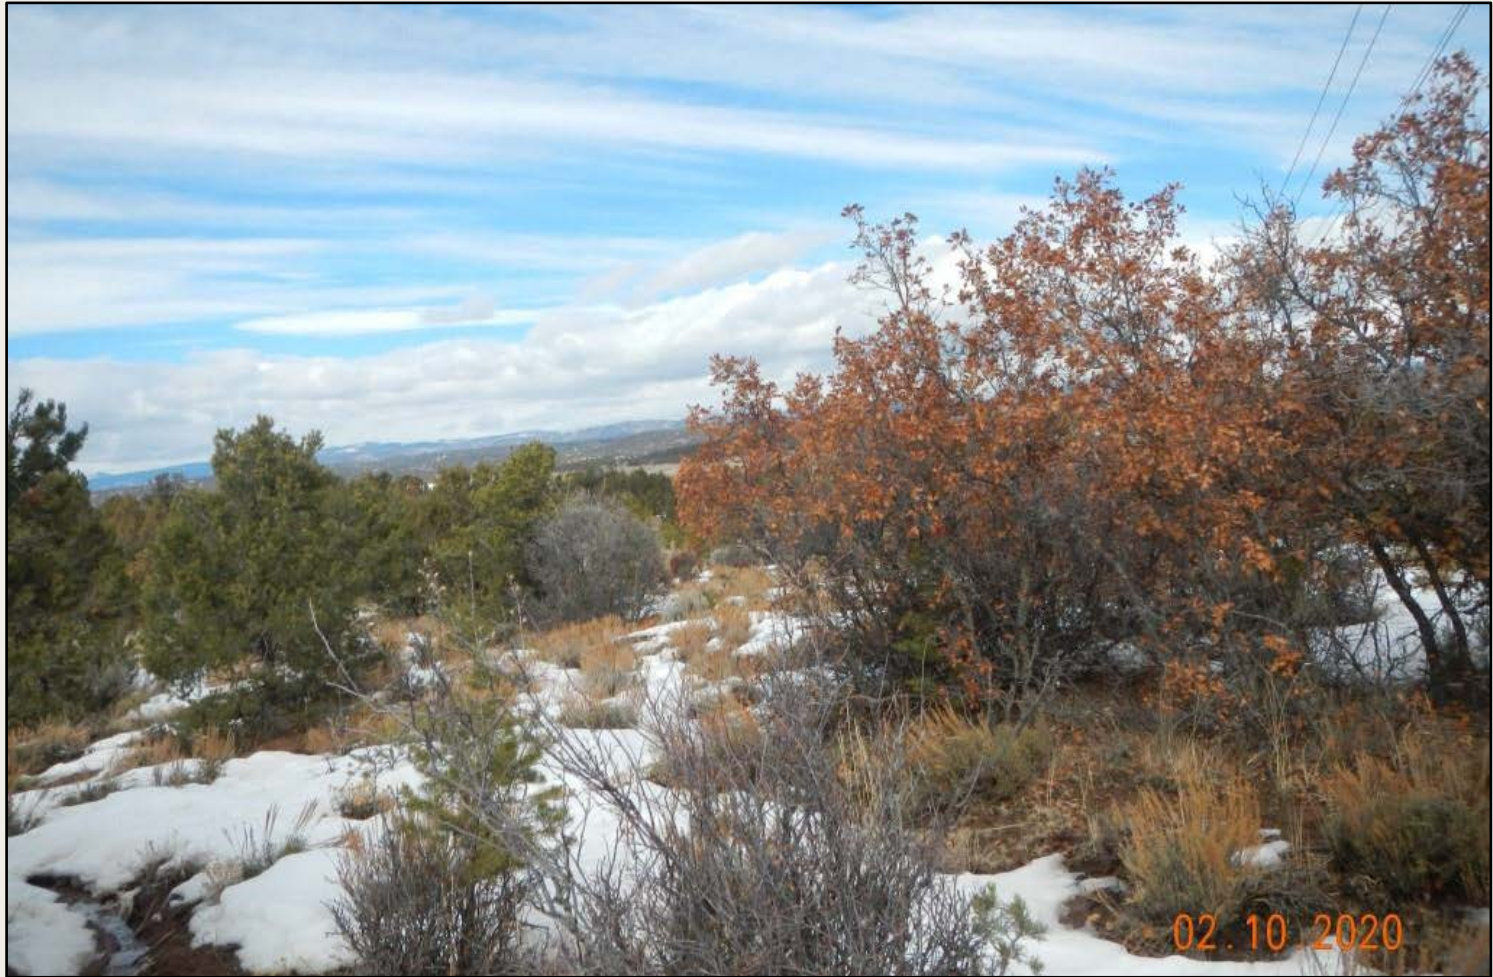
Photo 4. View of the reference area, comprised of pinyon juniper woodland with sagebrush and gambel oak shrub and herbaceous understory.
