Banta Ridge Federal 12A-18-1-103

API: 05-103-10409

Inspection: 679707328

COLORADO
Oil & Gas Conservation
Commission
Department of Natural Resources

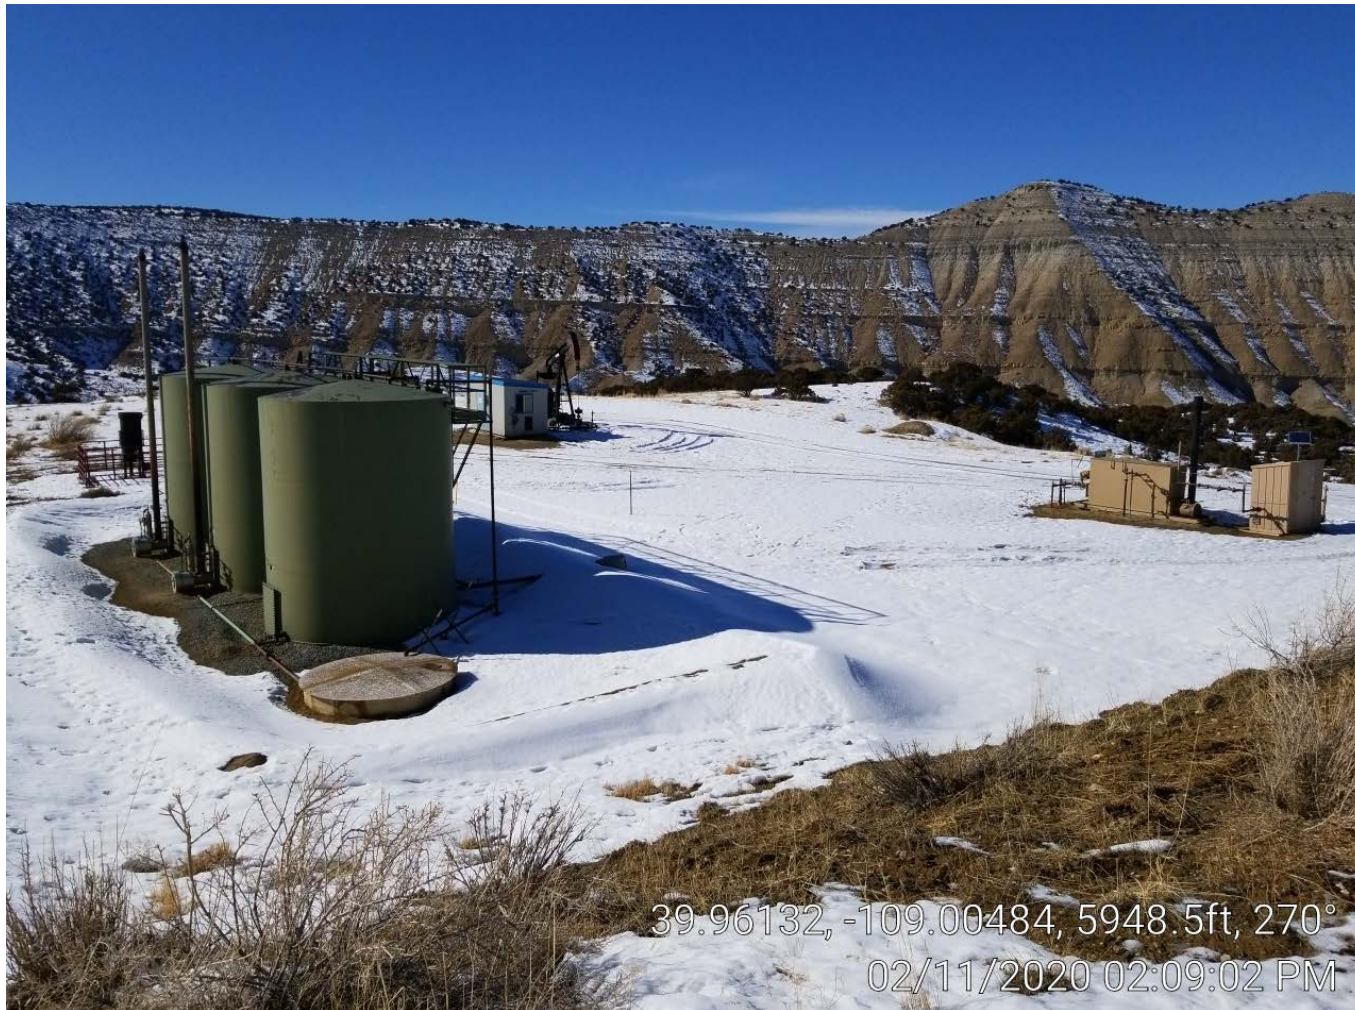
Photo 1. Location.

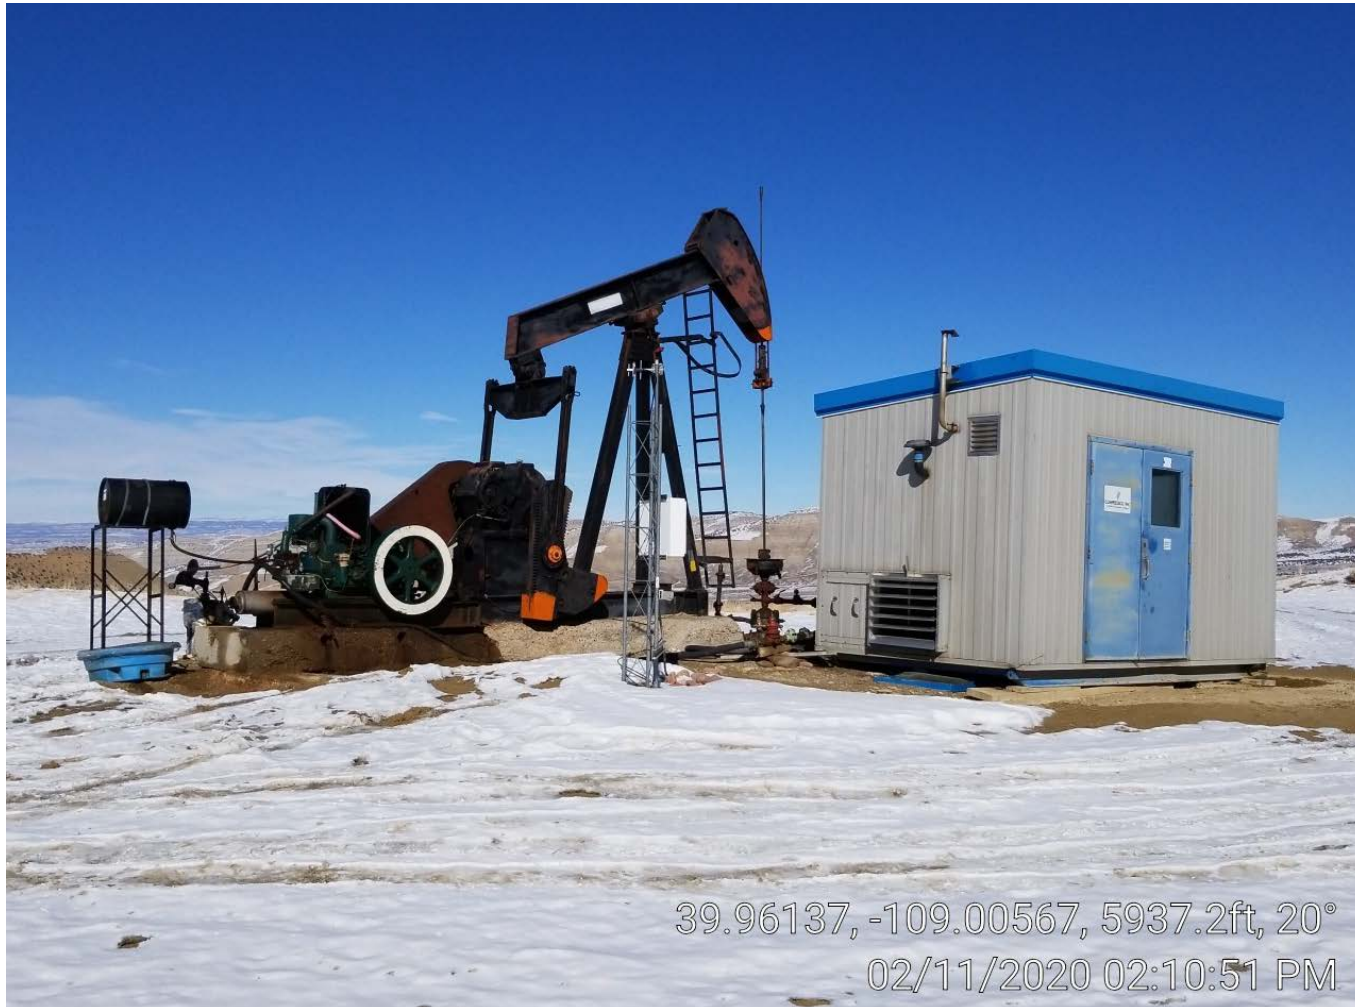
Photo 2. Pump jack & compressor building.

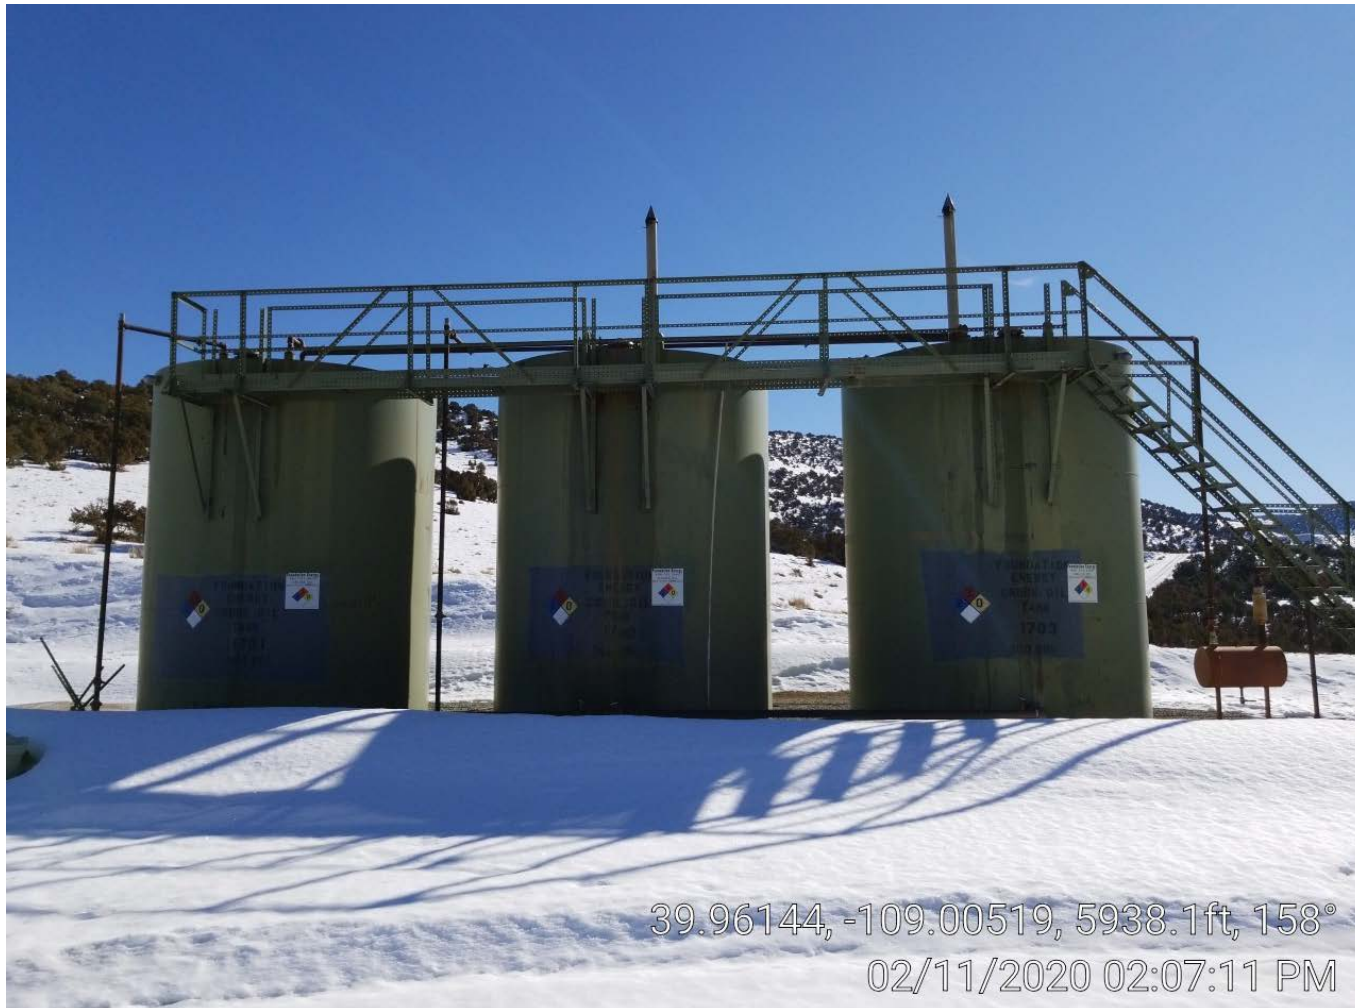
Photo 3. Tank battery.

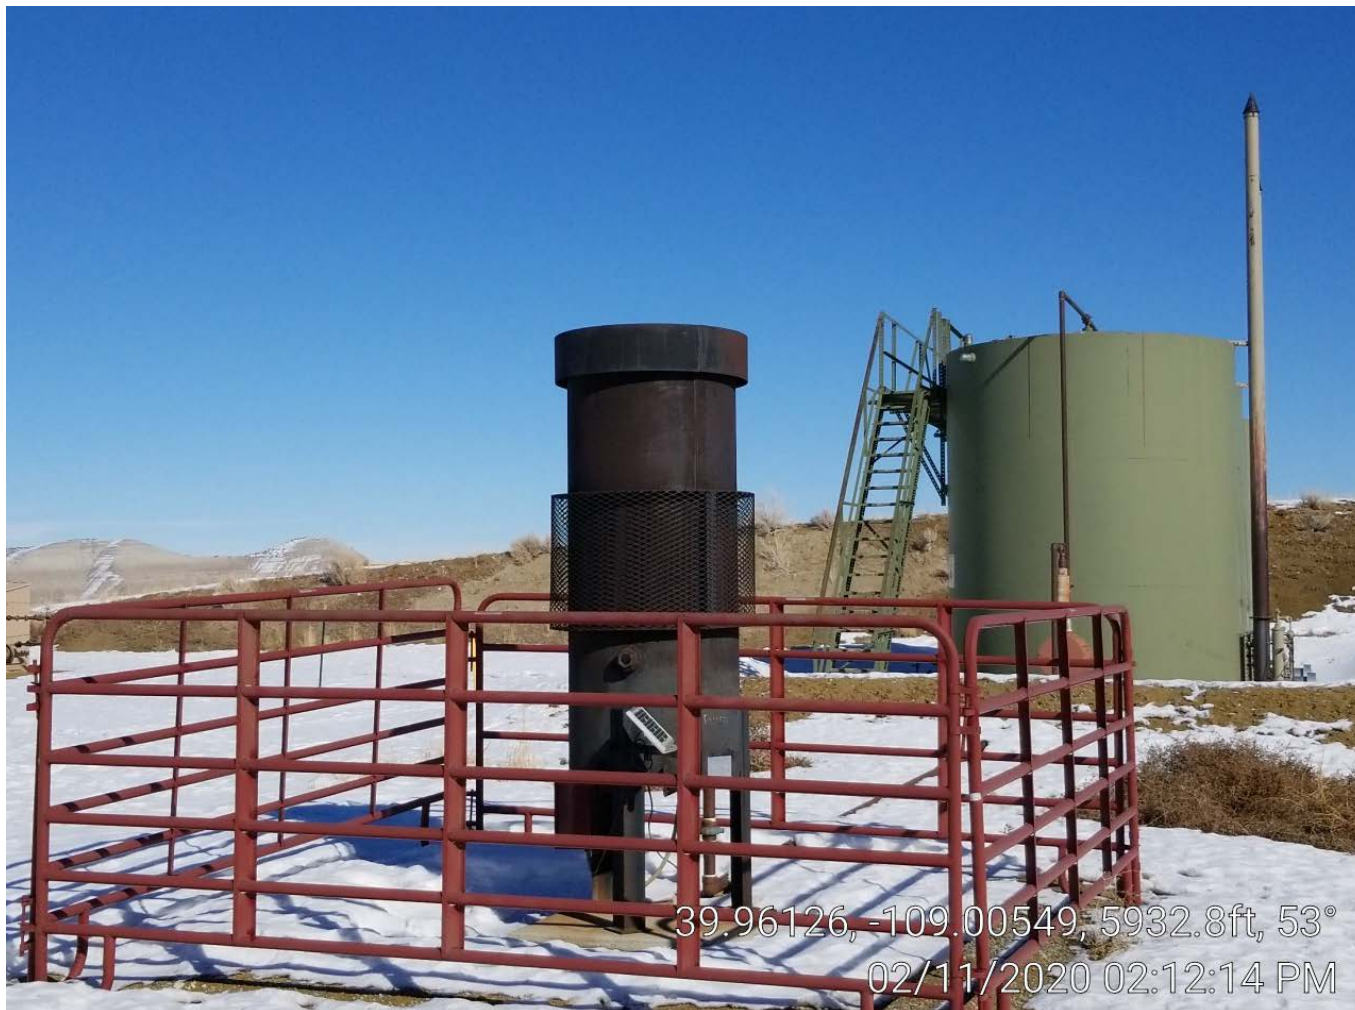
Photo 4. Compressor & tank battery.

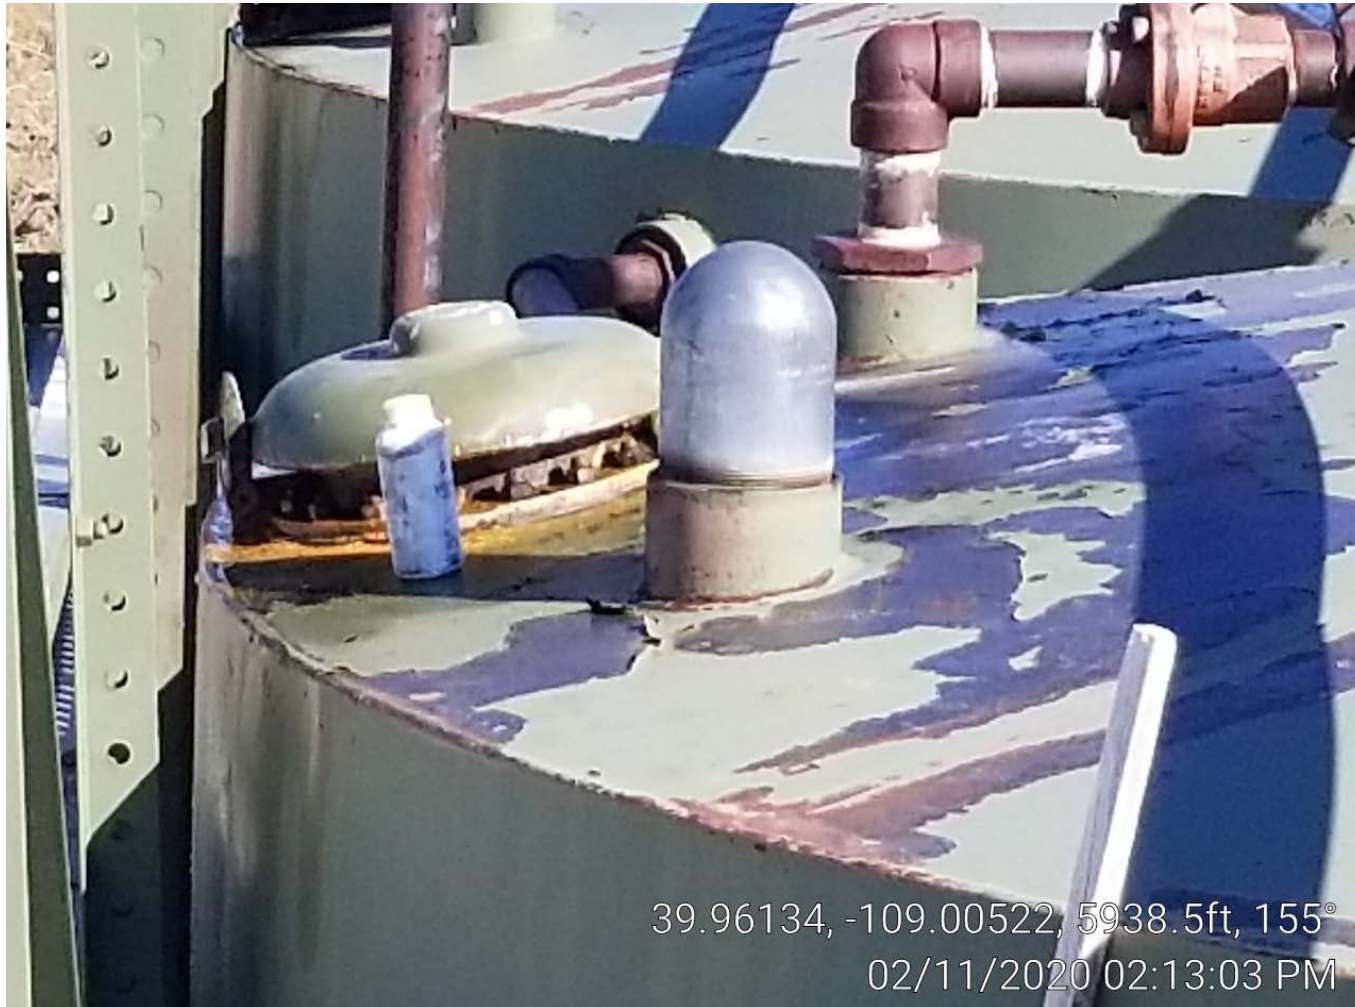
Photo 5. Gas venting out around edges of hatch on middle tank.
