Inspection Photos
Operator: BP America
Location #: 333994
Date: 1-31-2020

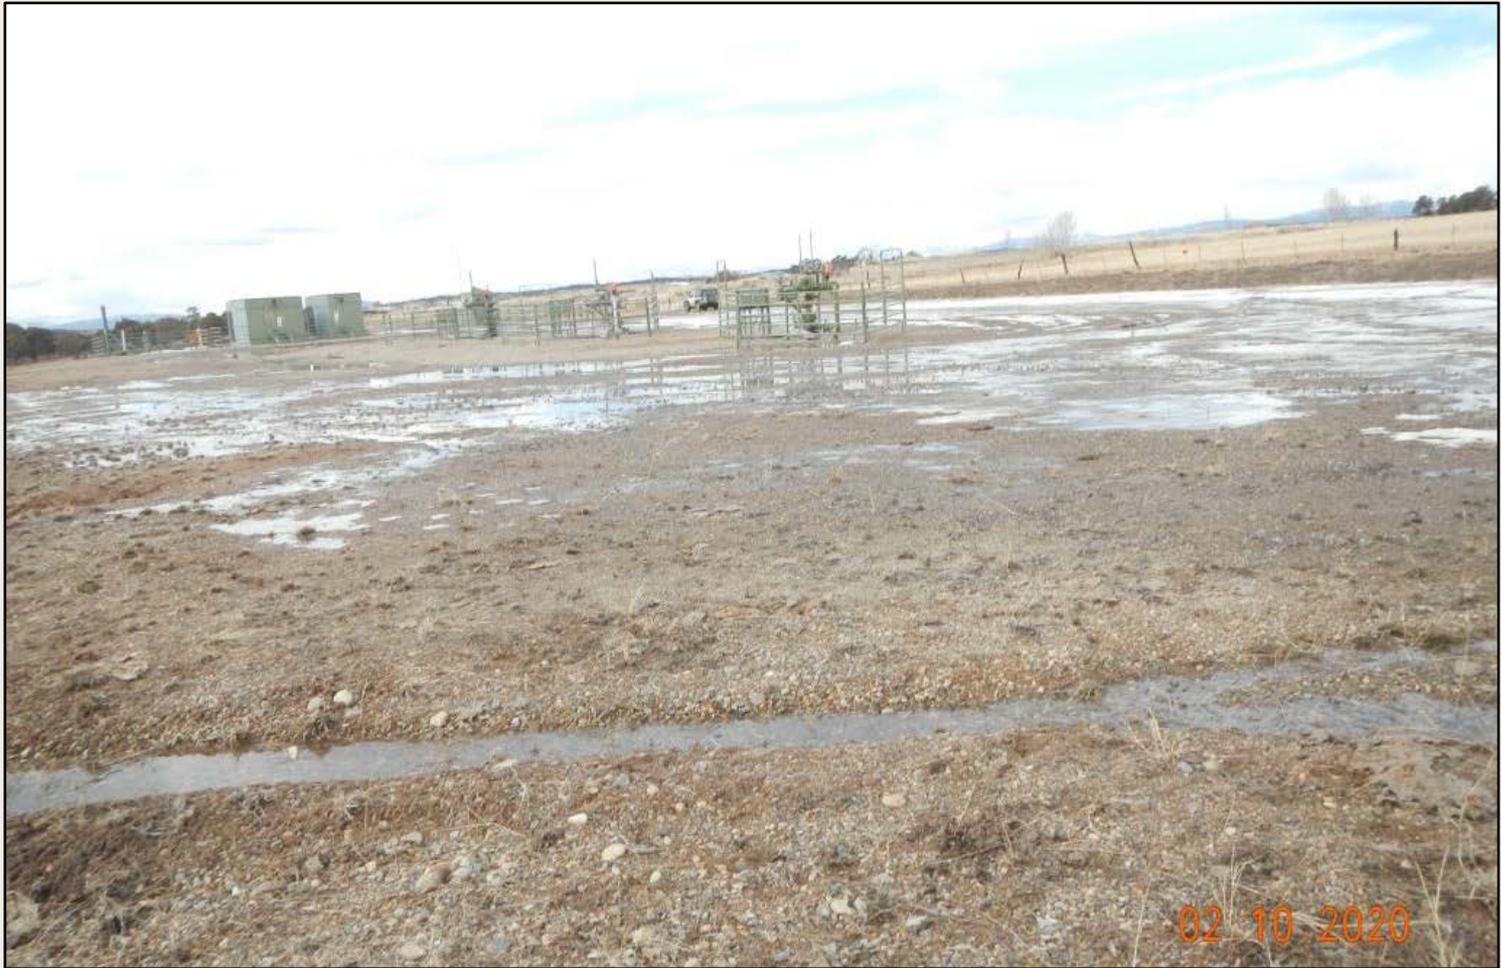
Photo 1. View of the project area from the southeastern corner facing center.

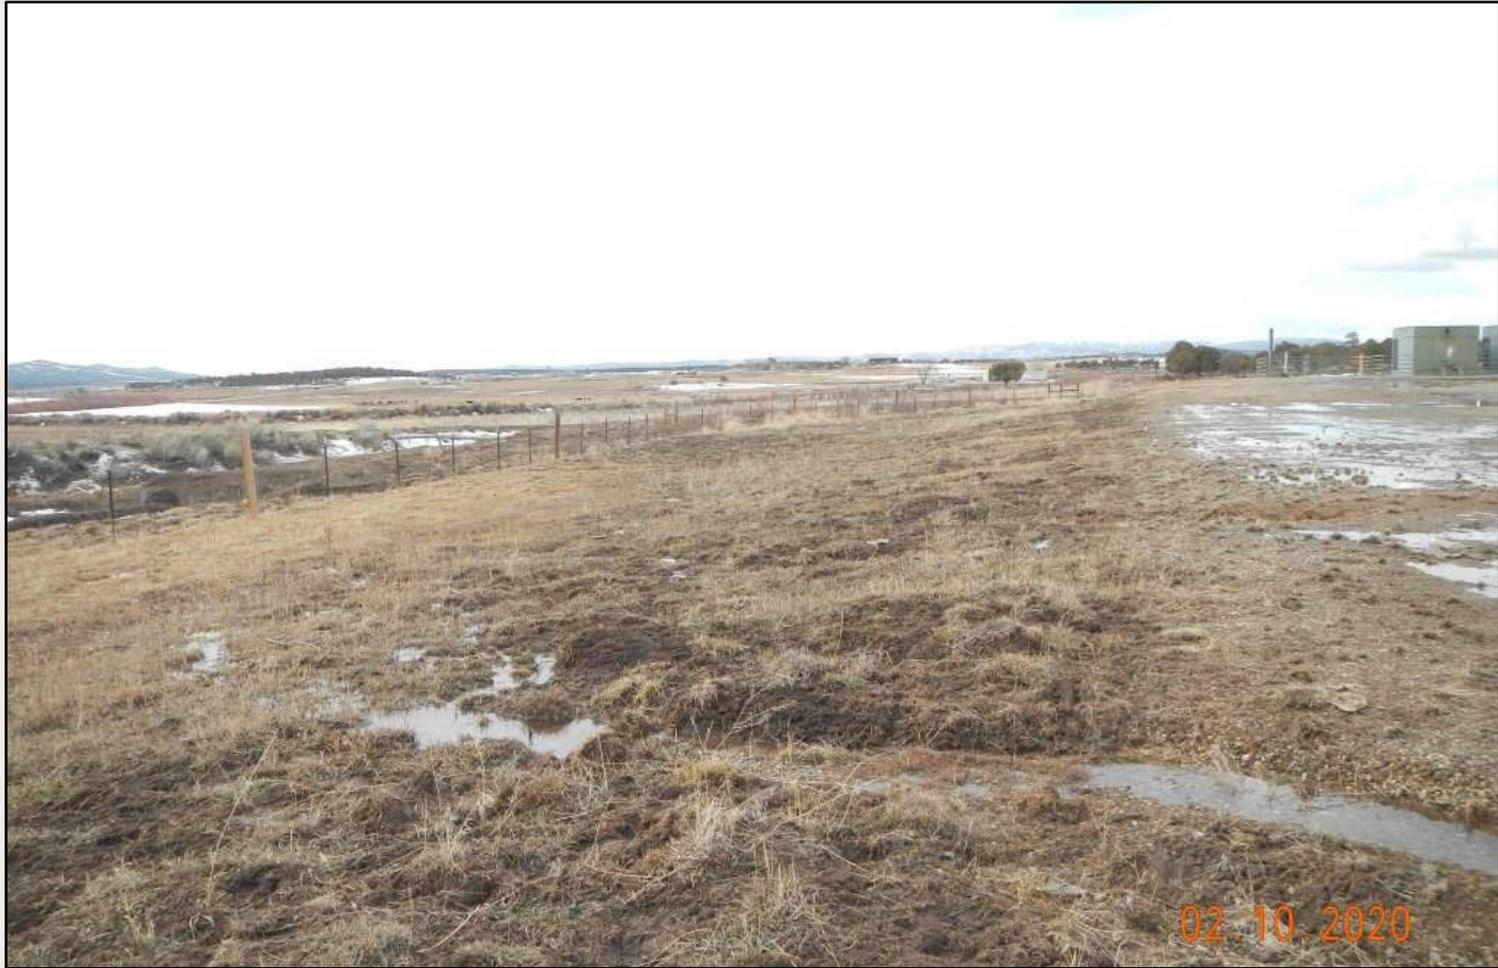
Photo 2. View of the southern project area from the southeastern corner facing westward. Vegetation is largely in a grazed/dormant condition at this time with perennial grasses largely not in identifiable condition. Stormwater erosion is occurring across the fill slope as grazed grasses are not sufficiently stabilizing the project area.

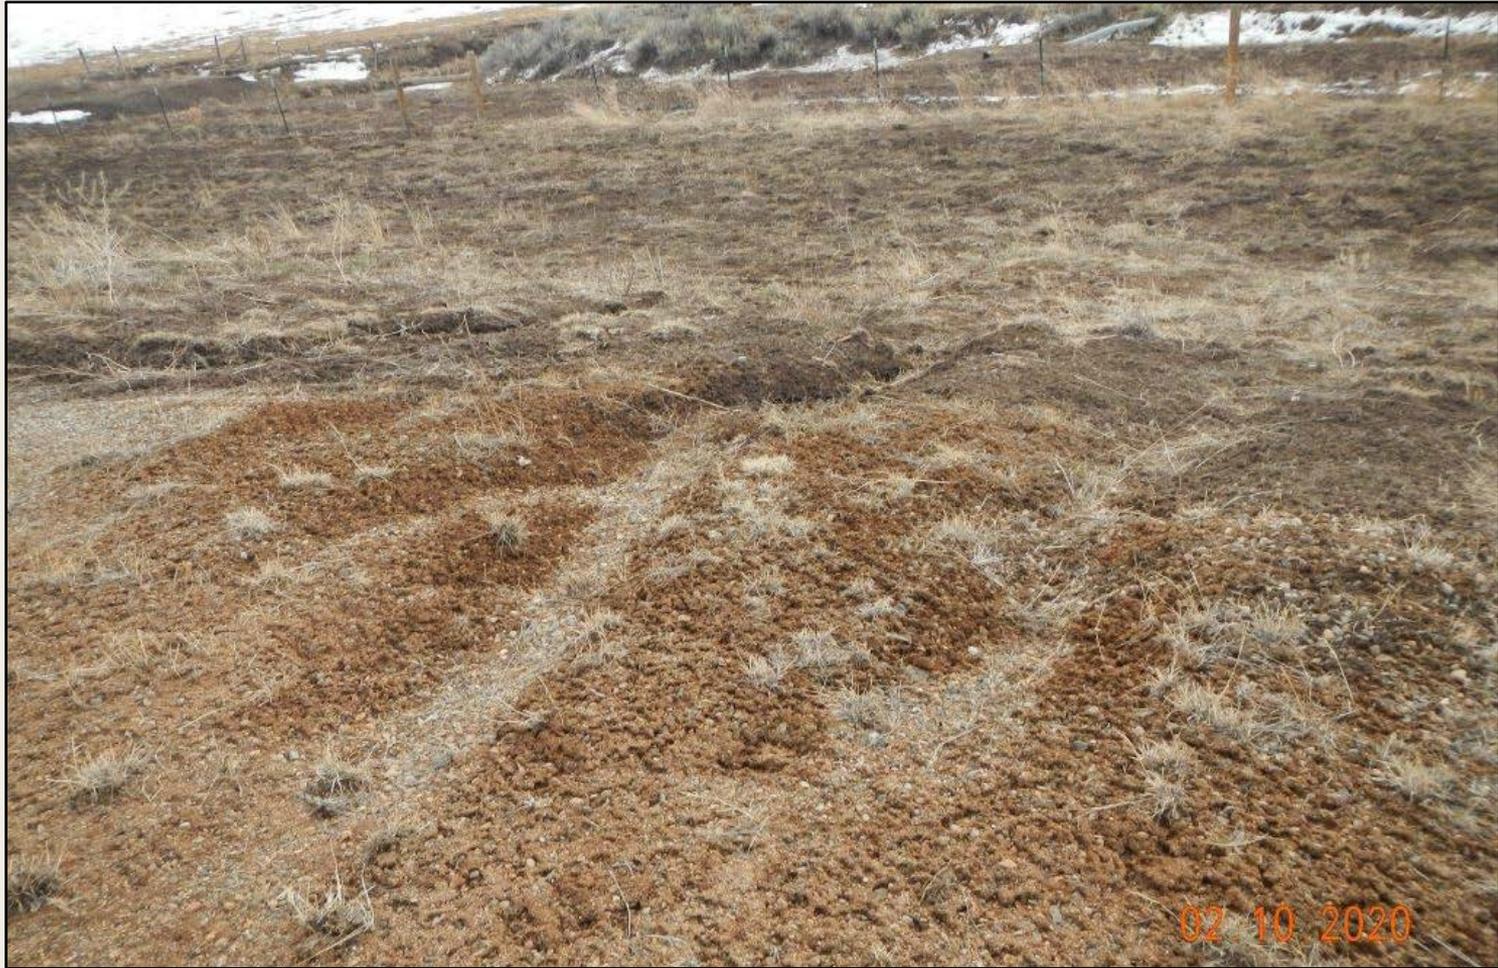
Photo 3. View of area within the southwestern fill slope where bare soils are not stabilized and rilling is evident.

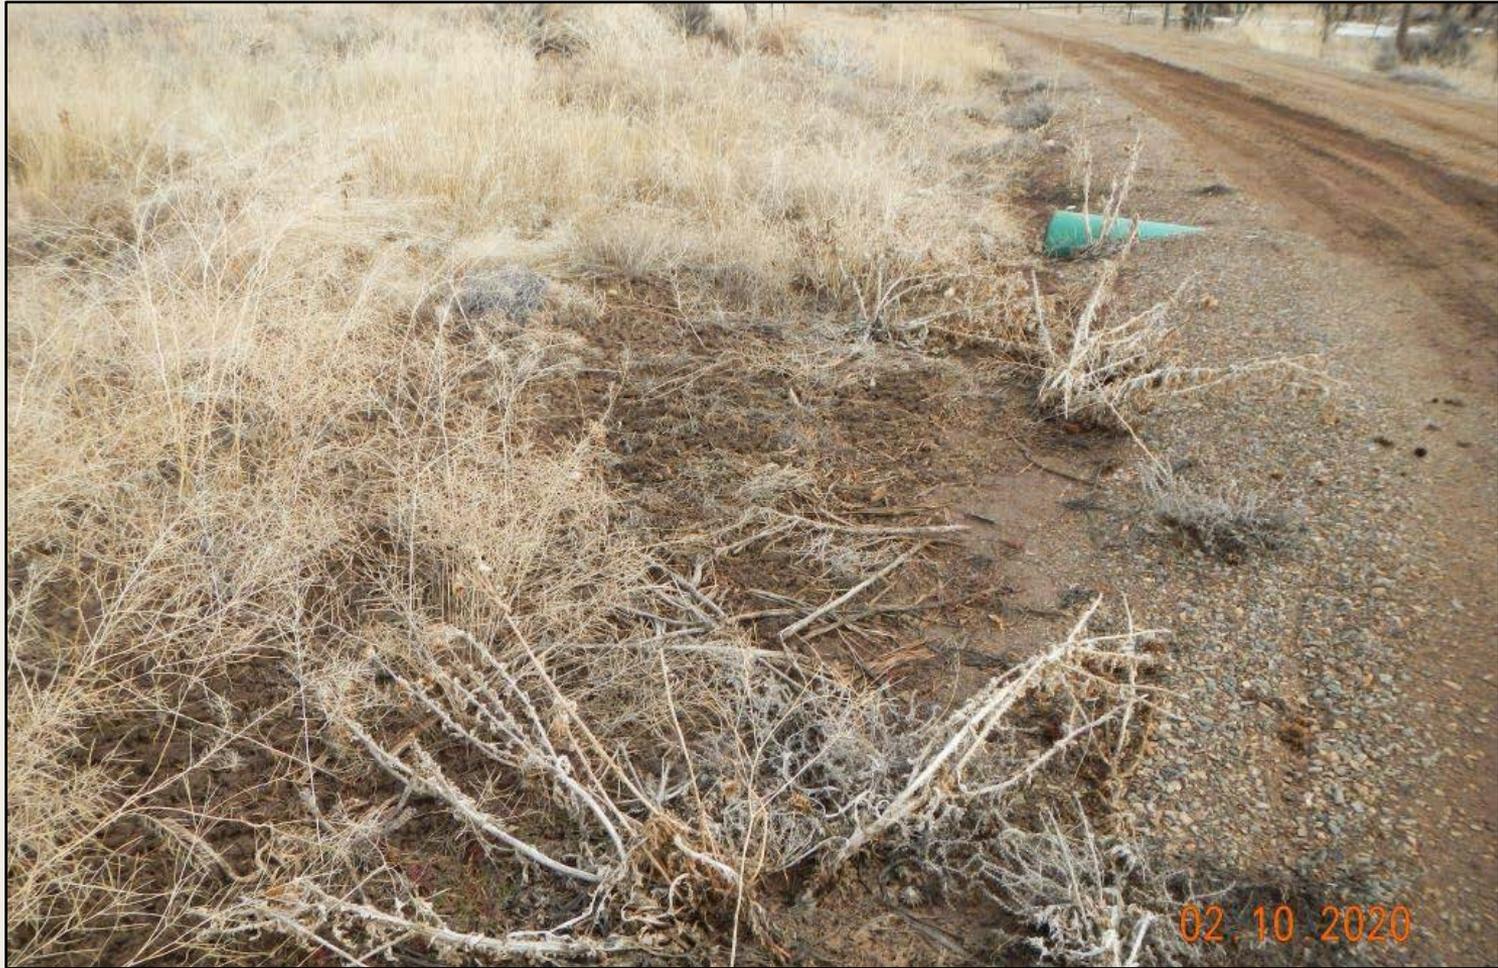
Photo 4. View of musk thistle debris along the access road. Approximately 75 individuals observed.

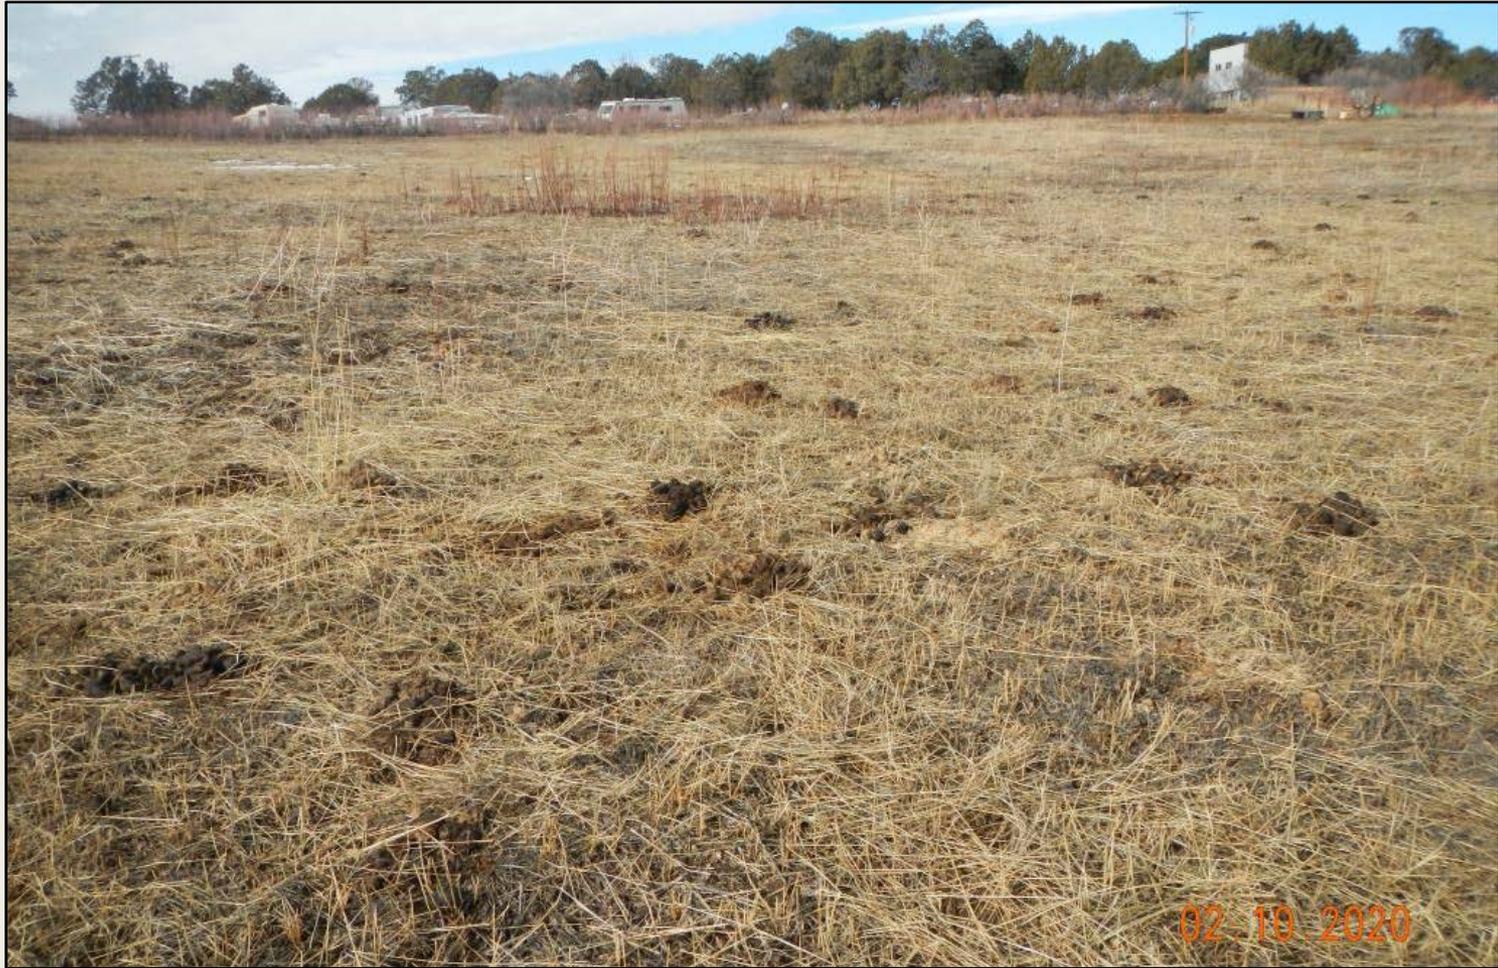
Photo 5. View of the reference area, comprised of pasture in grazed/dormant vegetative condition.
