Inspection Photos

Location Name: LARAMIE ENERGY LLC BRUTON /19-14 PAD,

Location ID: 417603

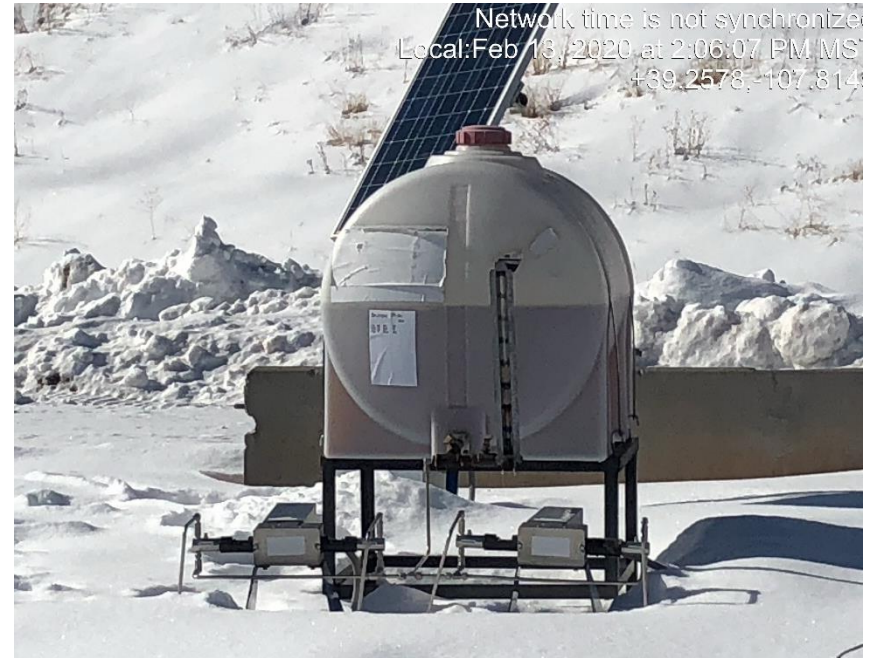
Photo #0585 Chemical tank by wellheads NFPA labels weathered and not legible.

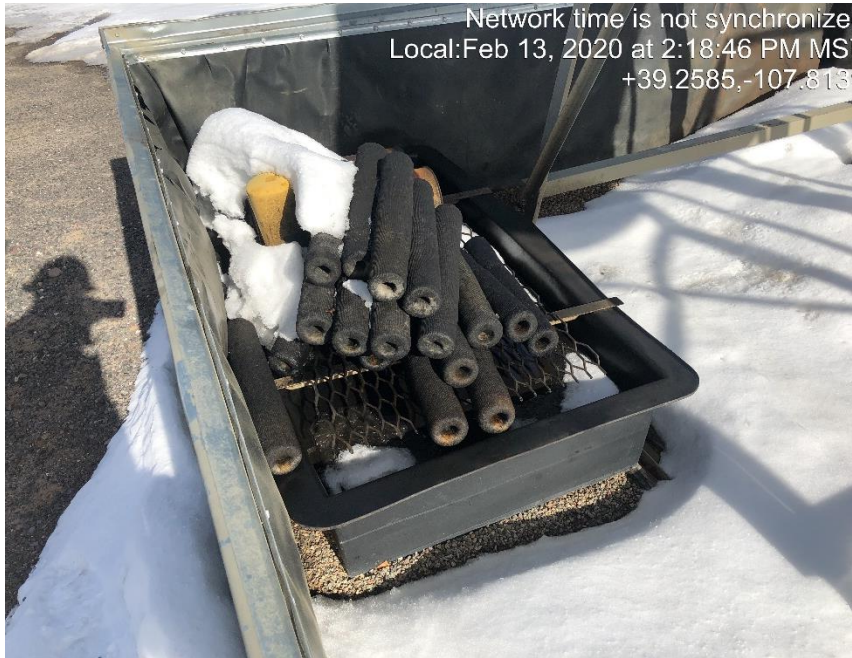
Photo #0586 Used filters and trash inside multiple tank containments.

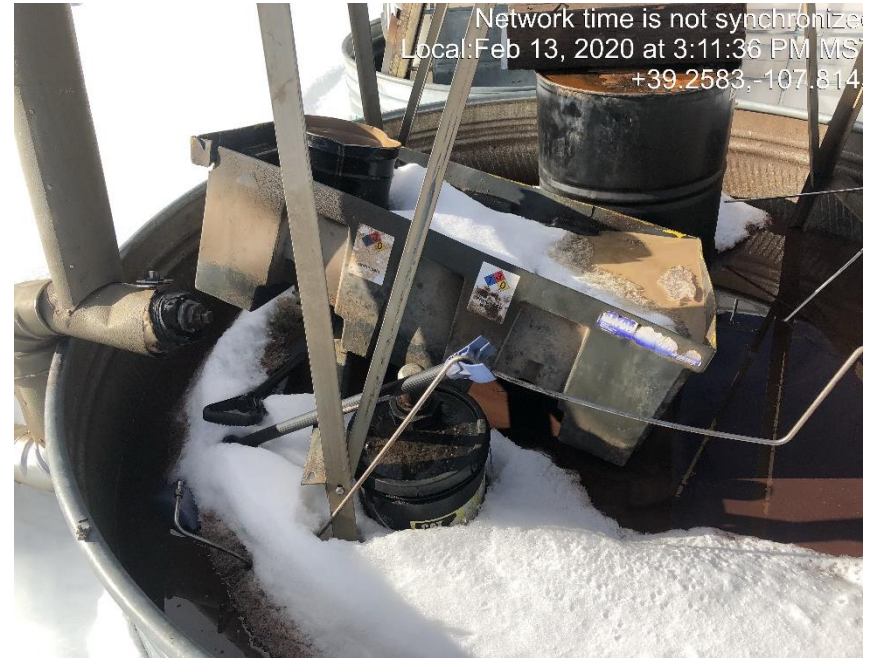
Photo #0593 Used filters and trash inside multiple tank containments.

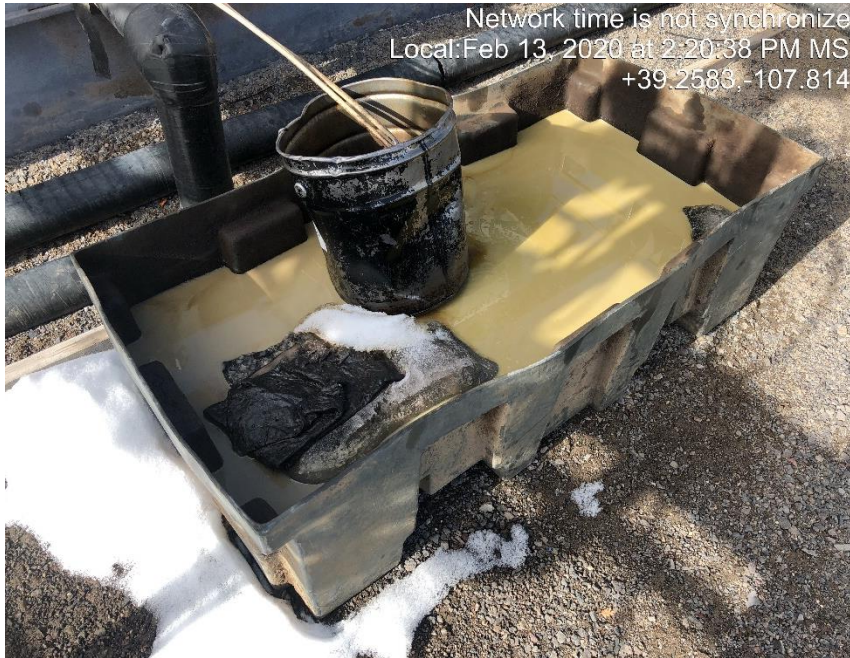
Photo #0587 Multiple containments with oily fluids inside them.

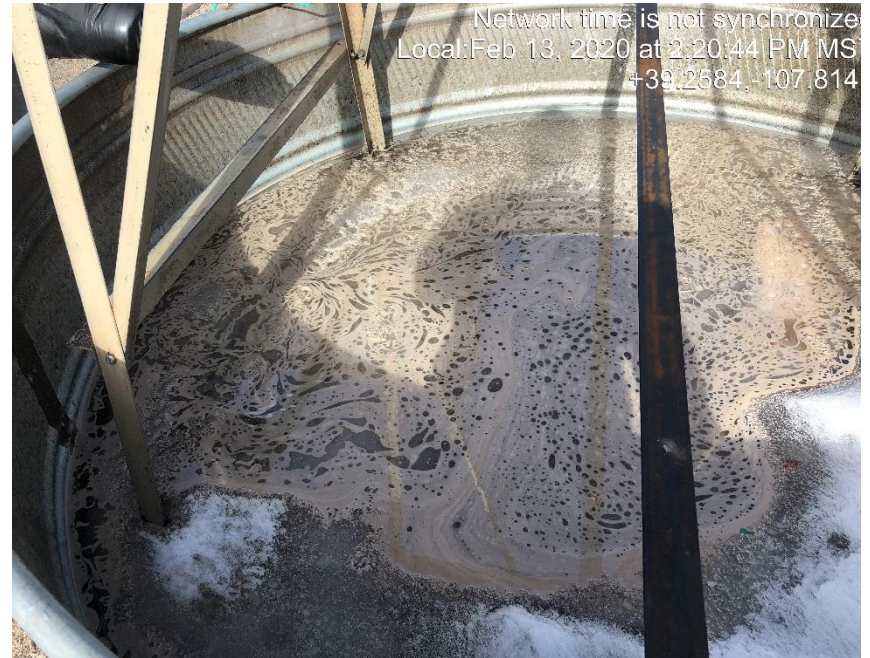
Photo #0588 Multiple containments with oily fluids inside them.

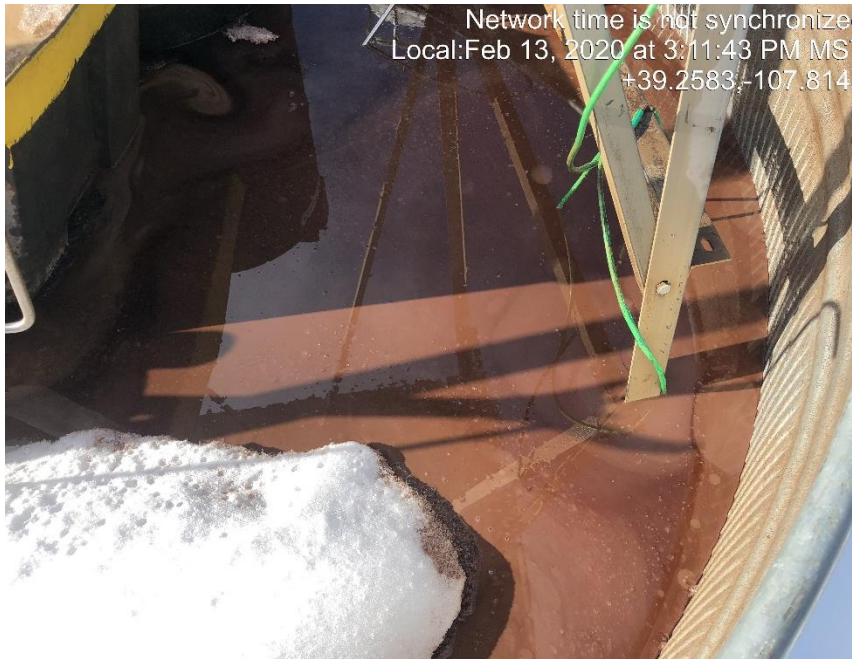
Photo #0594 Multiple containments with oily fluids inside them.

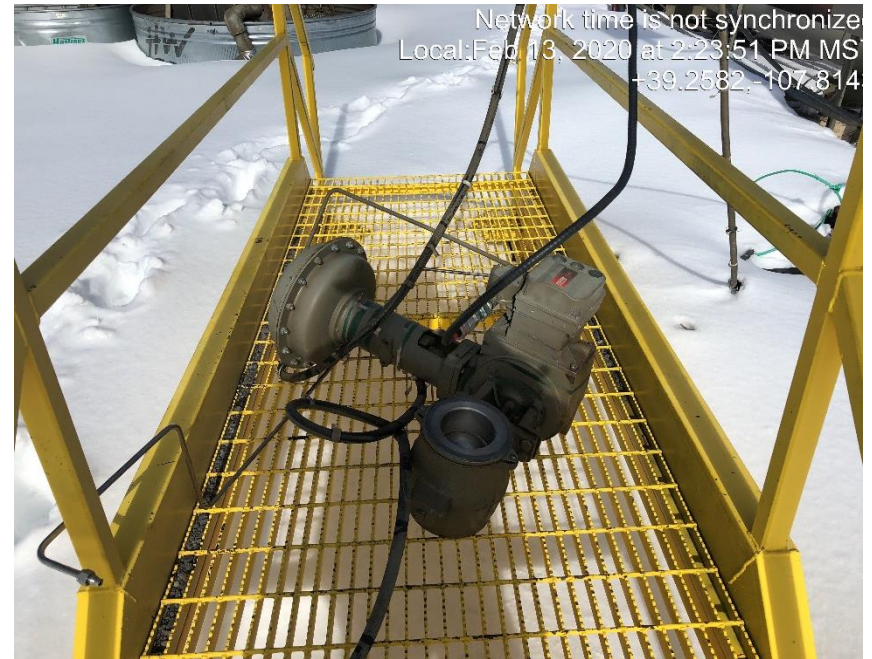
Photo #0589 Unused automated valve.

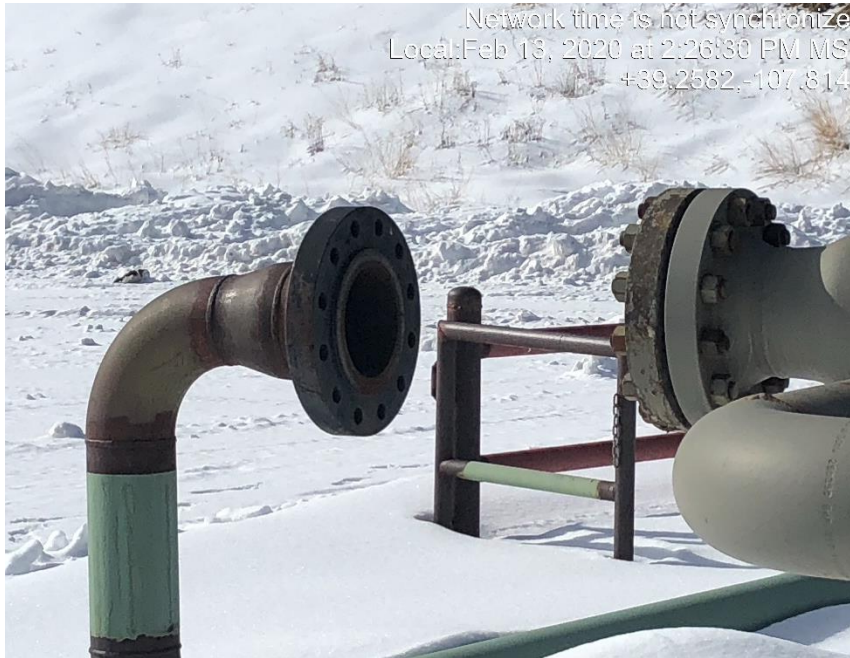
Photo #0592 open ended flowline.
