Inspection Photos

API: 071-08043

Operator: EVERGREEN NATURAL RESOURCES

Inspection Date: 2/14/2020

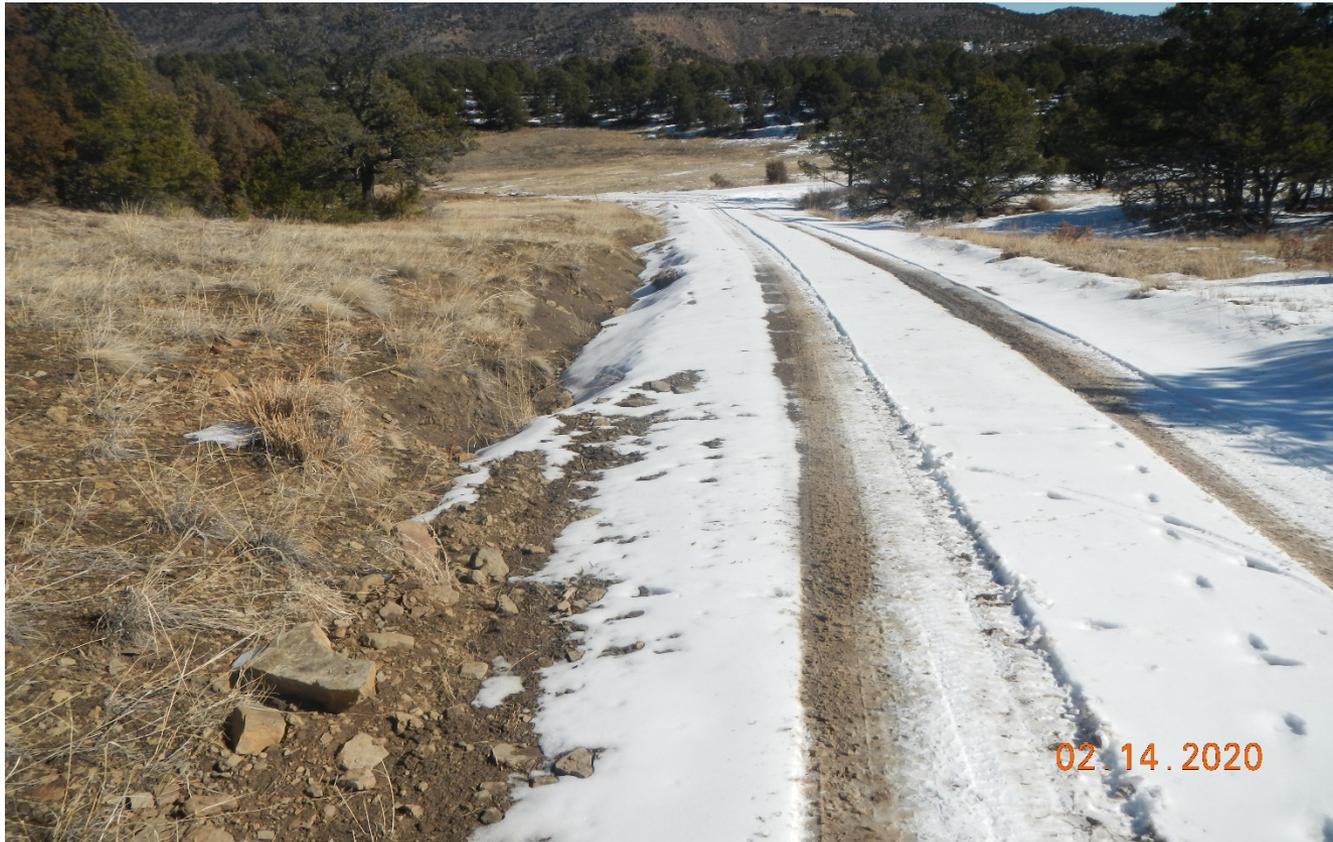
Photo 1. There is stormwater erosion which is occurring along the main road as it ascends the hill which is contributing to erosion further down the road. BMP's need to be installed. Lat/Long:37.14162,-104.86902.

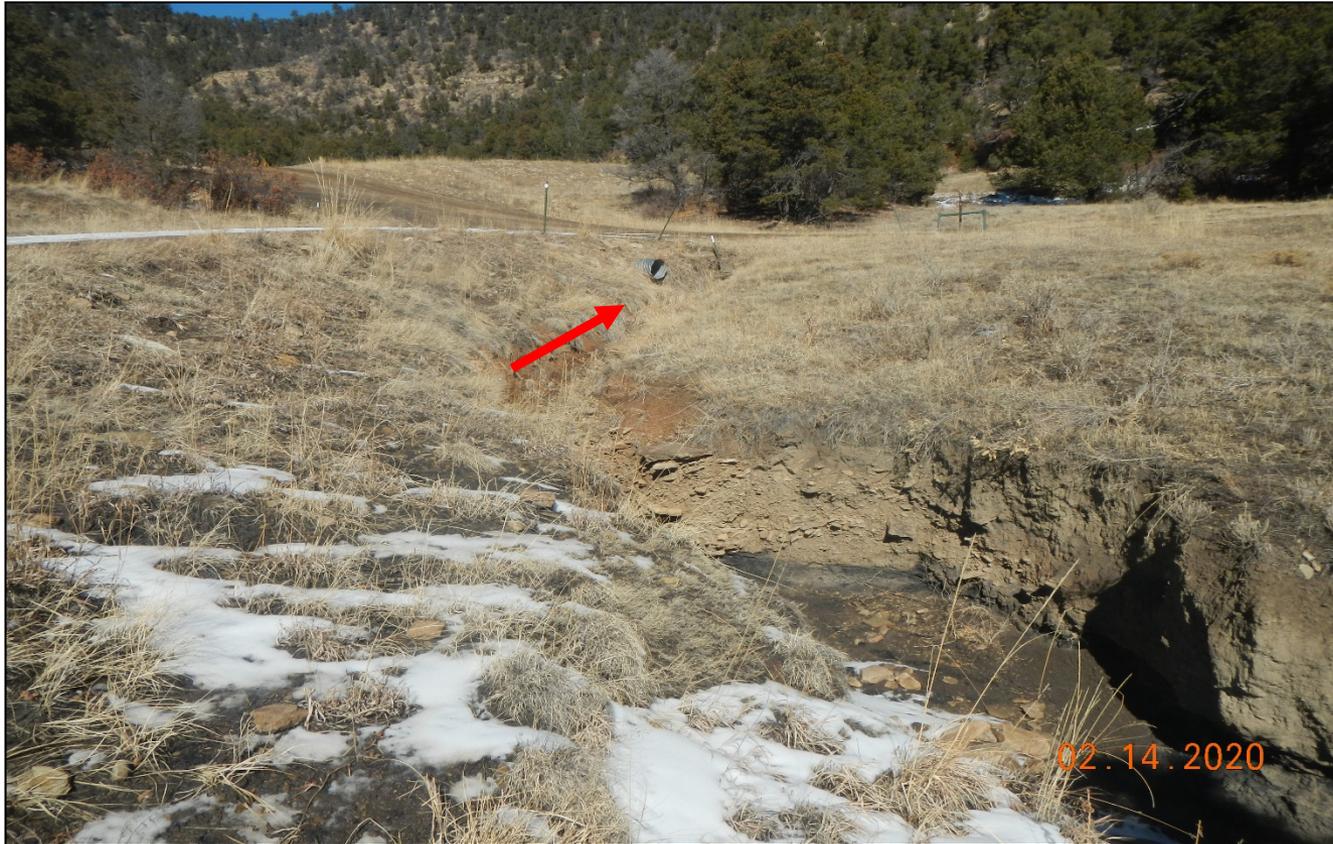
Photo 2. The culvert outlet which stormwater is direct from the Pacheco well sites is concentrating stormwater and causing erosion at this area Lat/Long:37.14117,-104.87398.

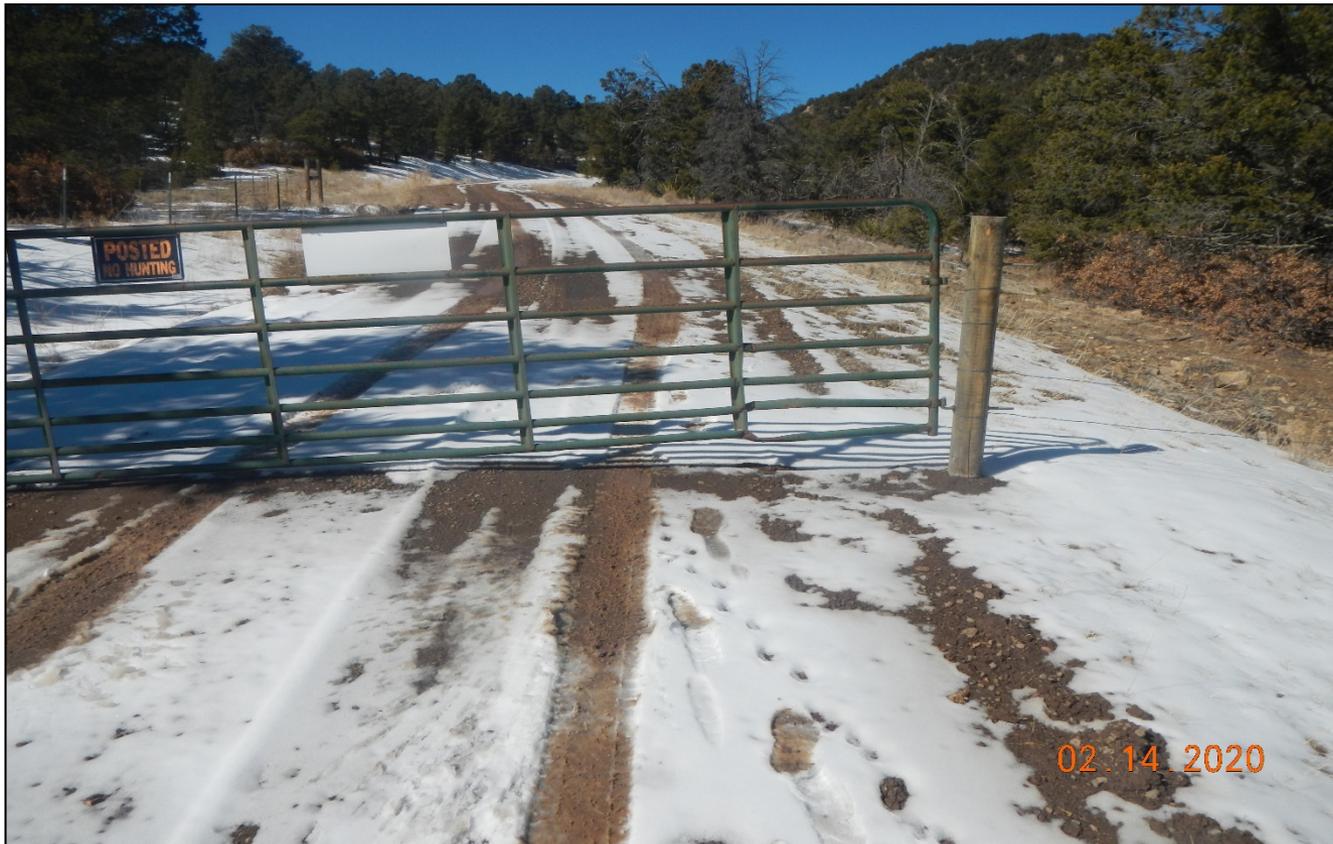
Photo 3. The gate leading to the location is off the hinges and needs to be repaired.

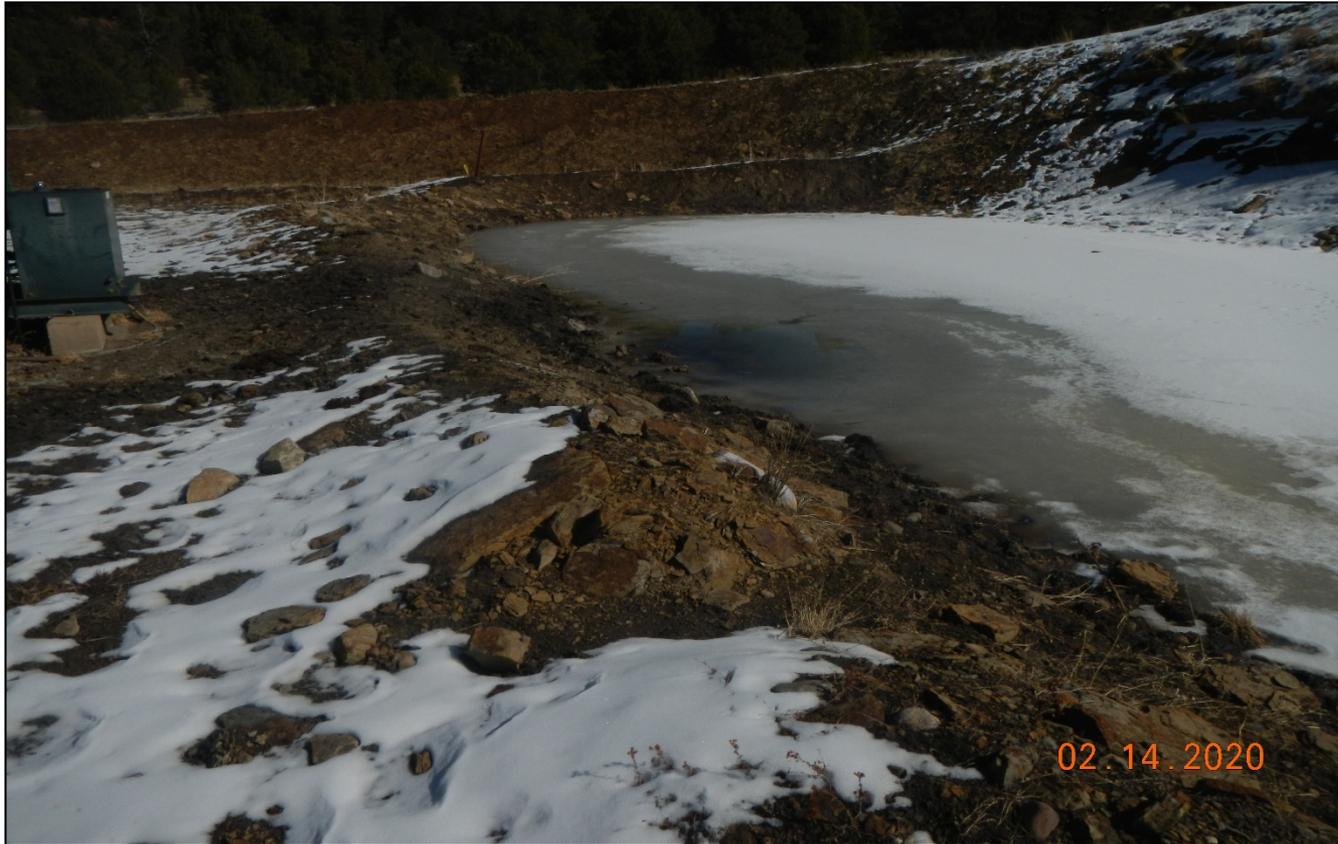
Photo 5. The water level at the pit is nearing 2 ft. freeboard.
