Inspection Photos

API: 071-07803

Operator: EVERGREEN NATURAL RESOURCES

Inspection Date: 2/14/2020

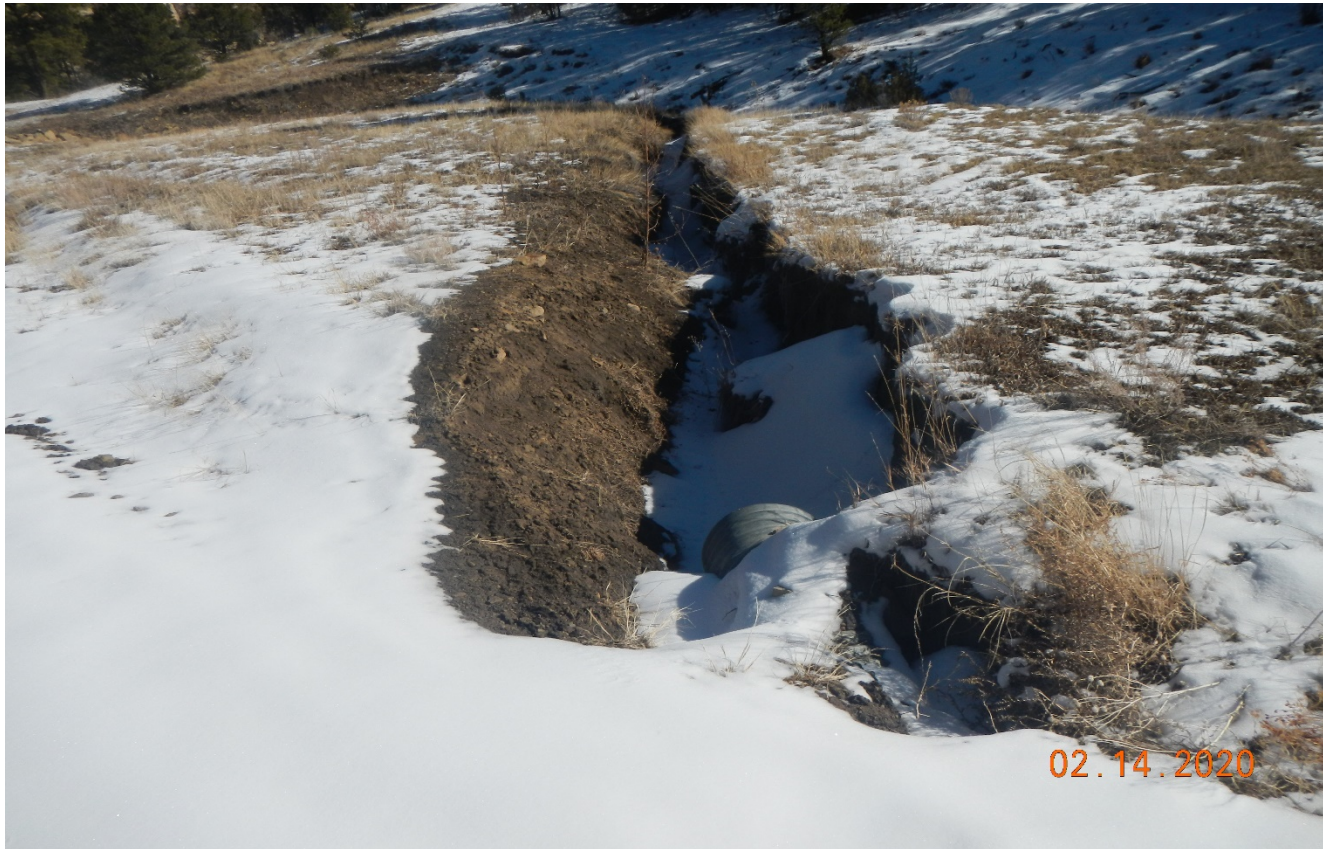
Photo 1. There a deep erosion channel at the outlet of the culvert along the main access road at Lat/Long:37.14466,-104.86788.

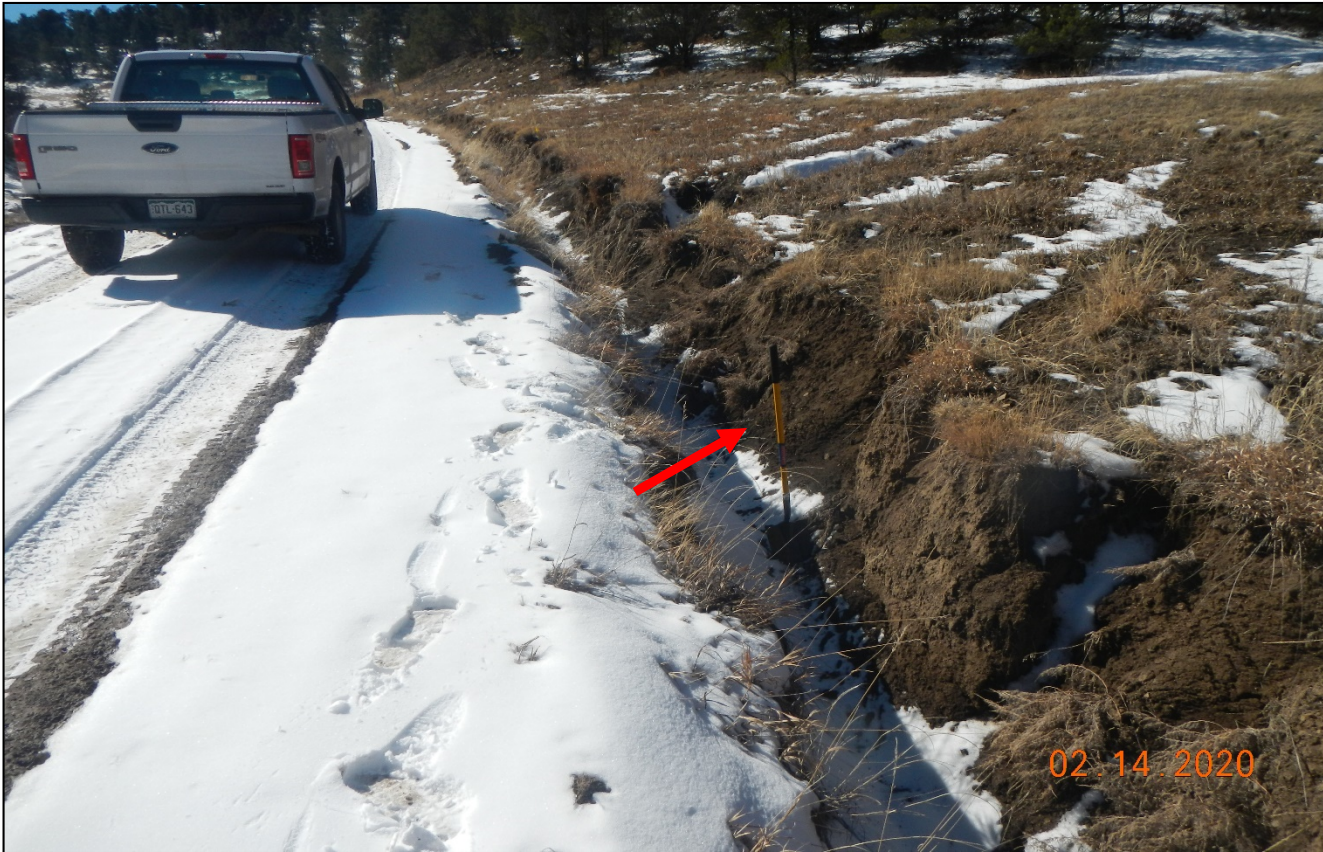
Photo 2. There is a deep erosion channel along the side of the main access to the location. Arrow points to 4.5 ft. shovel to show depth of erosion.

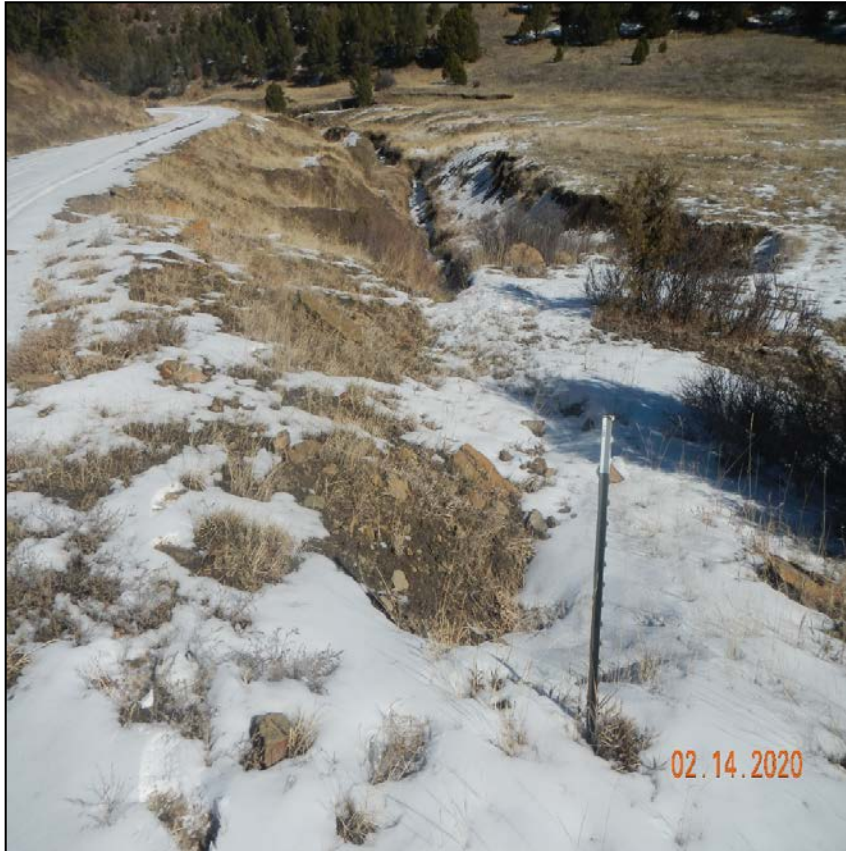
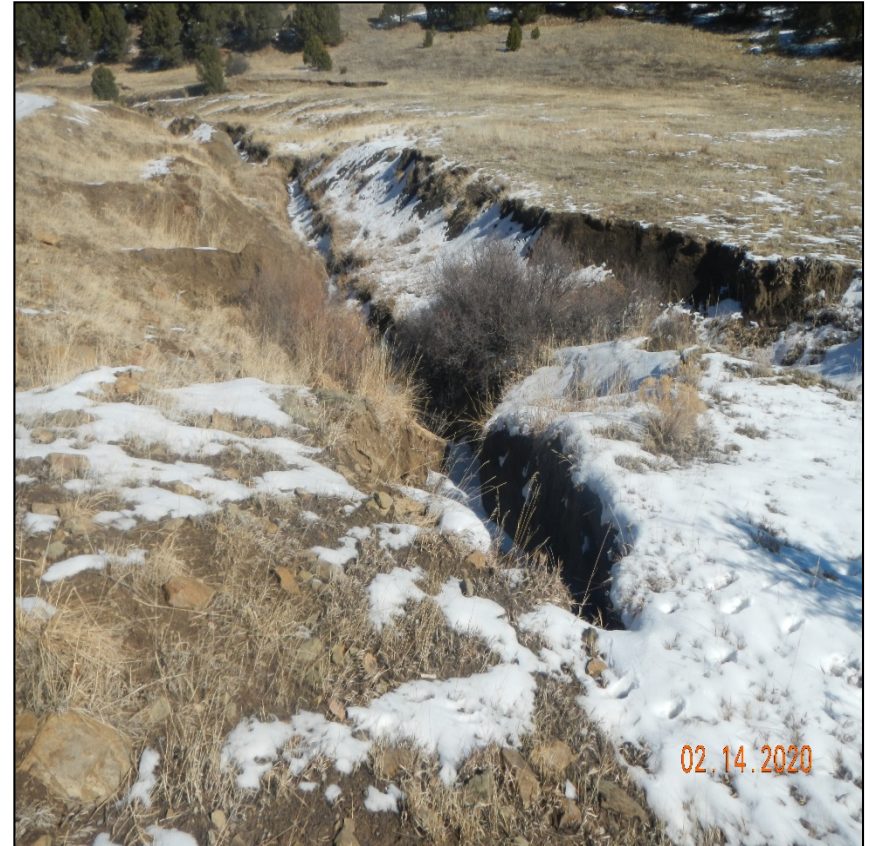
Photo 3. The stormwater outlet from this culvert is contributing to erosion of this gully. Lat/Long:37.14924,-104.86830.

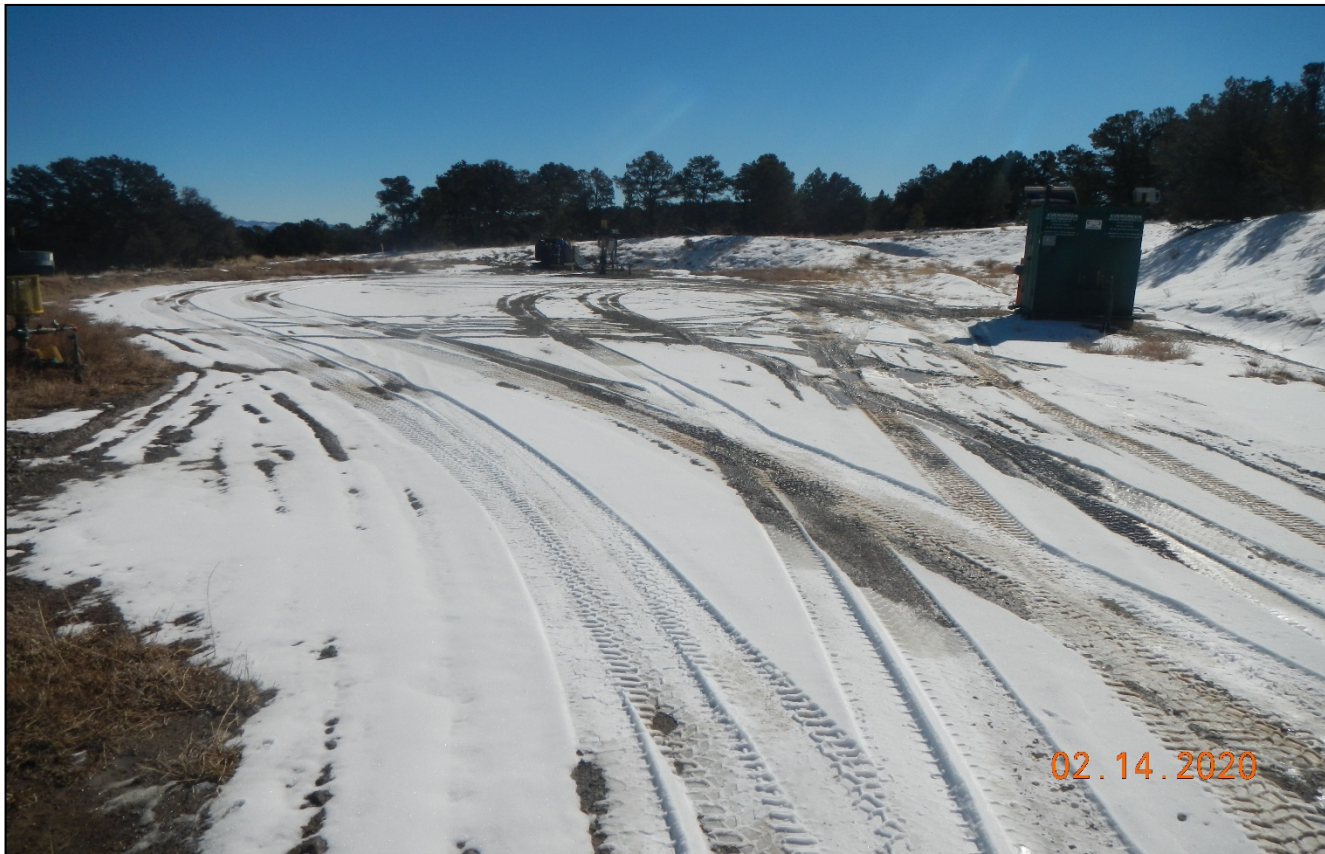
Photo 4. Facing toward the location.
