# Inspection Photos

API: 071-07640

Operator: EVERGREEN NATURAL RESOURCES

Inspection Date: 2/14/2020

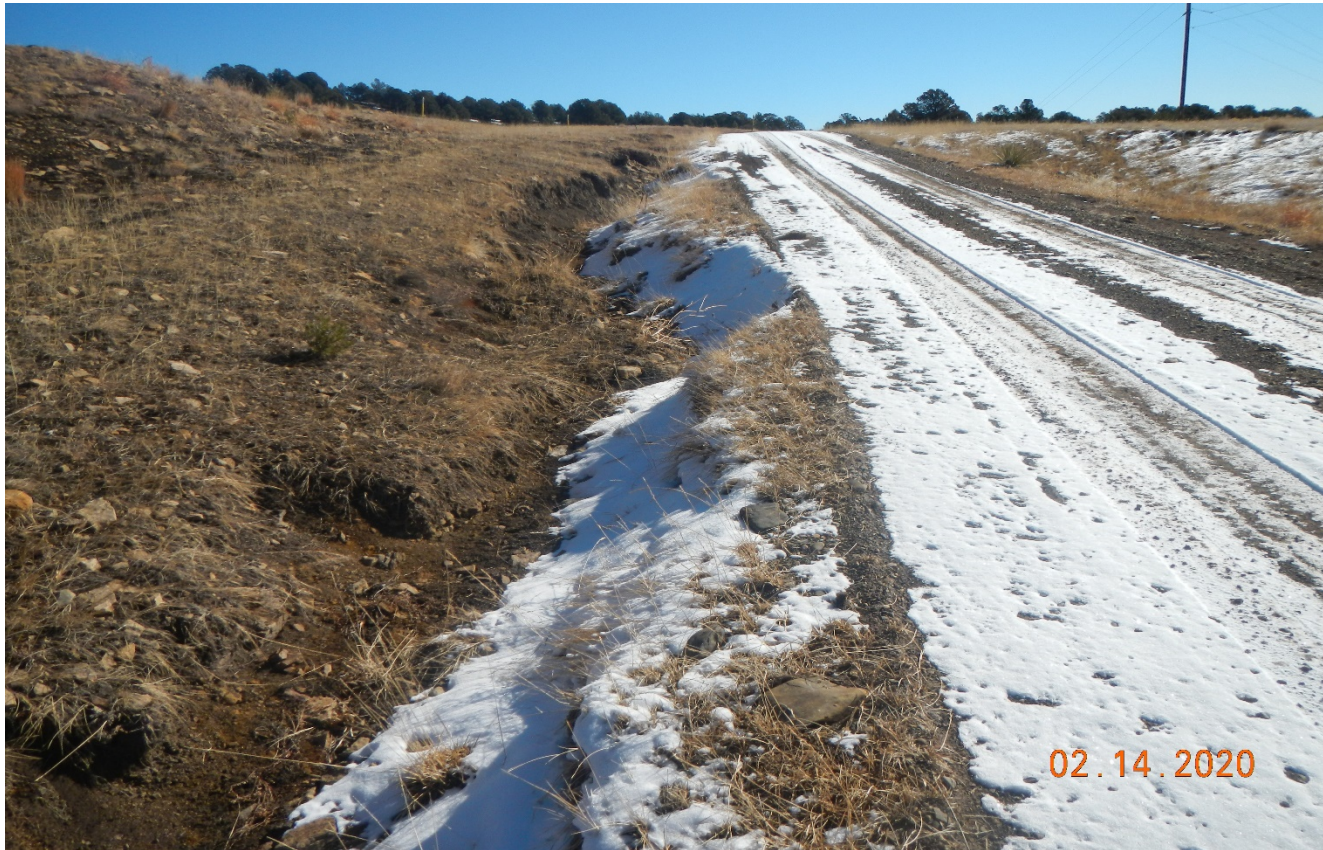
**Photo 1.** There is stormwater erosion which is occurring along the main road as it ascends the hill. BMP's need to be installed. Lat/Long:37.13882,-104.85030.

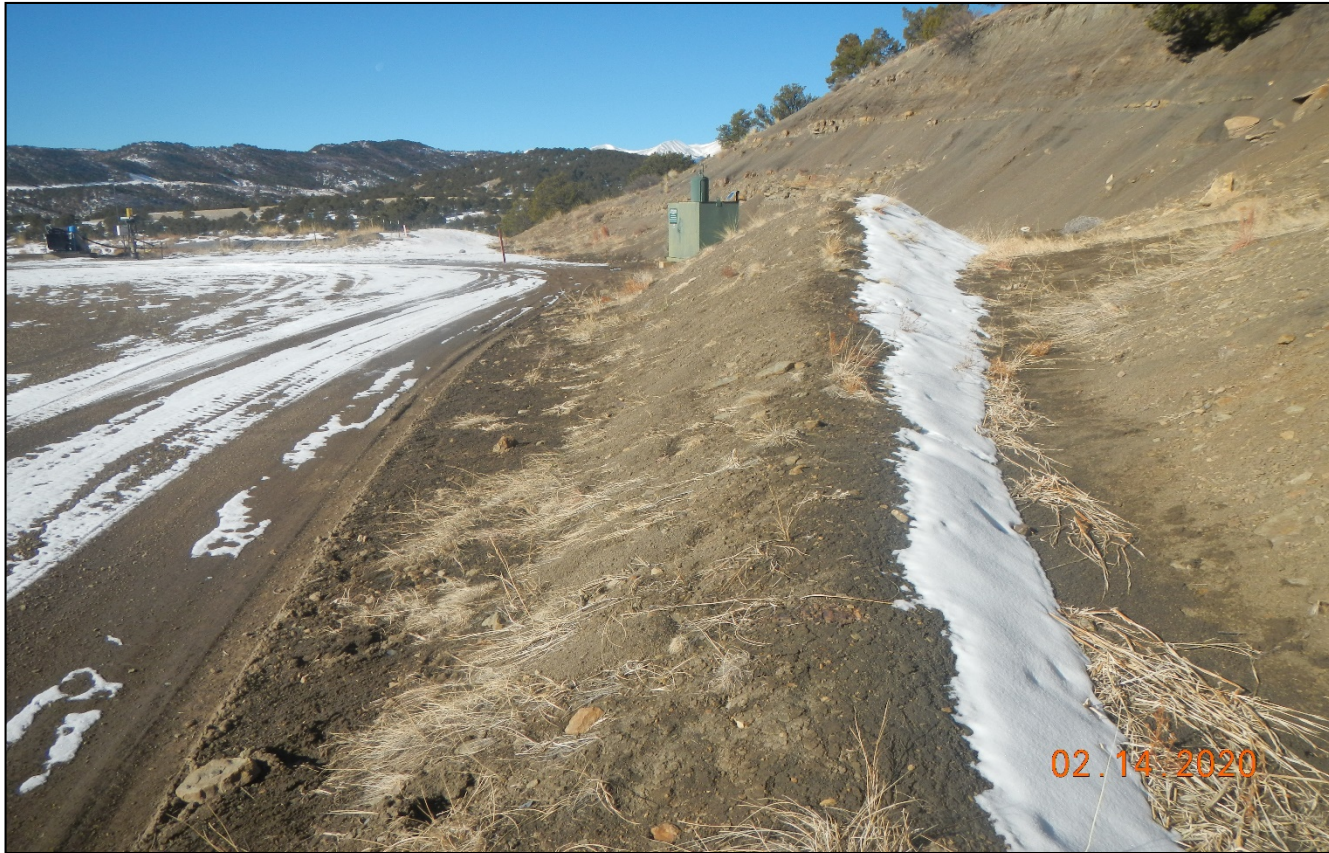
**Photo 2.** Facing toward the location. A berm is installed along the cut slope to contain erosion.

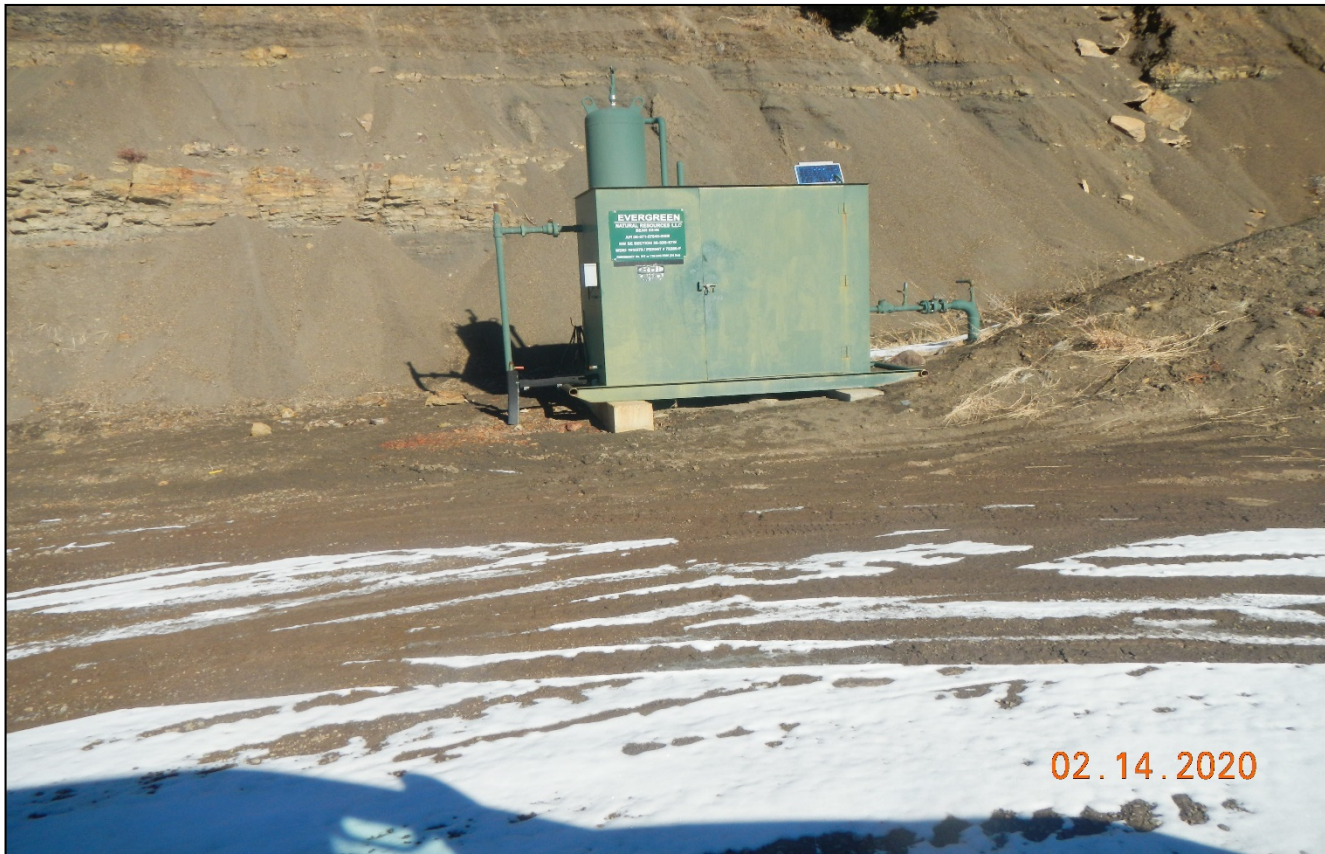
**Photo 3.** Well sign is installed at meter shed.

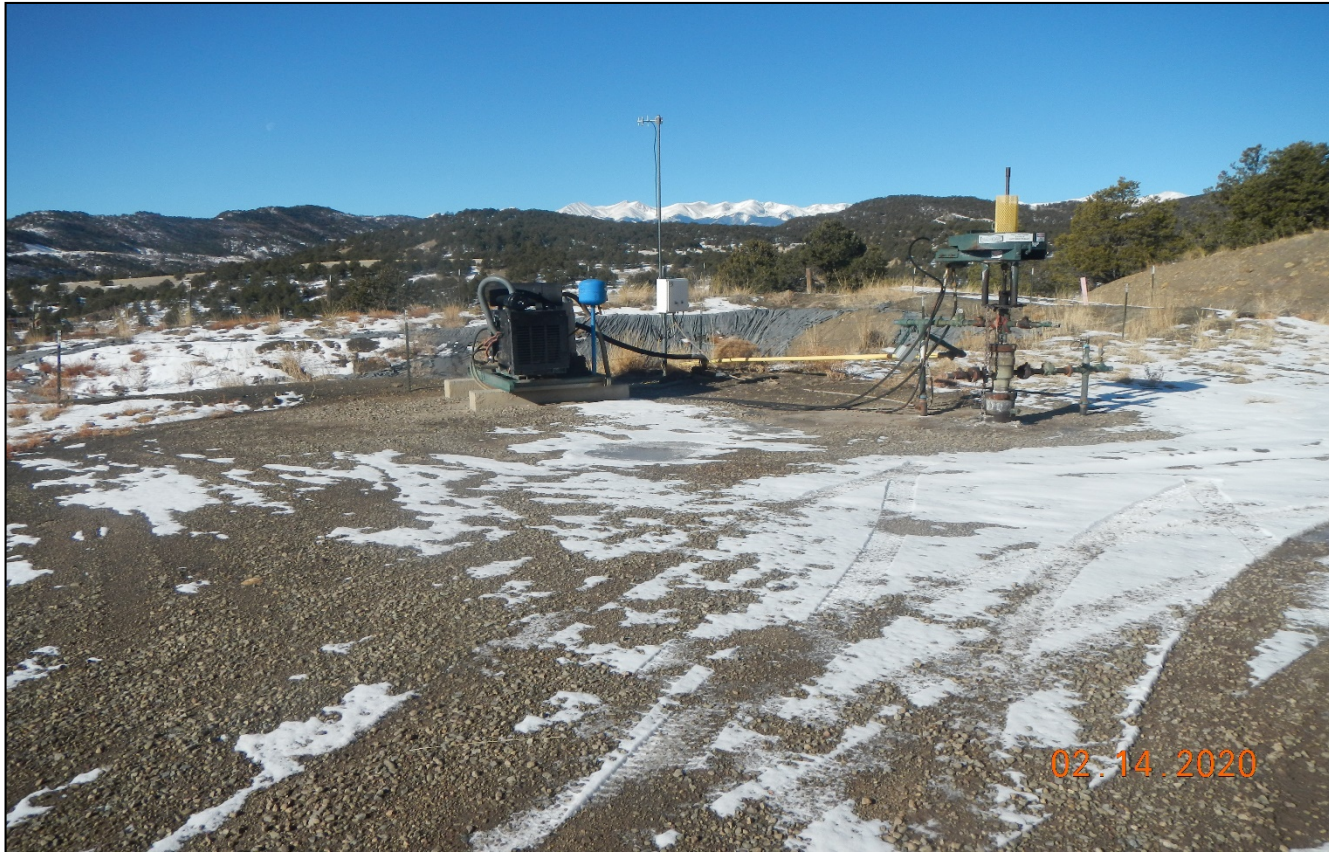
**Photo 4.** Facing west toward the well.

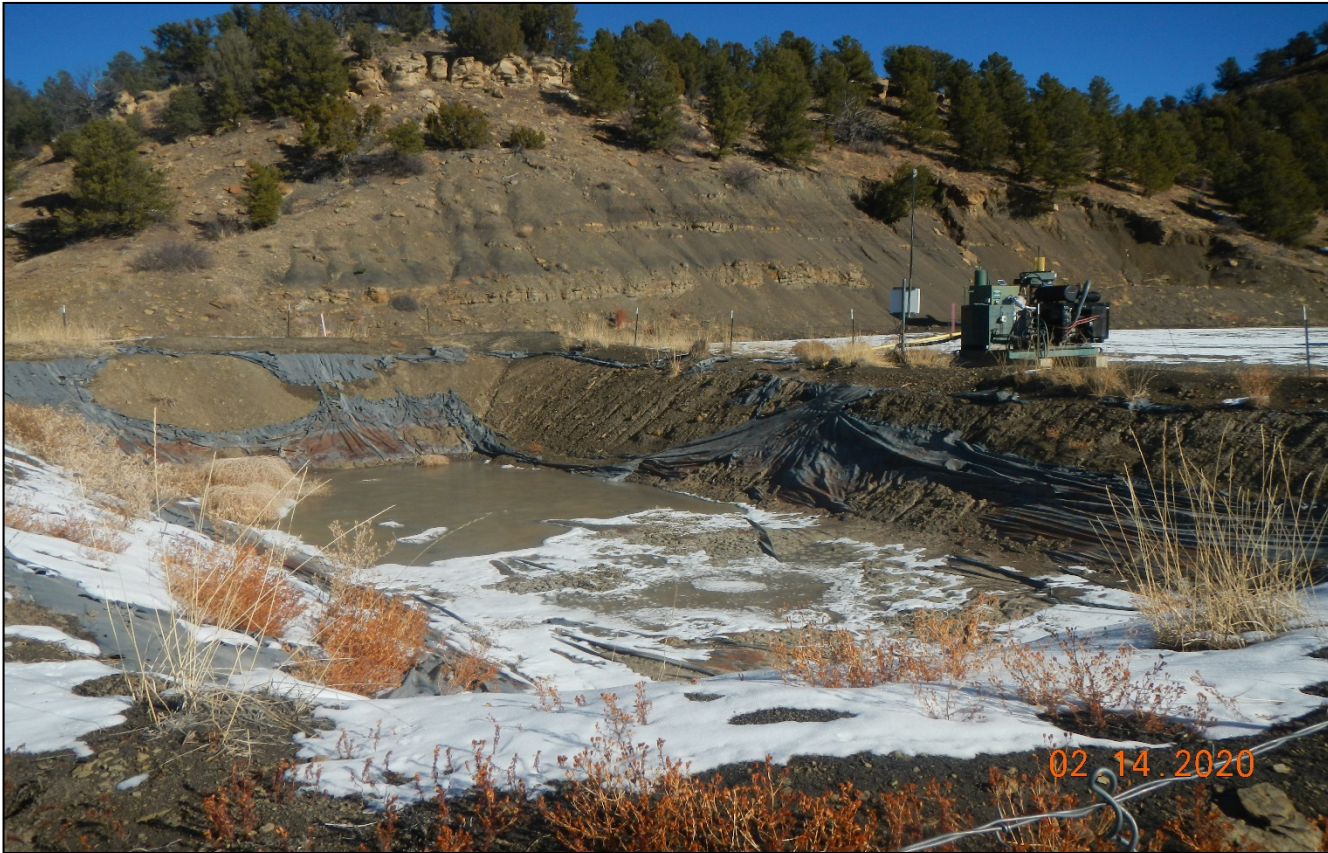
**Photo 5.** The pit liner is torn and degraded. There did not appear to be produced water in the pit at time of inspection.
