Inspection Photos
Operator: Kinder Morgan
Location #: 313490
Date: 2/20/2020

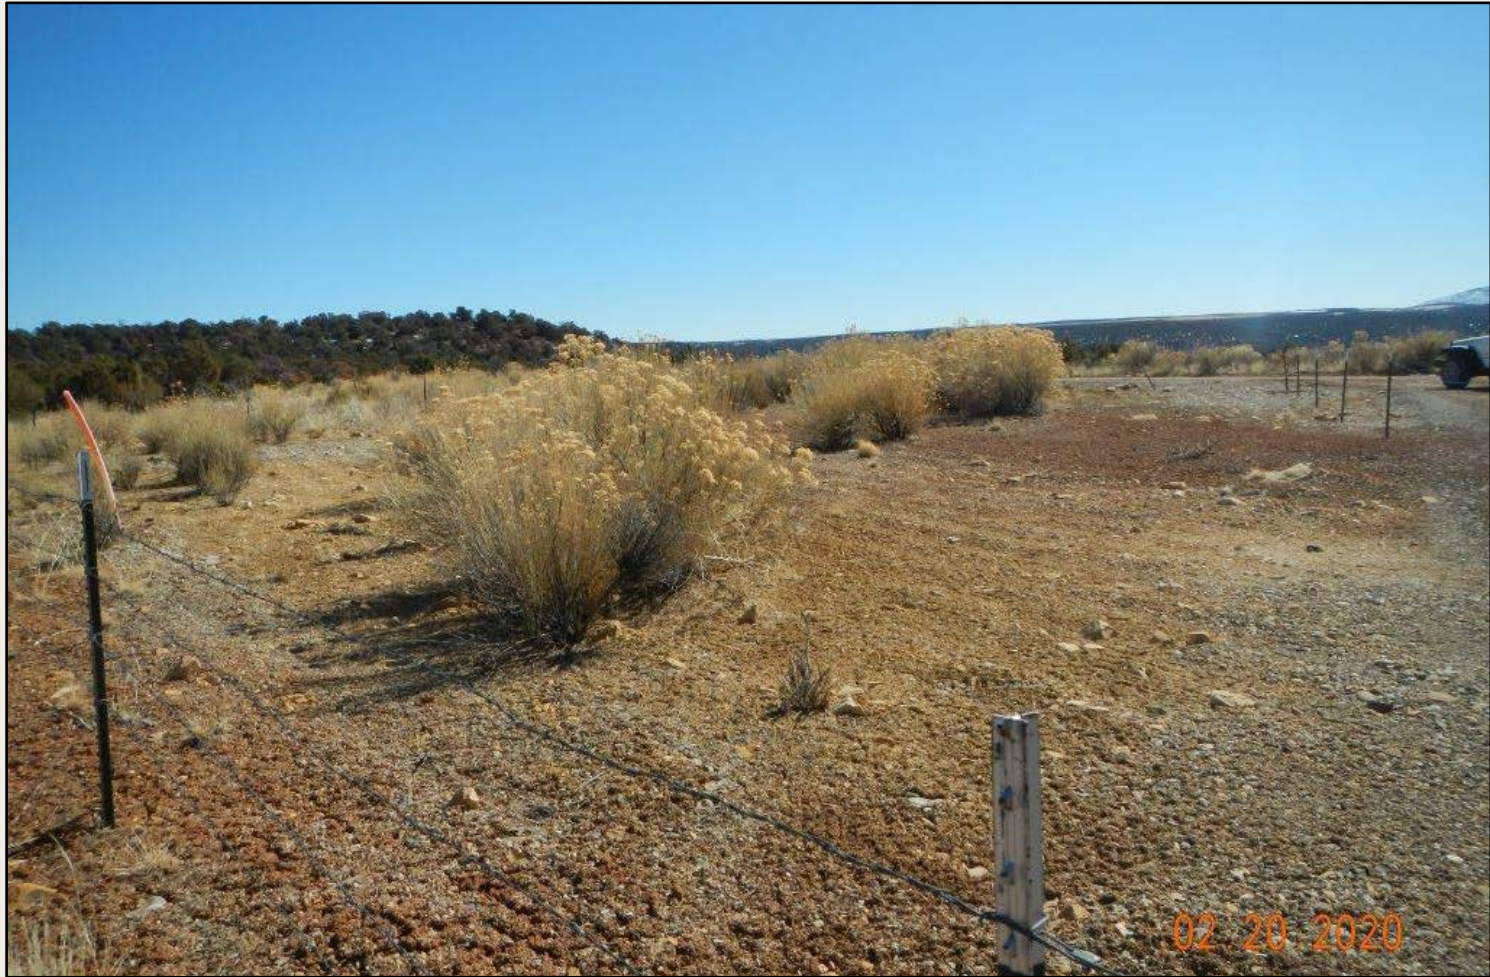
Photo 2. View of the eastern project area from the northeastern edge facing southward. Sparse revegetation within fenced areas. Additional reclamation is needed.

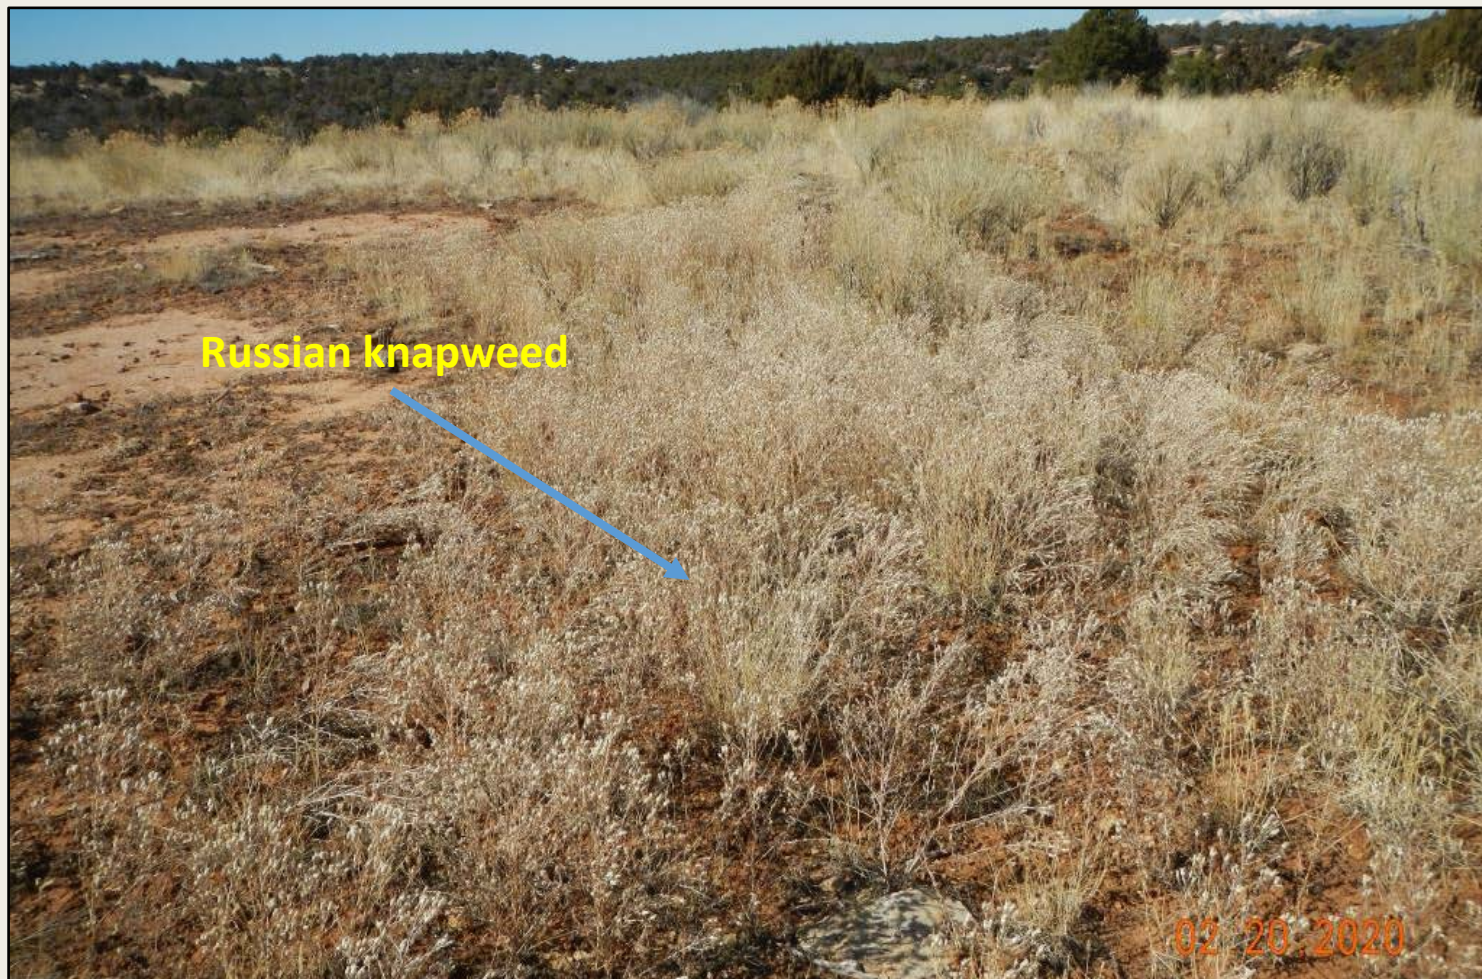
Photo 3. View of Russian knapweed infestation within the northern project area.

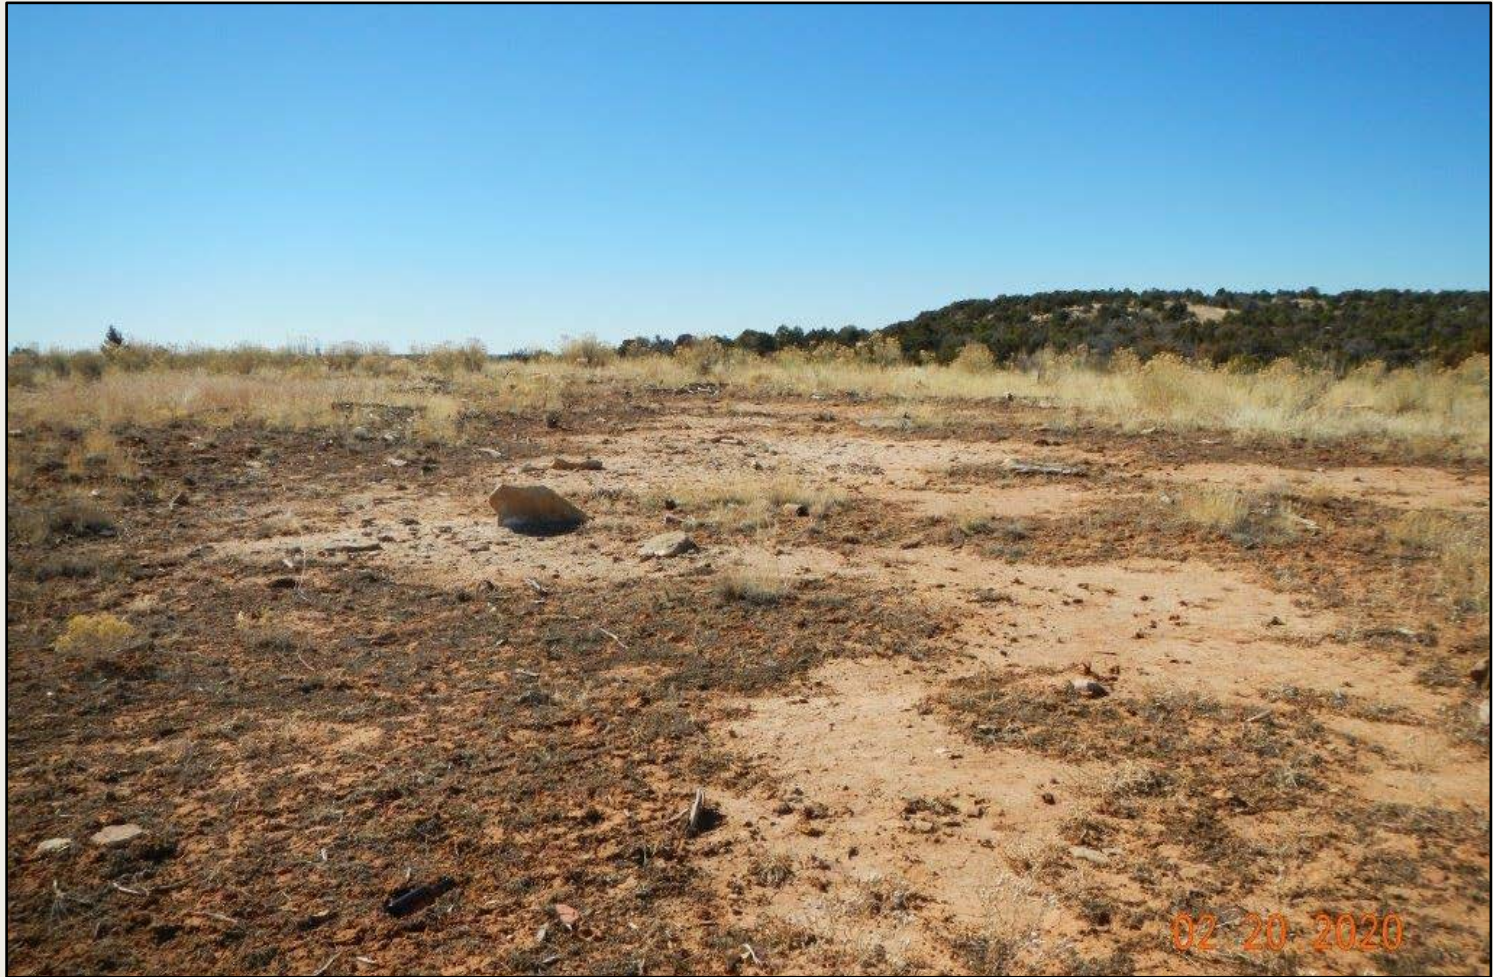
Photo 4. View of bare soils that appear to be salt impacted within the northern project area. Revegetation will likely require soil testing and amendment.

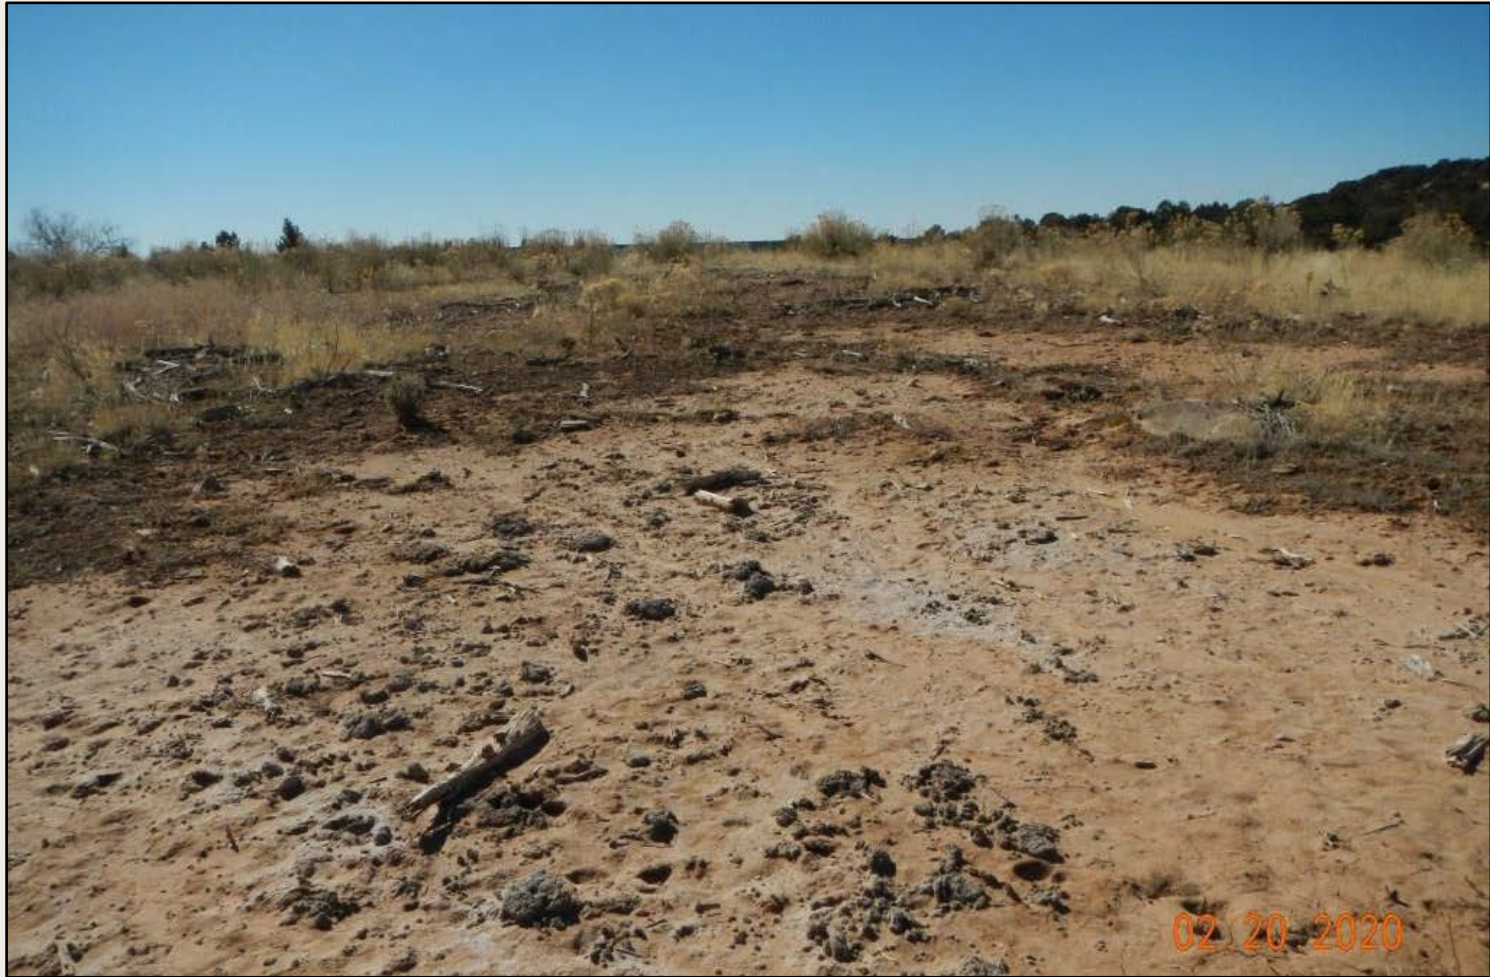
Photo 5. View of bare soils that appear to be salt impacted within the western project area. Revegetation will likely require soil testing and amendment.

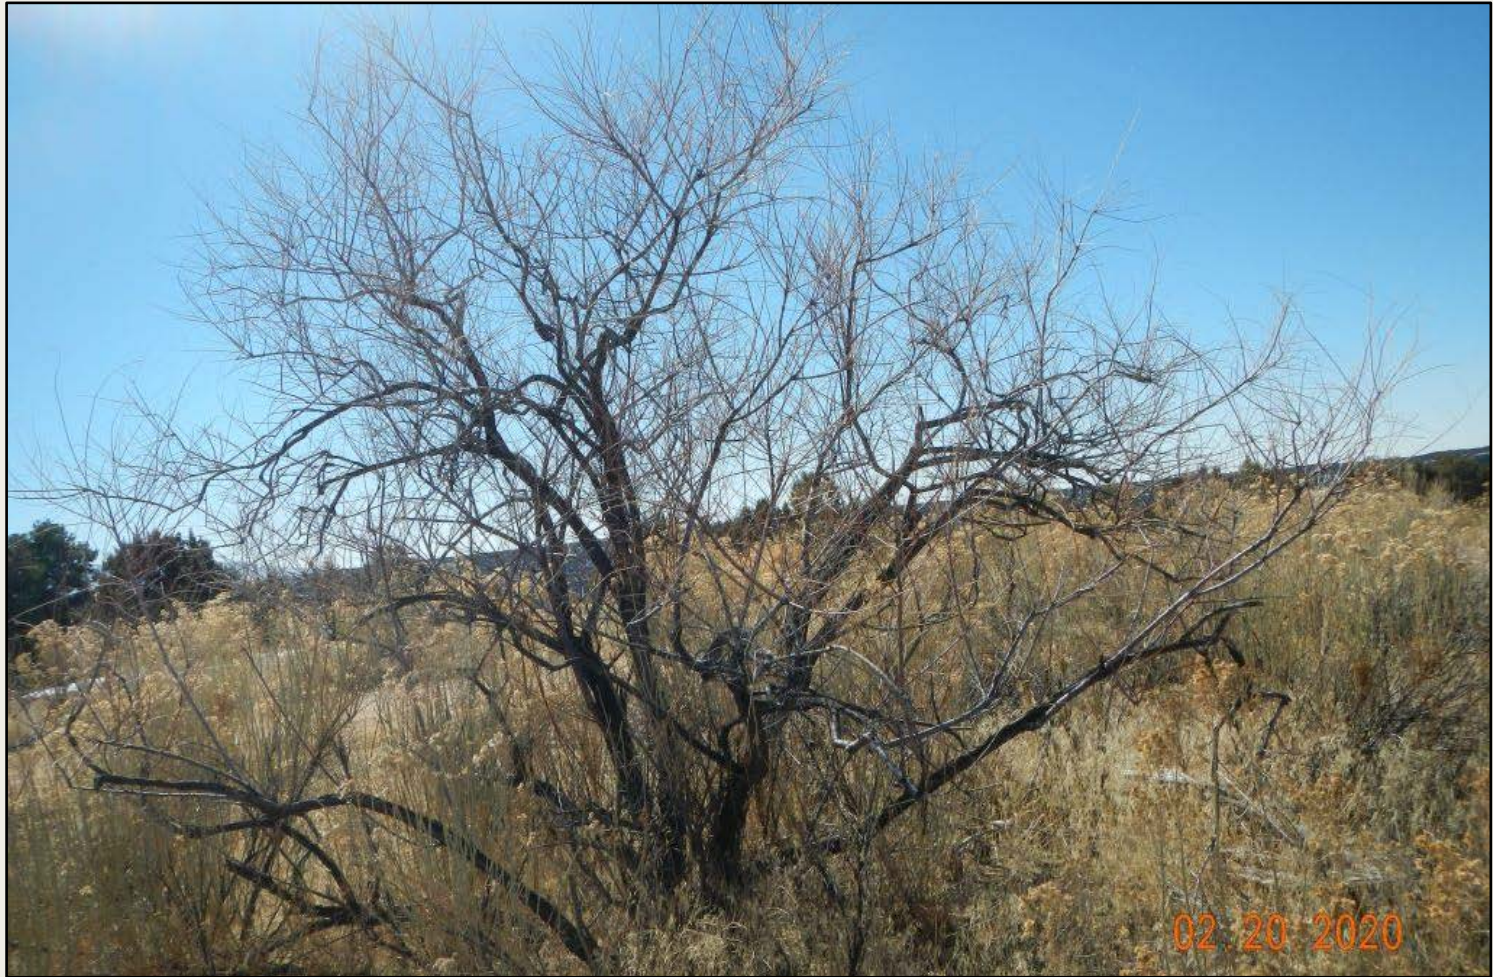
Photo 6. View of salt cedar weed within the western project area, needs to be controlled and removed.
