Inspection Photos

Location Name: Yellow Jacket Produced Water Pump #103B

Spill/Release Point ID: 471621

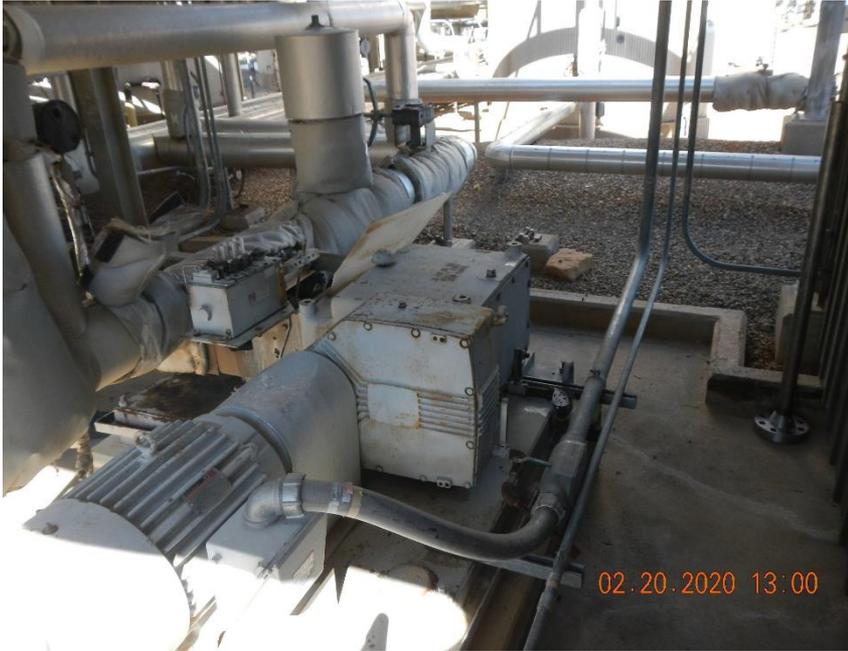
Packing failed on produced water pump.

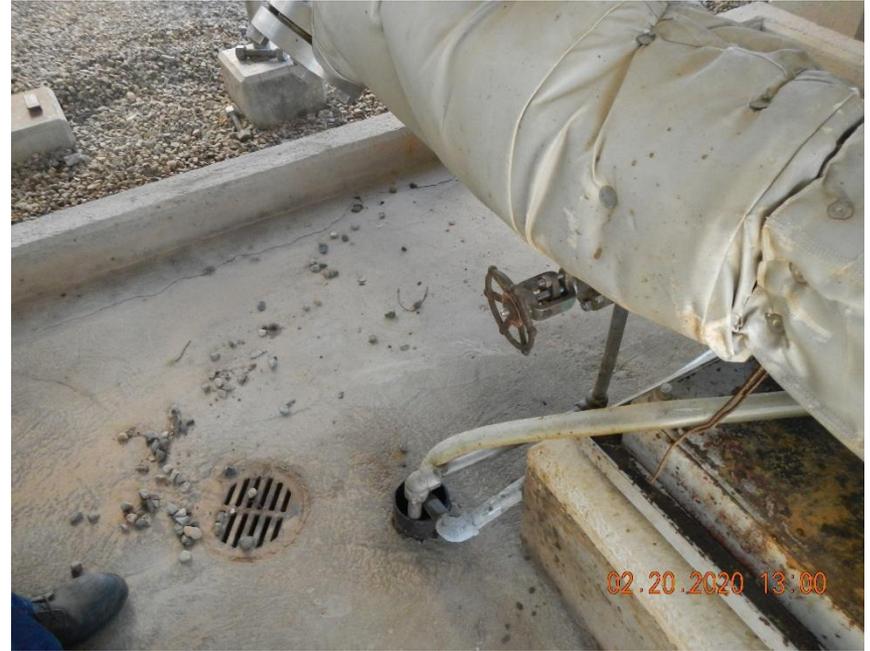
Secondary containment and sump drain.

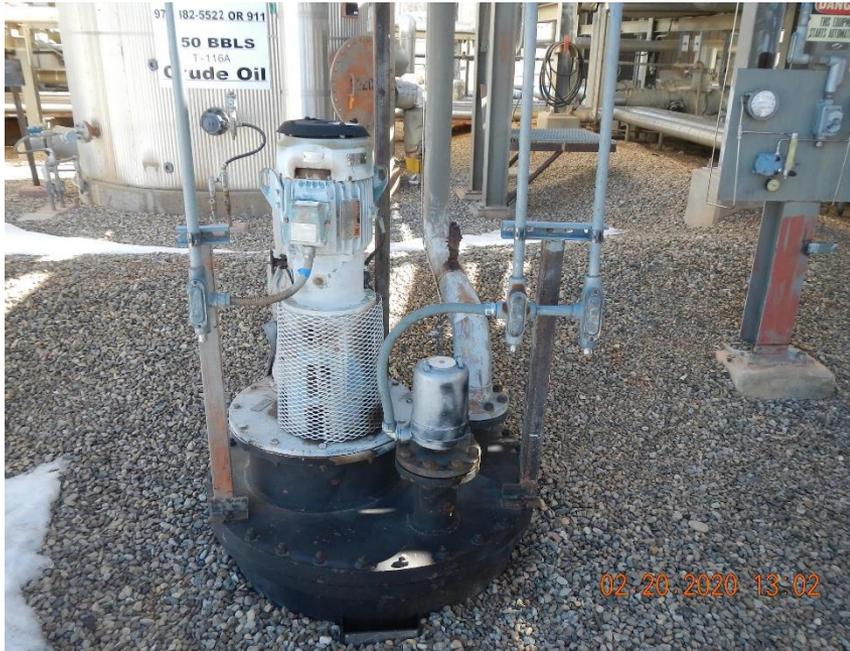
Sump pump failed to activate, resulting in overflowed secondary containment areas.

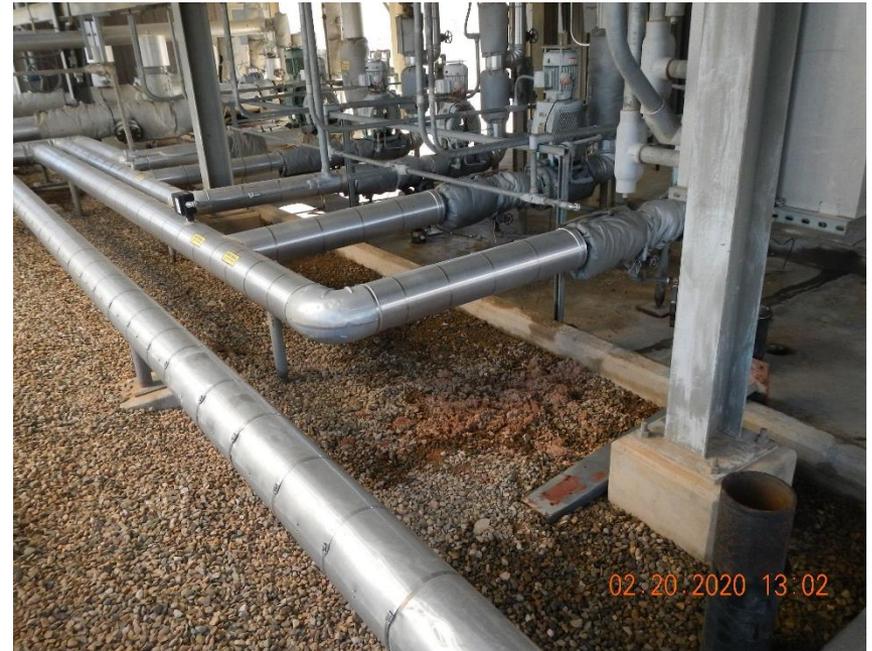
Stained and wet soil along edge of containment areas.

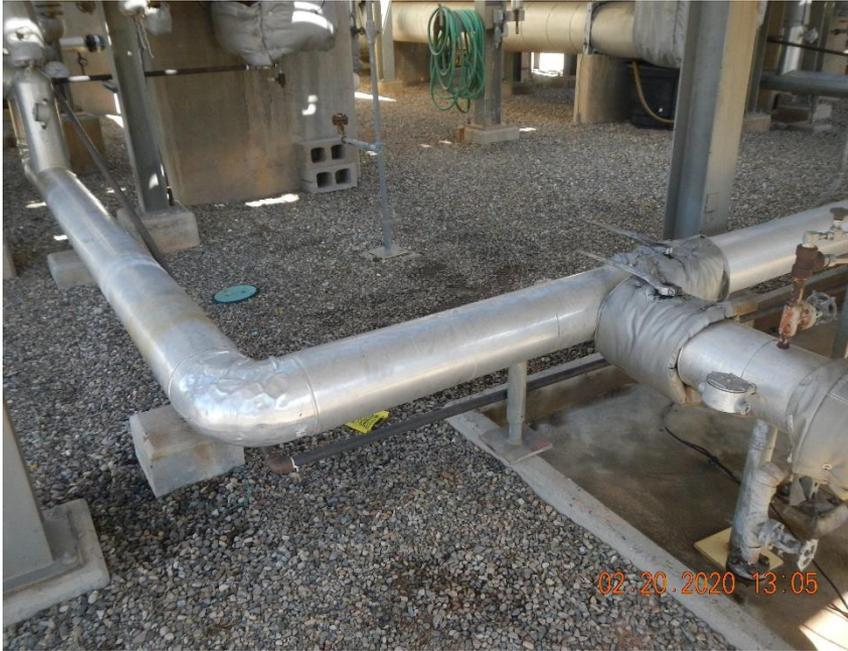
Wet soil near glycol pumps.

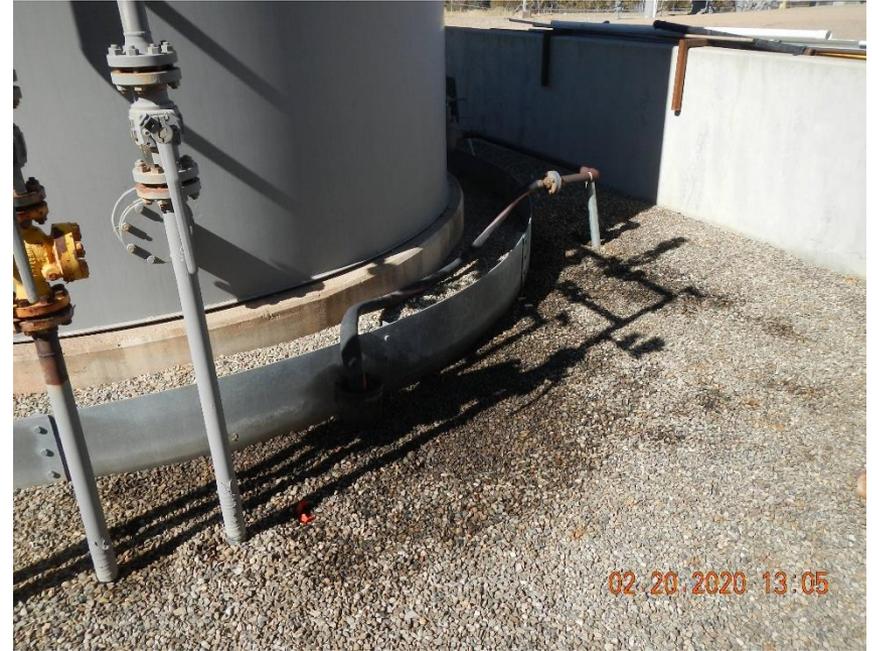
Stained and wet soil near blow down tank.
