Inspection Photos
Operator: Kinder Morgan
Location #: 428396
Date: 2/20/2020

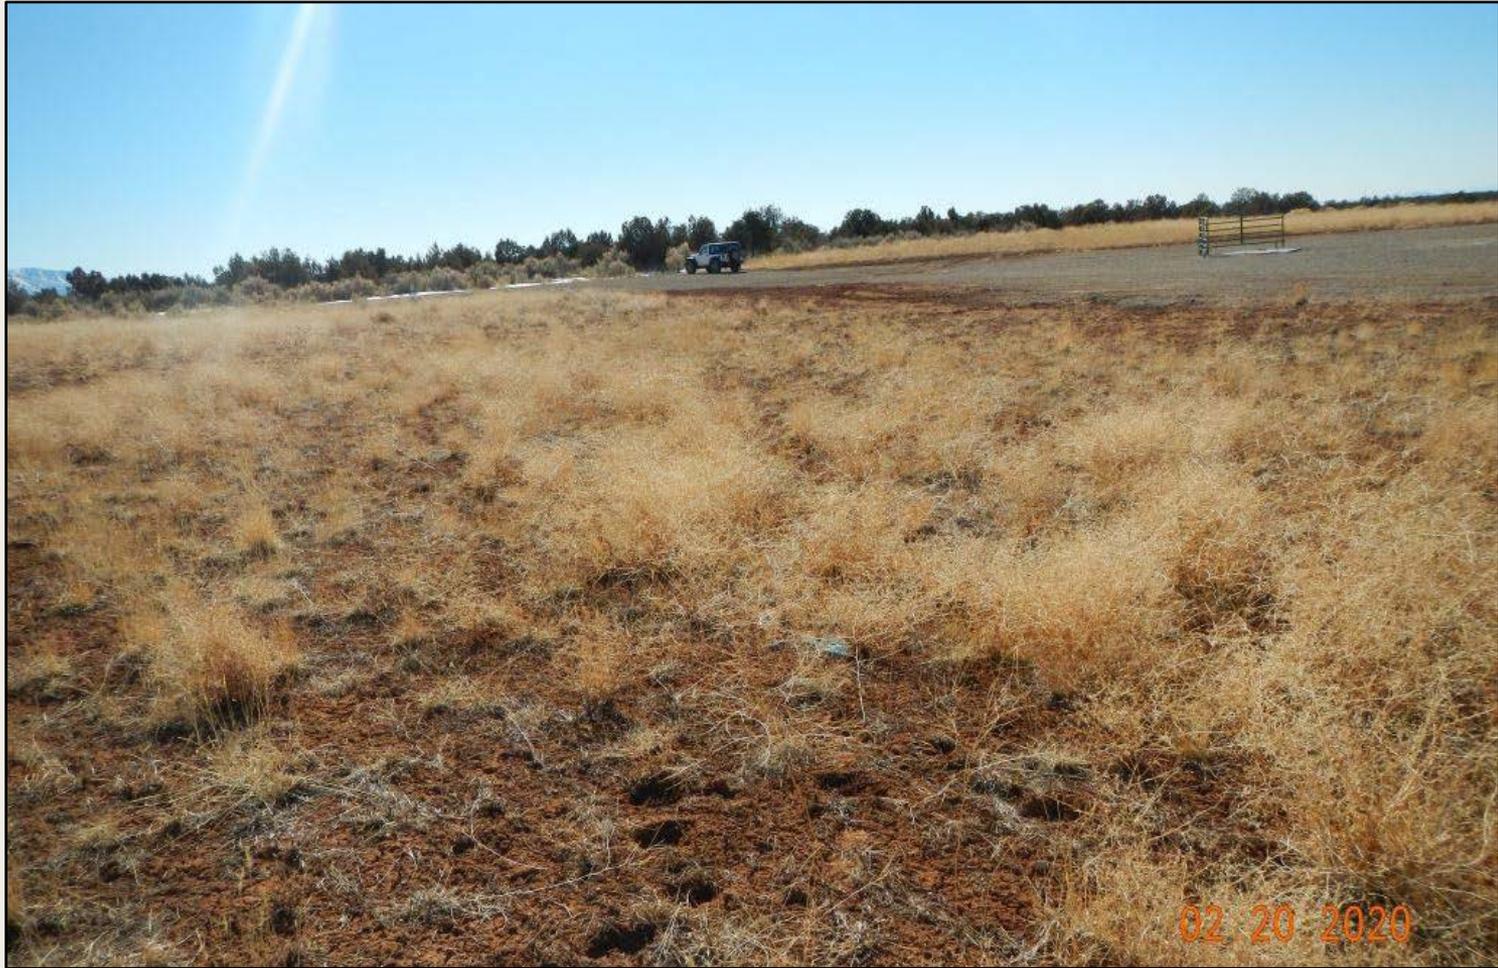
Photo 1. View of the project area from the northeastern corner facing center.

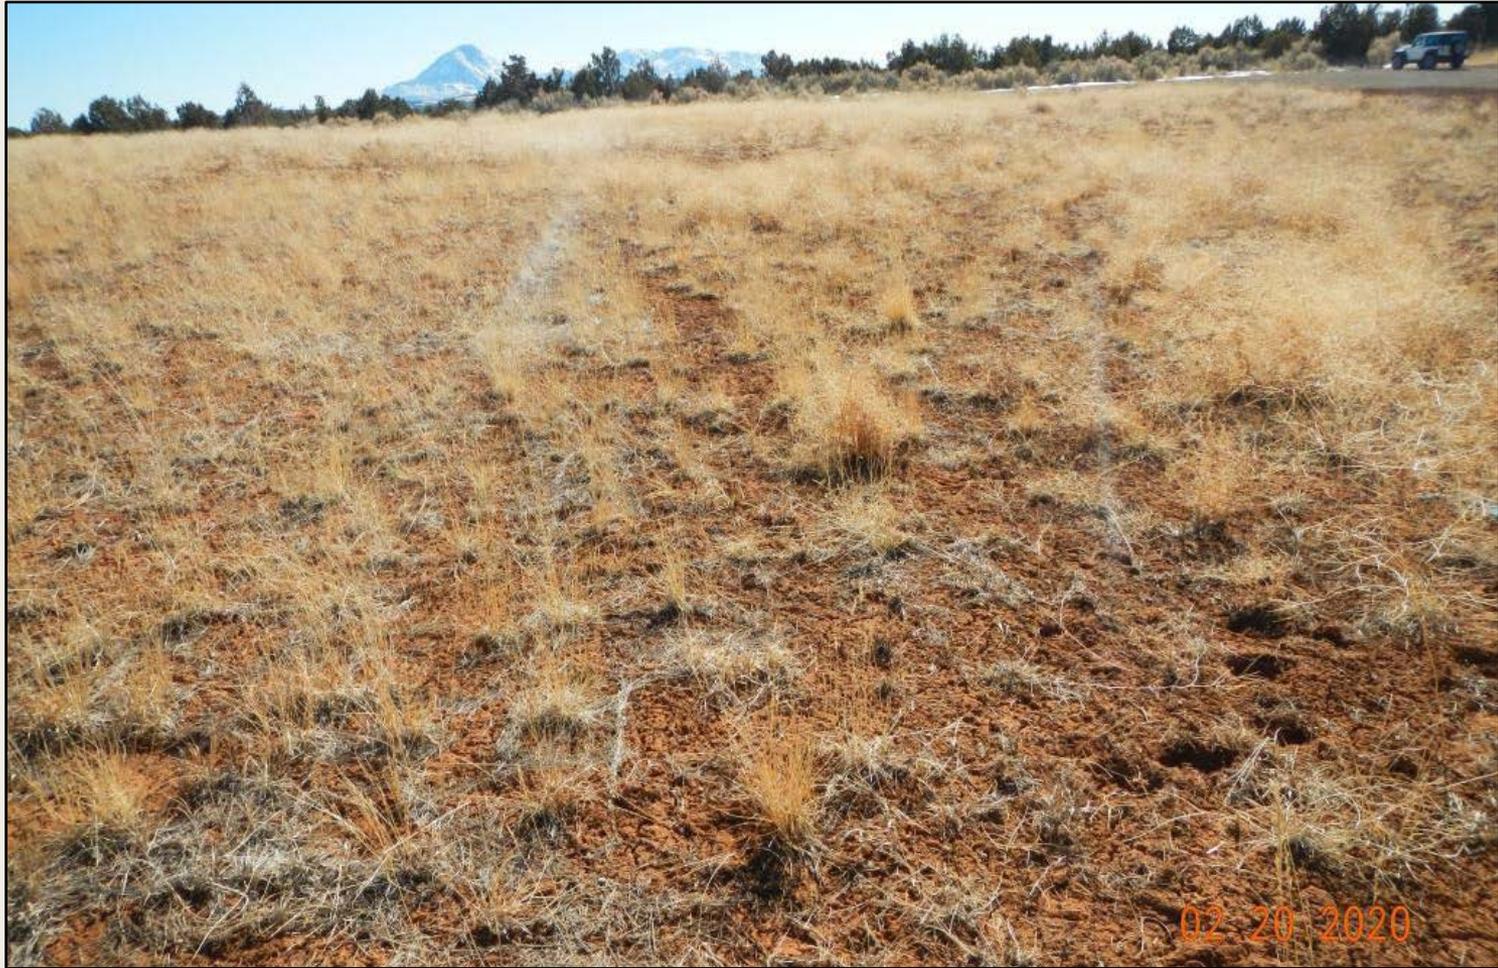
Photo 2. View of the eastern project area from the northeastern corner facing southward. Revegetation appears to be progressing with grasses such as western wheatgrass, Indian ricegrass, and sand dropseed.

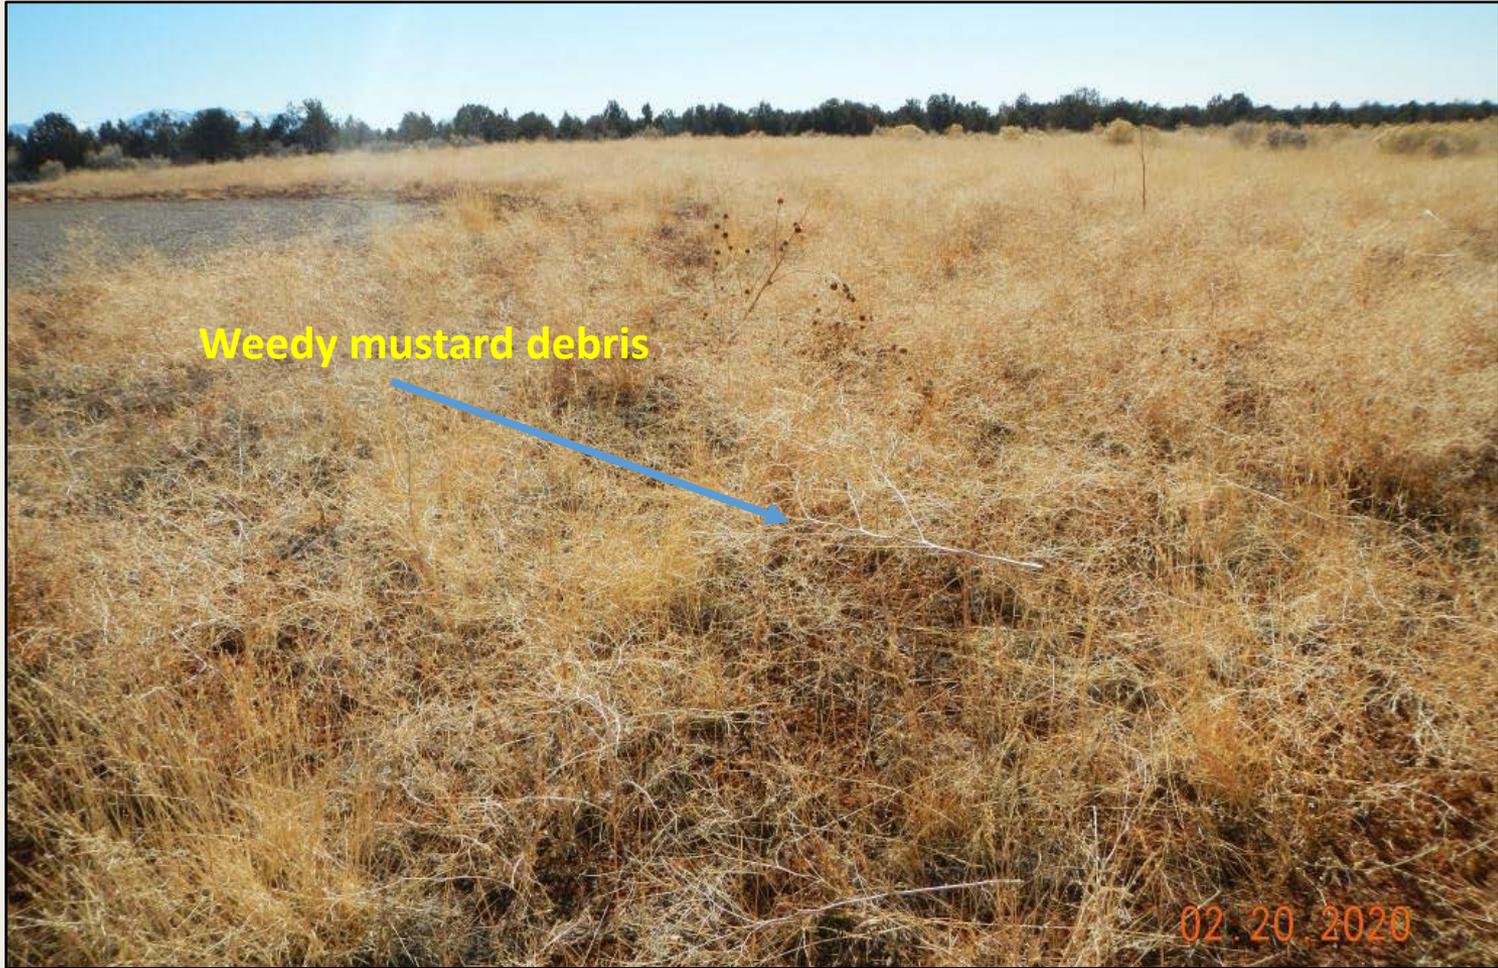
Photo 3. View of northern project area from the northeastern corner facing southwestward. Numerous annual weeds/debris are threatening successful revegetation in portions of the interim reclamation area and need to be managed.

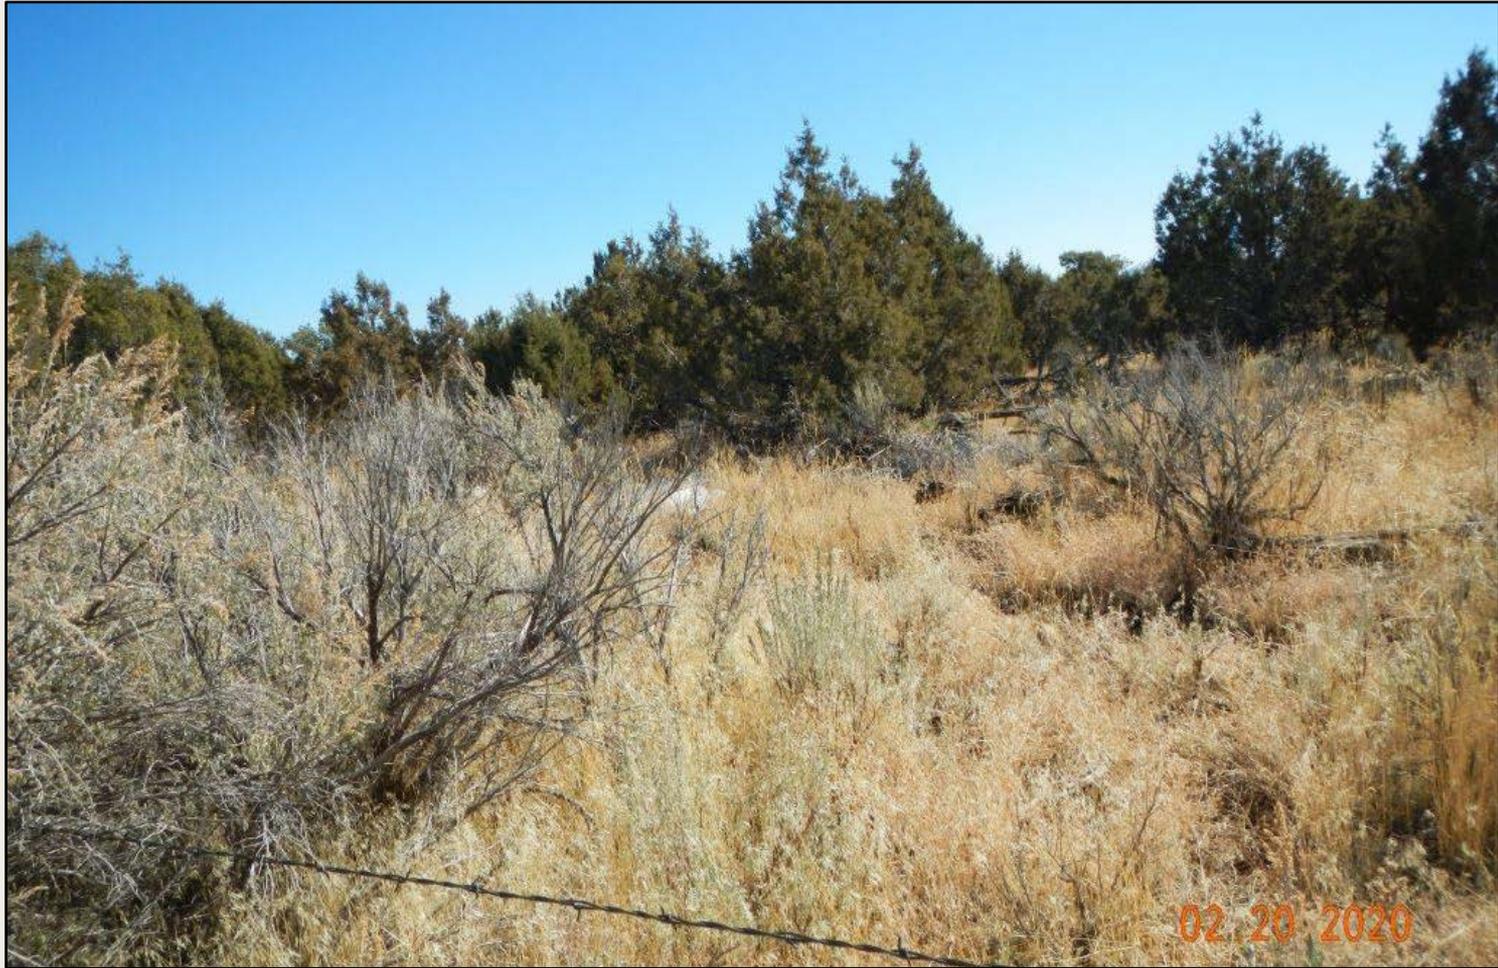
Photo 4. View of reference area vegetation comprised of pinyon juniper woodland, with sagebrush and mixed grass/forbs in the understory.
