Inspection Photos

Location Name: Exxon Tank Farm PA 313-33

Location ID: 324188 & Spill/Release ID: 471286

Inspection Date: February 13, 2020

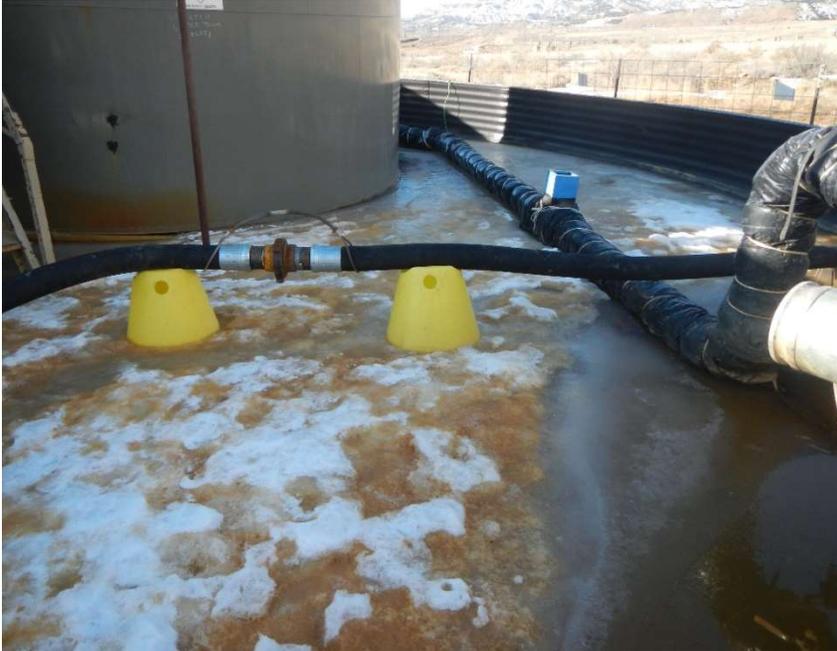
Photo #3 – Impacted snow and fluid within the tank battery secondary containment.

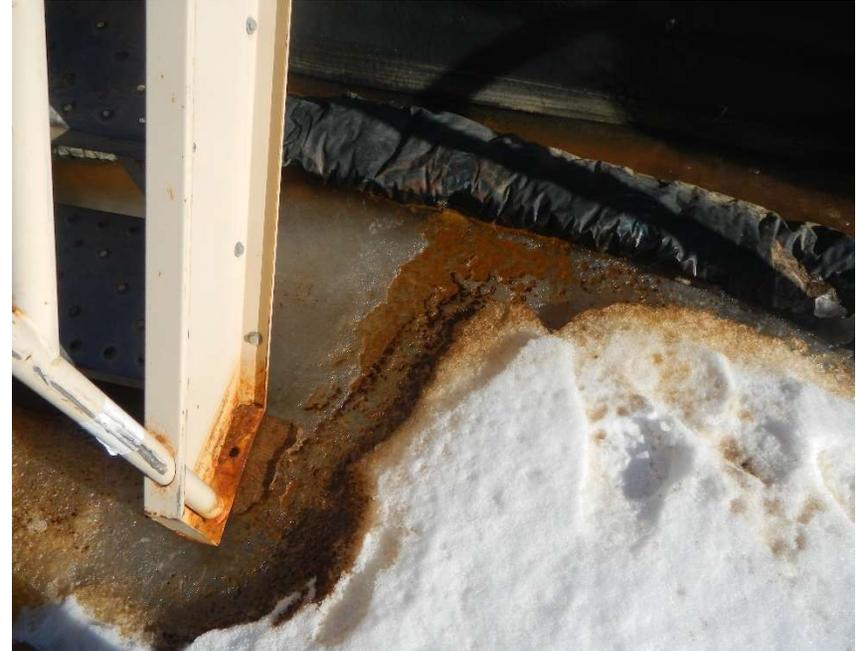
Photo #4 - Impacted snow and fluid within the tank battery secondary containment.

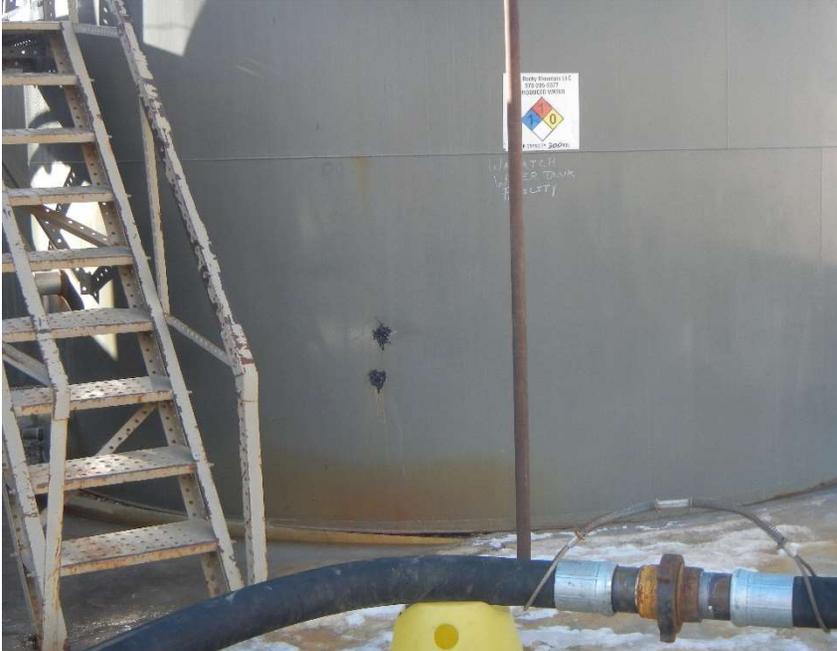
Photo #5 - Multiple repairs of the northwest Produced Water Steel AST.

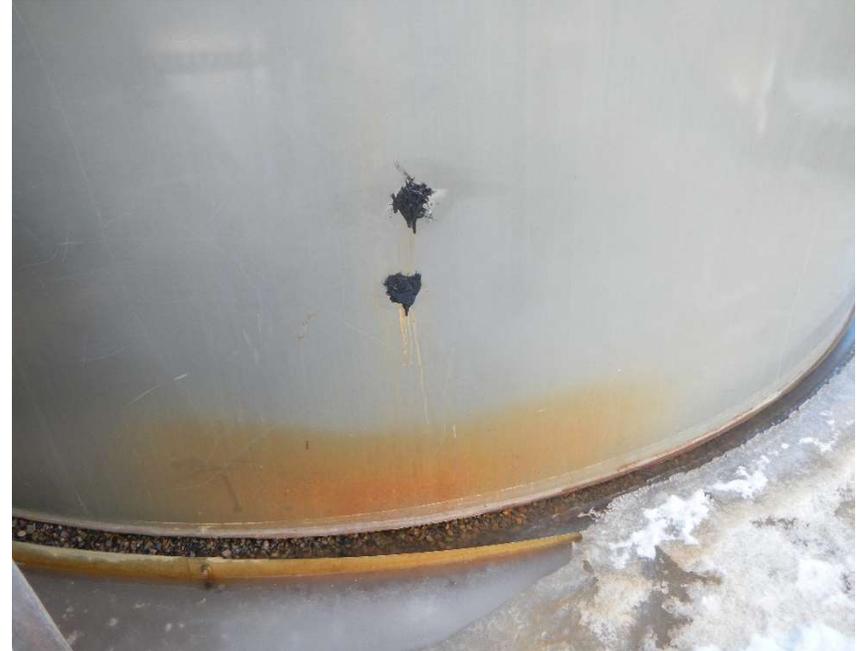
Photo #6 - Multiple repairs of the northwest Produced Water Steel AST.
