Stagner 2 & 6
API: 05-103-07101 & 07362
Inspection: 700400164

COLORADO
Oil & Gas Conservation
Commission
Department of Natural Resources

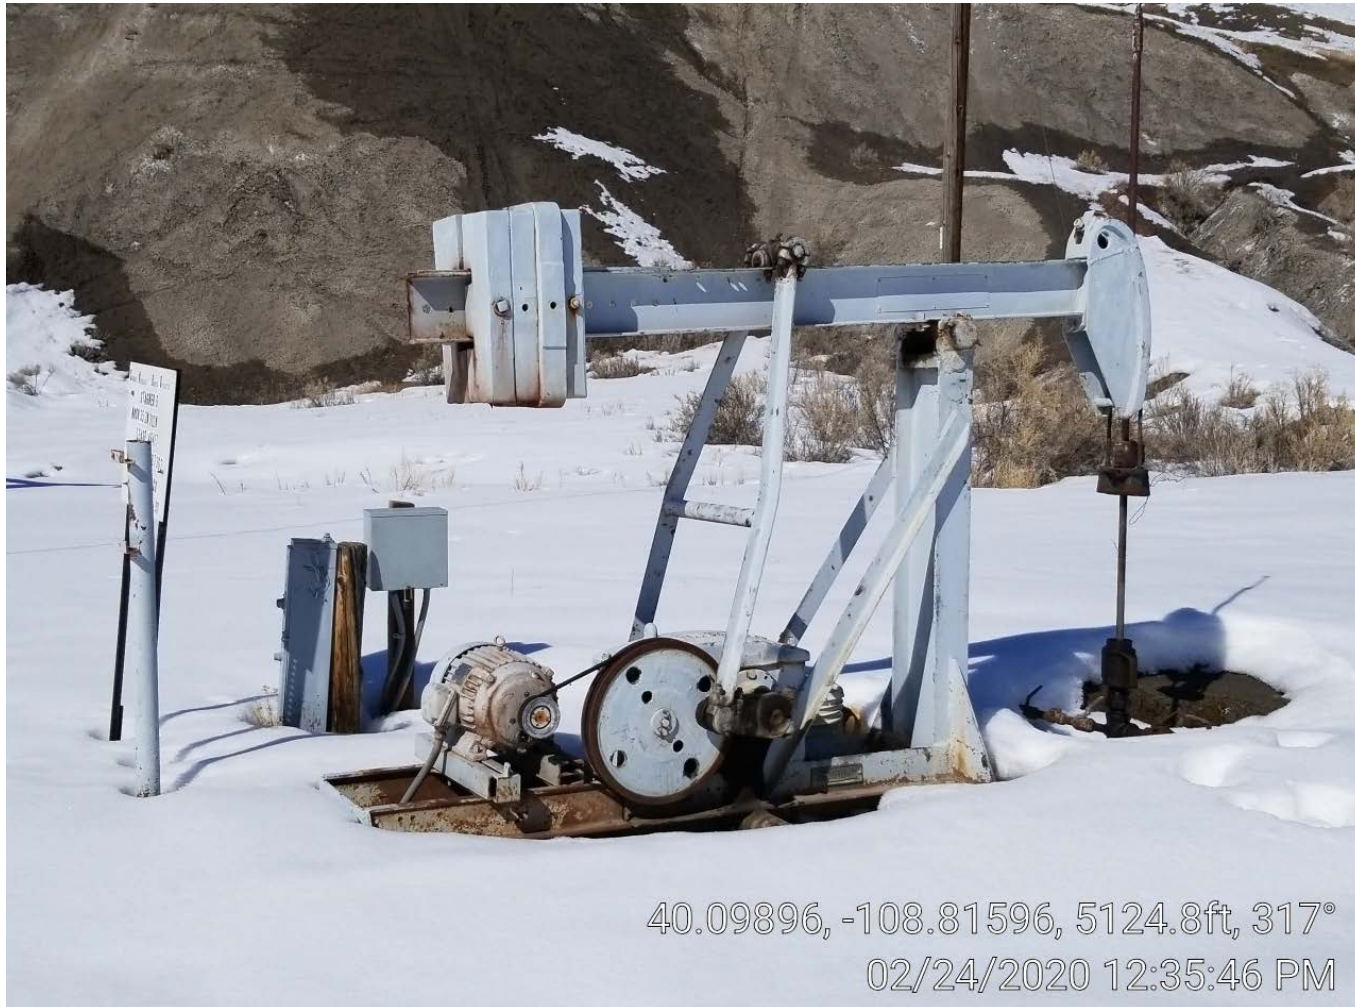
Photo 2. Pump jack of well Stagner 2.

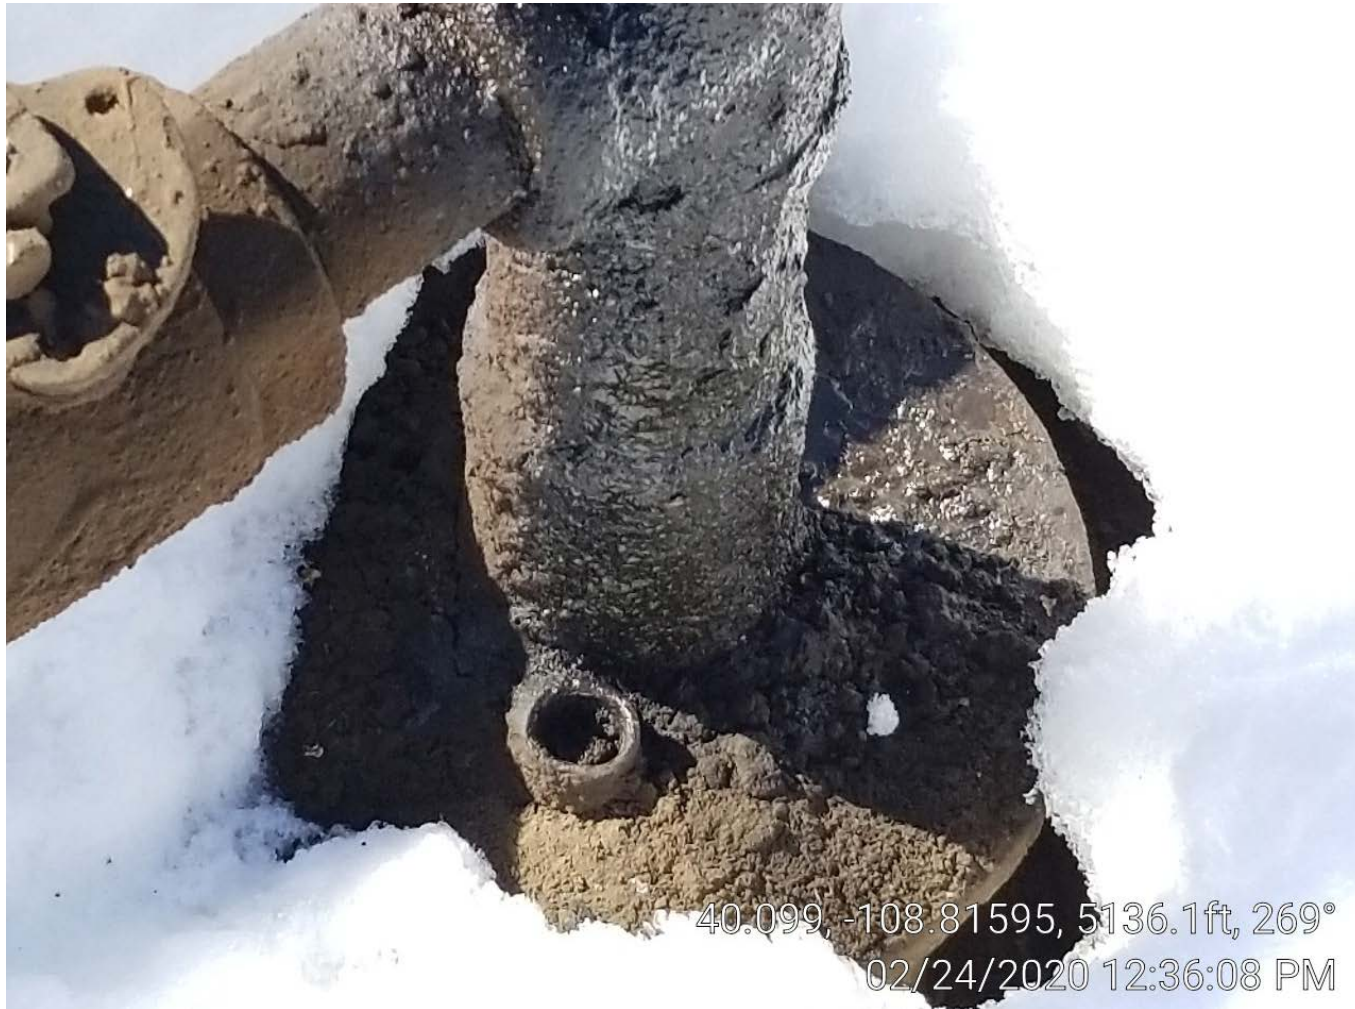
Photo 3. Hole on top of casing of well Stagner 2.

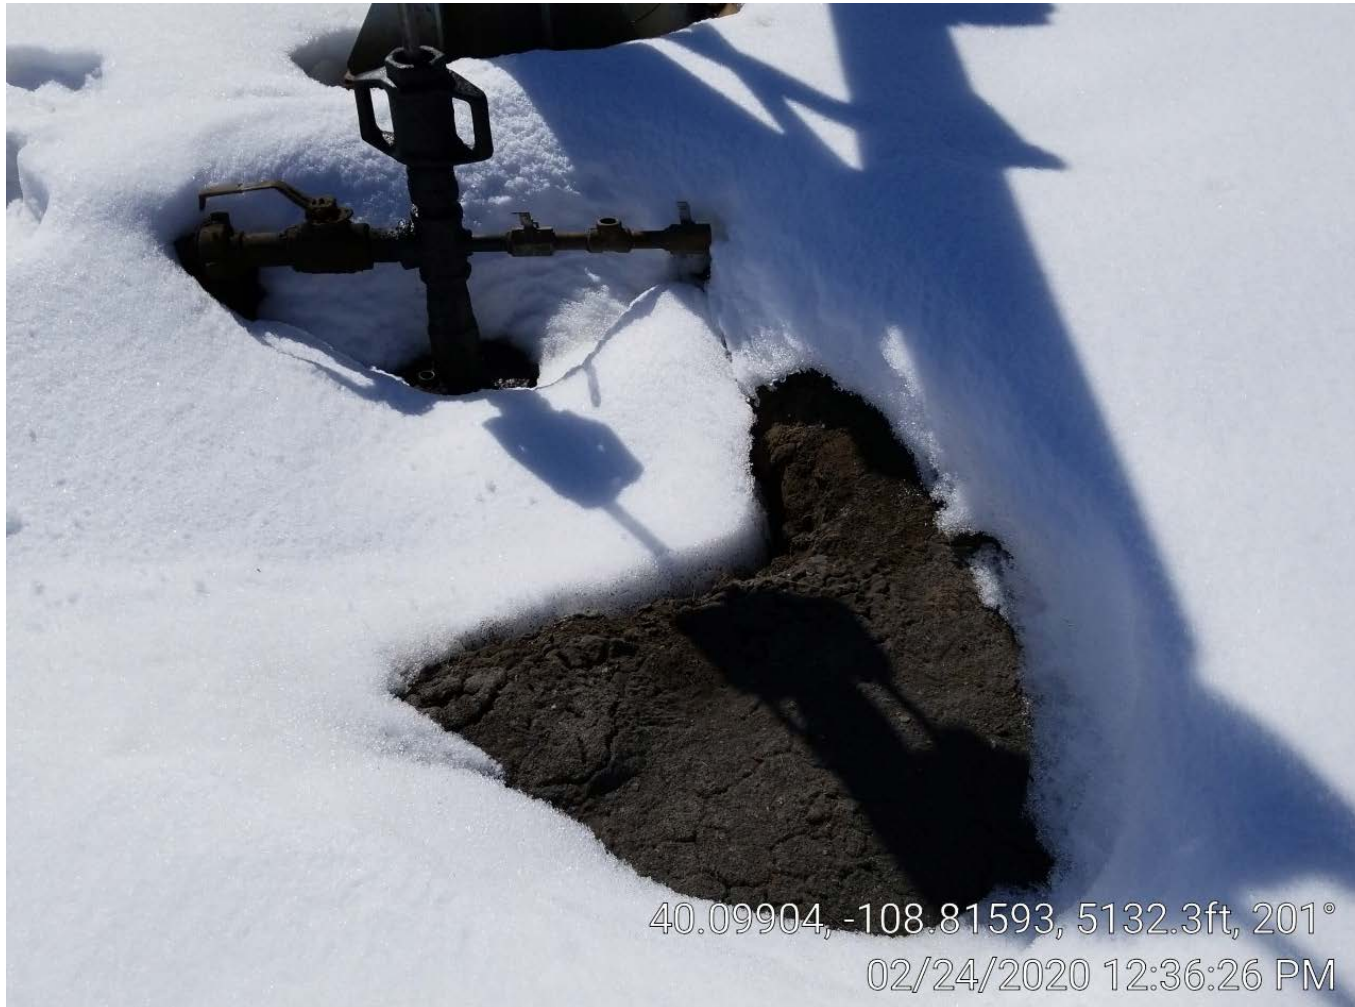
Photo 4. Oily soil next to well Stagner 2.

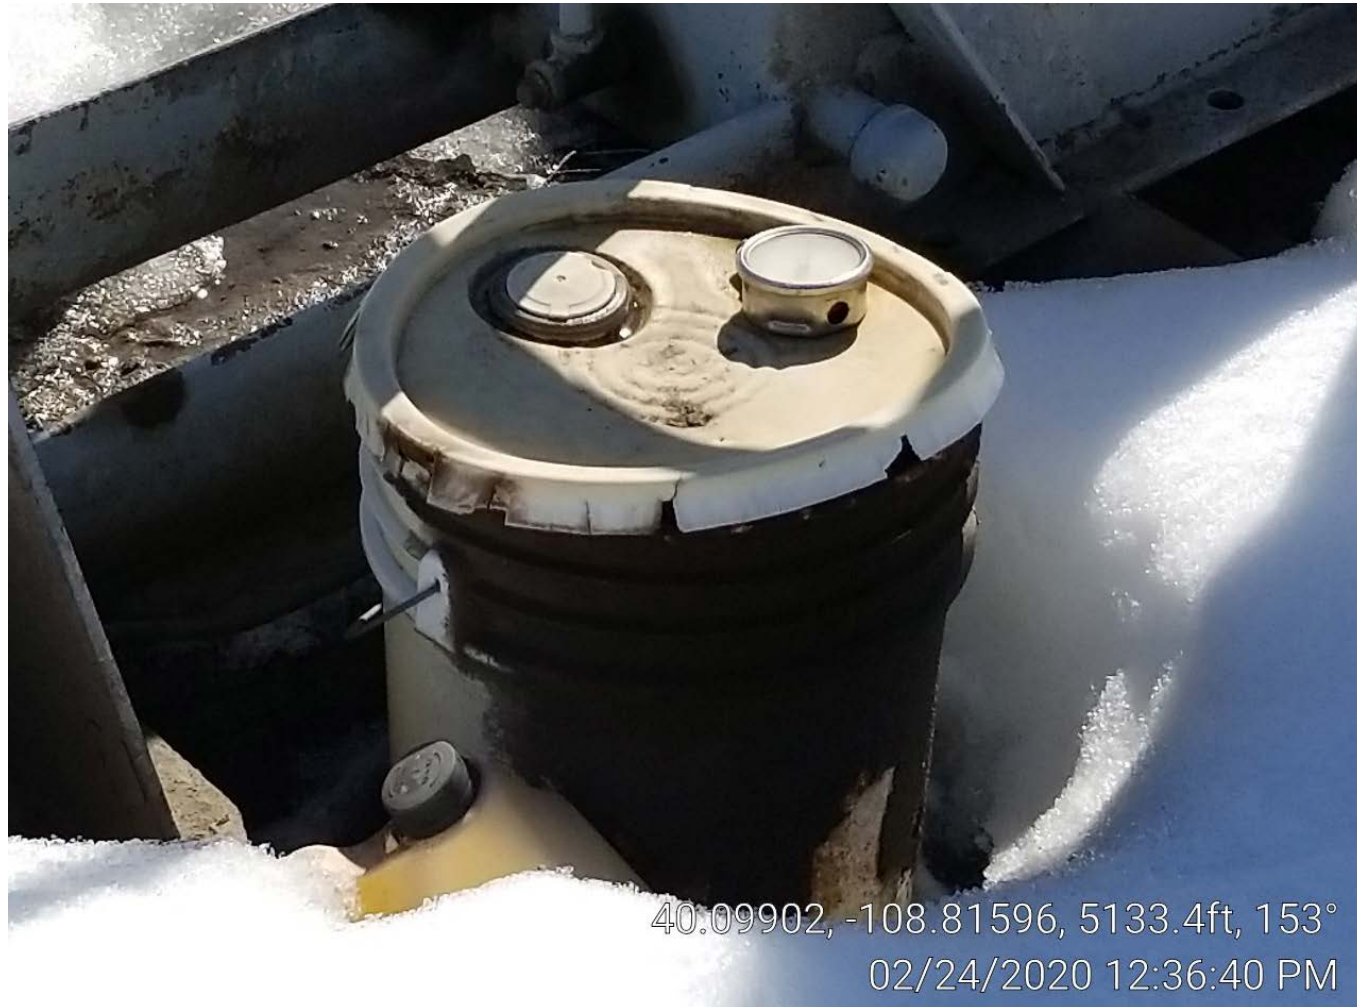
Photo 5. Bucket next to well Stagner 2.

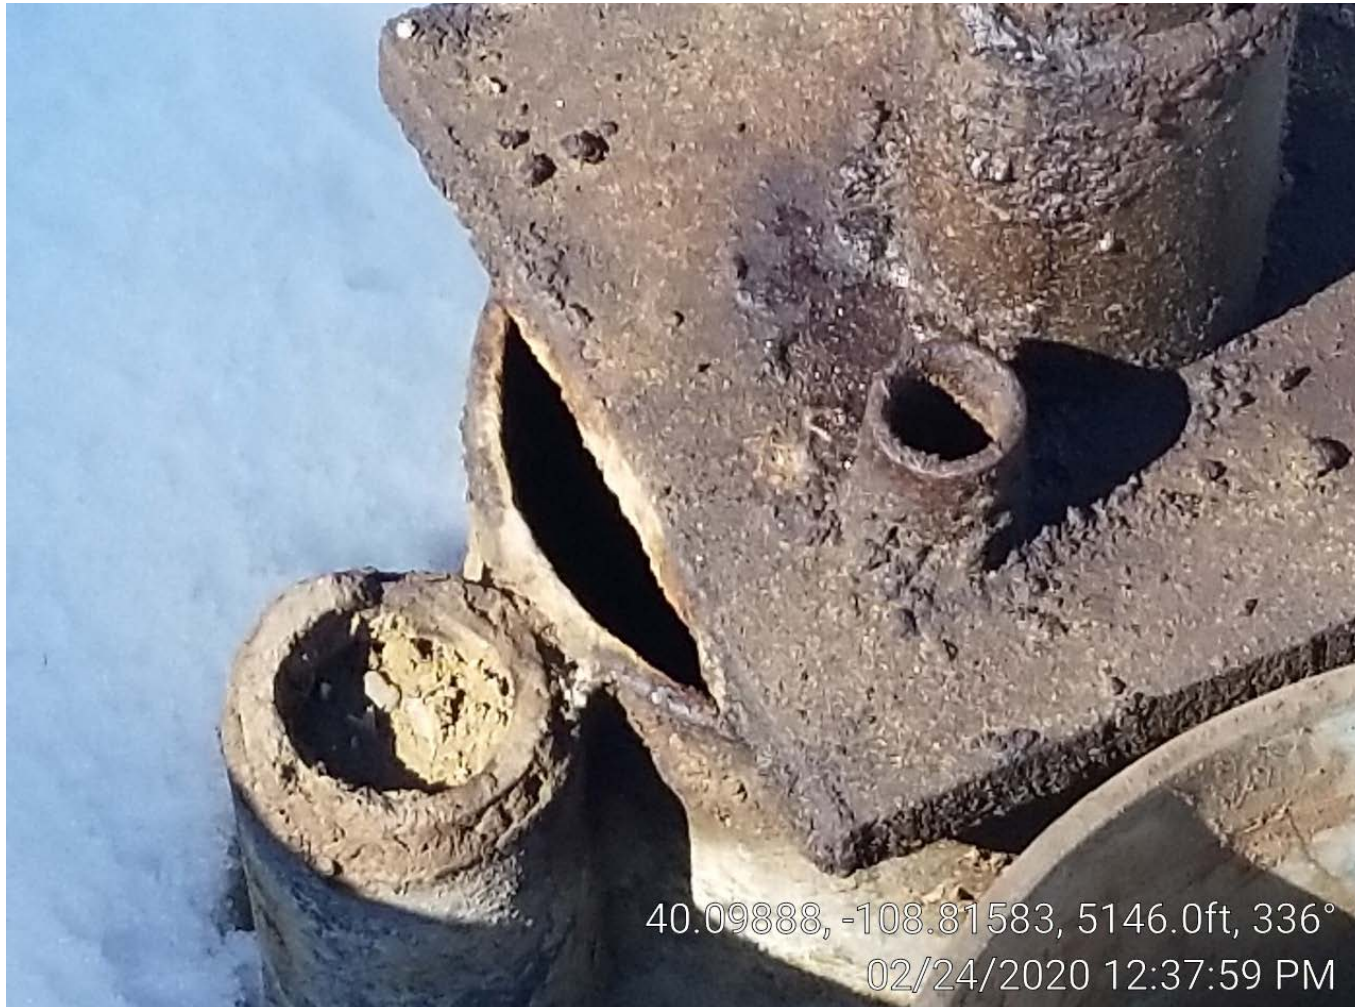
Photo 7. Casing open to atmosphere well Stagner 6.

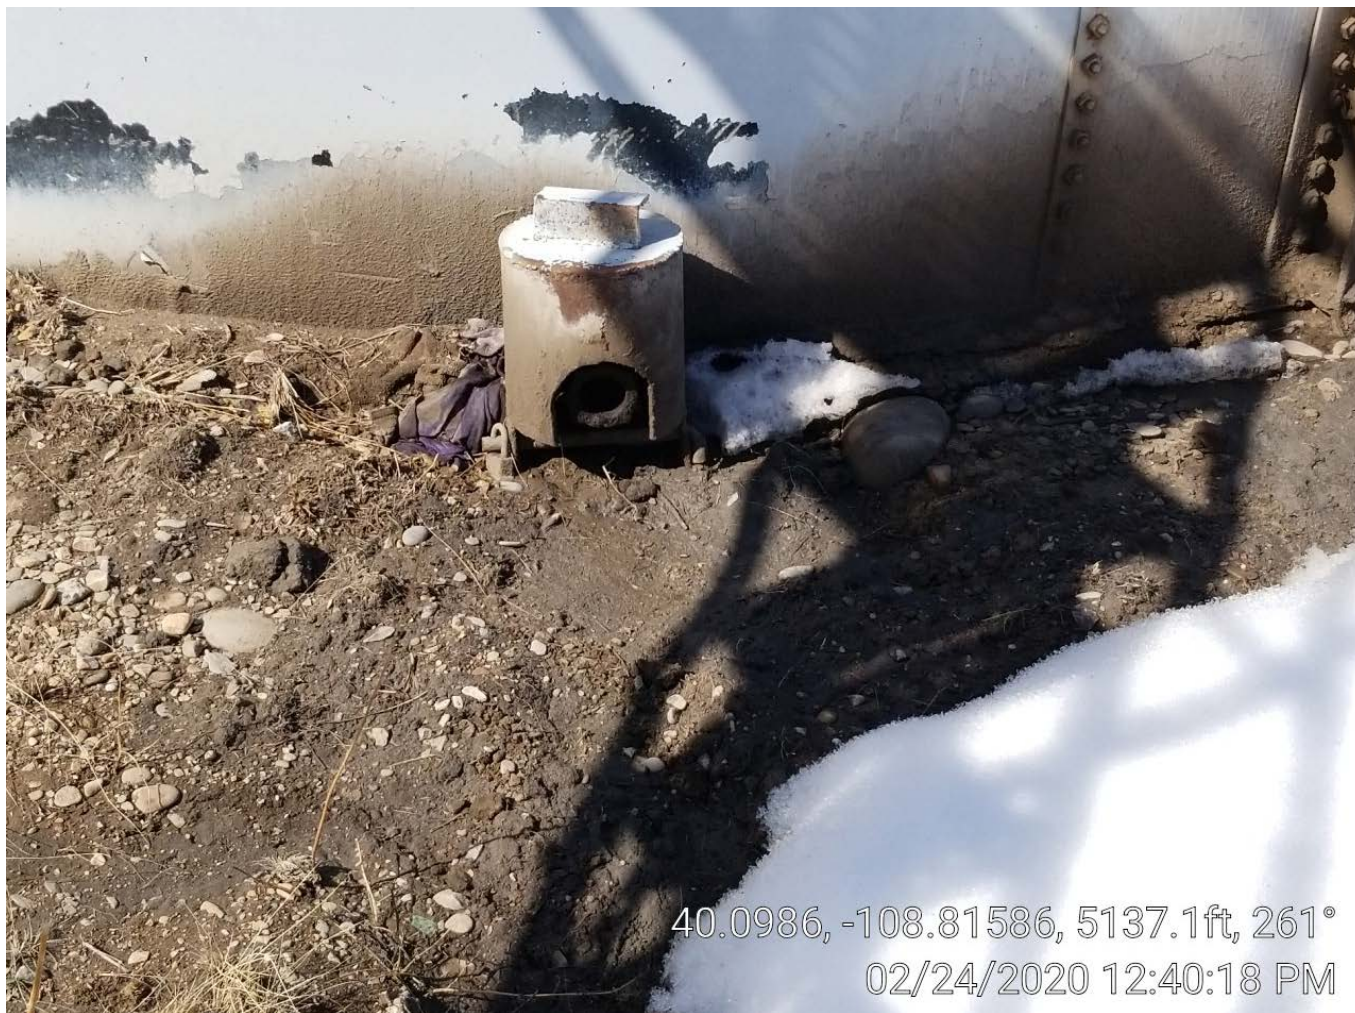
Photo 9. Stained soil next to tank.

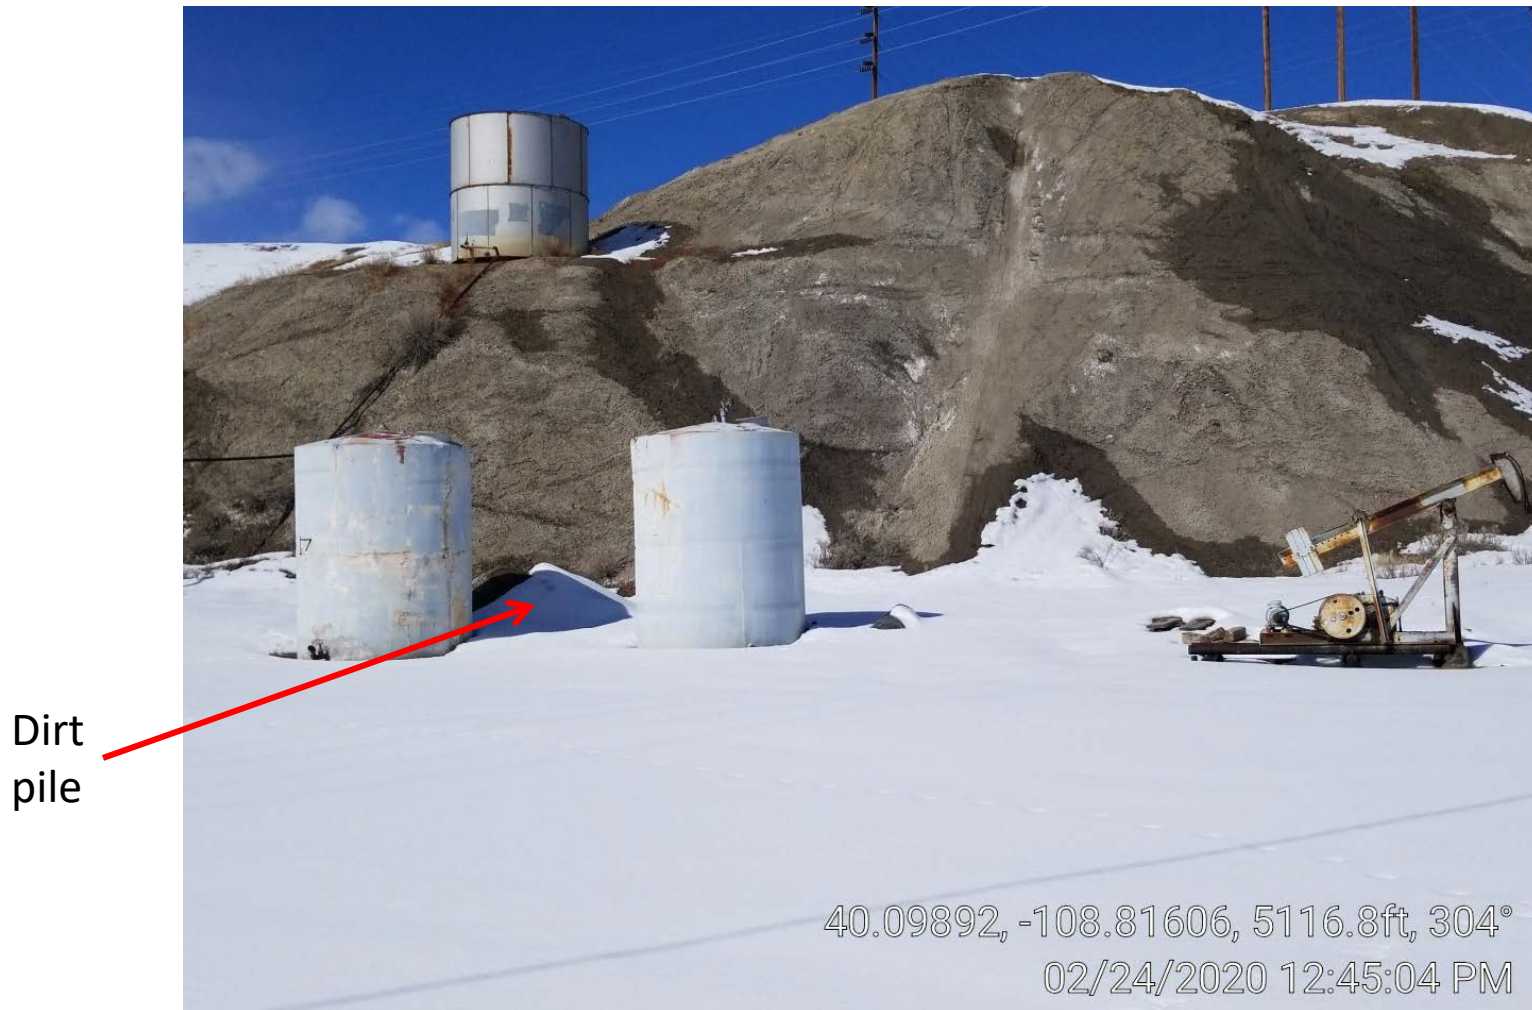
Photo 10. Unused equipment. Unknown if silver tank on hill is associated with this location.
