Inspection Photos

API: 055-06157

Operator: PETROGLYPH OPERATING

Inspection Date: 2/27/2020

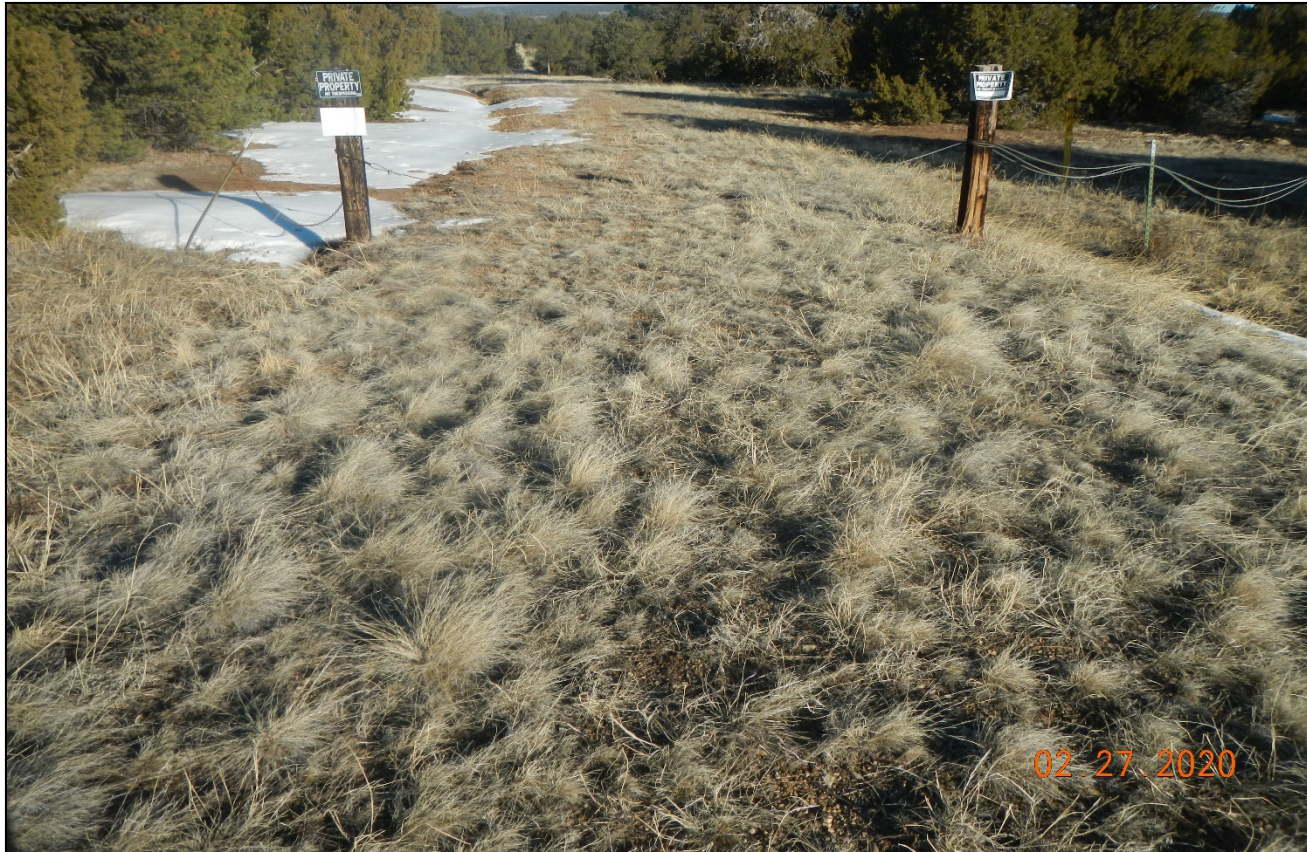
Photo 1. Facing northwest at the beginning of the access road.

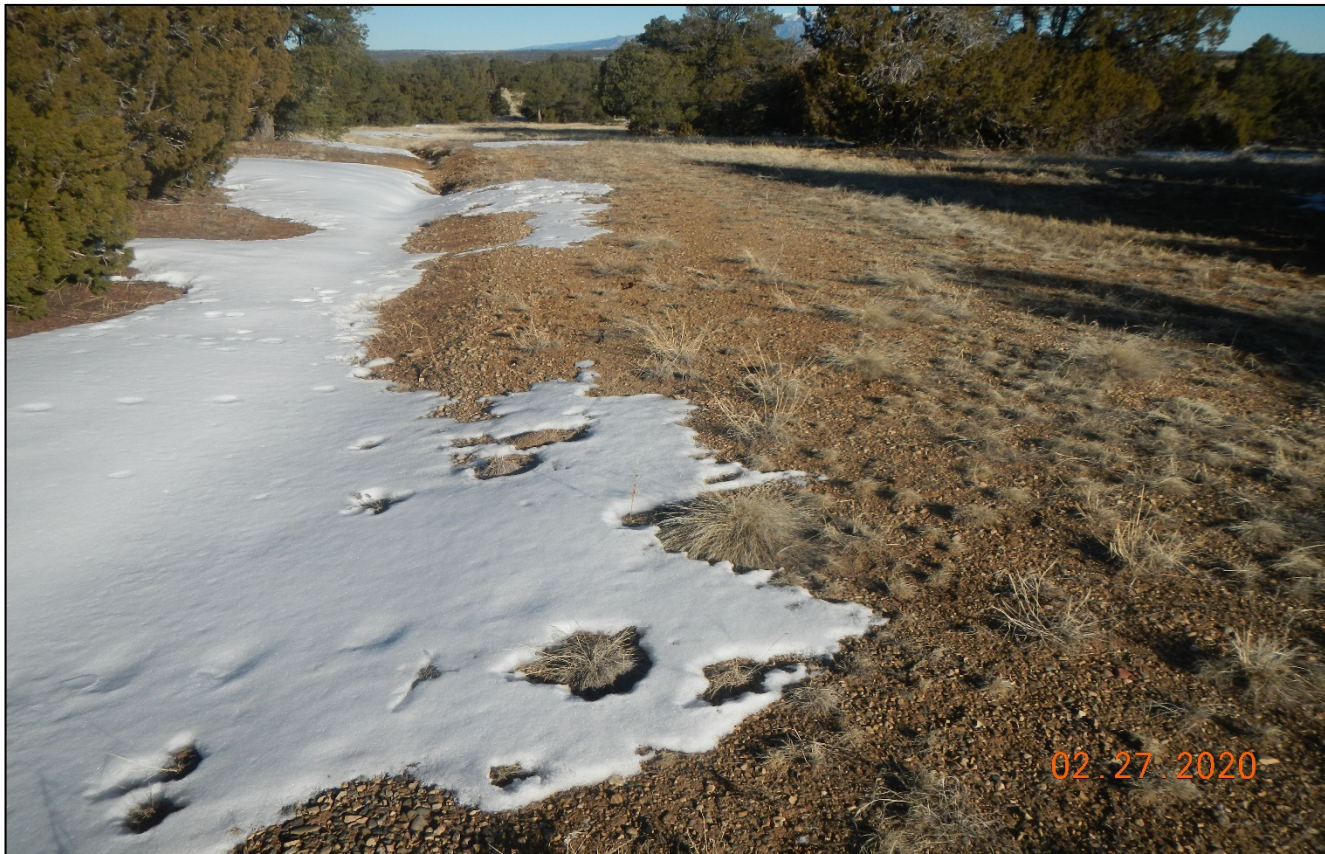
Photo 2. Northwest along the access road. This area is sparse of vegetation. This area may need decompaction and leveling to fill in erosion shown in the next photo.

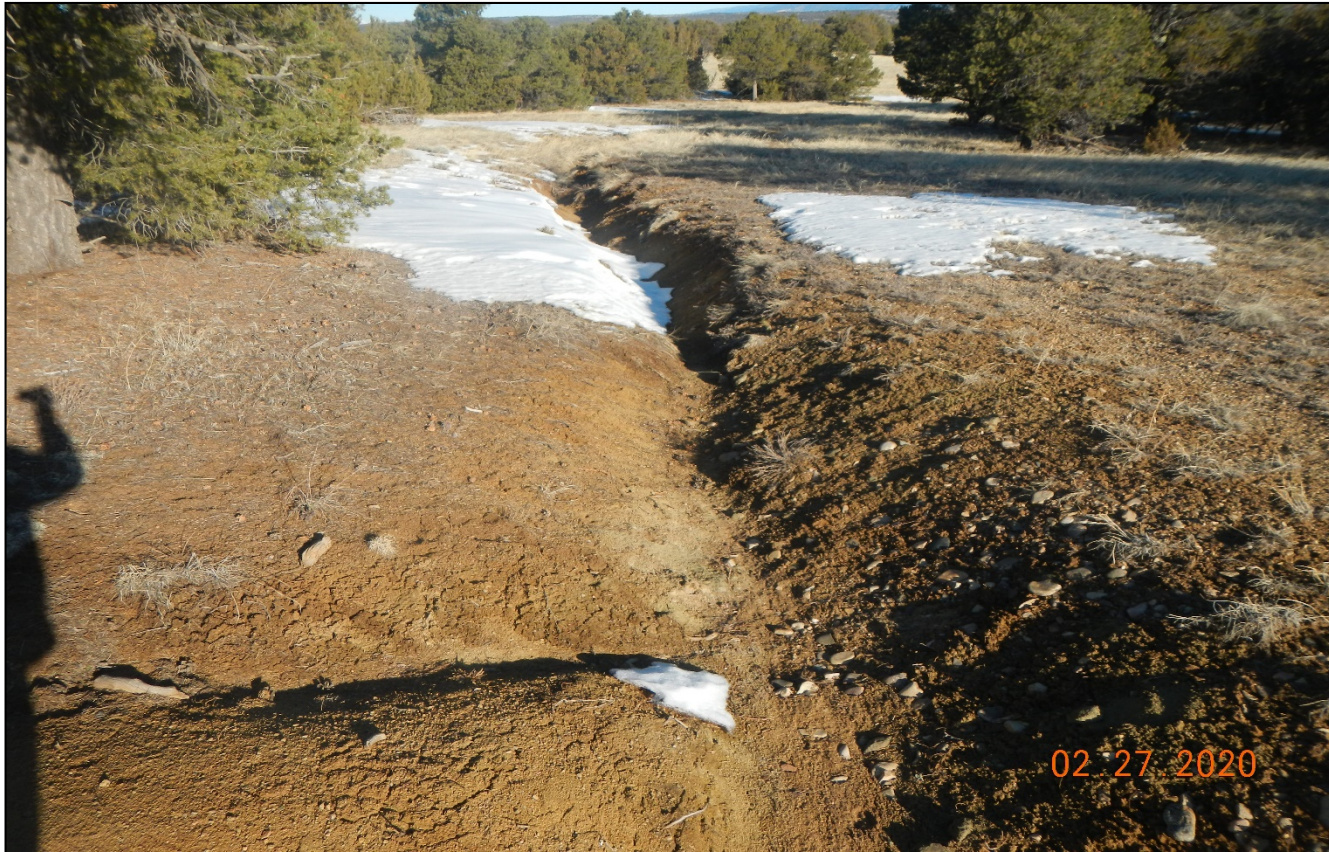
Photo 3. This erosion channel along the access road needs to be repaired and stabilized with vegetation. This channel needs to be filled in and reclaimed.

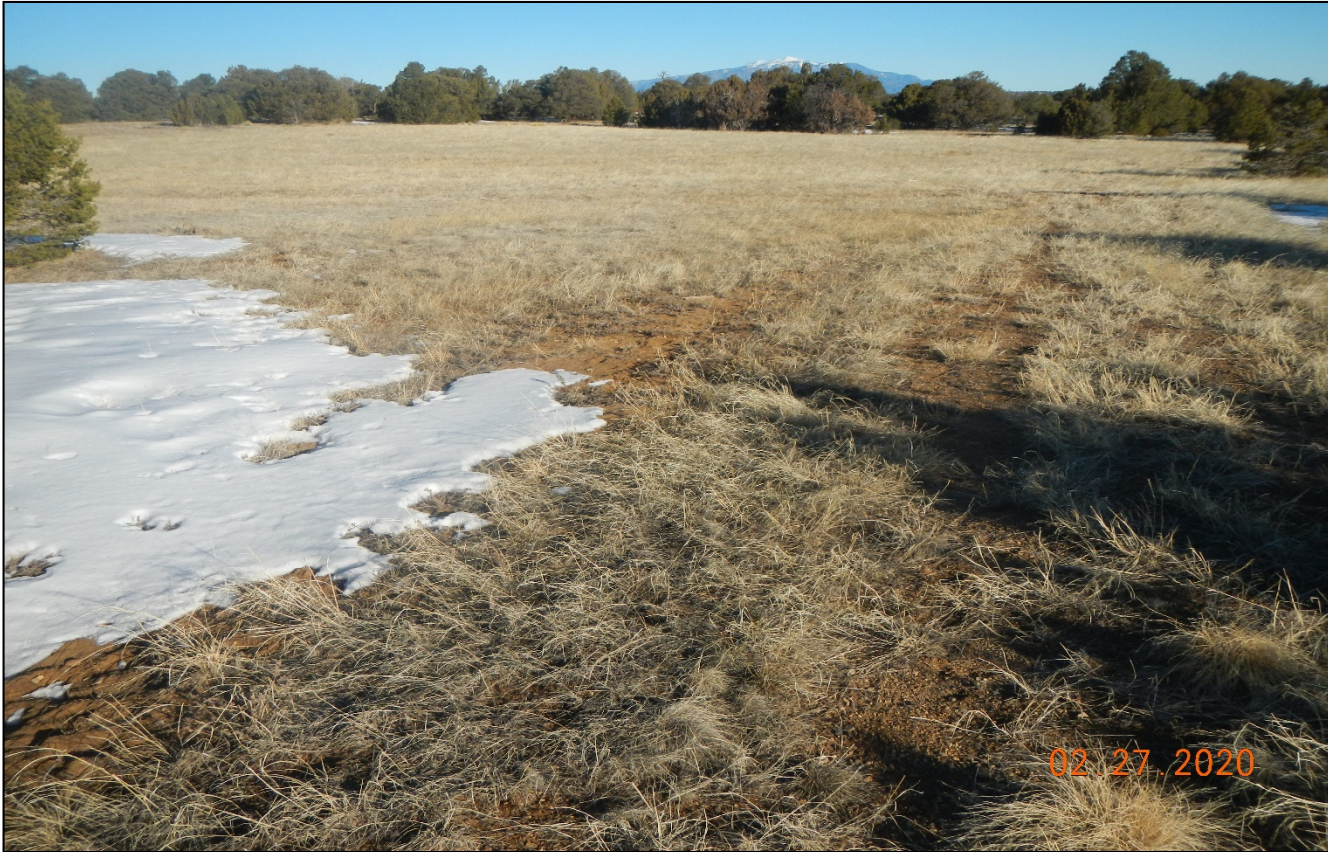
Photo 4. Facing north toward the location. Vegetation appears to be fully established at the location.

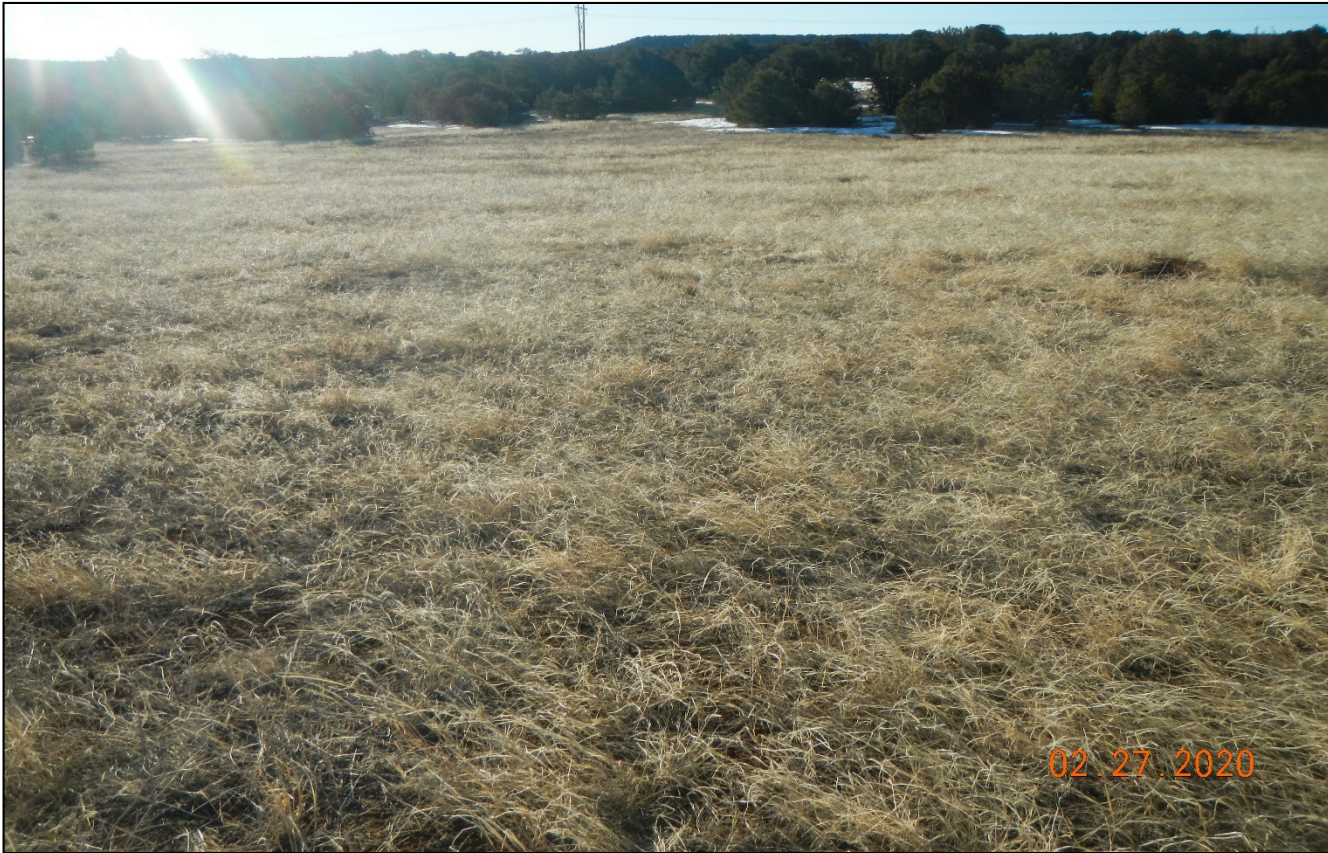
Photo 5. Facing south at the location. Vegetation appears to be fully established at the location.

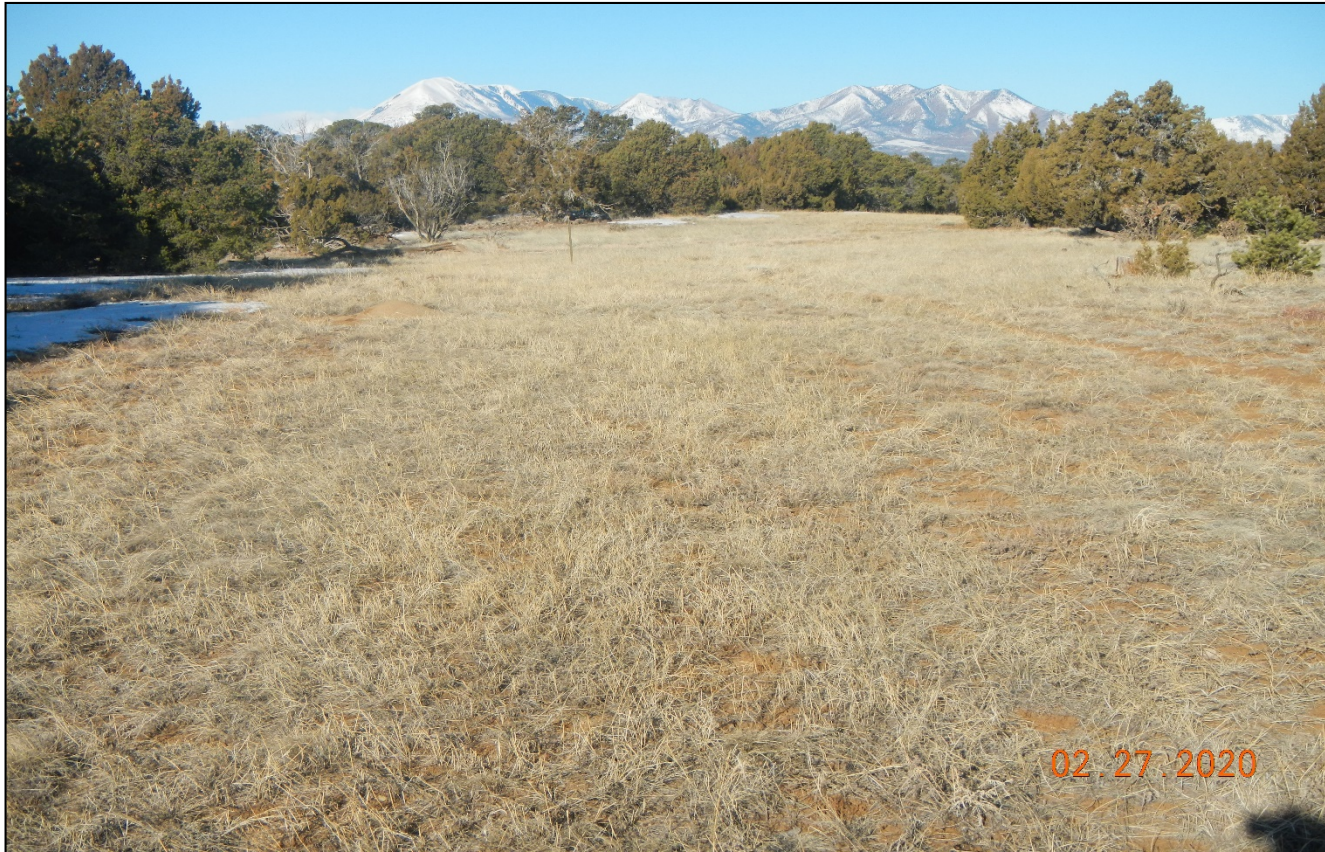
Photo 6. The disturbance area which heads northwest appears to be revegetated. This area was not fully inspected further.

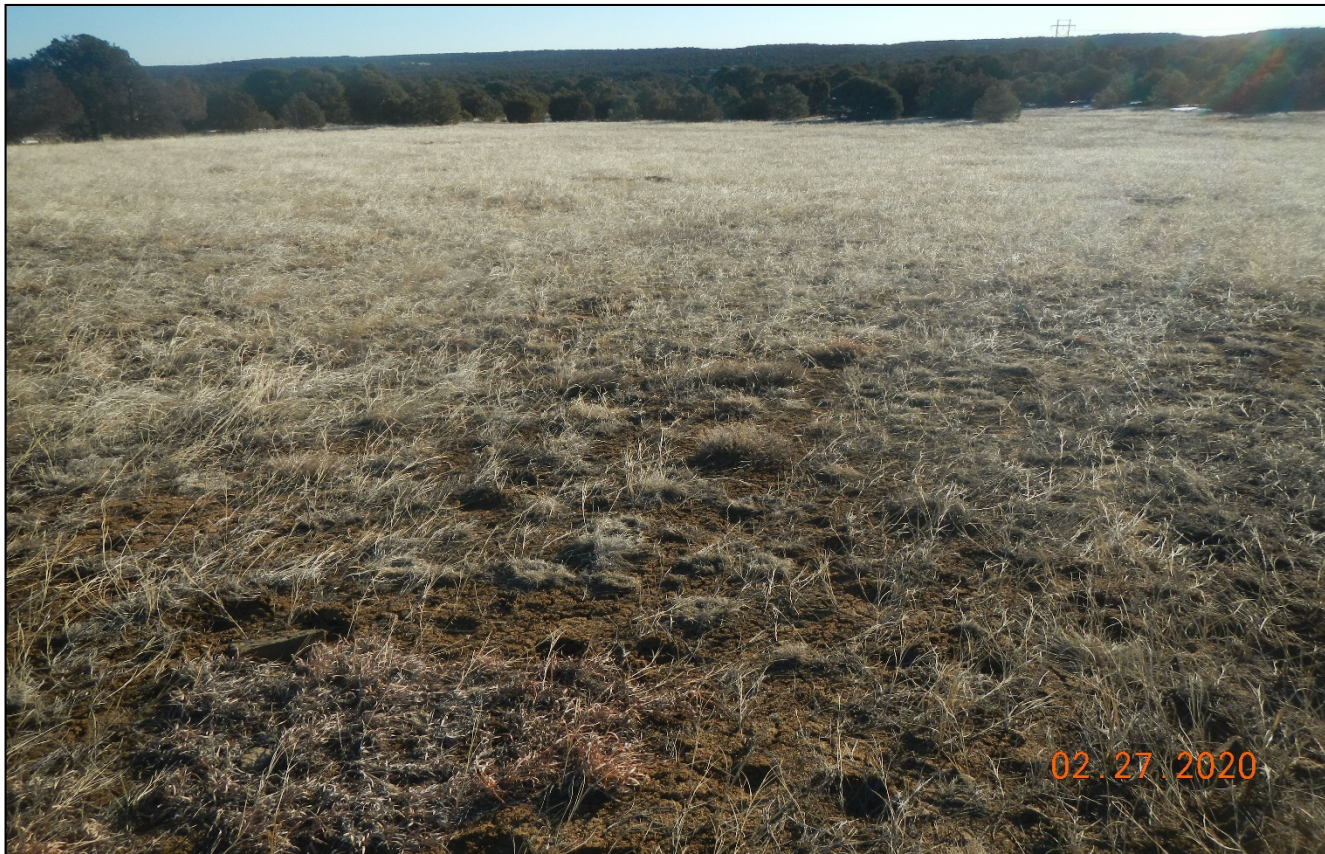
Photo 7. Facing east toward the location.
