Inspection Photos

API: 055-06221

Operator: PETROGLYPH OPERATING

Inspection Date: 2/27/2020

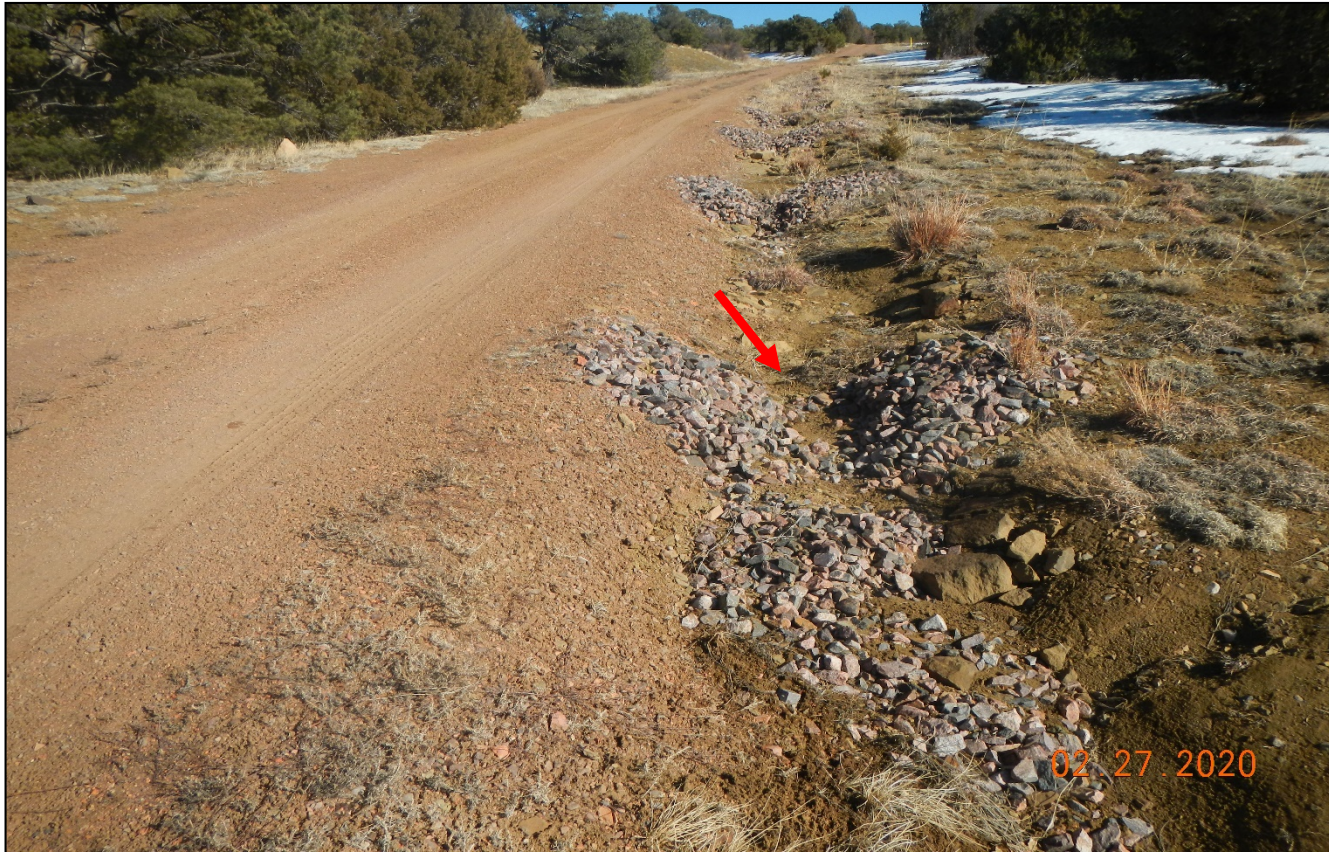
Photo 1. Facing southeast along the access road. Rock check dams were installed along the side of the road but have since failed. The rock has been displaced as shown by arrow.

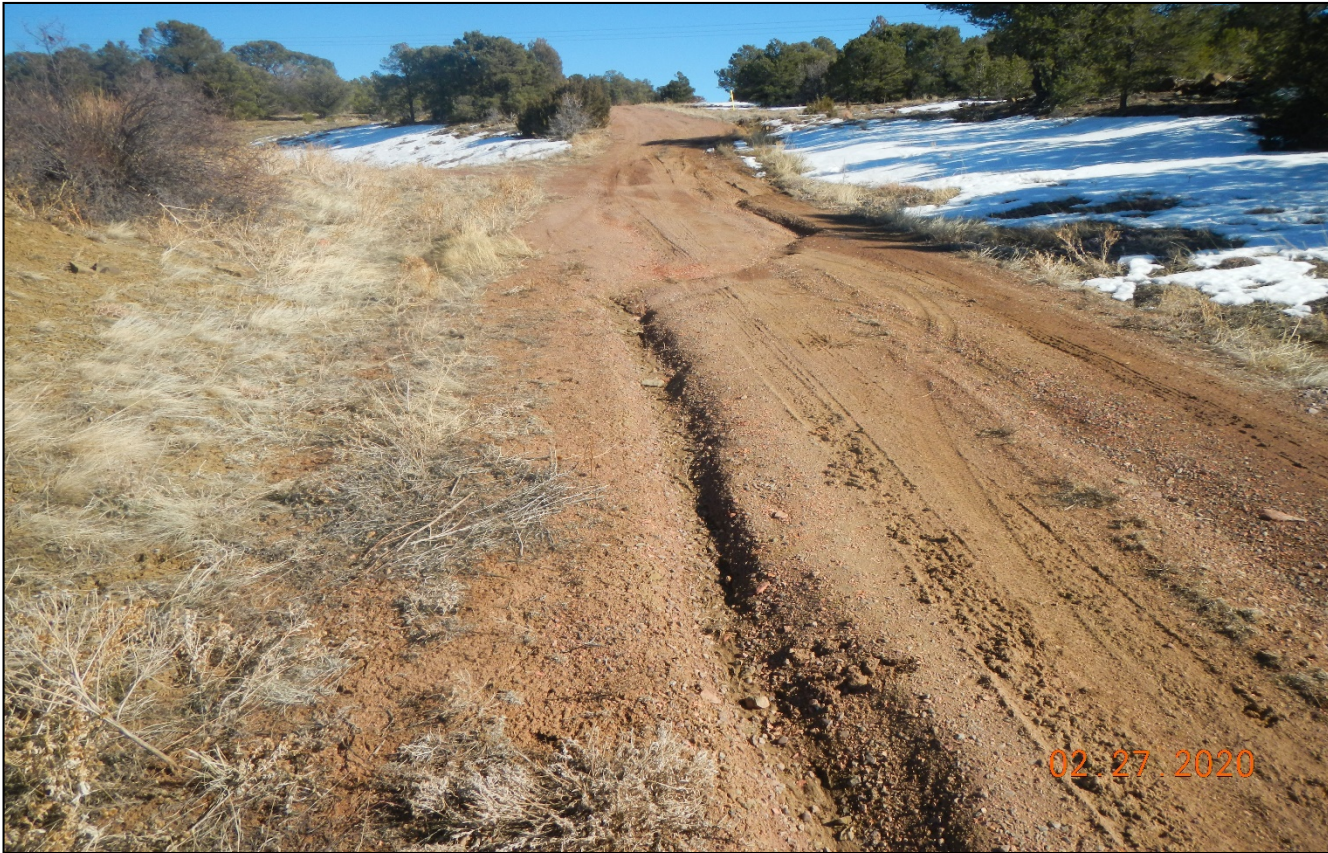
Photo 2. Stormwater is flowing down the road causing erosion near the State 7W location.

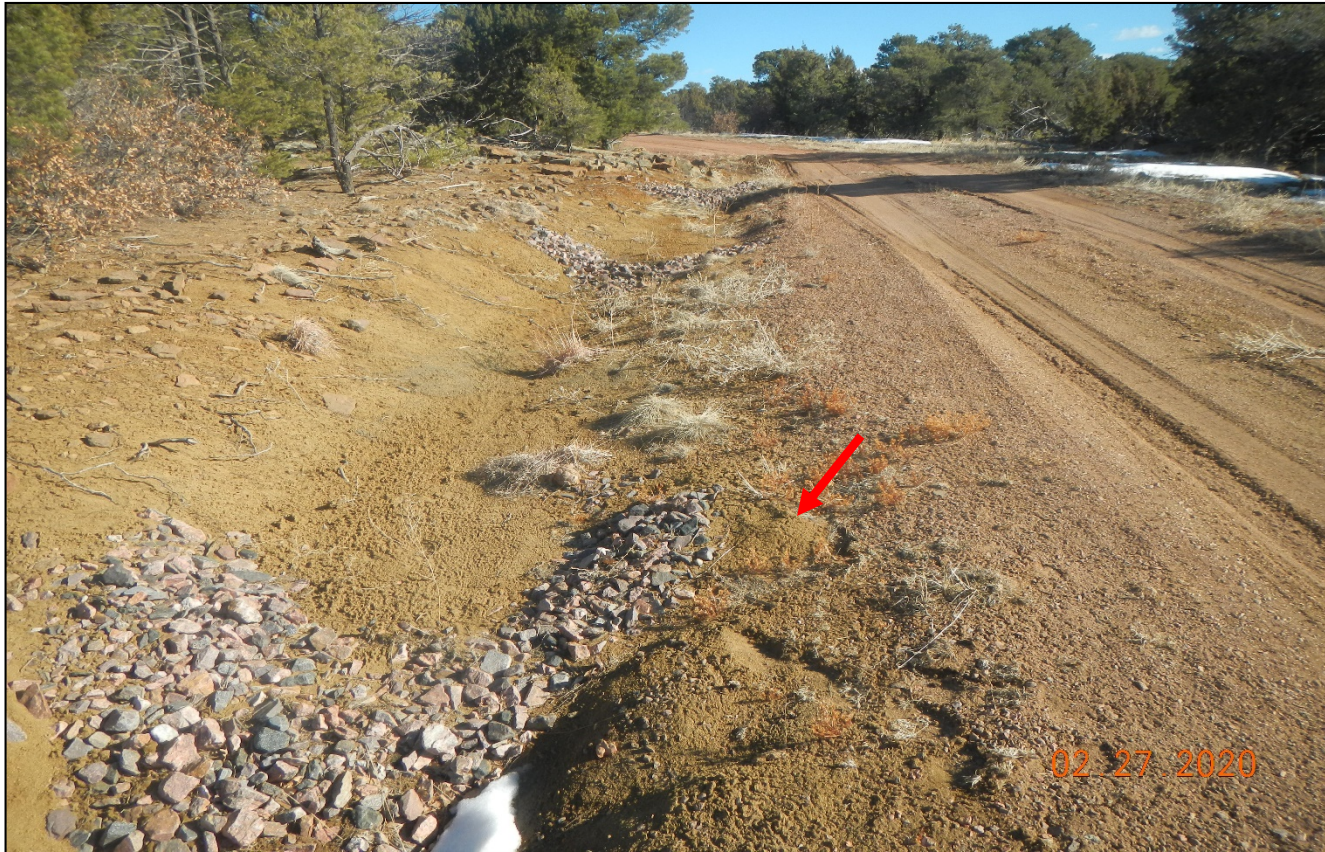
Photo 3. The check dams have filled in with sediment and are starting to erode around the check dam shown by arrow. The side of road should be seeded and stabilized.

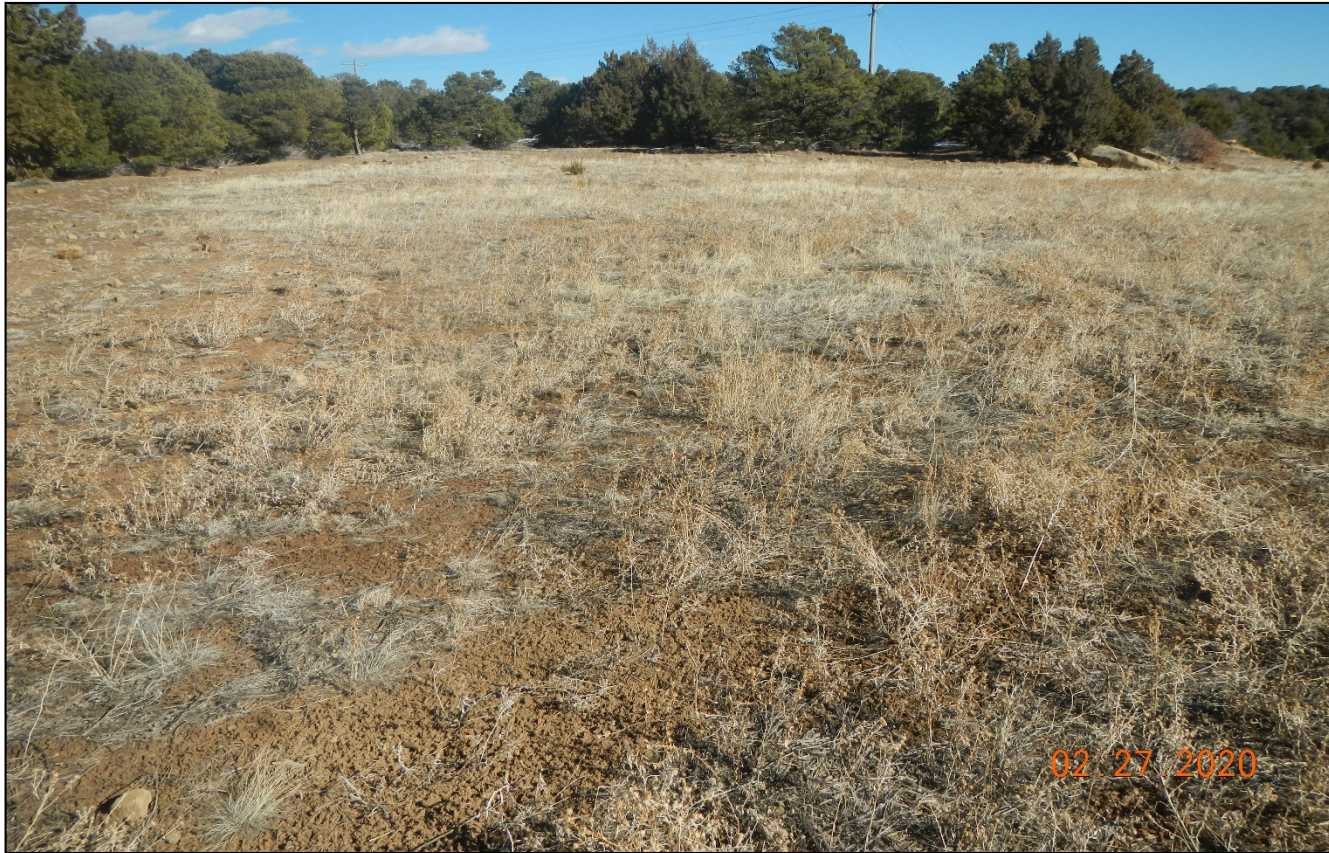
Photo 4. Facing east toward the location. Vegetation appears to be establishing well.

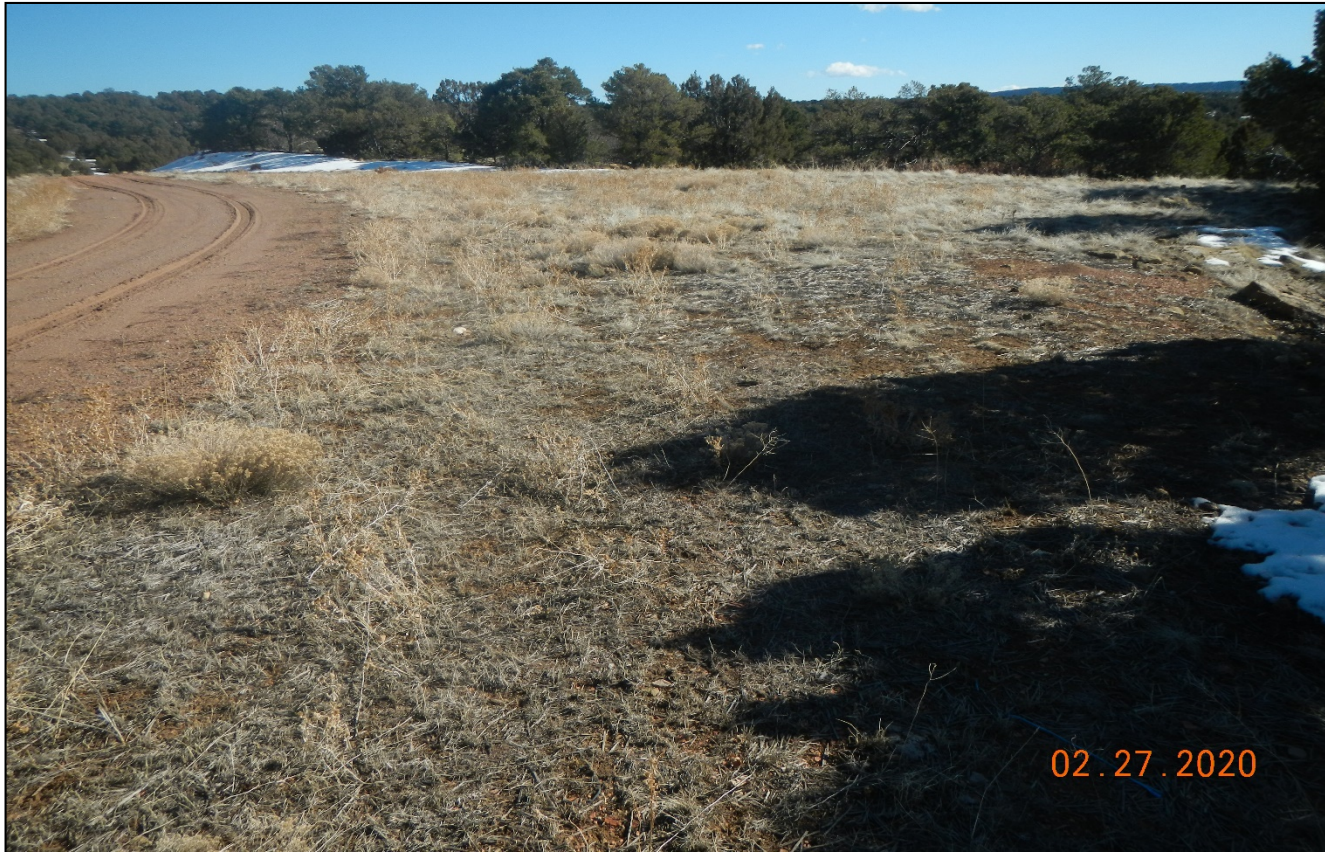
Photo 5. Facing southeast at the location. Vegetation appears to be establishing well.

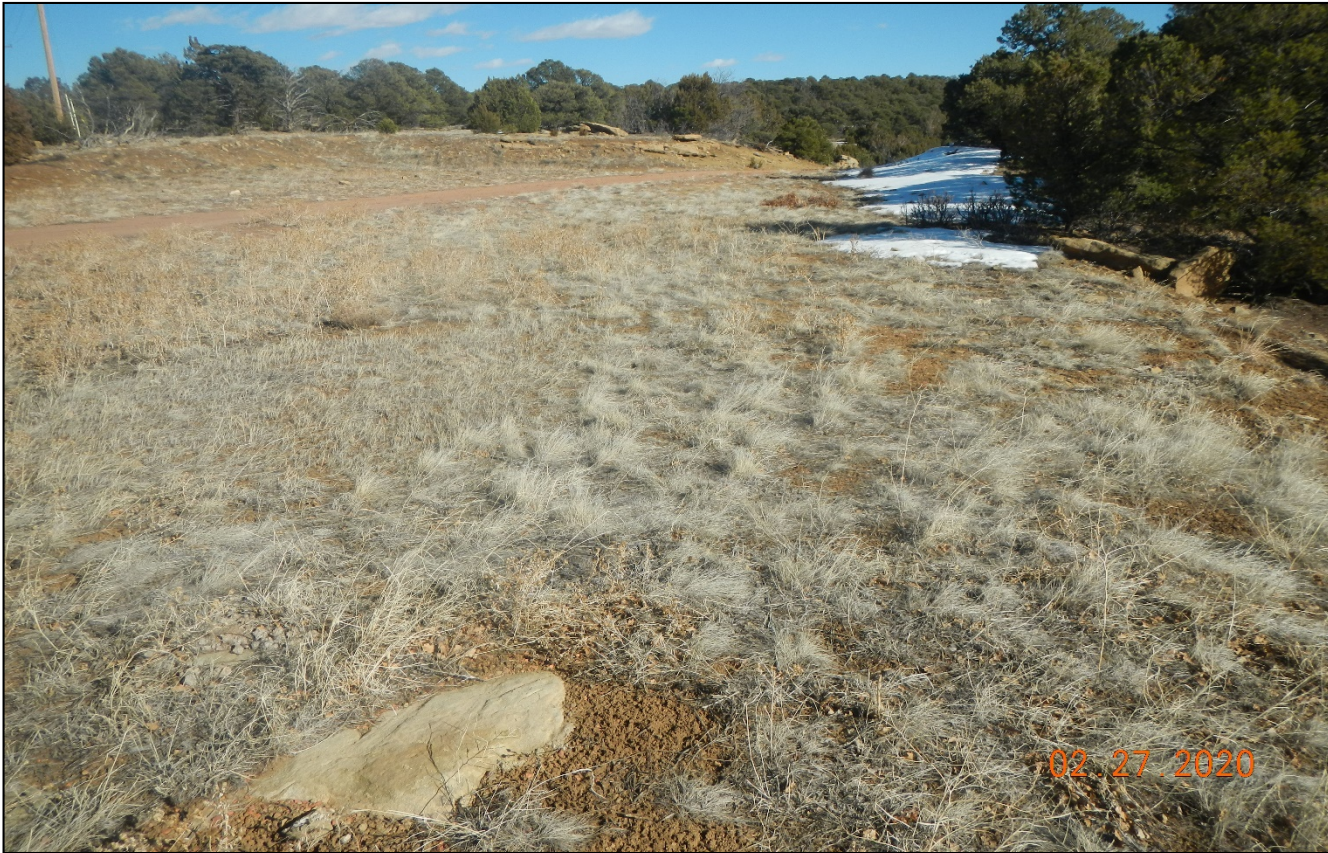
Photo 6. Facing east at the south side of the location.

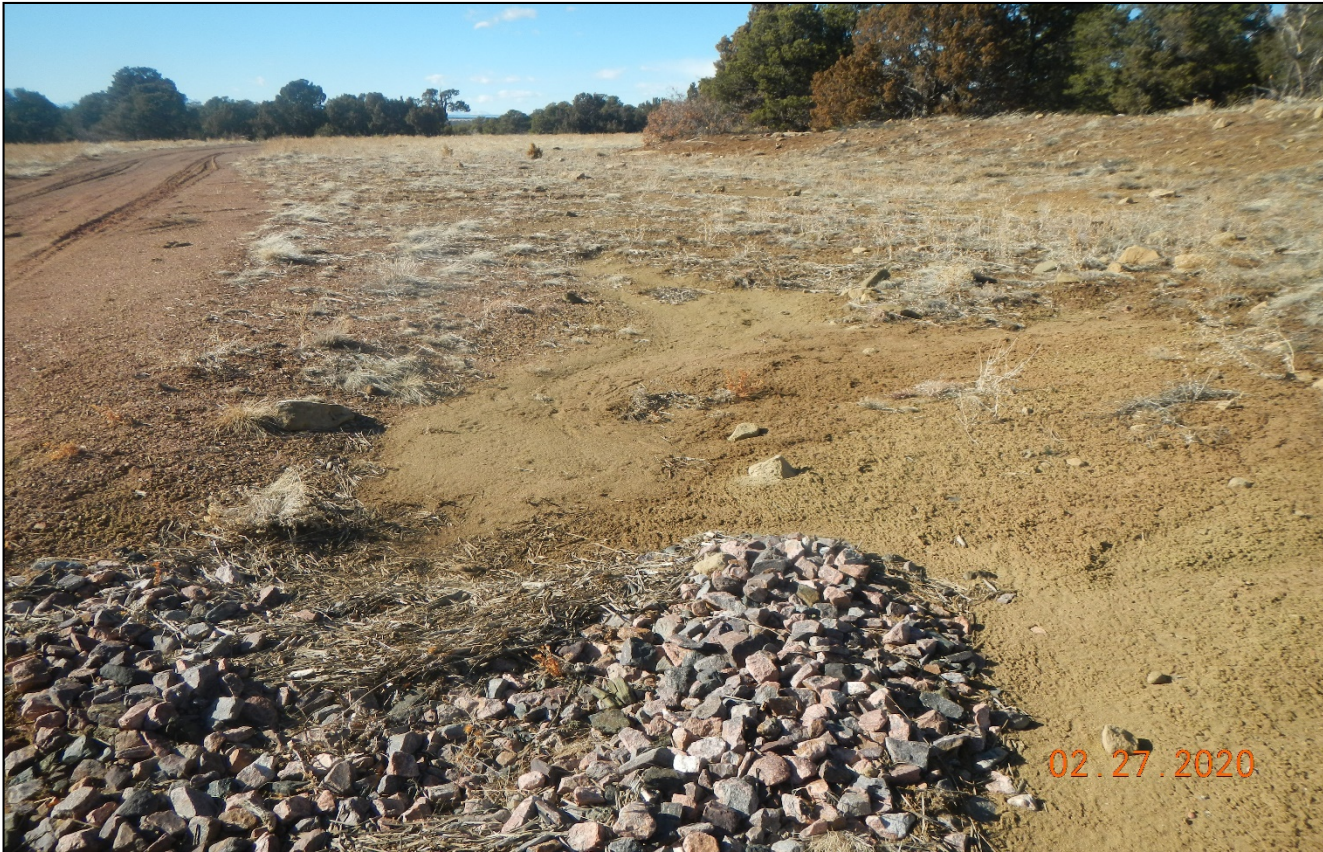
Photo 7. Facing northwest at the south side of the location.

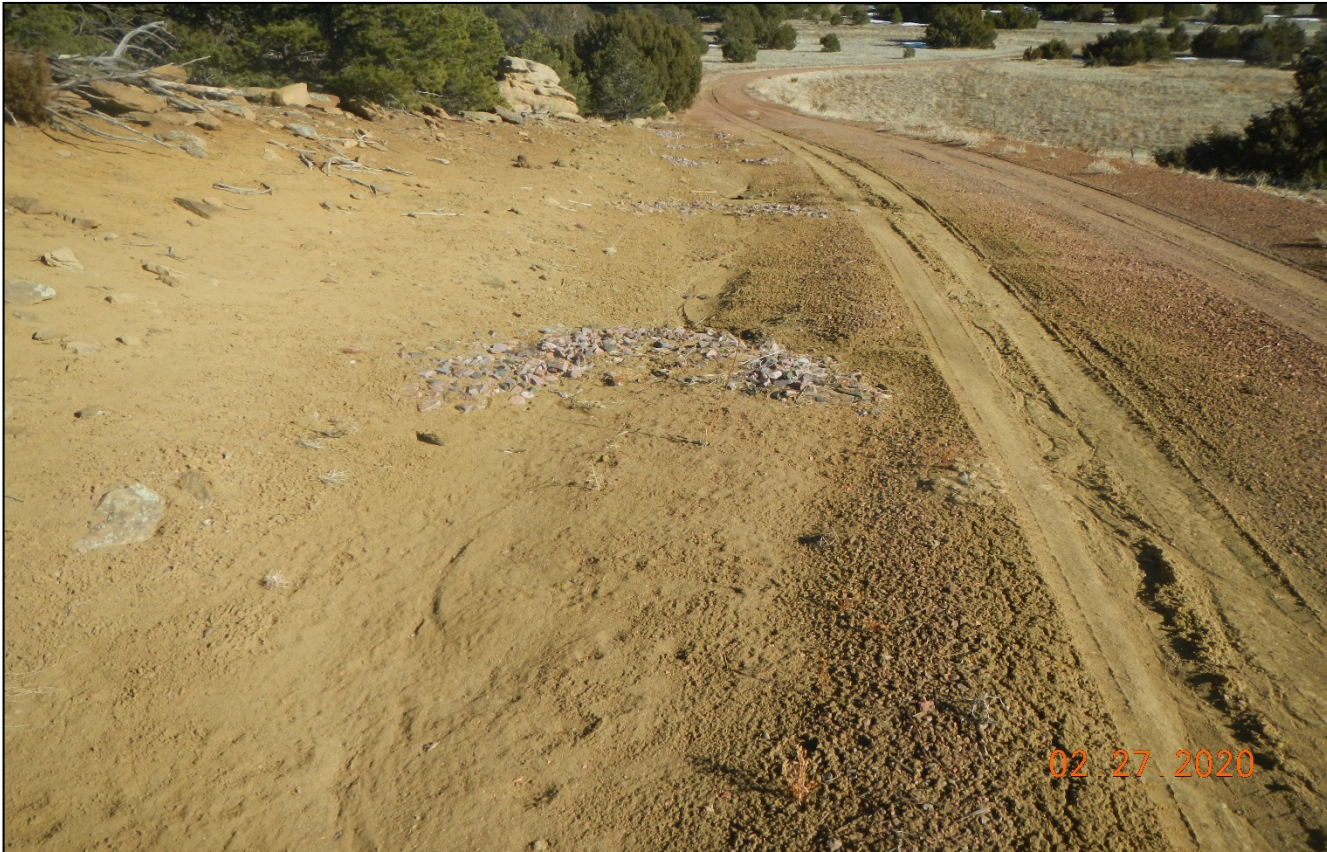
Photo 8. Facing southeast at the south side of the location. The access road continues toward the State 10WB. This check damn has filled in with sediment. The side of road should be seeded and stabilized.

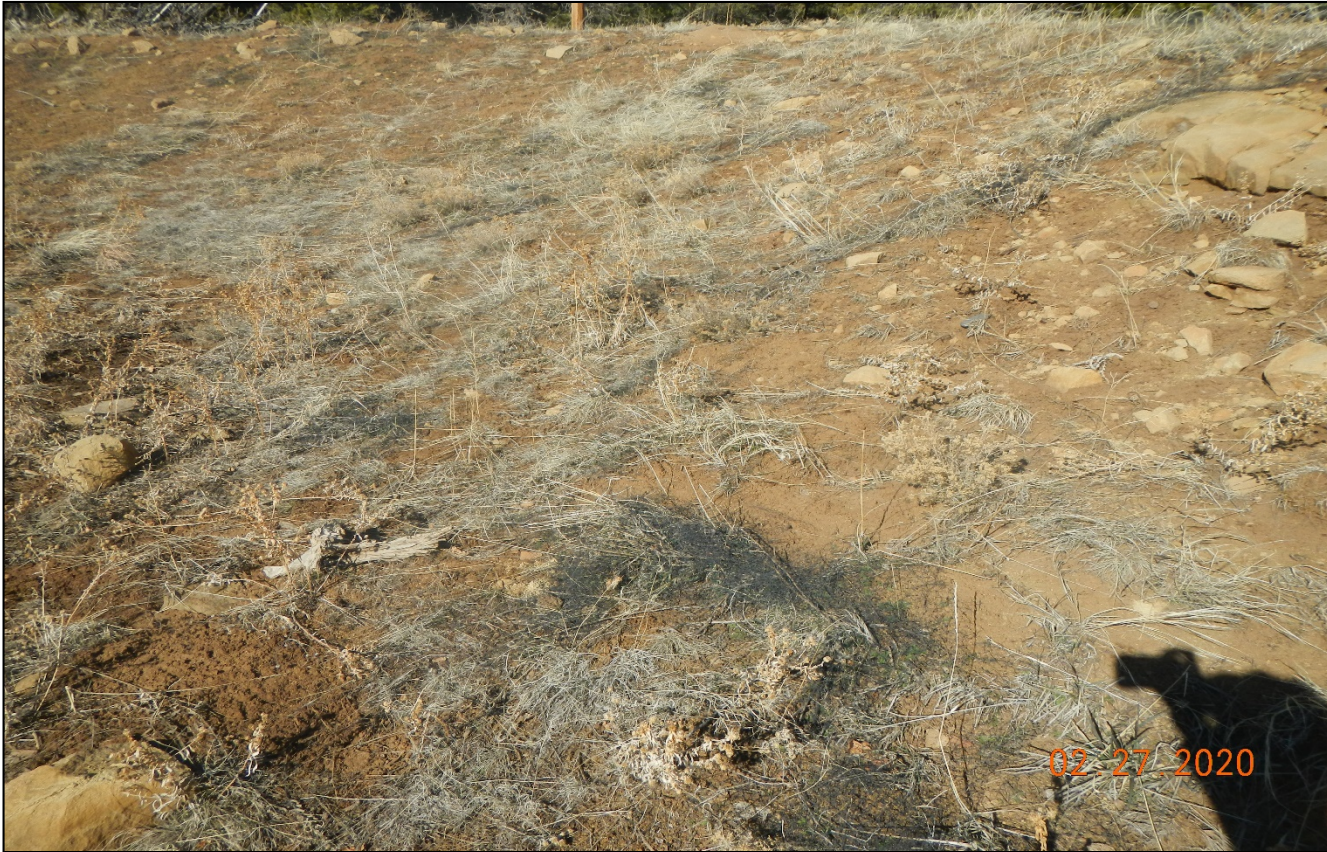
Photo 9. There is plastic netting debris along the southeast cut slope that should be removed.
