Inspection Photos

API: 055-06214

Operator: PETROGLYPH OPERATING

Inspection Date: 2/27/2020

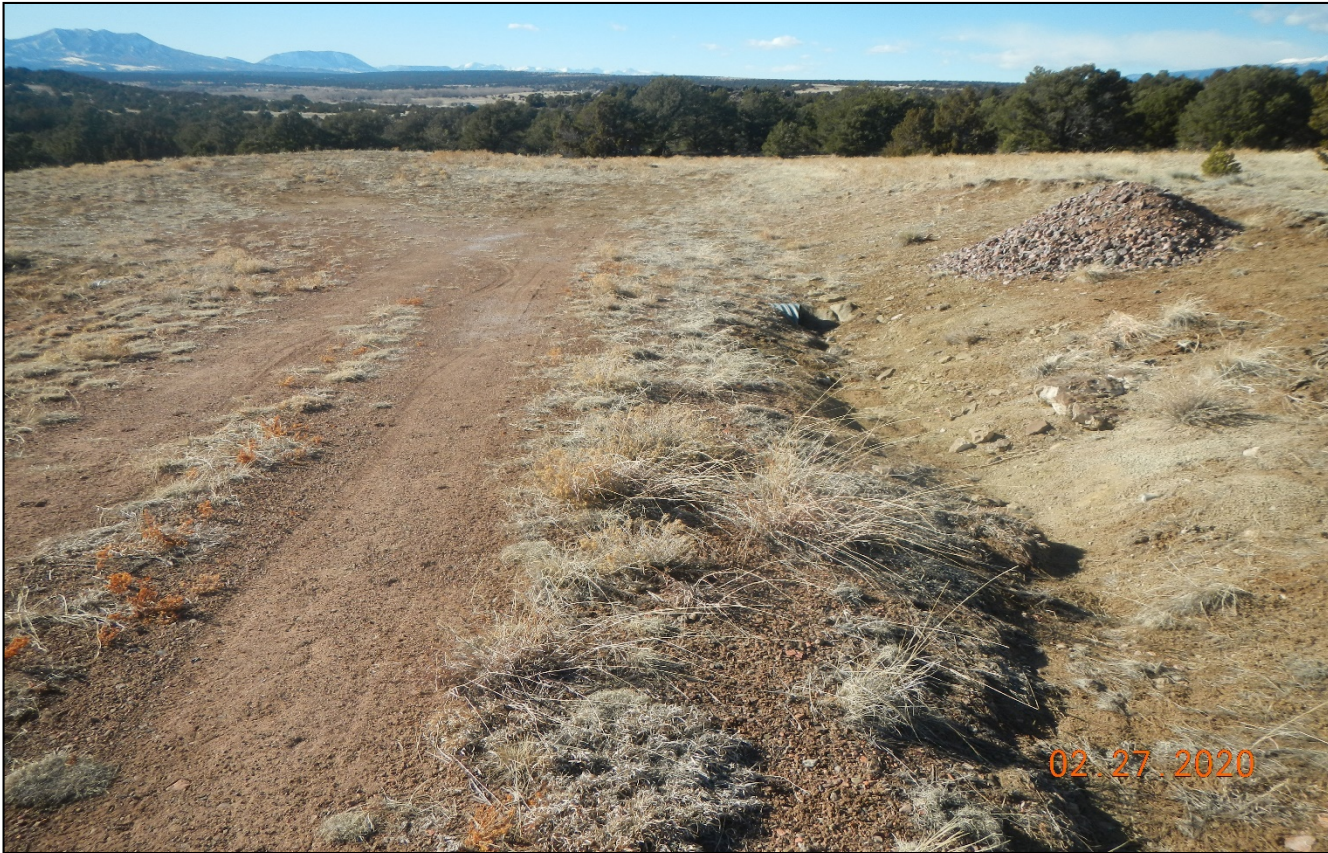
Photo 1. Facing northwest toward the location.

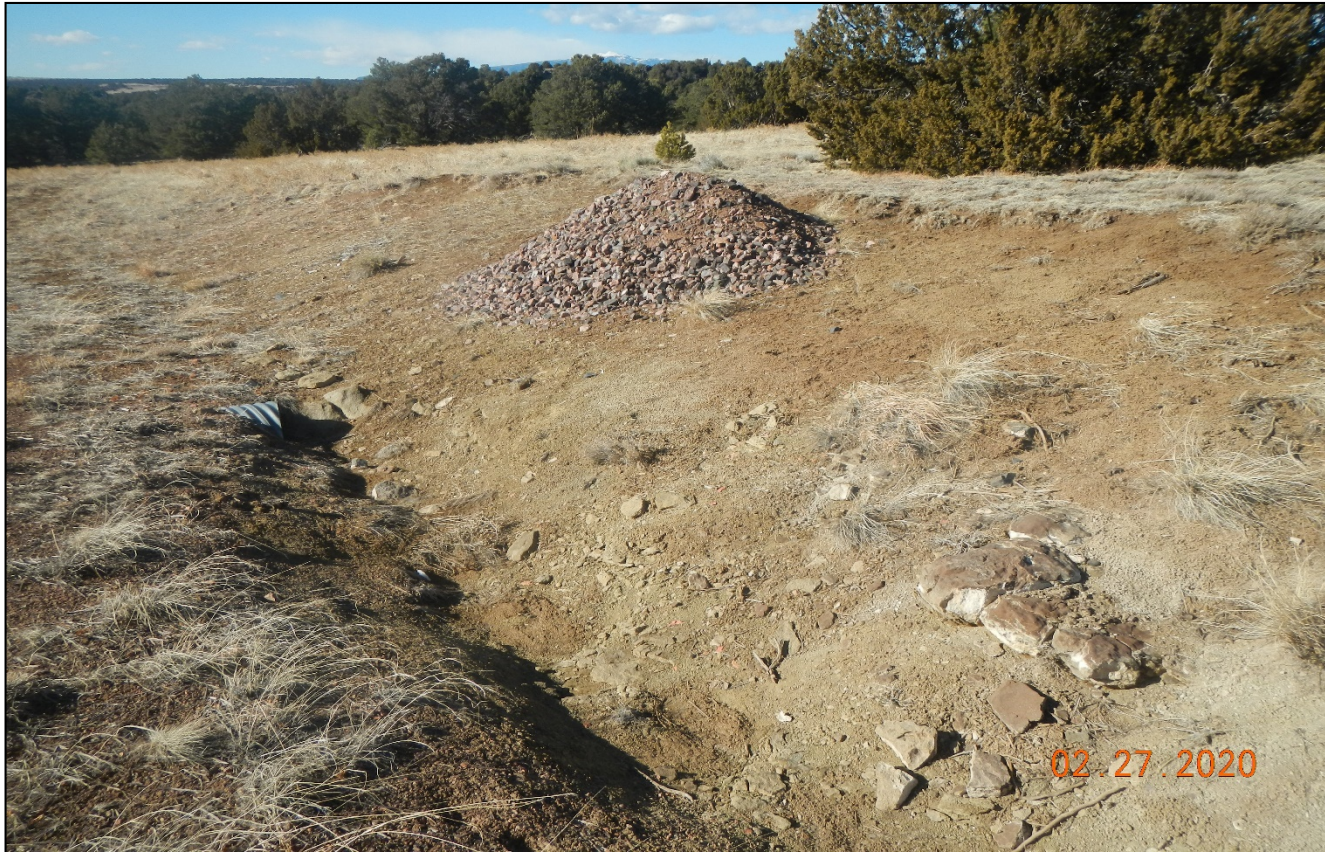
Photo 2. This cut slope area near the culvert does not have adequate vegetation establishment. There is a pile of rock left at the slope.

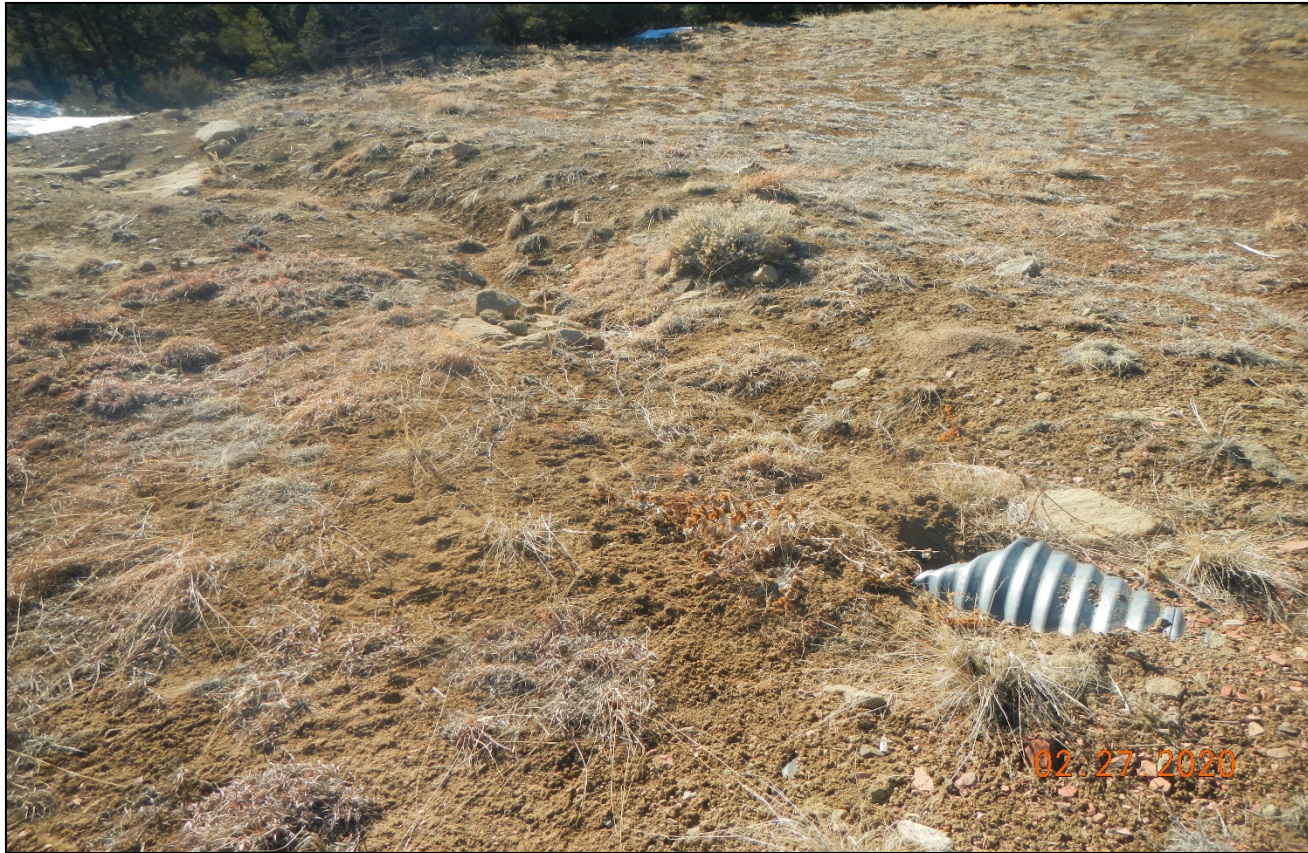
Photo 3. The outlet culvert has filled in with sediment. A sediment trap may be need at culvert outlet.

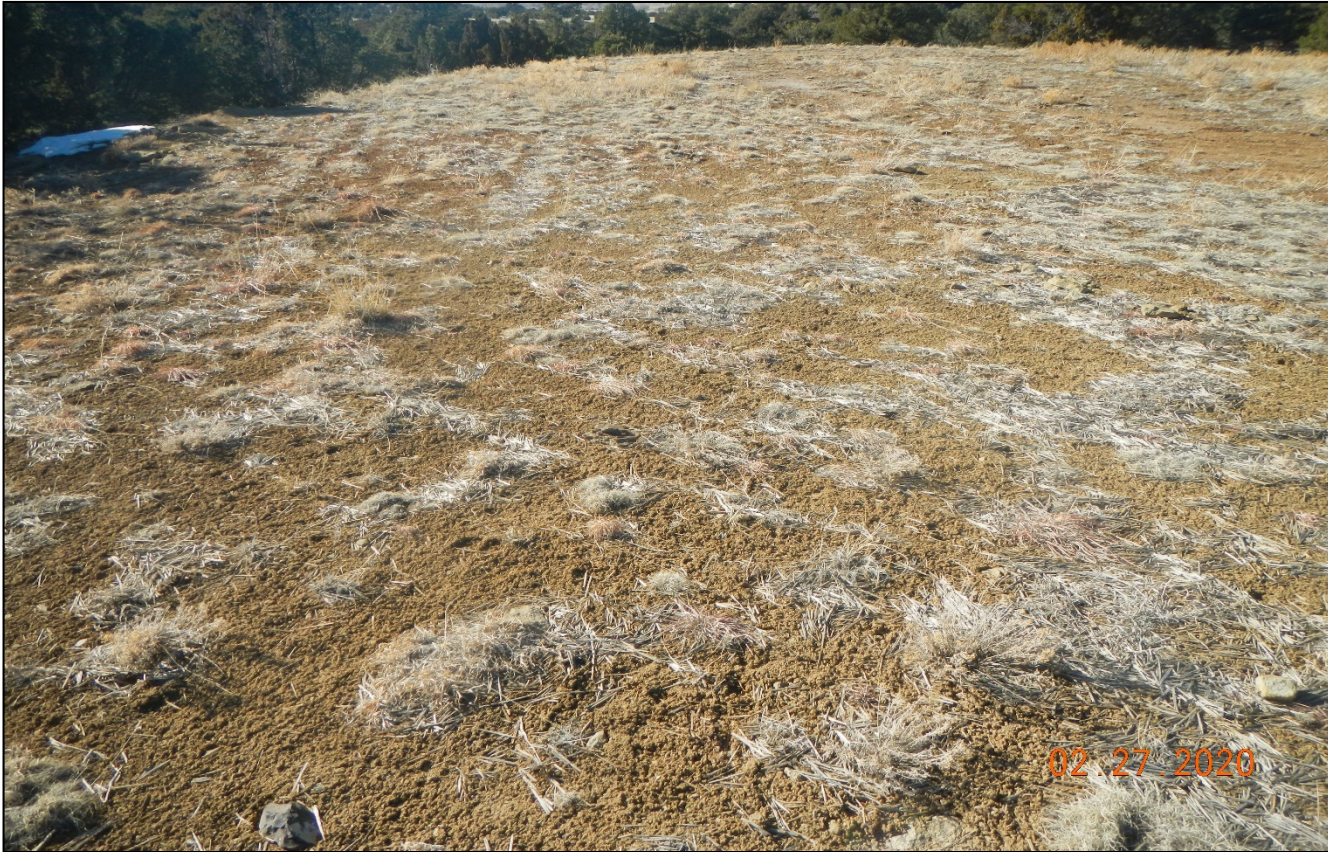
Photo 4. West side of location. Vegetation appears to be progressing but has not fully established.

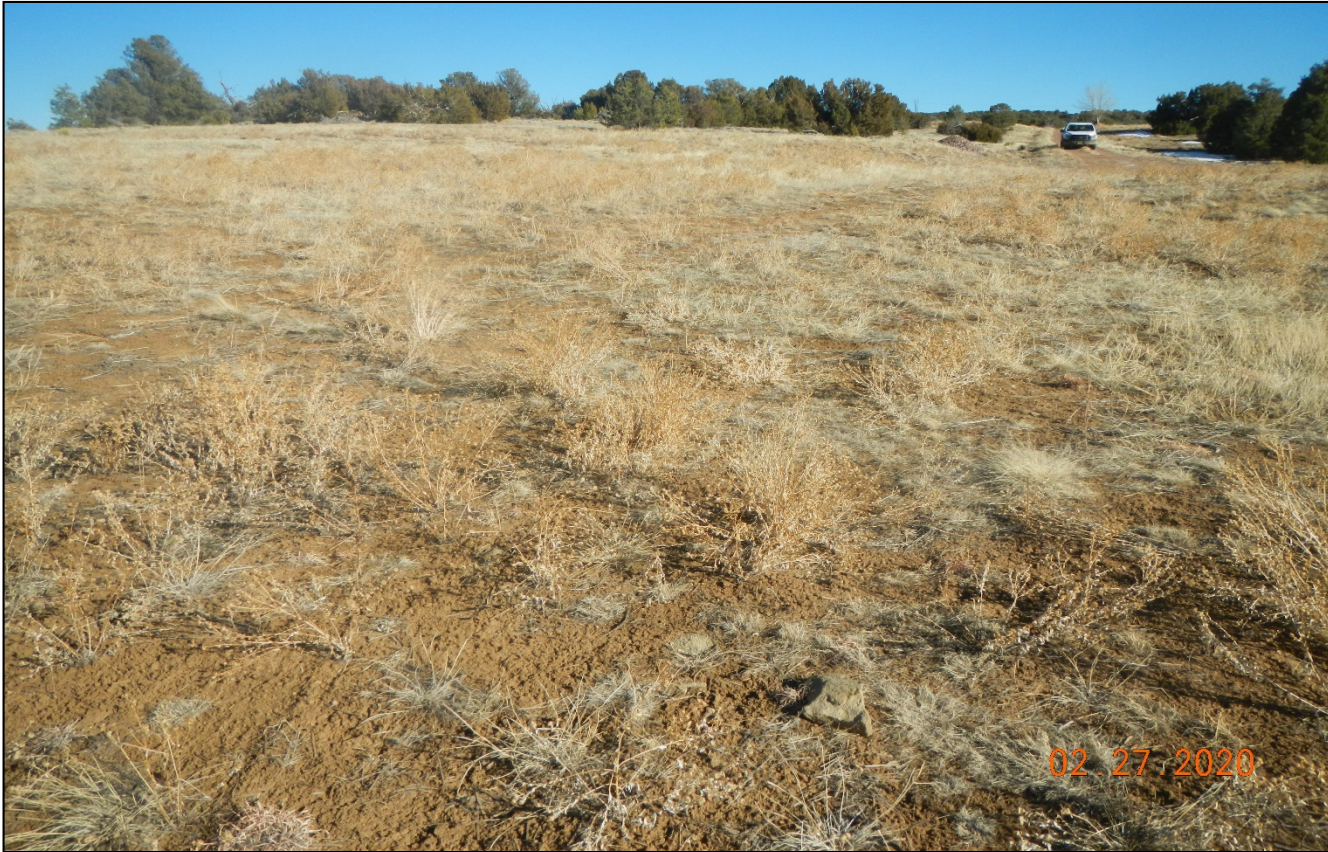
Photo 5. North side of the location facing southeast. Vegetation appears to be progressing.

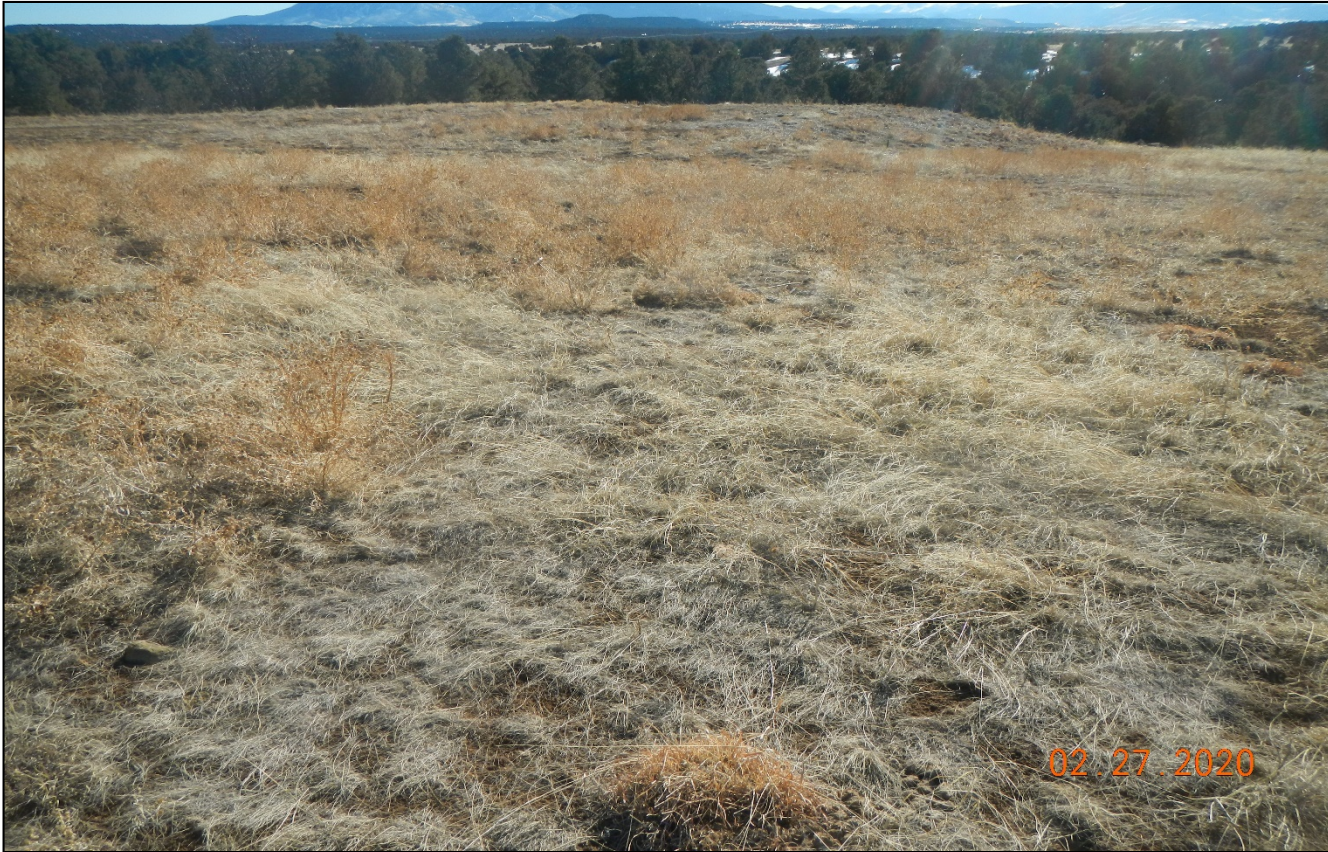
Photo 6. North side of the location facing southwest. Vegetation appears to be progressing.

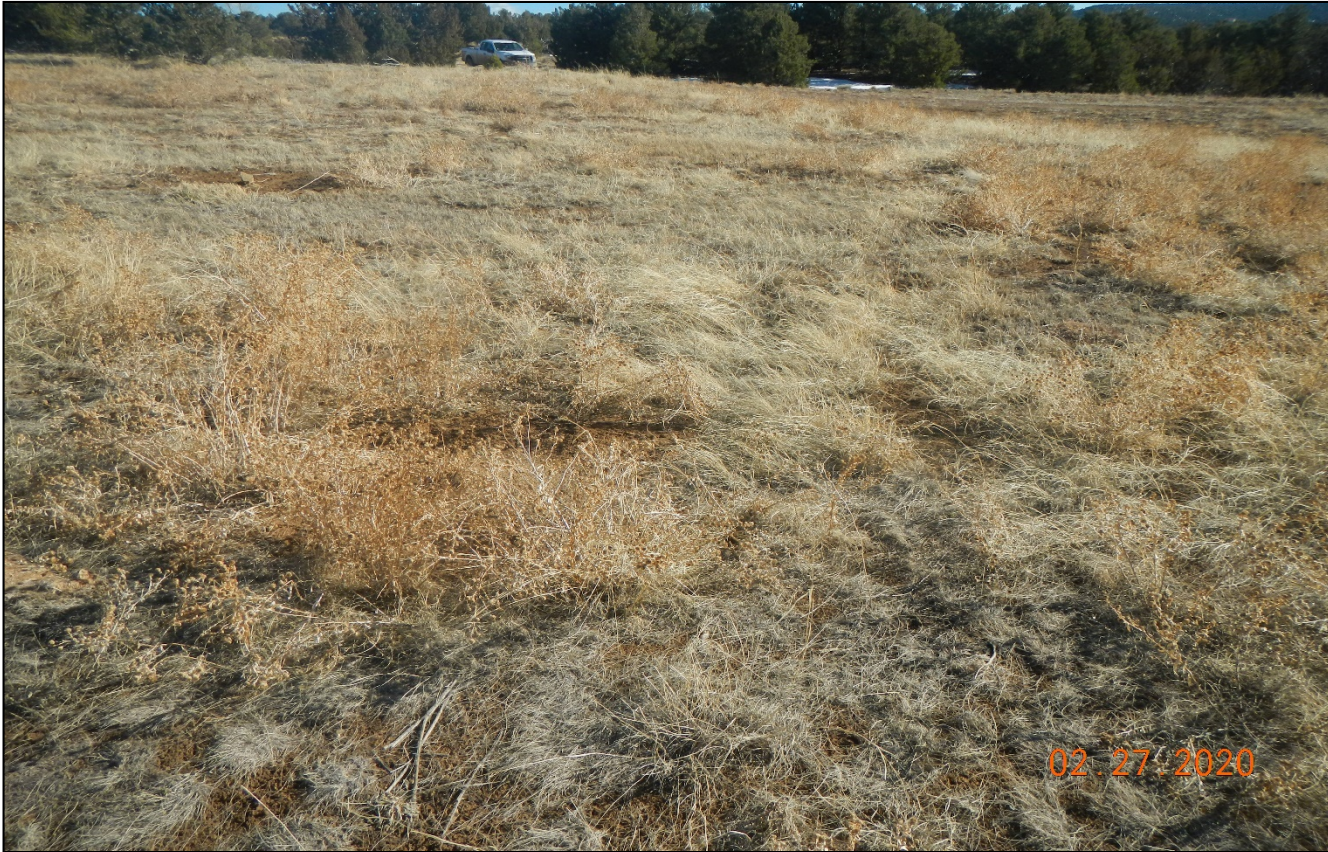
Photo 7. Facing south at the location. Vegetation appears to be establishing well at the east side of the location.
