Inspection Photos

API: 055-06155

Operator: PETROGLYPH OPERATING

Inspection Date: 2/27/2020

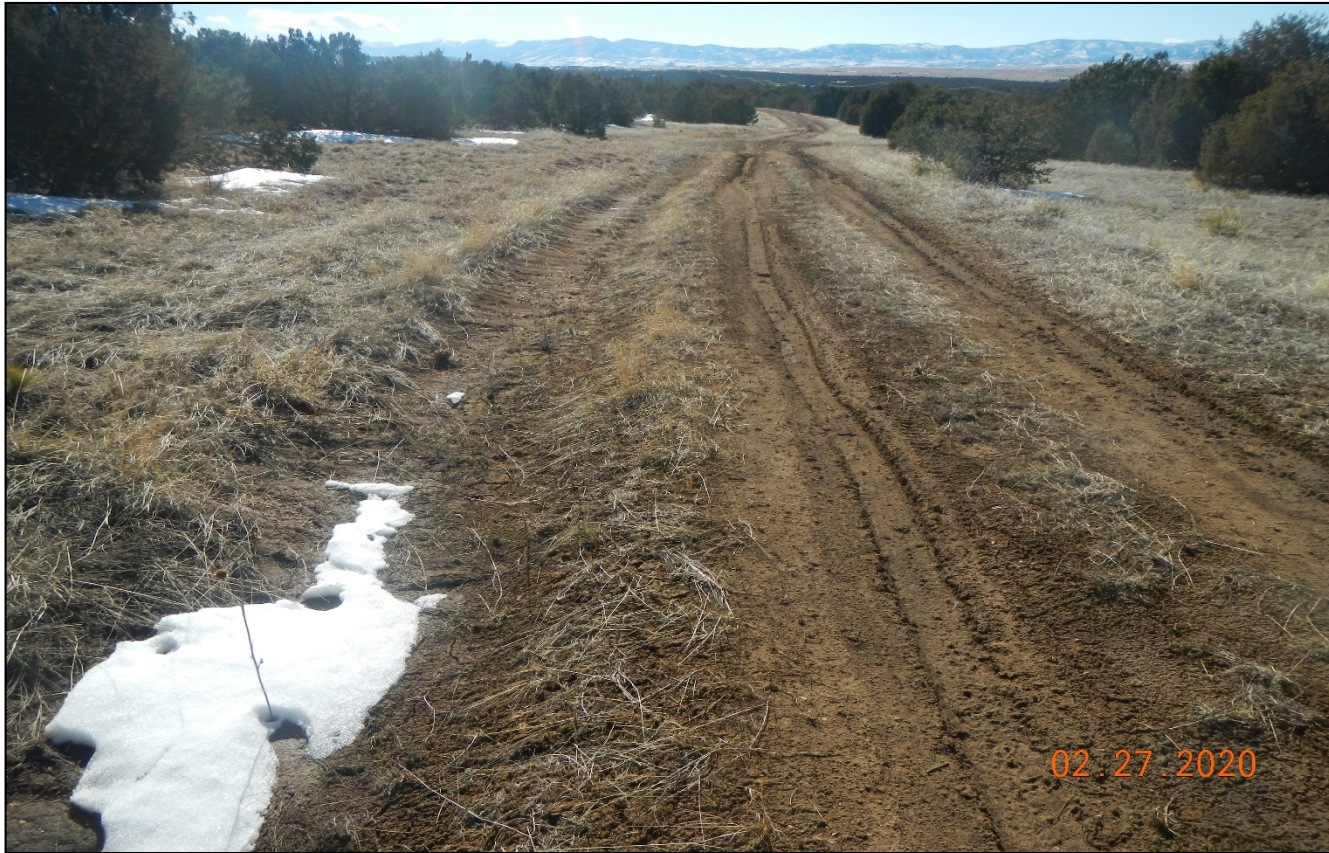
Photo 1. Facing southwest along the access road.

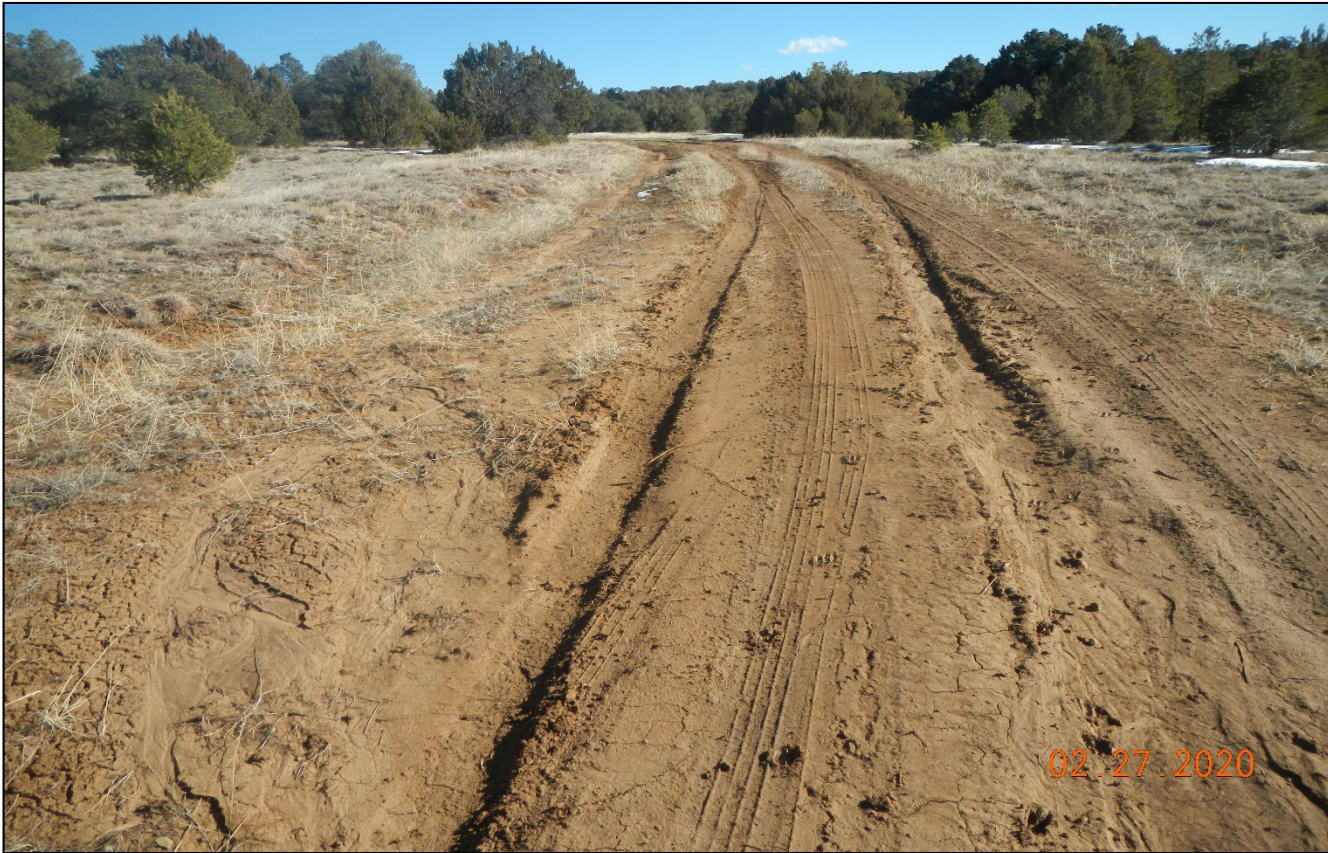
Photo 2. There is vehicle rutting along the road. The ruts will cause stormwater to flow down along the ruts and could cause erosion.

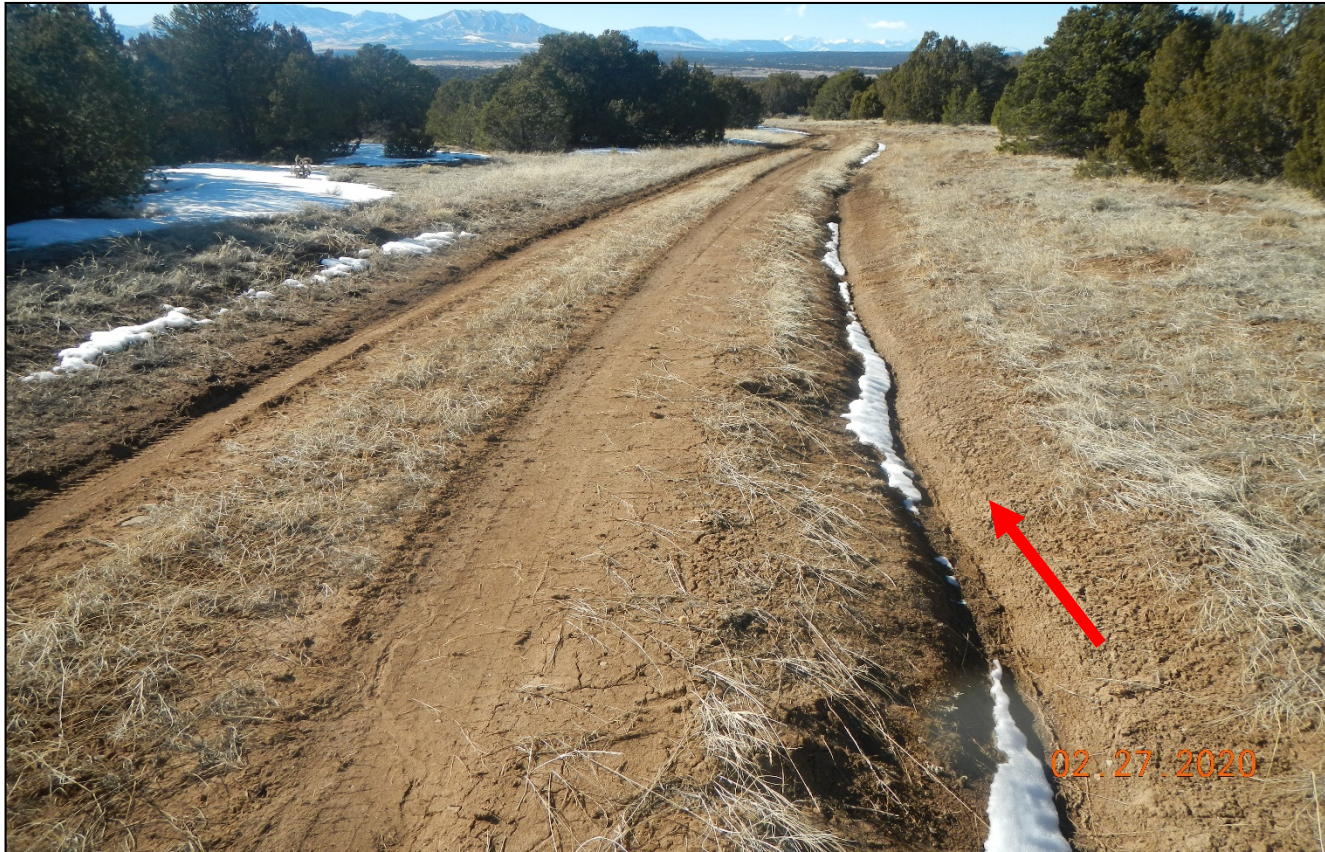
Photo 3. The side of the road has no BMP's installed to prevent erosion. The long downward grade of the road will accelerate stormwater and may deepen the side shown by red arrow.

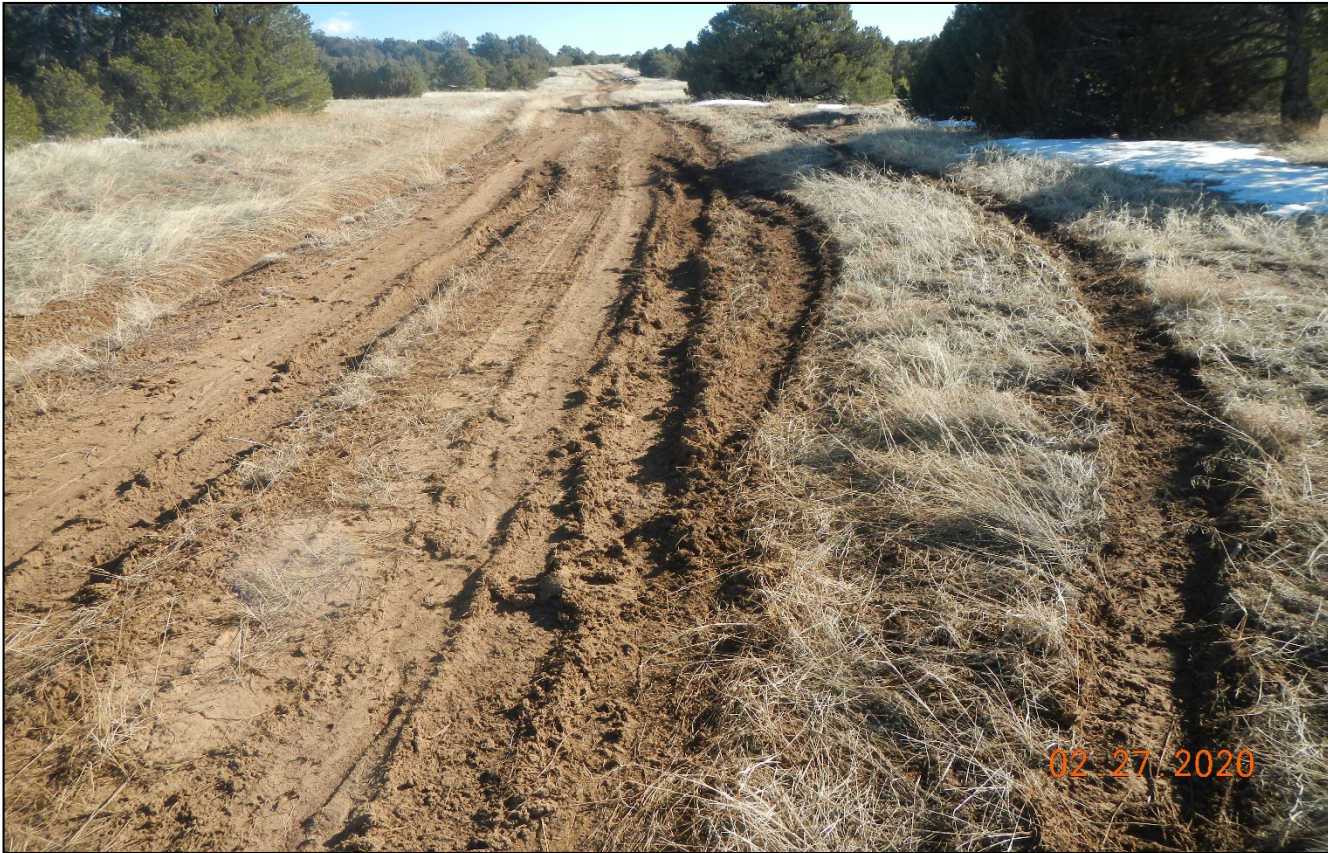
Photo 4. Vehicle use of the road during wet conditions is causing ruts and damage along the road.

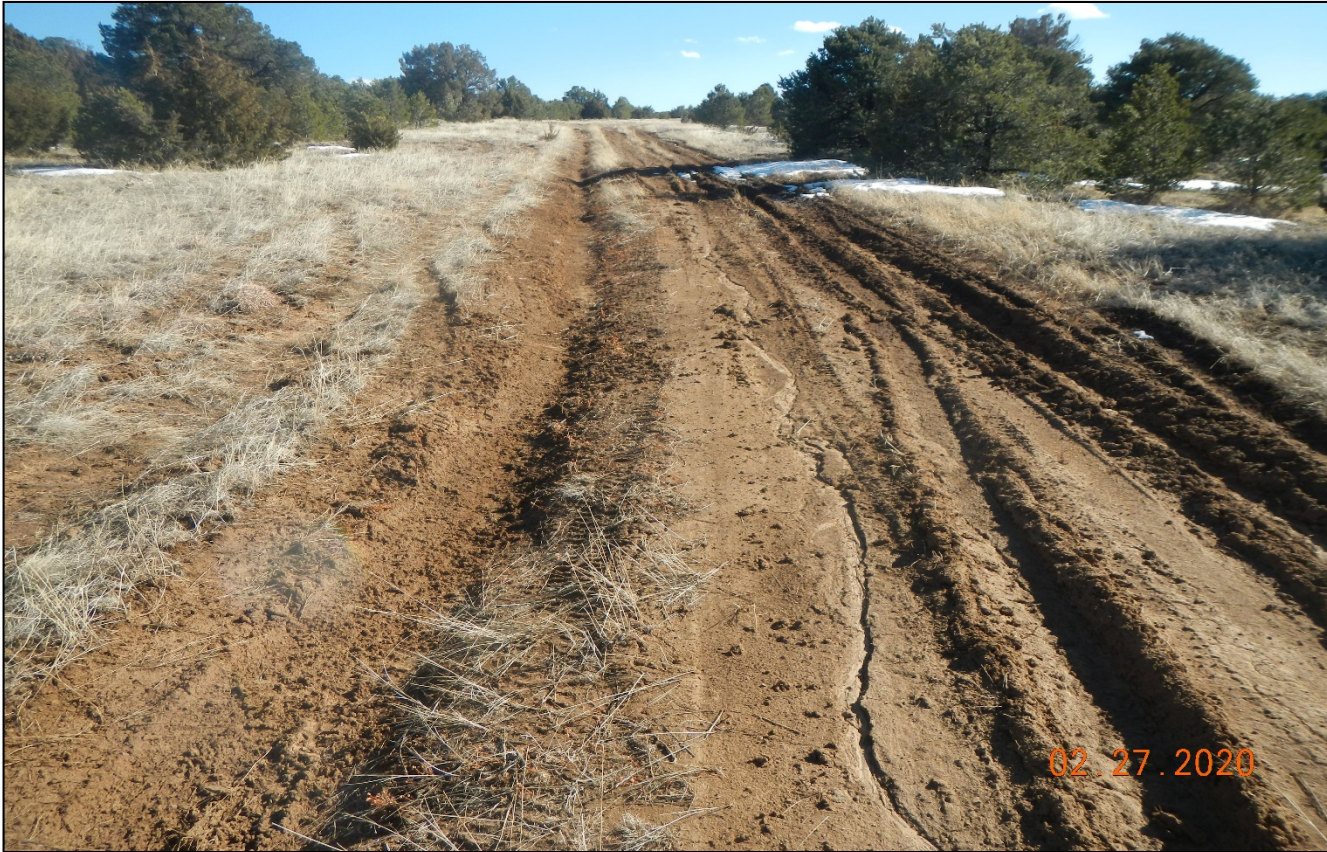
Photo 5. Vehicle use of the road during wet conditions is causing ruts and damage along the road.

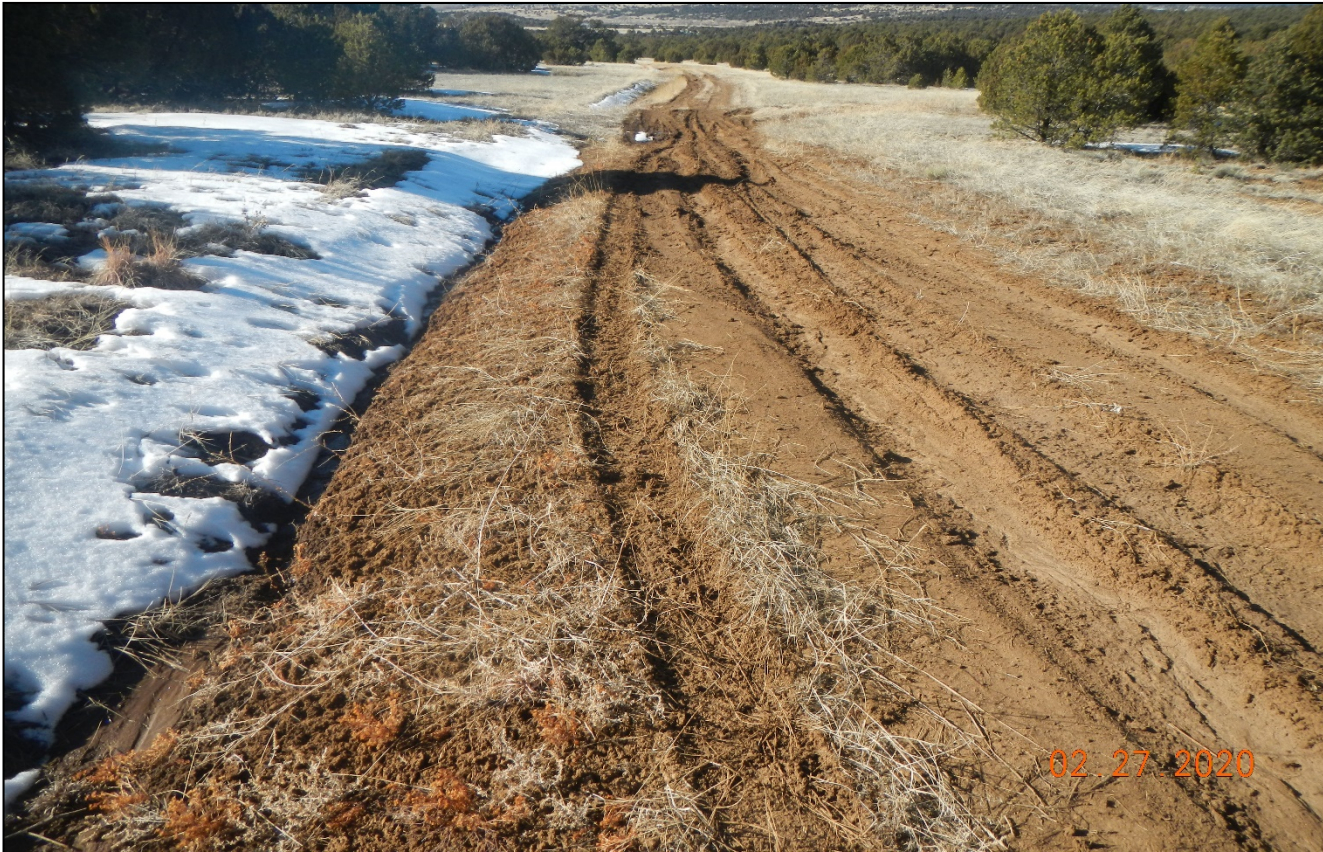
Photo 6. Facing northwest along the access road. The long downward grade of the road could accelerate stormwater along the side of the road and also along the vehicle ruts.

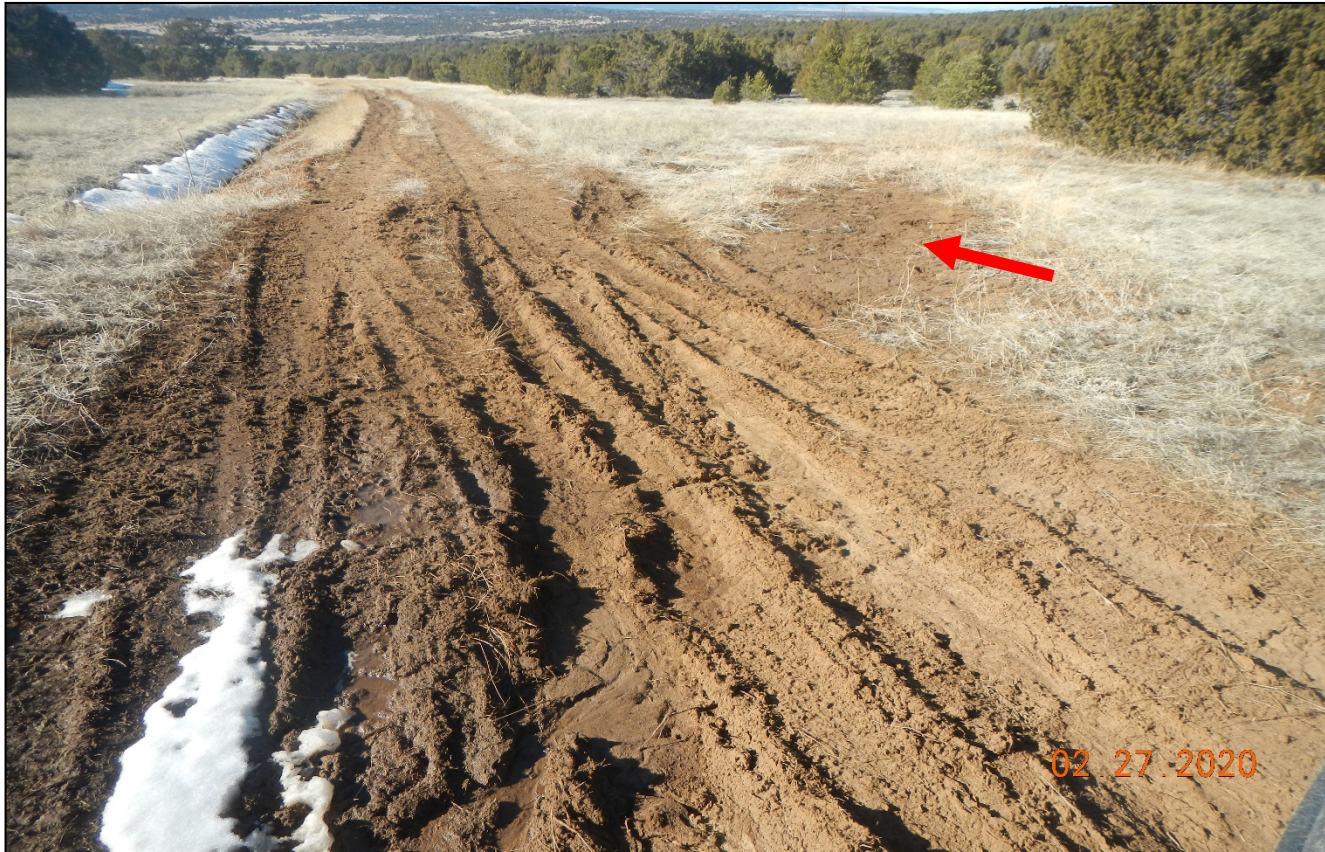
Photo 7. Facing northwest along the road at the water bar. It appears sediment is accumulating at outlet (red arrow). This may cause stormwater to flow over the water bar and down the road. A sediment trap or other BMP may be needed at the end of the water bar outlet.

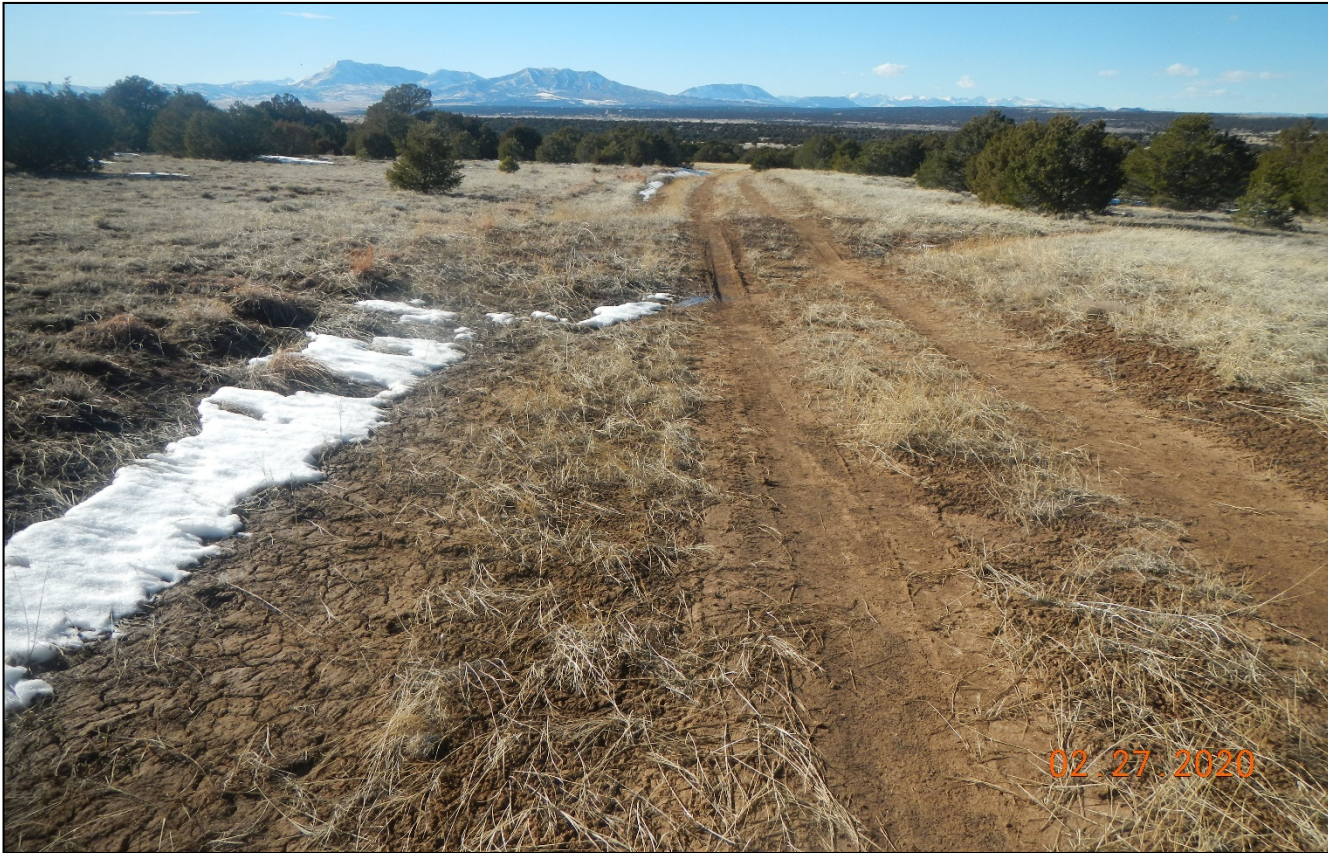
Photo 8. Facing northwest along the access road. Vegetation appears to be establishing along the side of the road. Vehicle rutting is not occurring in this area.

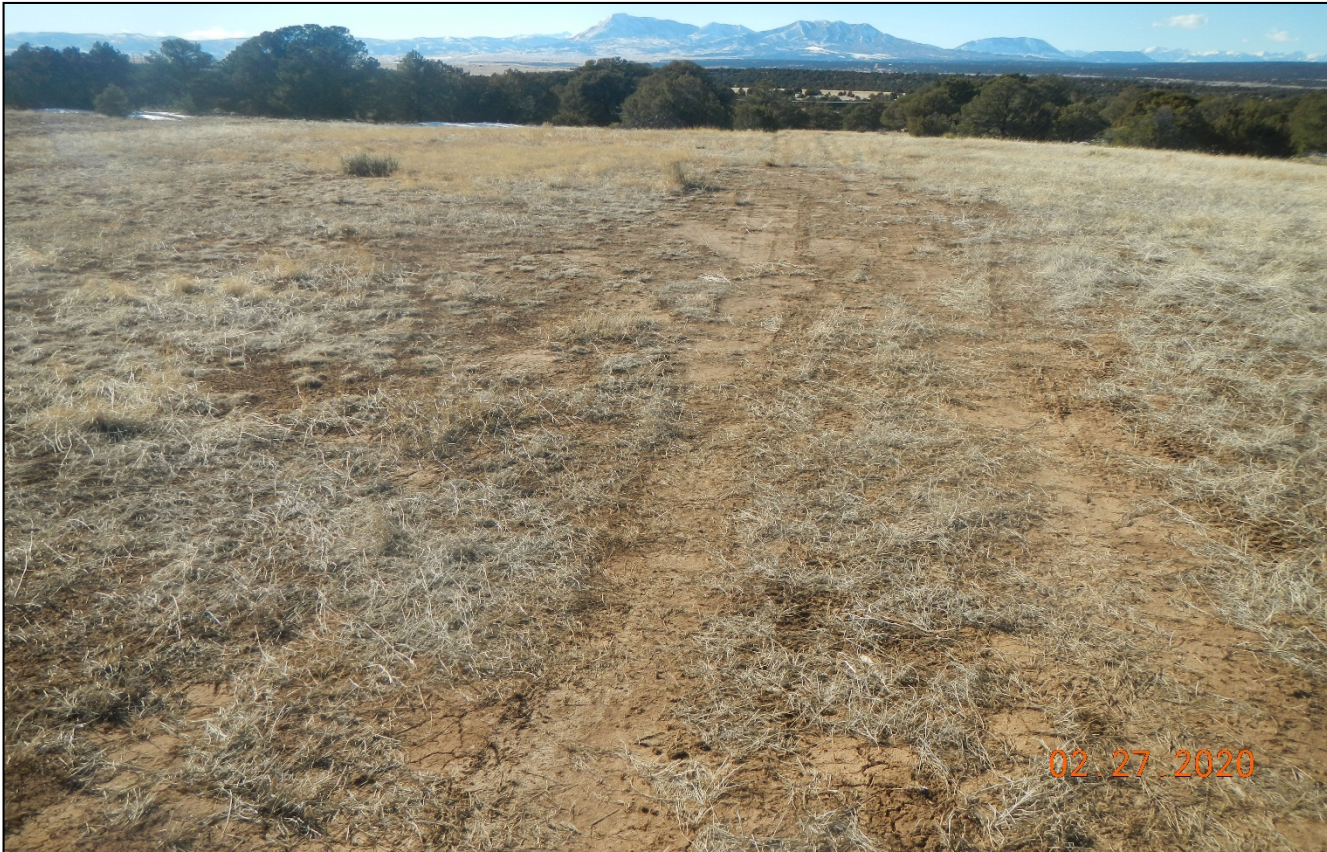
Photo 9. Facing south toward the location. The vegetation appears to be well established at the location.

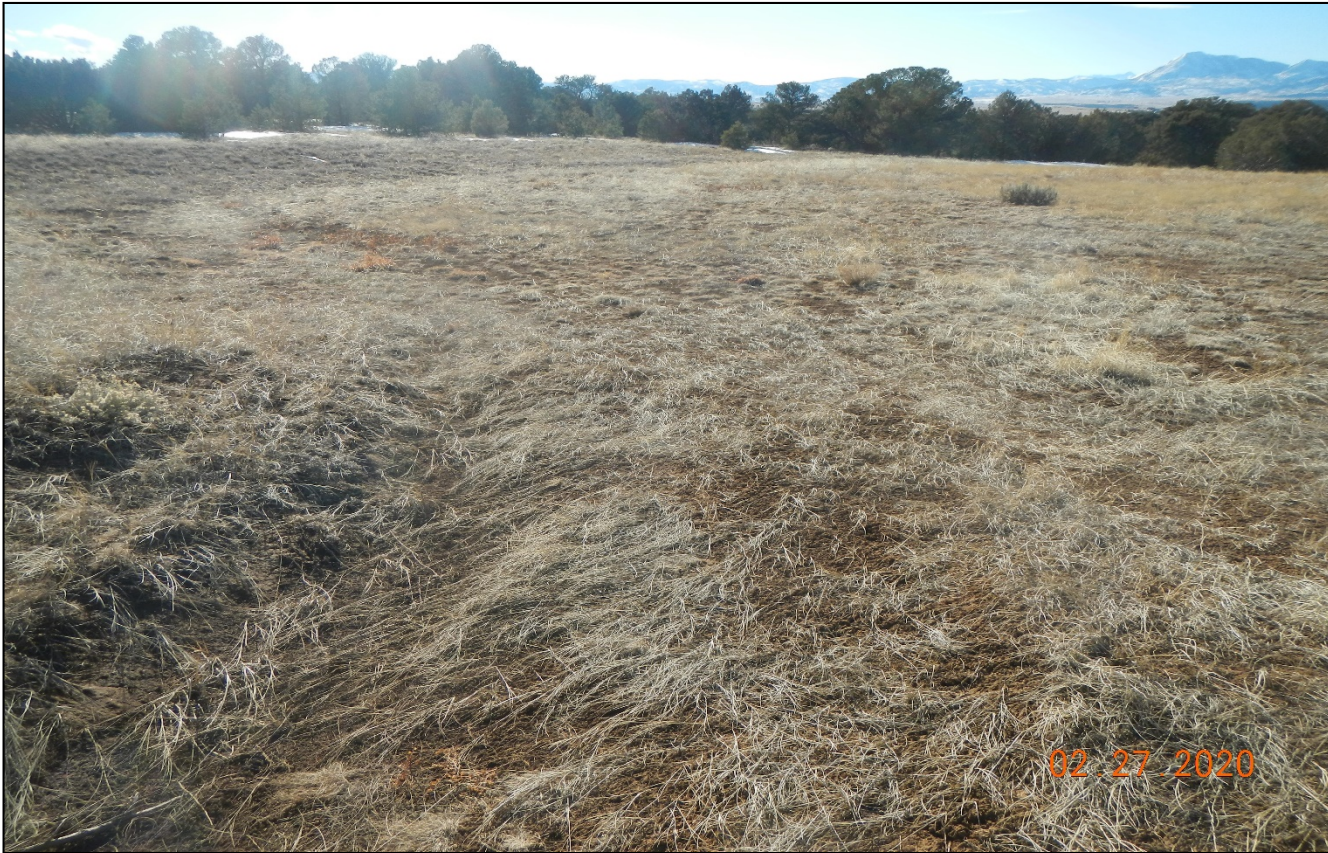
Photo 10. Facing east toward the location. The vegetation appears to be well established at the location.
