Inspection Photos  
Operator: Hilcorp Energy  
Location #: 067-09339  
Date: 2/27/2020

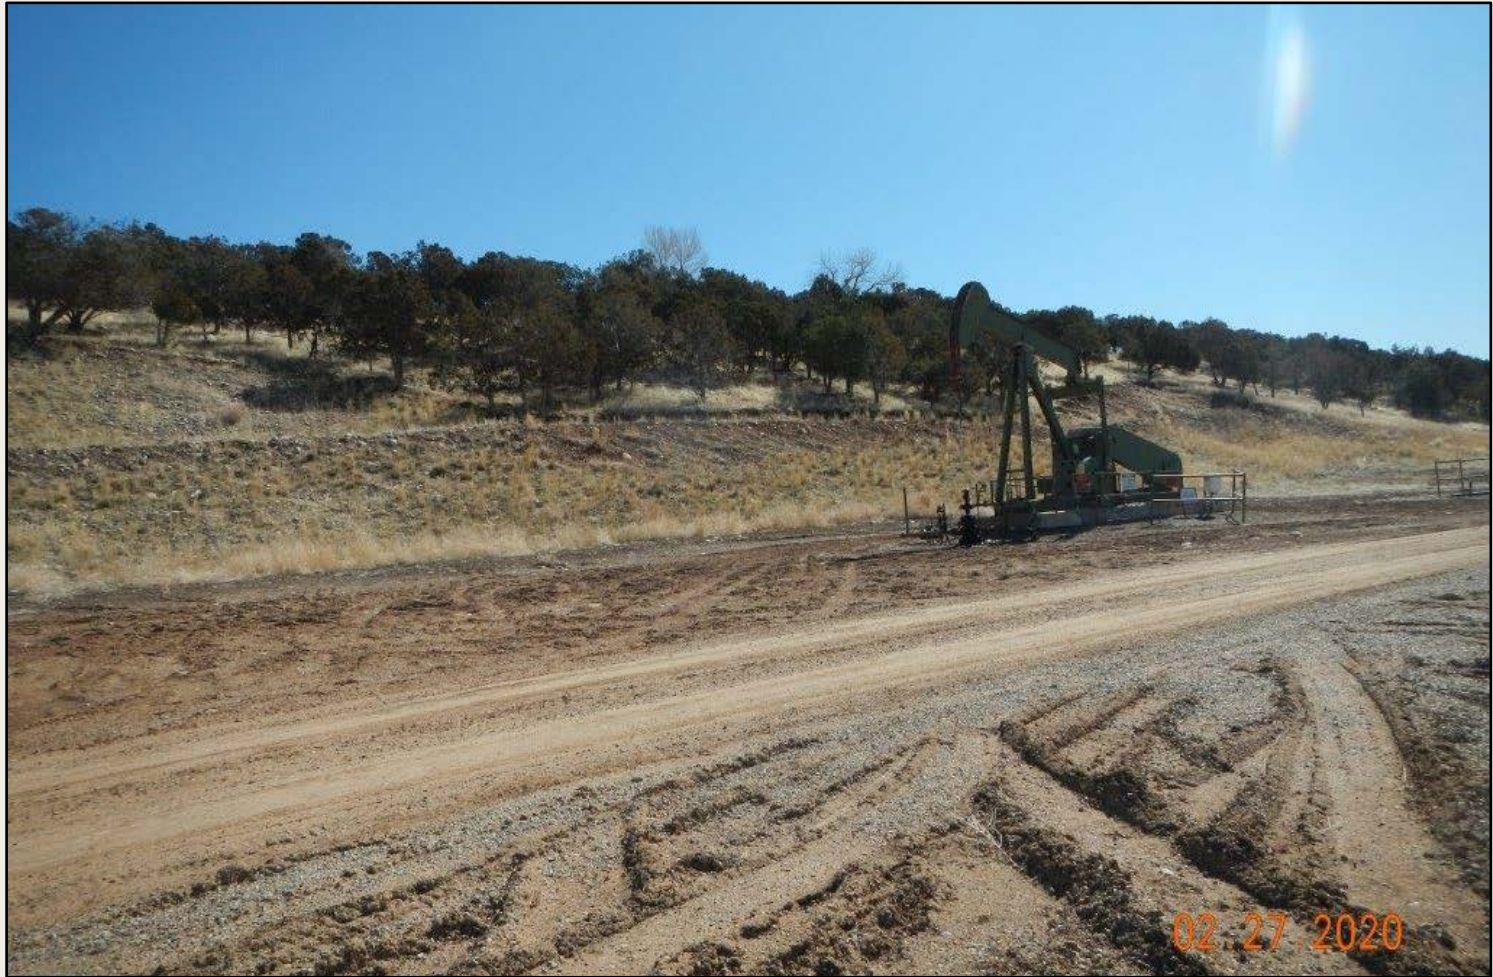
Photo 1. View of the project area from the northeastern corner facing center.

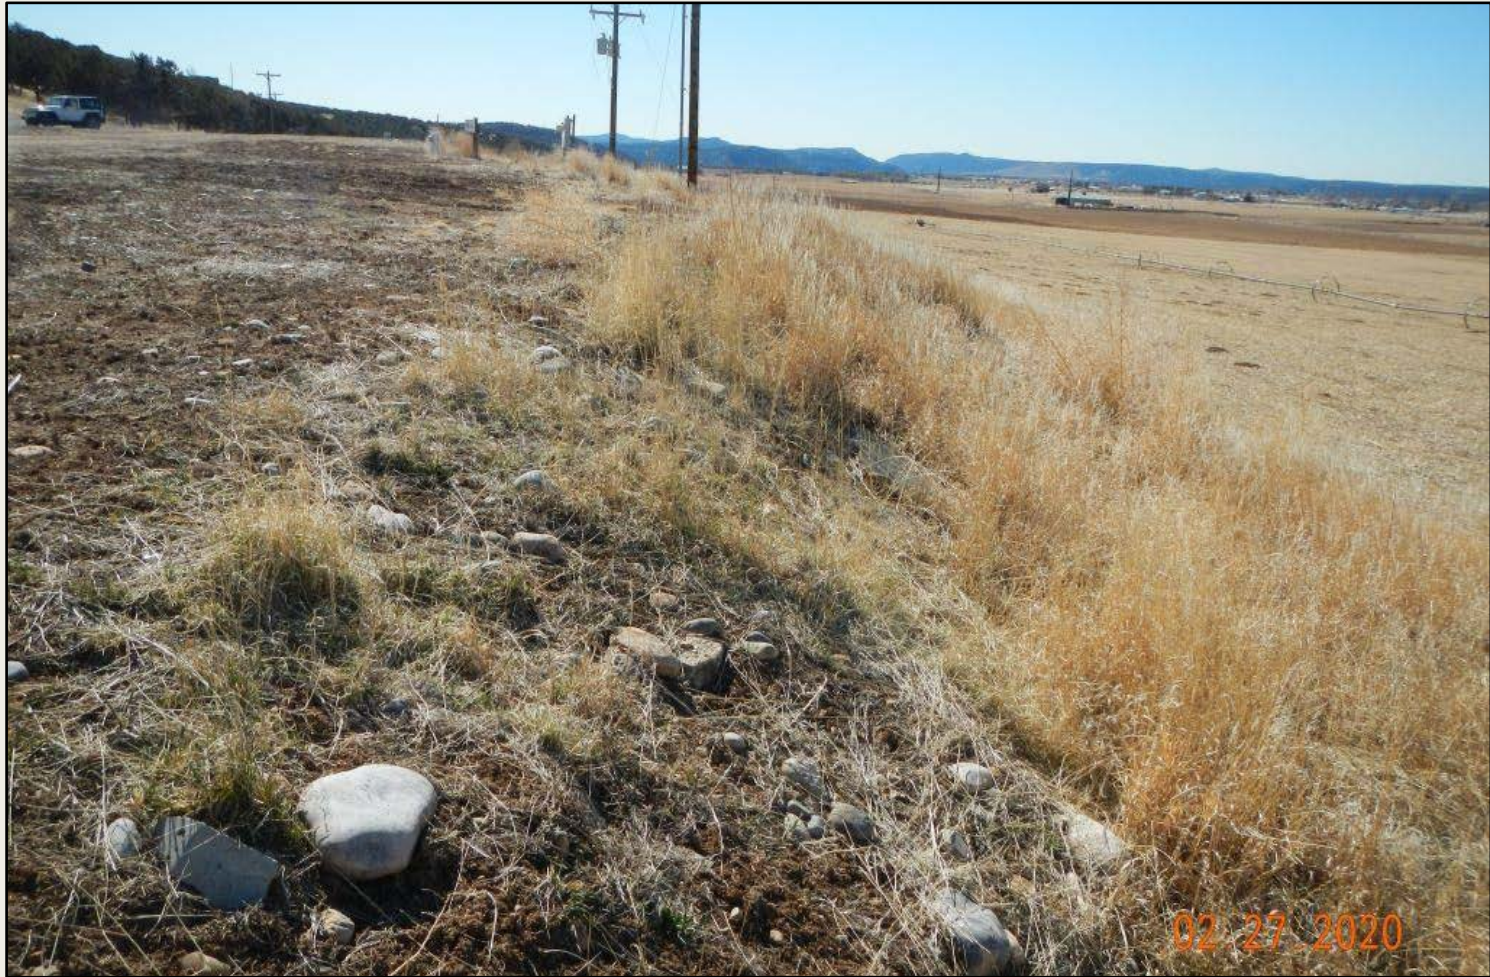
Photo 2. View of the eastern fill slope, revegetation appears to be progressing with grasses such as smooth brome.

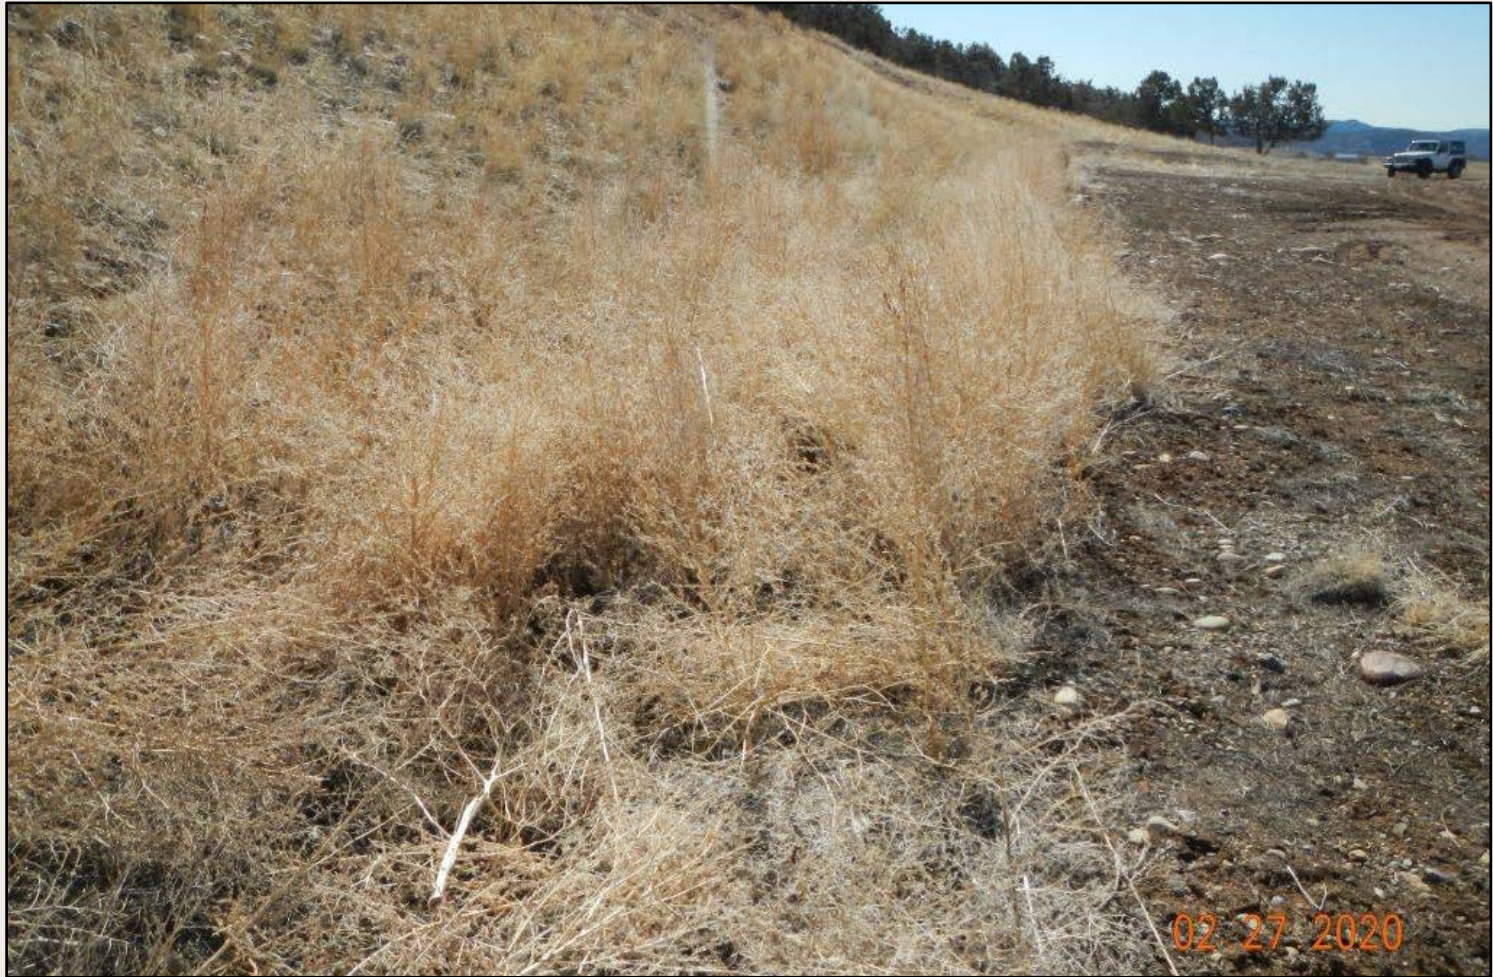
Photo 3. View of Kochia debris, up to 3 feet tall, along the eastern edge of the working area.

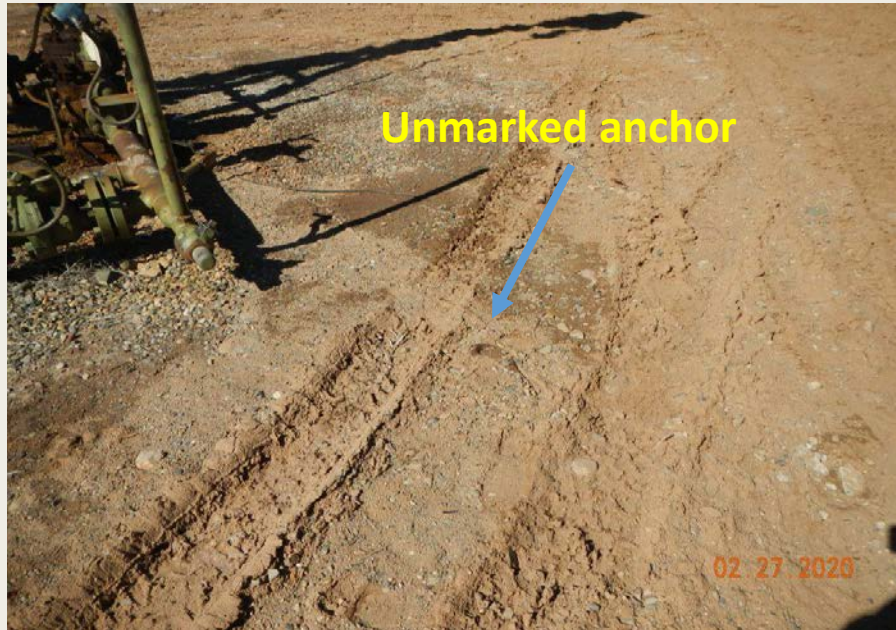
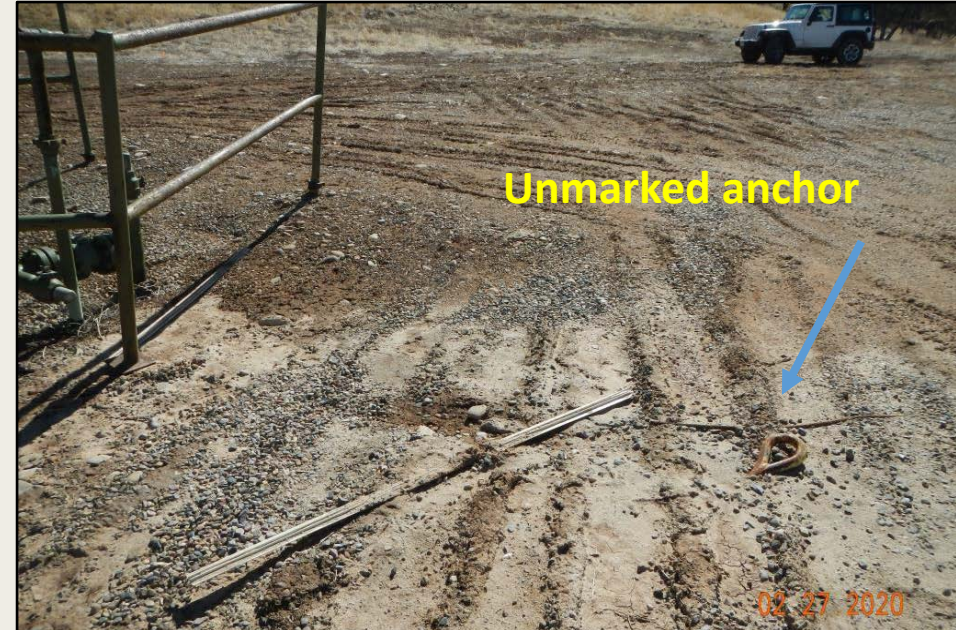
Photos 4/5. View of unmarked guyline anchors within the project area.

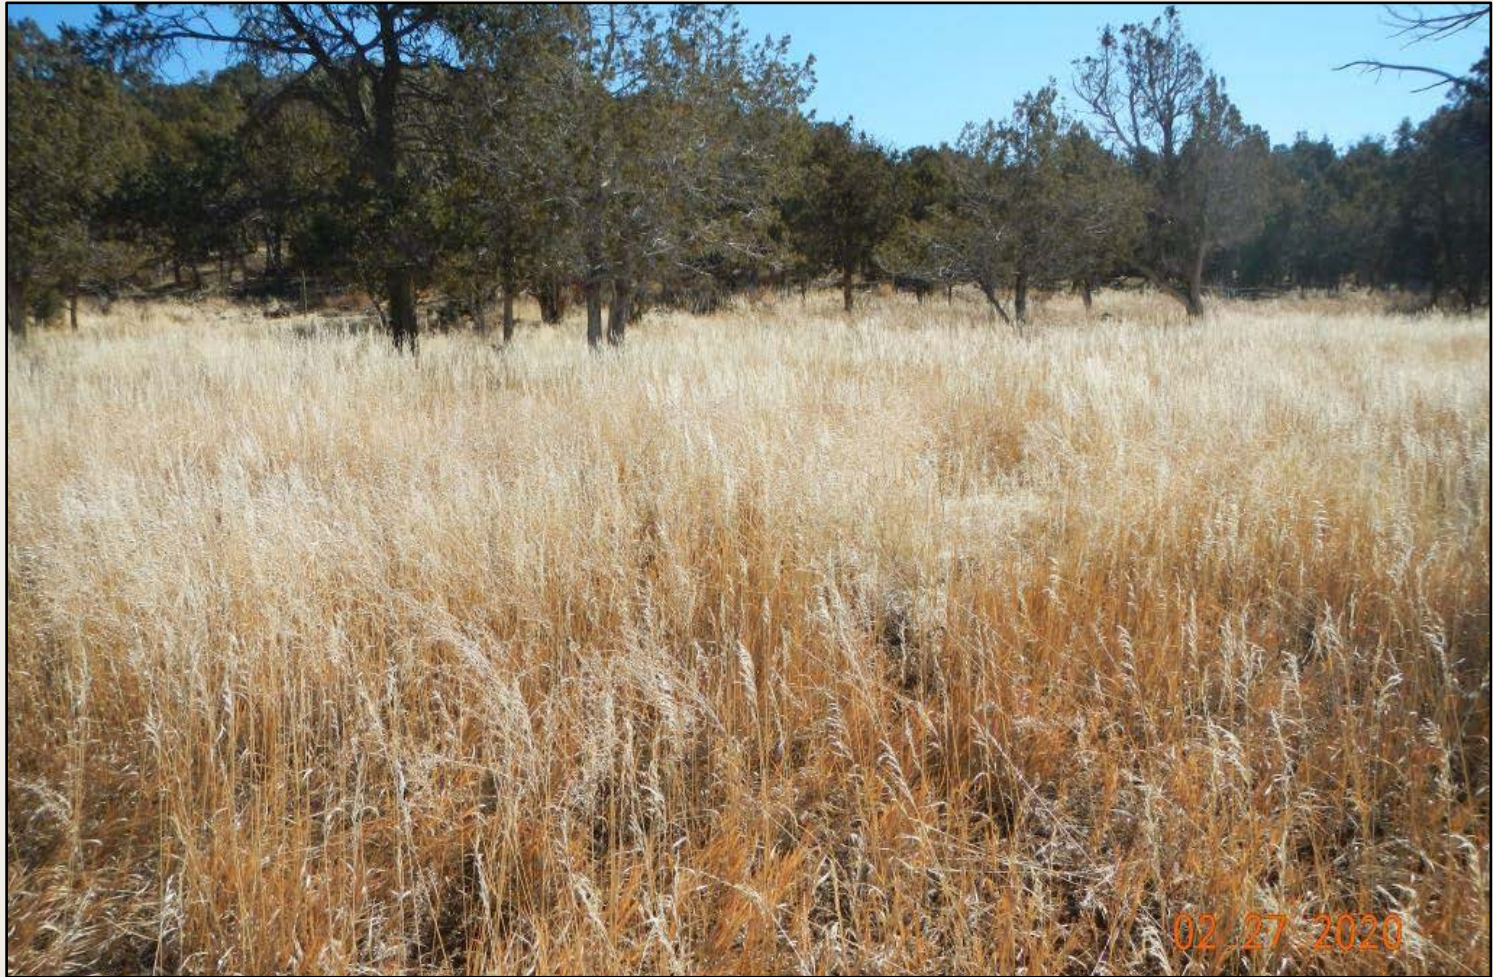
Photo 6. View of reference area vegetation comprised of pinyon and juniper woodland with smooth brome dominated understory.
