Inspection Photos
Operator: Hilcorp Energy
Location #: 067-09459
Date: 2/27/2020

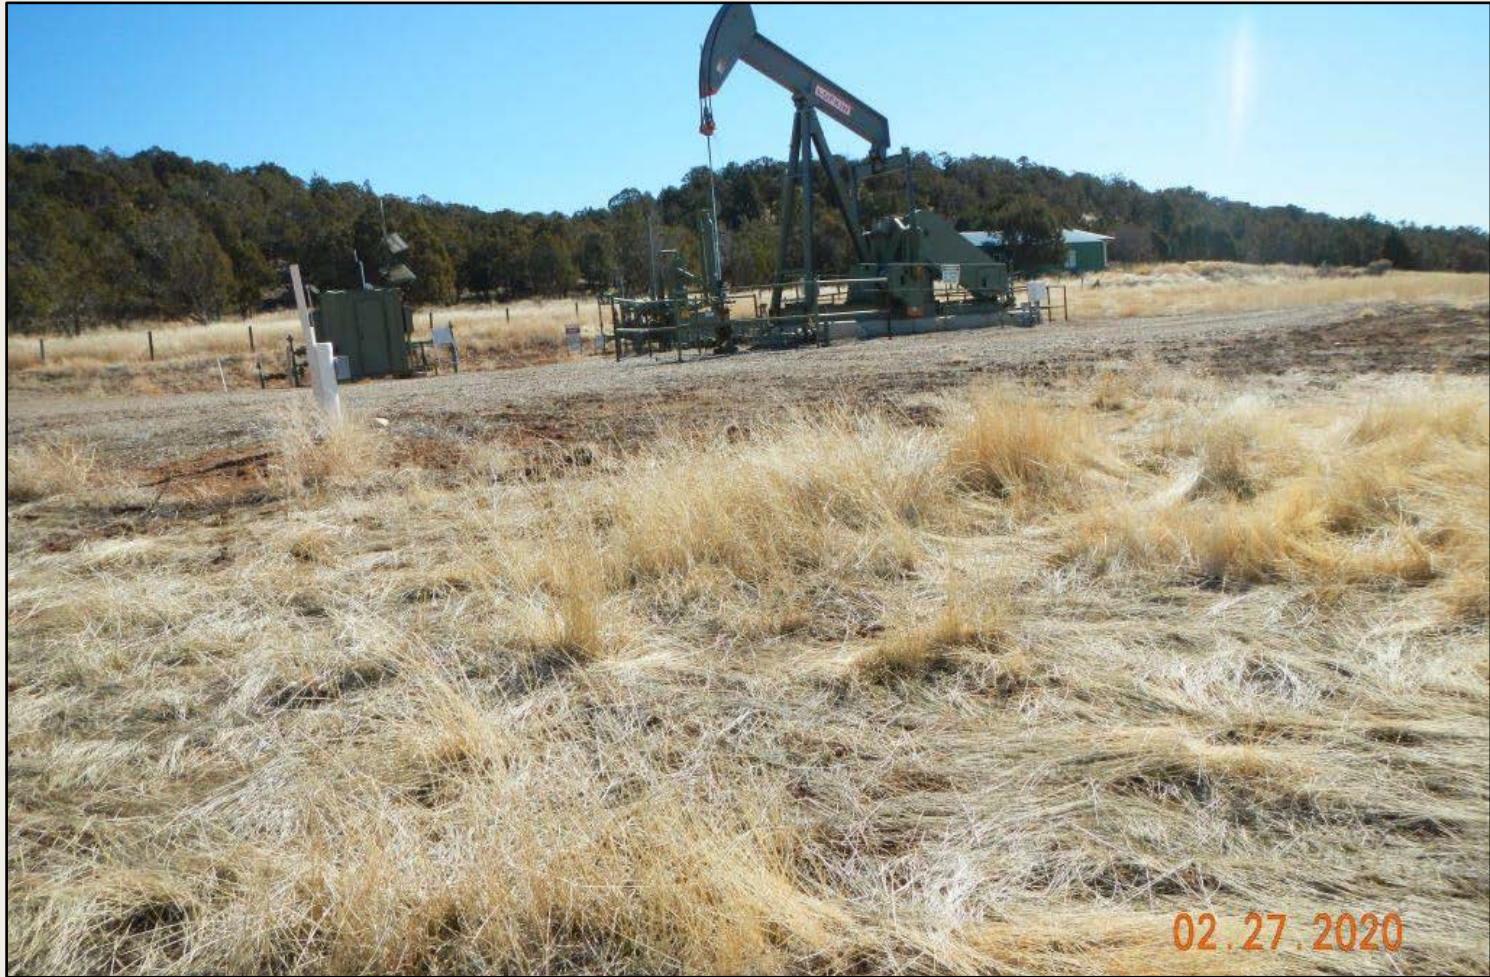
Photo 1. View of the project area from the northwestern corner facing center.

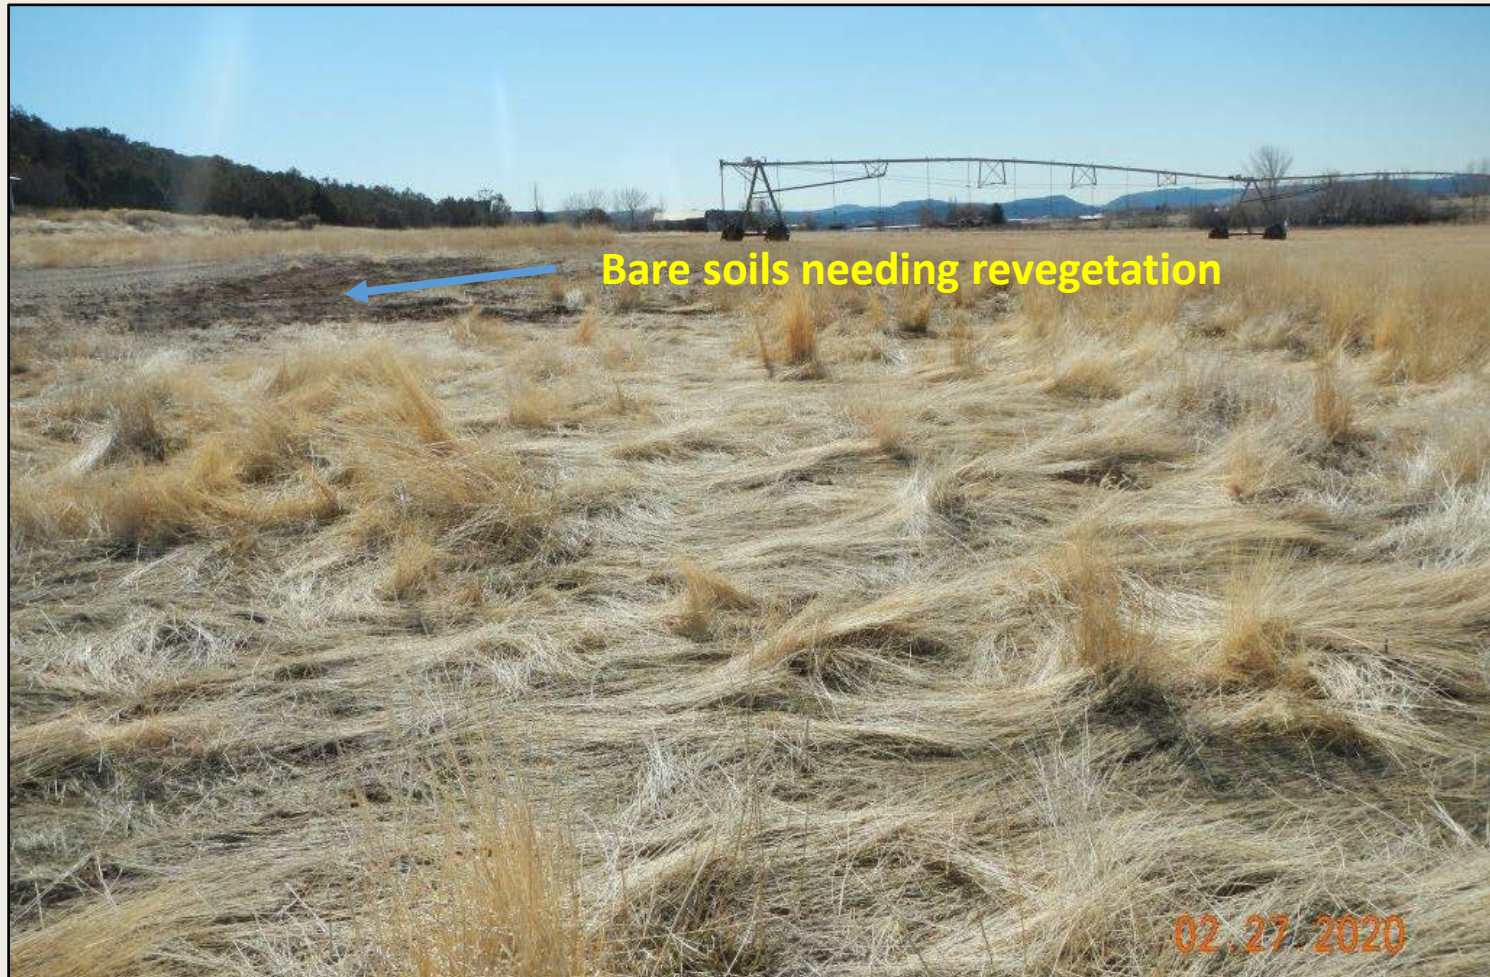
Photo 2. View of the western fill slope, revegetation appears to be progressing with a mixture of wheatgrasses in a dormant vegetative condition. Spot seeding is needed along the western edge of the working area where bare soils persist.

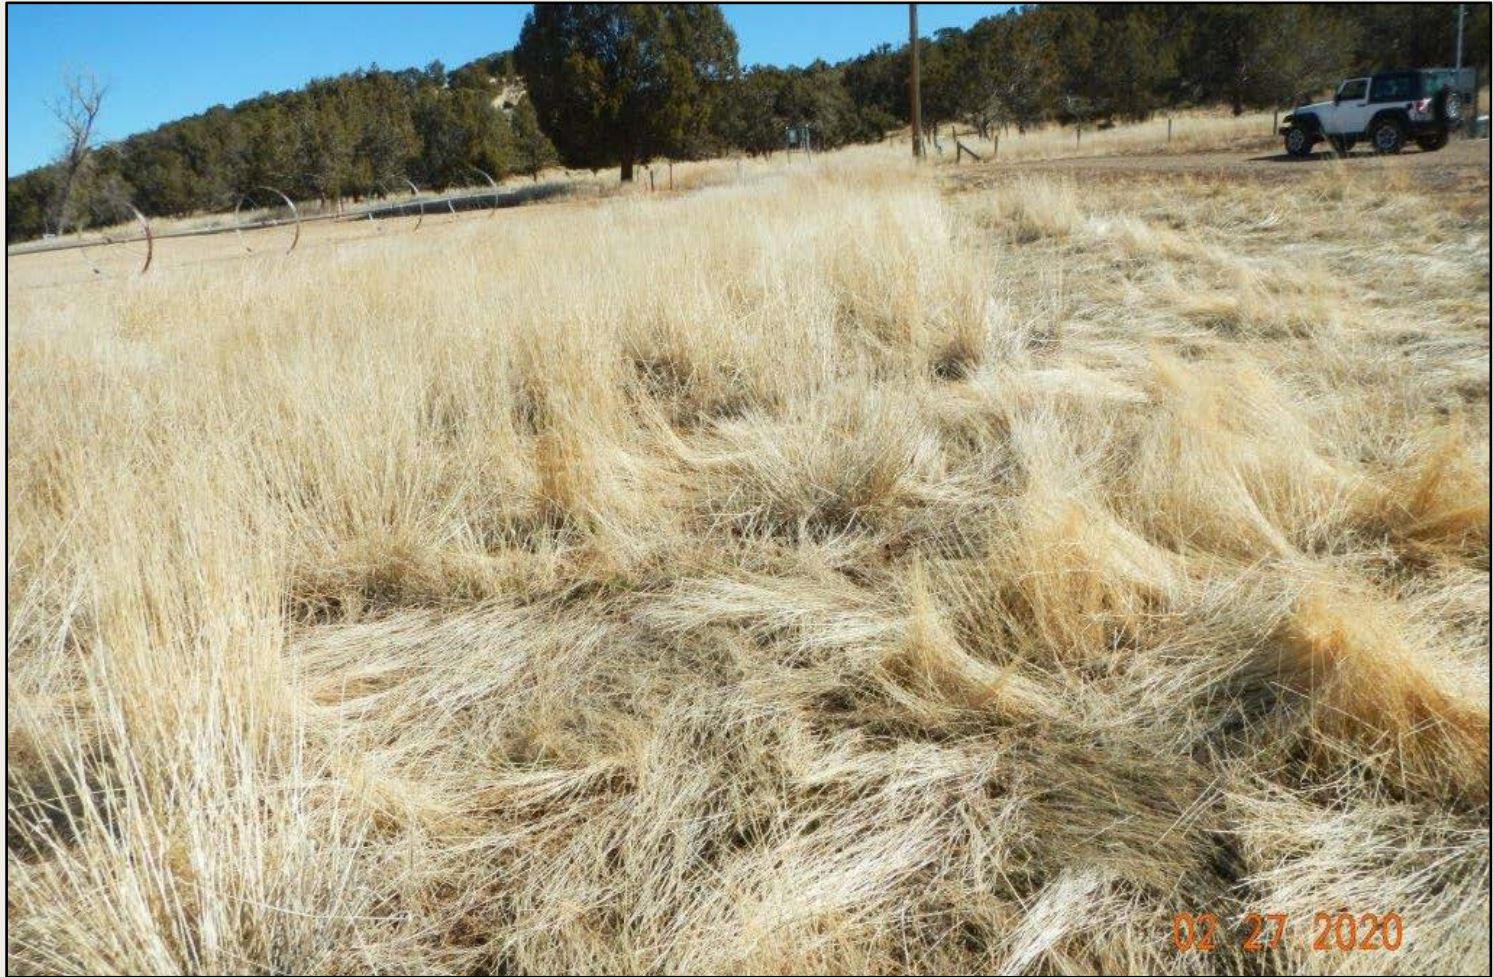
Photo 3. View of the northern project area from the northwestern corner facing eastward.

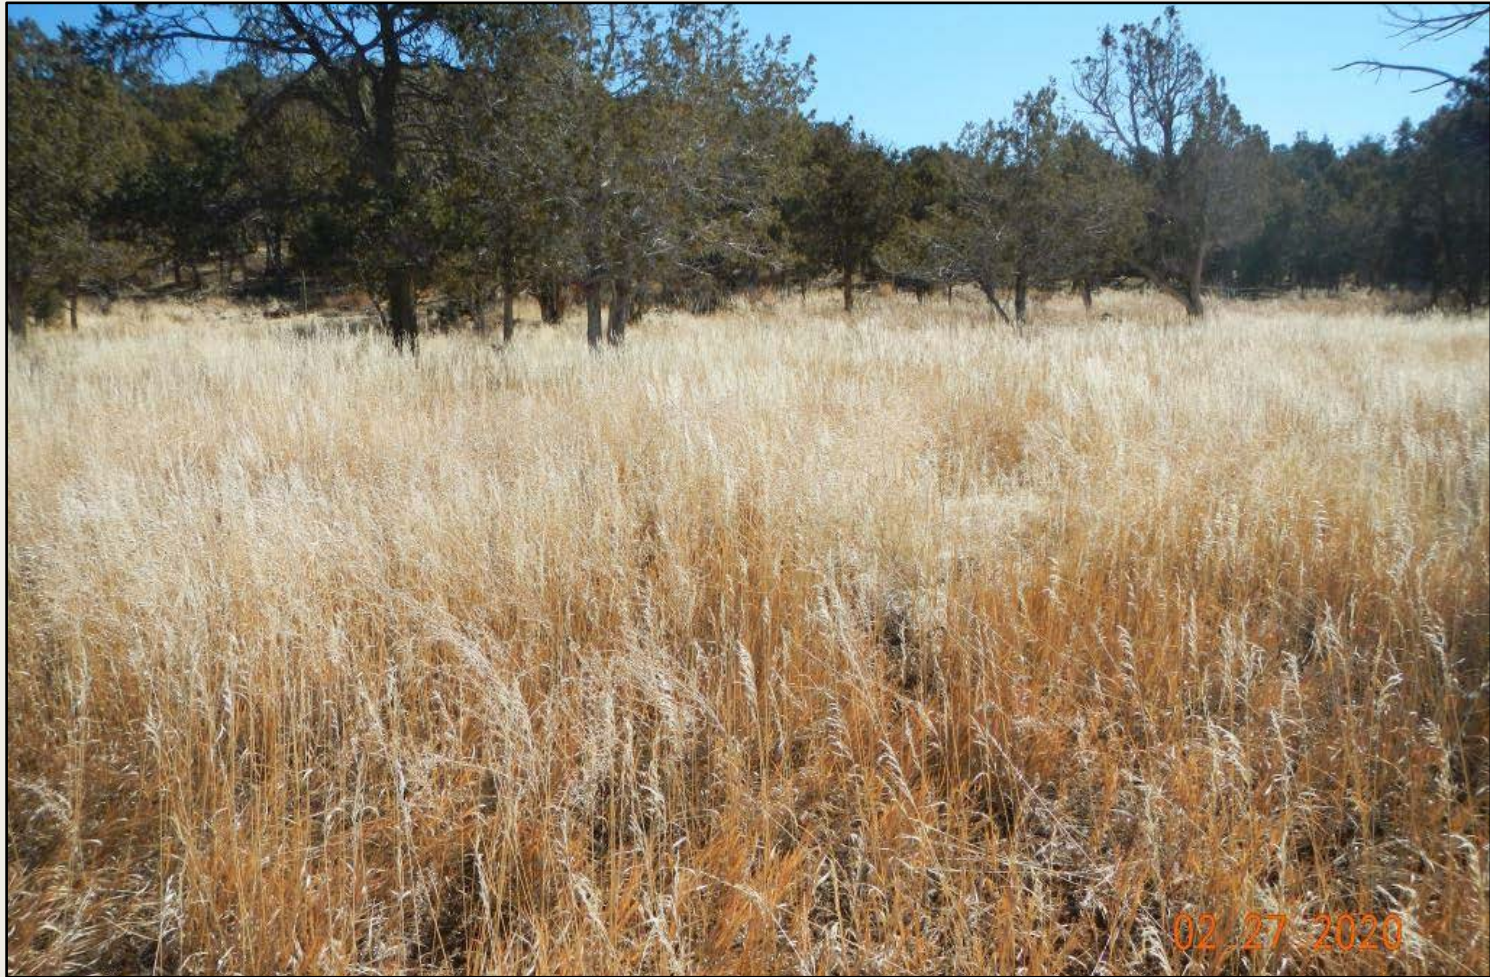
Photo 6. View of reference area vegetation comprised of pinyon and juniper woodland with smooth brome dominated understory.
