## Inspection Photos

Location Name: MARALEX RESOURCES INC SOUTH SHALE RIDGE-68S98W /7NWSE

Location ID: 323851

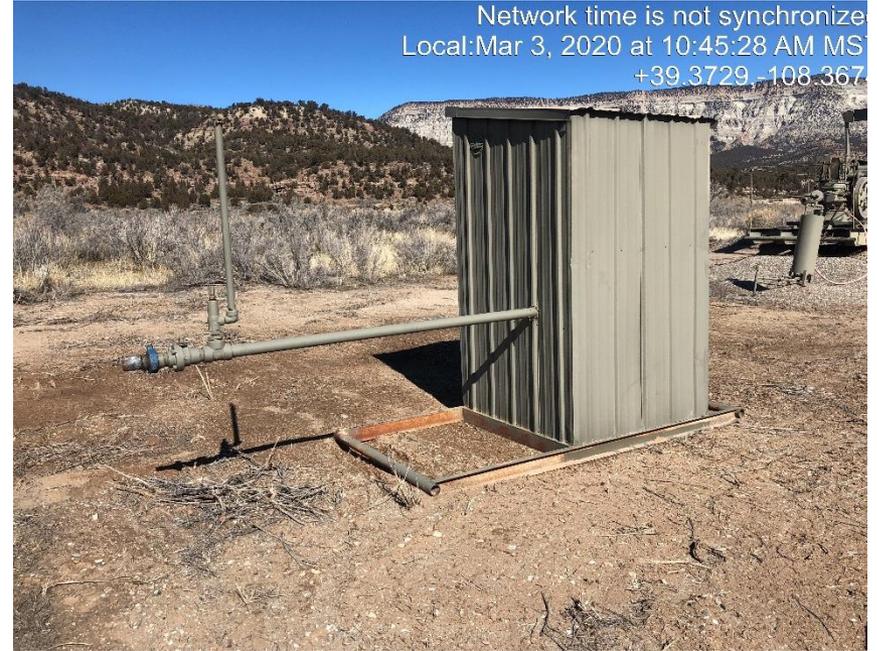
**Photo #0679 Unused meter run.**

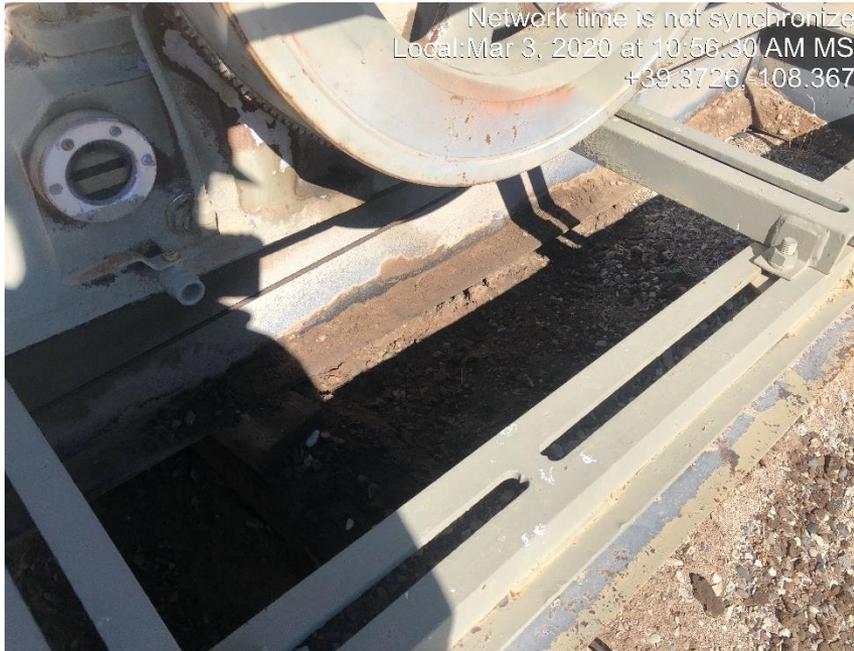
Photo #0682 Stained soils under pump jack.

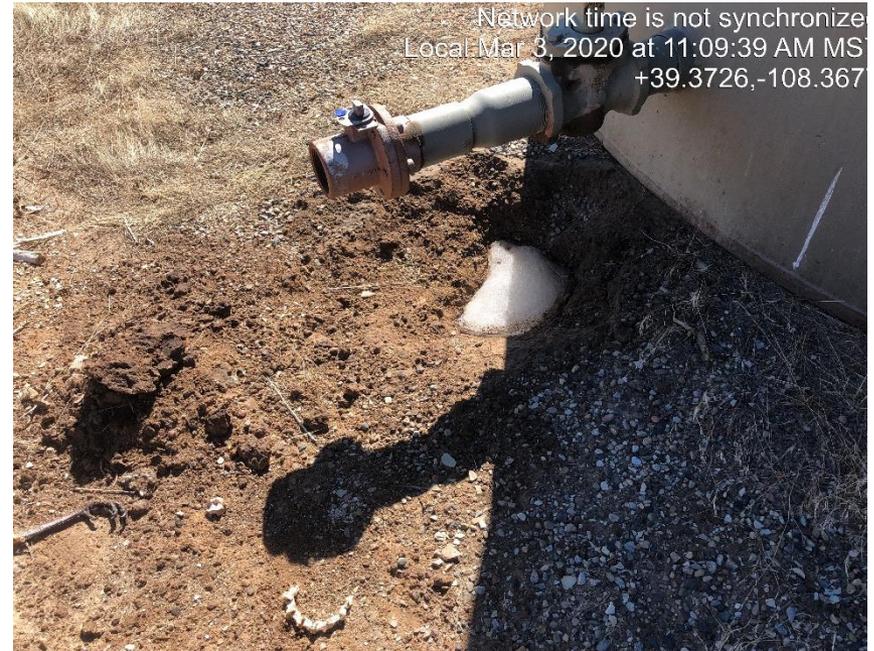
Photo #0683 Stained soils under load out valve on tank.
