Inspection Photos

Location Name: ELIOT NESS 22-17 INCIDENT FOLLOWUP ca date 4-3-20

API#: 05-071-06202

INSP. #: 695102281

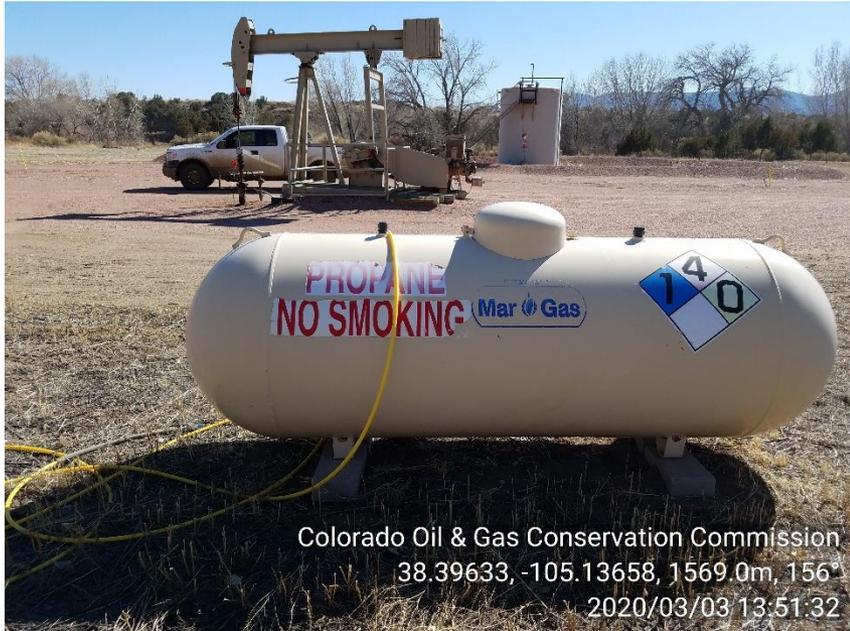
PHOTO 3: unused equipment stored on location (propane tank is not being used). Remove unused equipment per rule 603.F. ca date 4-3-20

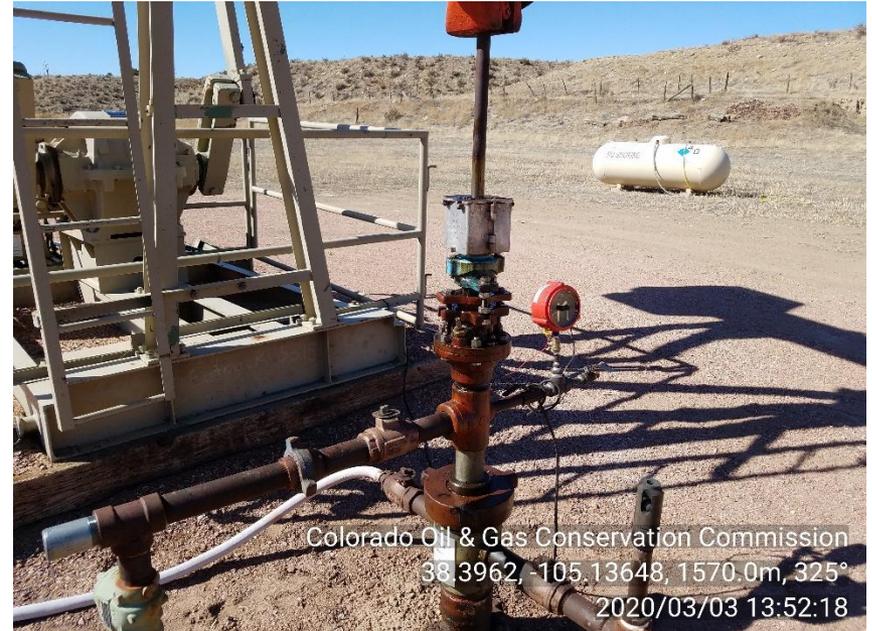
PHOTO 4: Polish rod oiler is running oil down wellhead assembly, This is not a ca notice as oil has not reached the ground. This is just a reminder that if this oil contaminated the soil that would result in a corrective action being administered.

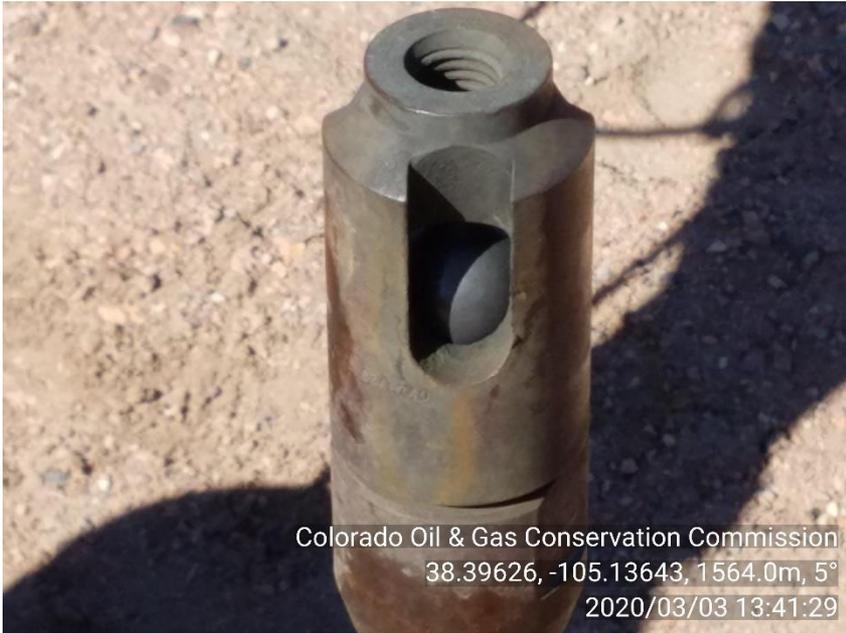
PHOTO 5: 1" produced gas vent plumbed from casing head, I can hear gas venting at a whisper. (This is just documenting that there is light gas venting at the wellhead.)
