Inspection Photos

3/2/2020

Operator: MARALEX RESOURCES INC - 53255

Location ID: 312599

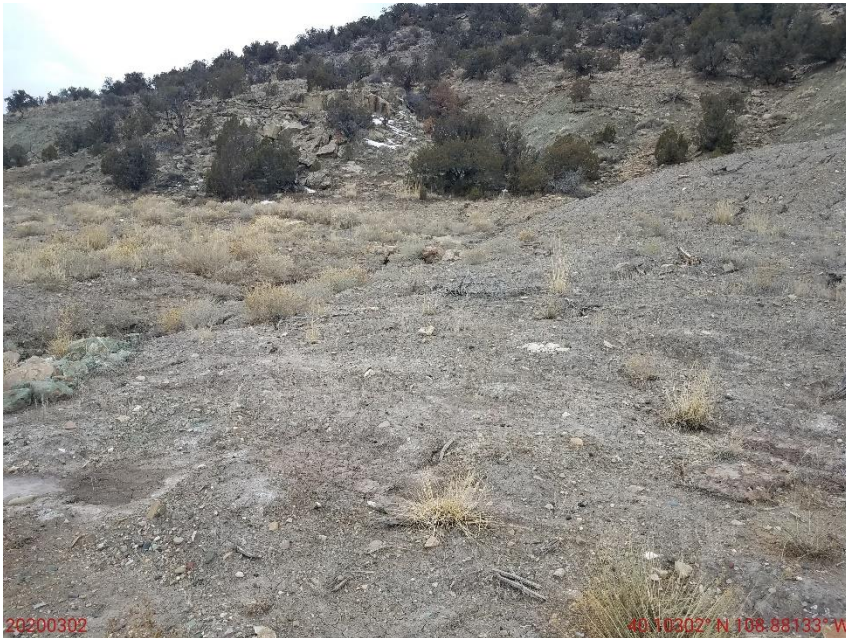
Photo 1: Photo taken from the access road on the east end of the Location, facing west. Photos 1-3 provide an overview of the Location from west northwest to north. Photos show erosion degradation remains evident; No stormwater BMPs have been installed in accordance with Rule 1002.f and corrective actions; No additional reclamation activities have been conducted.

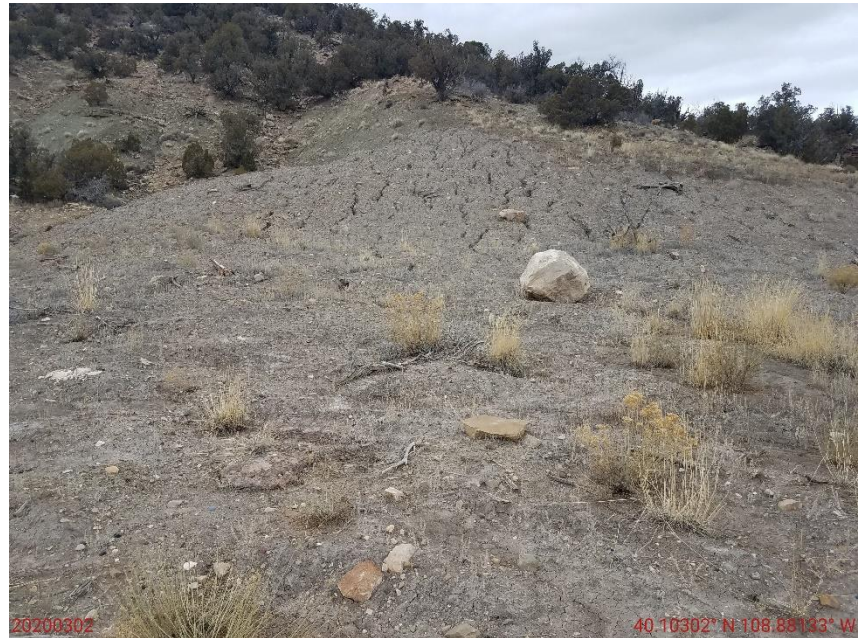
Photo 2: See comments under photo 1.

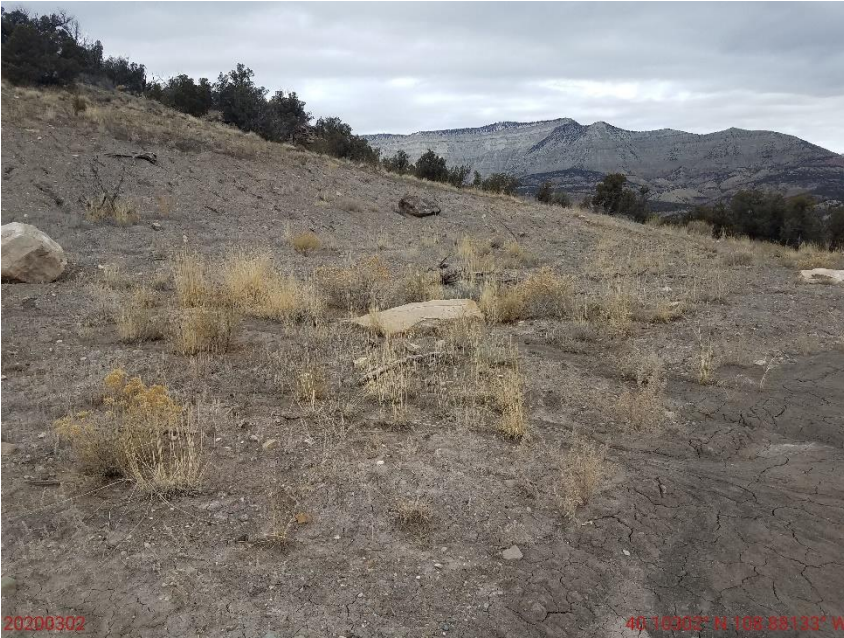
Photo 3: See comments under photo 1.

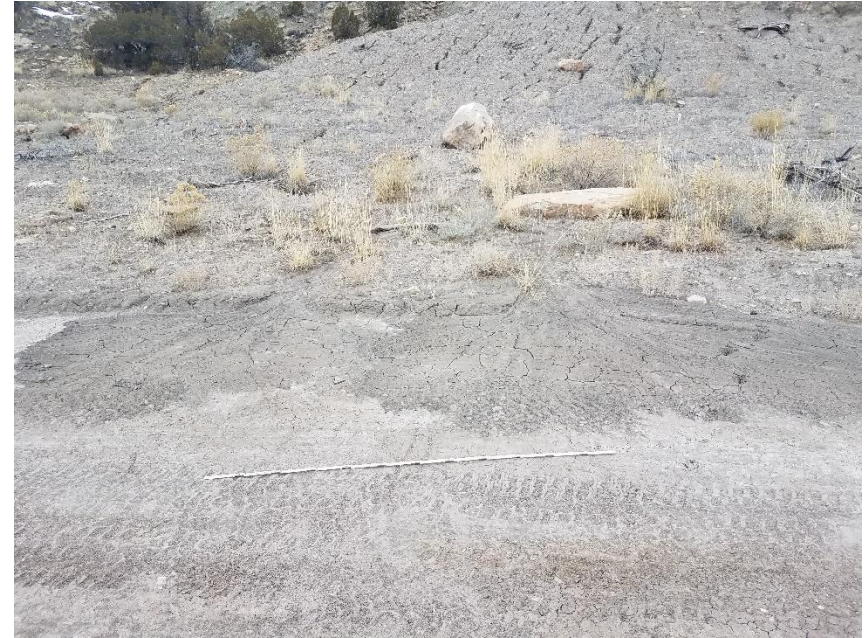
Photo 4: Photo taken from the access road, facing west. Photo shows sediment discharge from the Location onto the road. 6 foot measuring stick for reference.

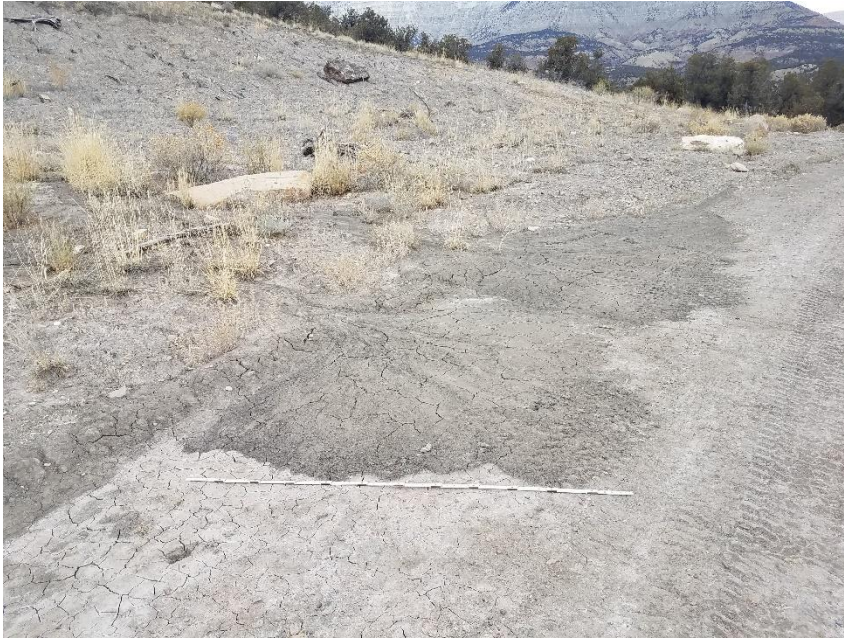
Photo 5: Photo taken from the access road, facing north. Photo shows sediment discharge from the Location onto the road. 6 foot measuring stick for reference.

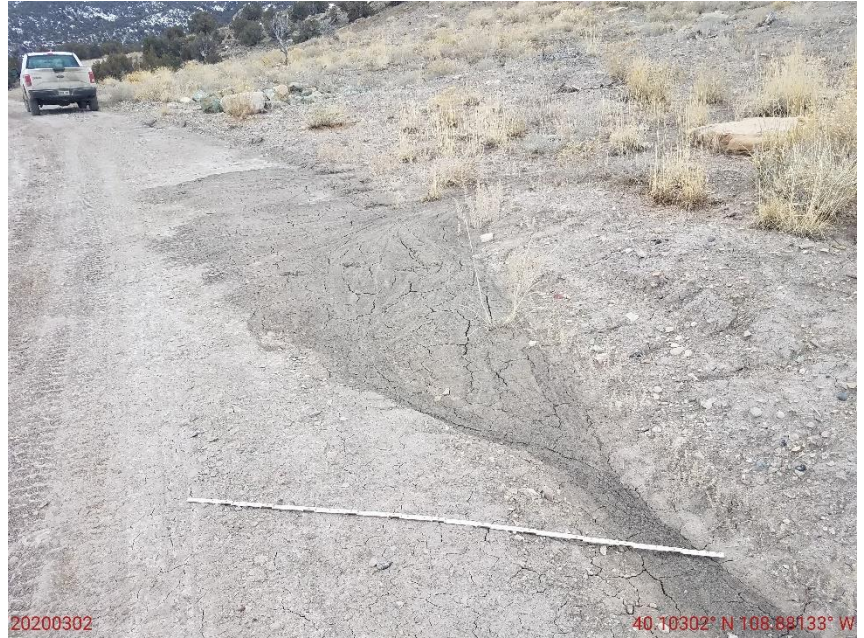
Photo 6: Photo taken from the access road, facing south. Photo shows sediment discharge from the Location onto the road. 6 foot measuring stick for reference.

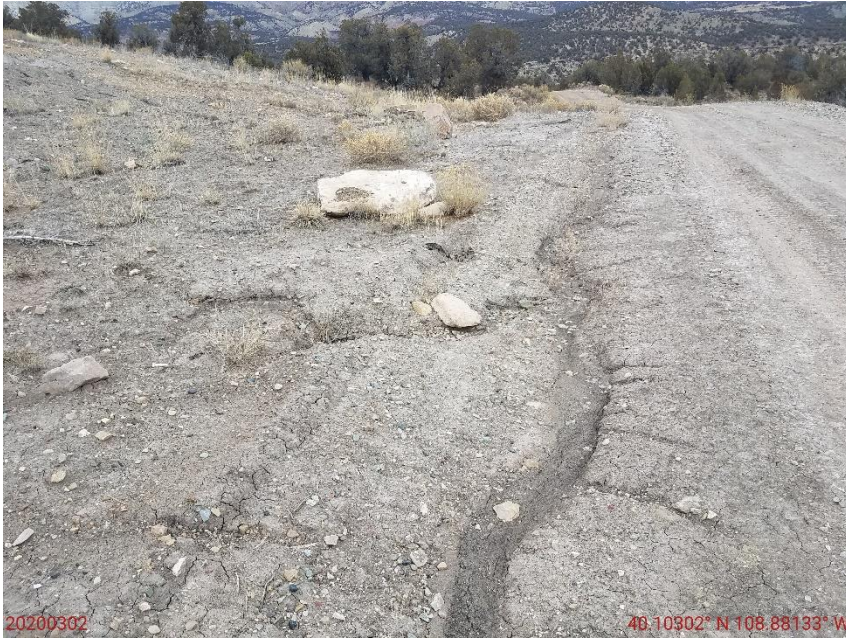
Photo 7: Photo taken from the access road, facing north. Photo shows stormwater runoff has caused degradation to the access road, and transported sediment off Location.

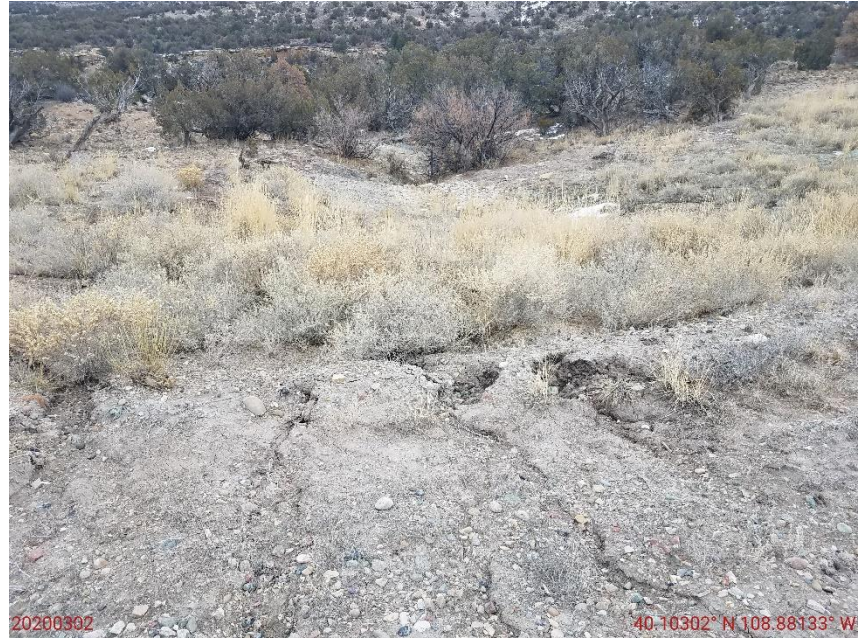
Photo 8: Photo taken from the access road, facing east. Photo shows erosion degradation on the eastern areas of the Location.

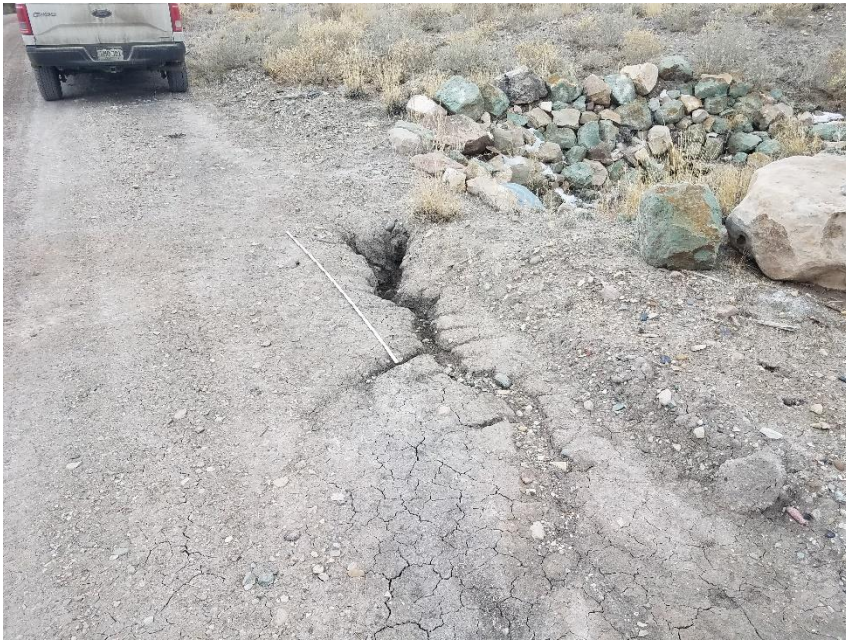
Photo 9: Photo taken from the access road, facing south. Photo shows stormwater erosion at access road has not been repaired/stabilized. Stormwater has continued to incise into the access road exposing the culvert. 6 foot measuring stick for reference.

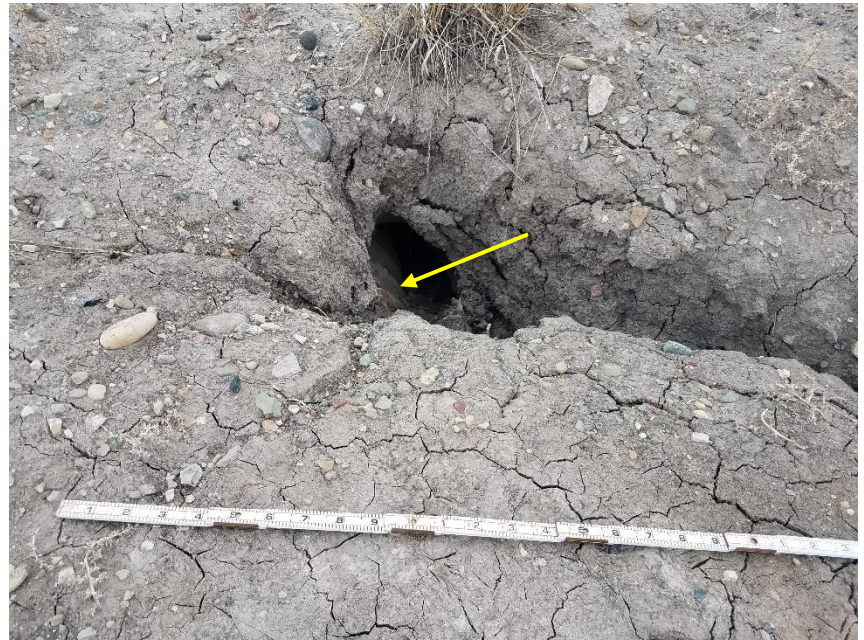
Photo 10: Continued from photo 9. Photo shows areas where Stormwater has continued to incise into the access road exposing the culvert (arrow).

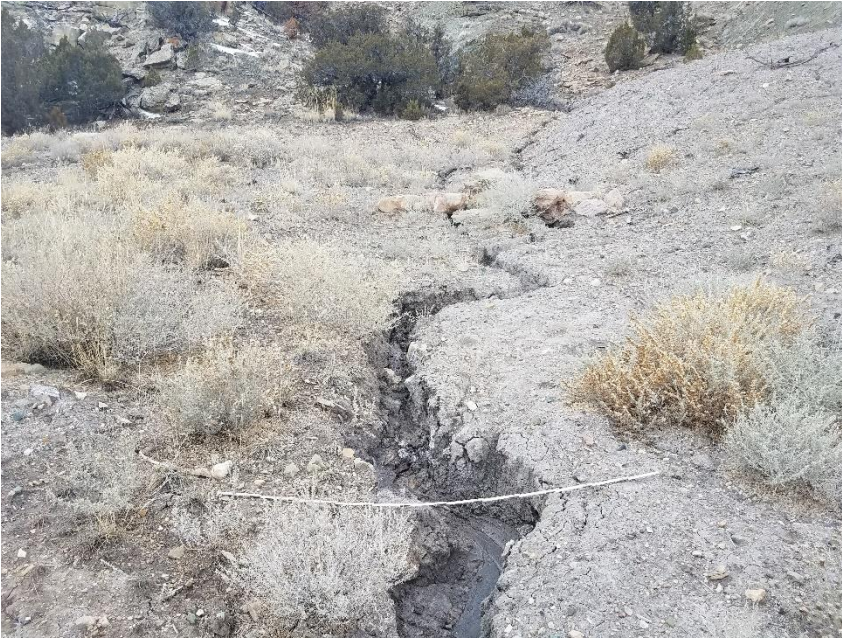
Photo 11: Photo taken from the Location, facing west. Photo shows gully erosion has not been repaired and stabilized, and stormwater BMPs have not been installed/maintained. 6 foot measuring stick for reference.

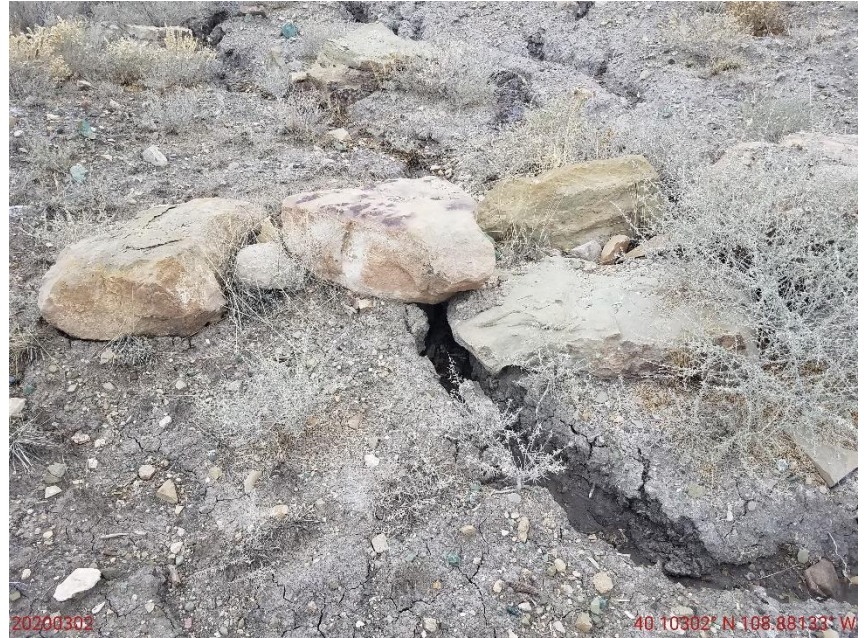
Photo 12: Photo taken from the Location, photo shows a rock-check documented in the previous inspection. Photo shows BMP has not been repaired or maintained in proper functioning condition, and installed in accordance with good engineering practices.

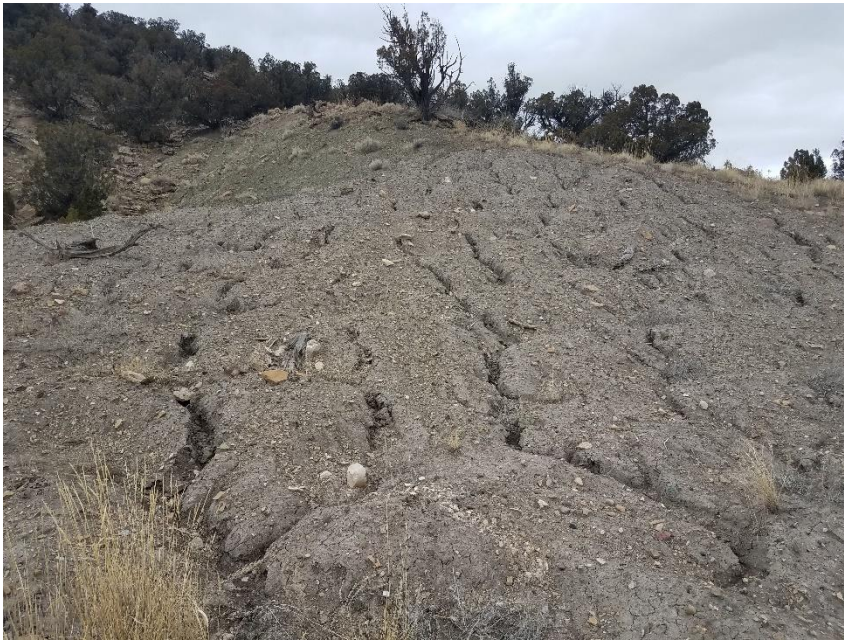
Photo 13: Photo taken from the Location, facing west. Photo shows slopes remain unstabilized; No additional reclamation or stormwater activities observed per corrective actions.

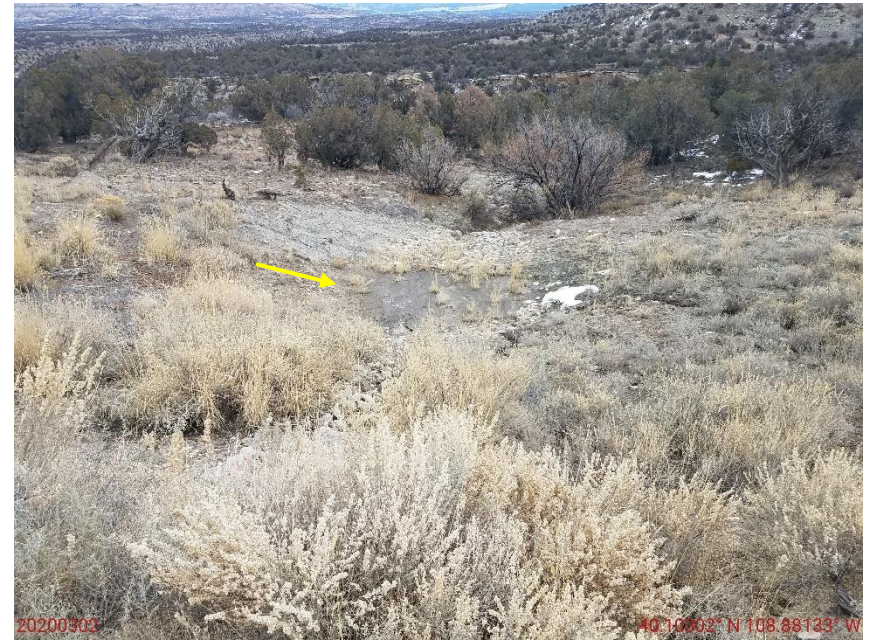
Photo 14: Photo taken from the east end of the location, facing east. Photo shows sediment trap has not been maintained and has filled with sediment due to sediment laden stormwater discharge.
