Pit Status Evaluation Form

Pit Name: WATKINS 1	Facility ID: 114647
Current Status: Unknown	Status Date: 9/23/1999
Current Operator: EXECUTIVE PROPERTIES INC / 28150	
Updated Operator:	
Form 15 Pit Permit Doc #:	Permit Date:
Related Facilities: WATKINS (OWP) #1 (API 05-009-05147, Facility ID 205454, Loc ID 320957)

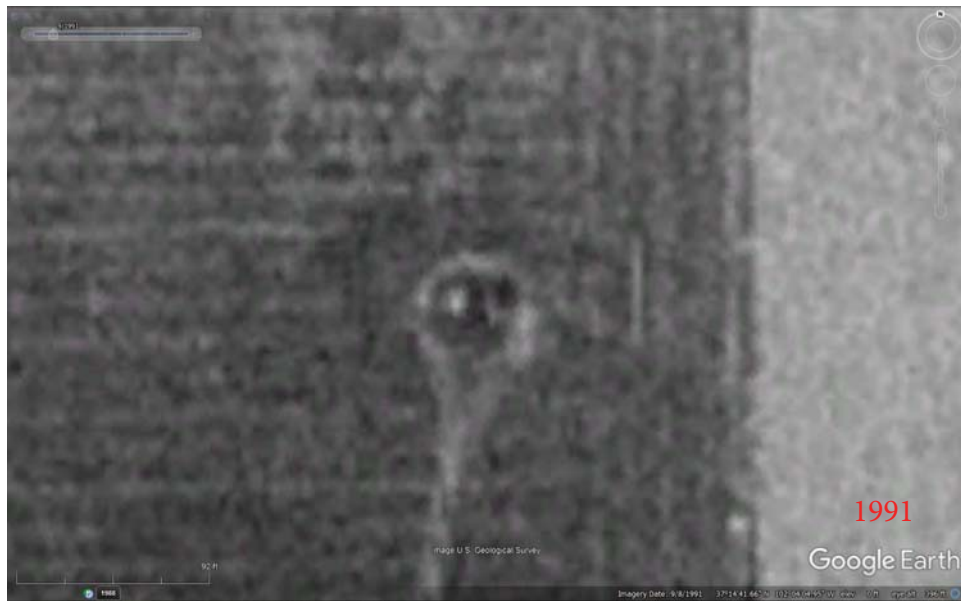
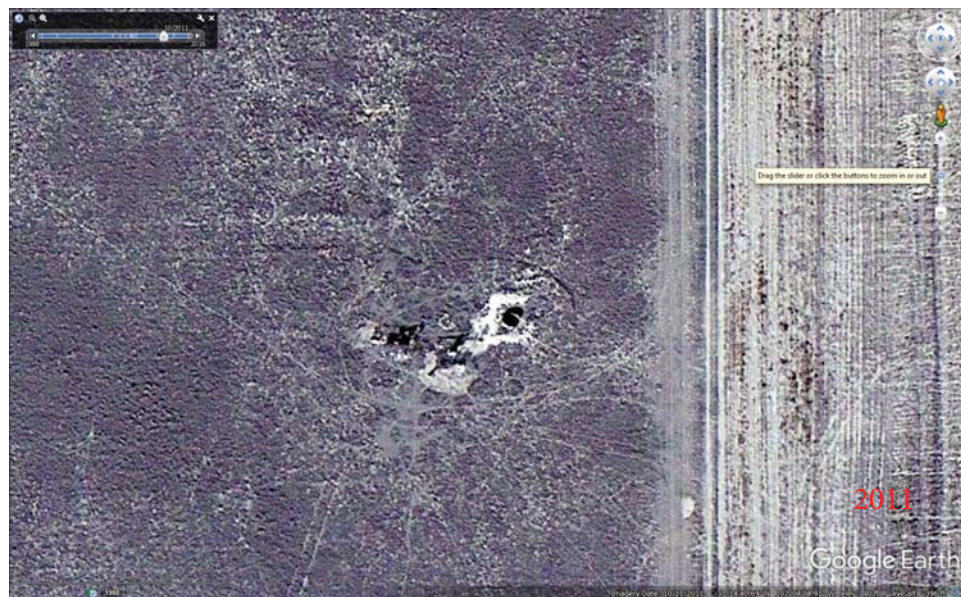
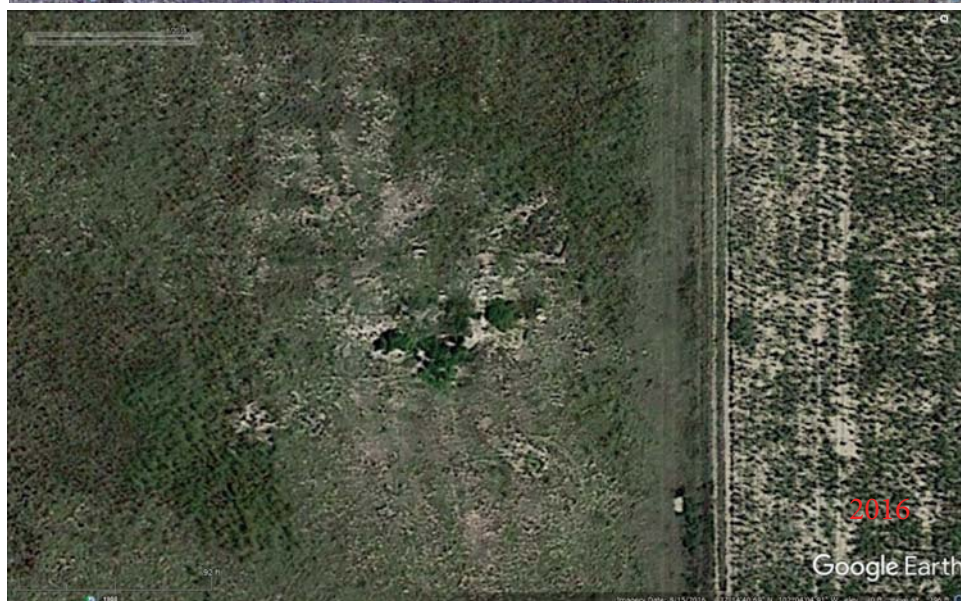
| <input checked="" type="checkbox"/> | Aerial Photo Verification (photos attached) | |

Based on records review there is no evidence that there was a pit on location; inspection reports document an open top fiberglass produced water tank on location. Pit status has been changed to closed.
