Inspection Photos
Operator: BP America
API#: 067-06818
Date: 3/2/2020

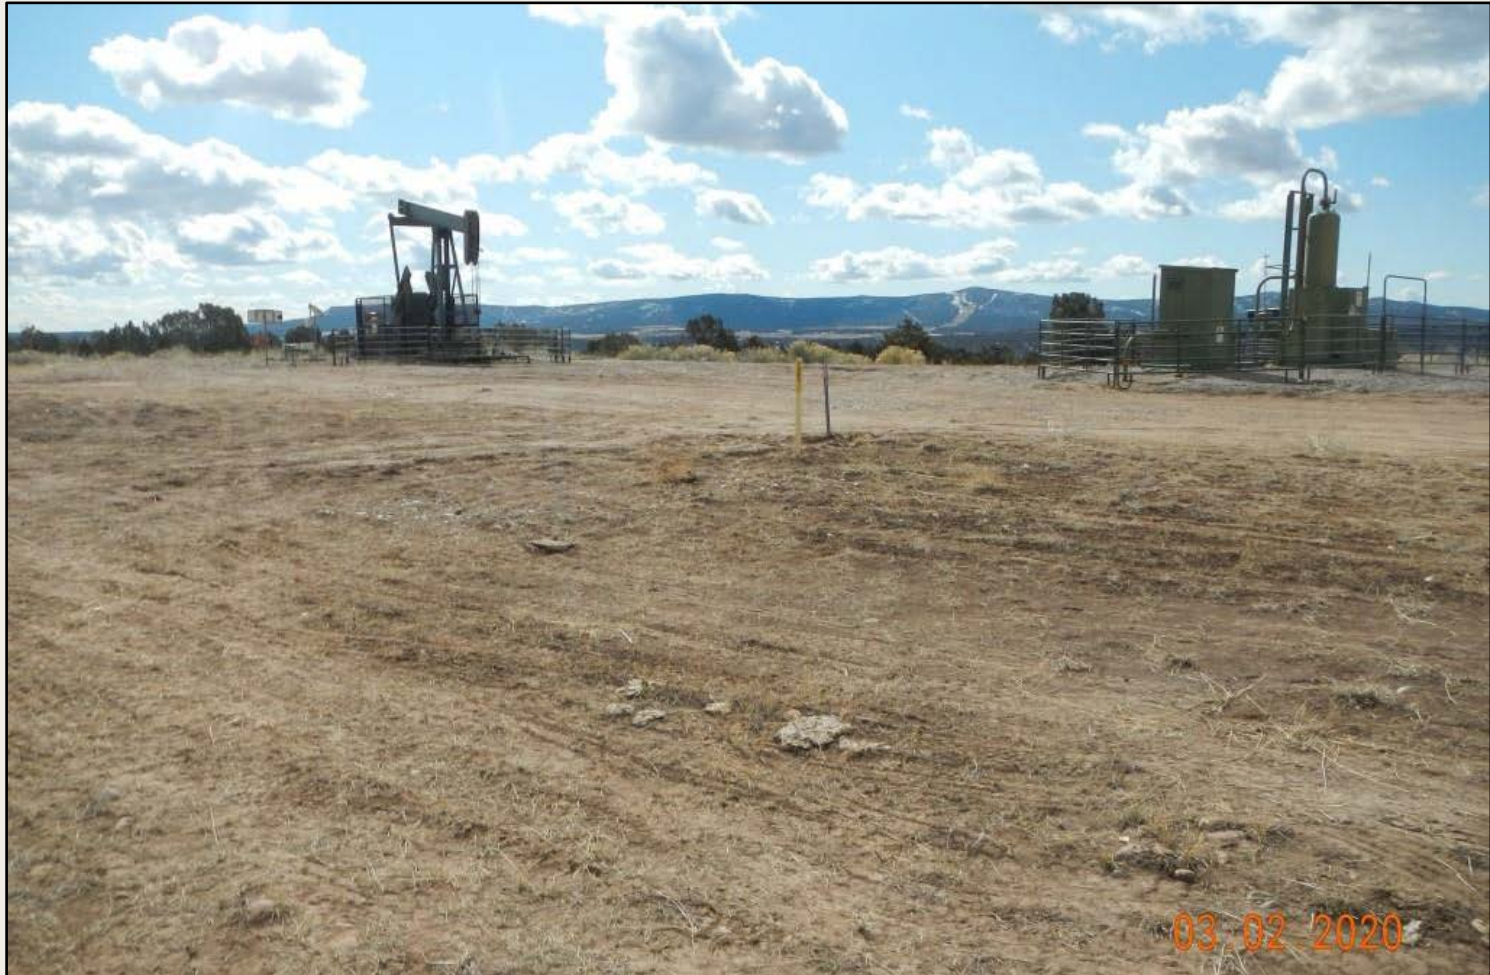
Photo 1. View of the project area from the northeastern corner facing center. Recent work on the well pad has resulted in compacted and damaged vegetation on the flat well pad surface.

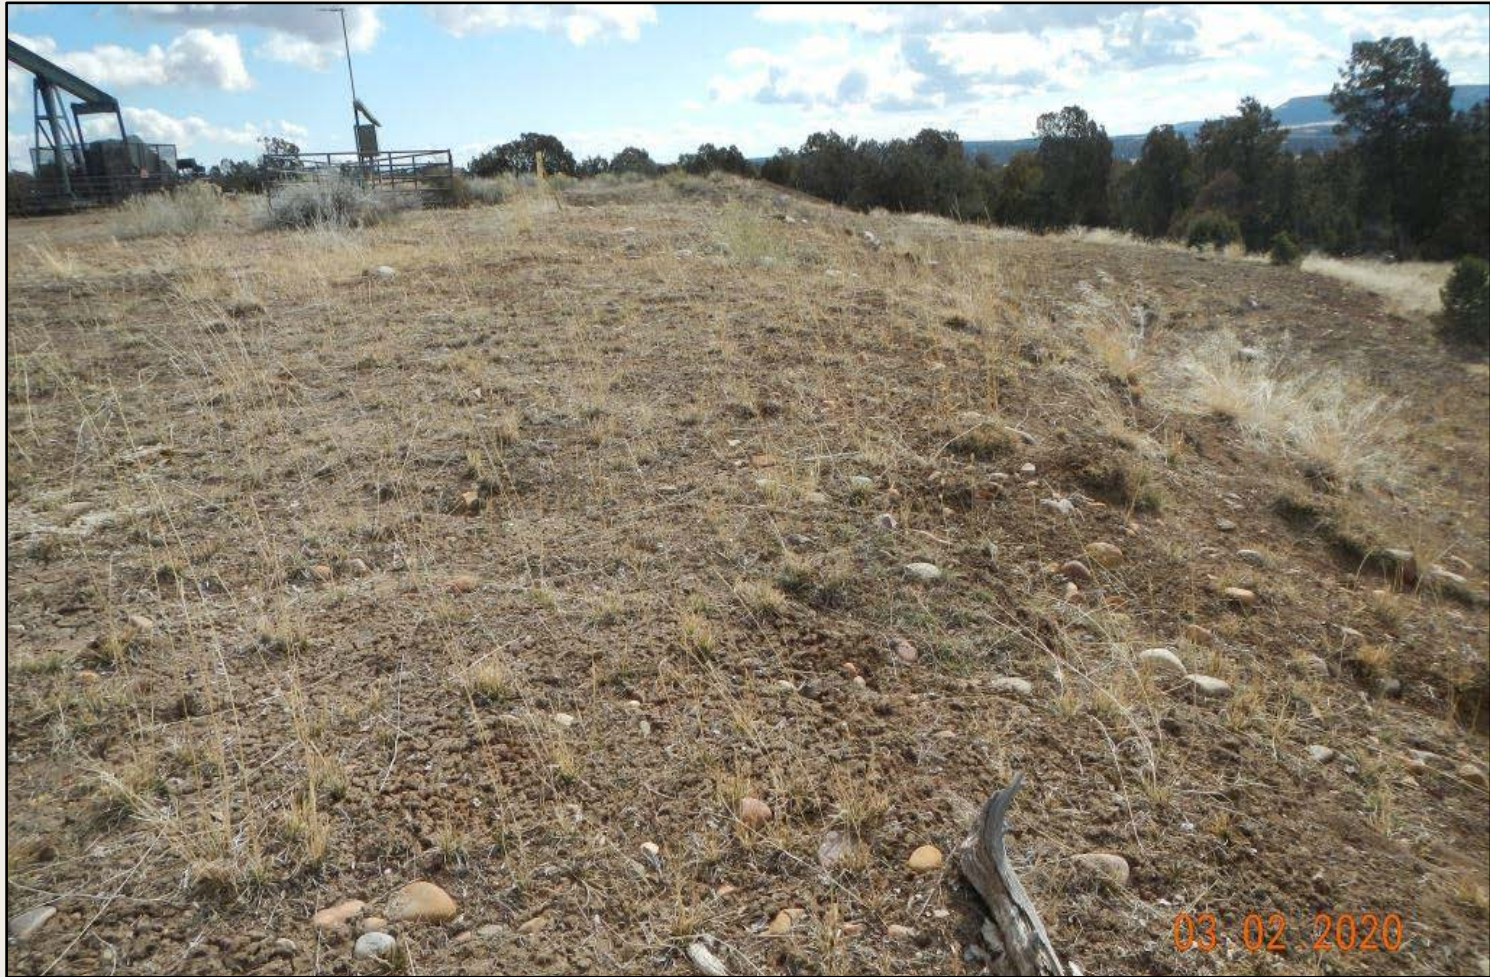
Photo 2. View of the southern fill slope facing eastward, revegetation is grazed but appears to be progressing with grasses such as sand dropseed and western wheatgrass.

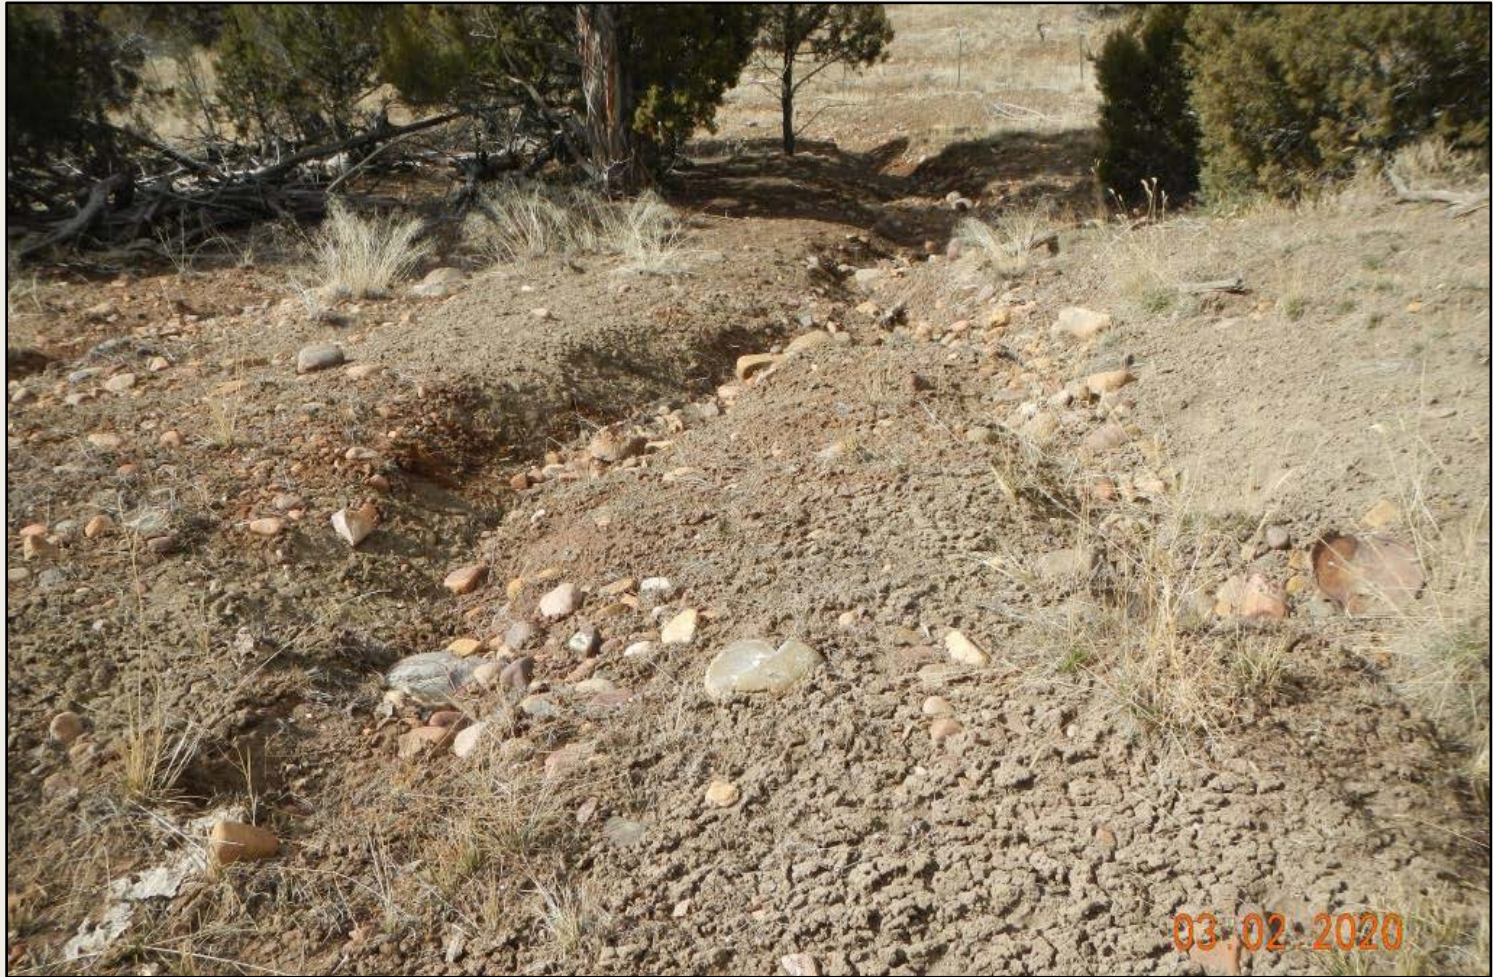
Photo 3. View of erosional channels approximately 2 feet wide and 1.5 feet deep within the southern project area.

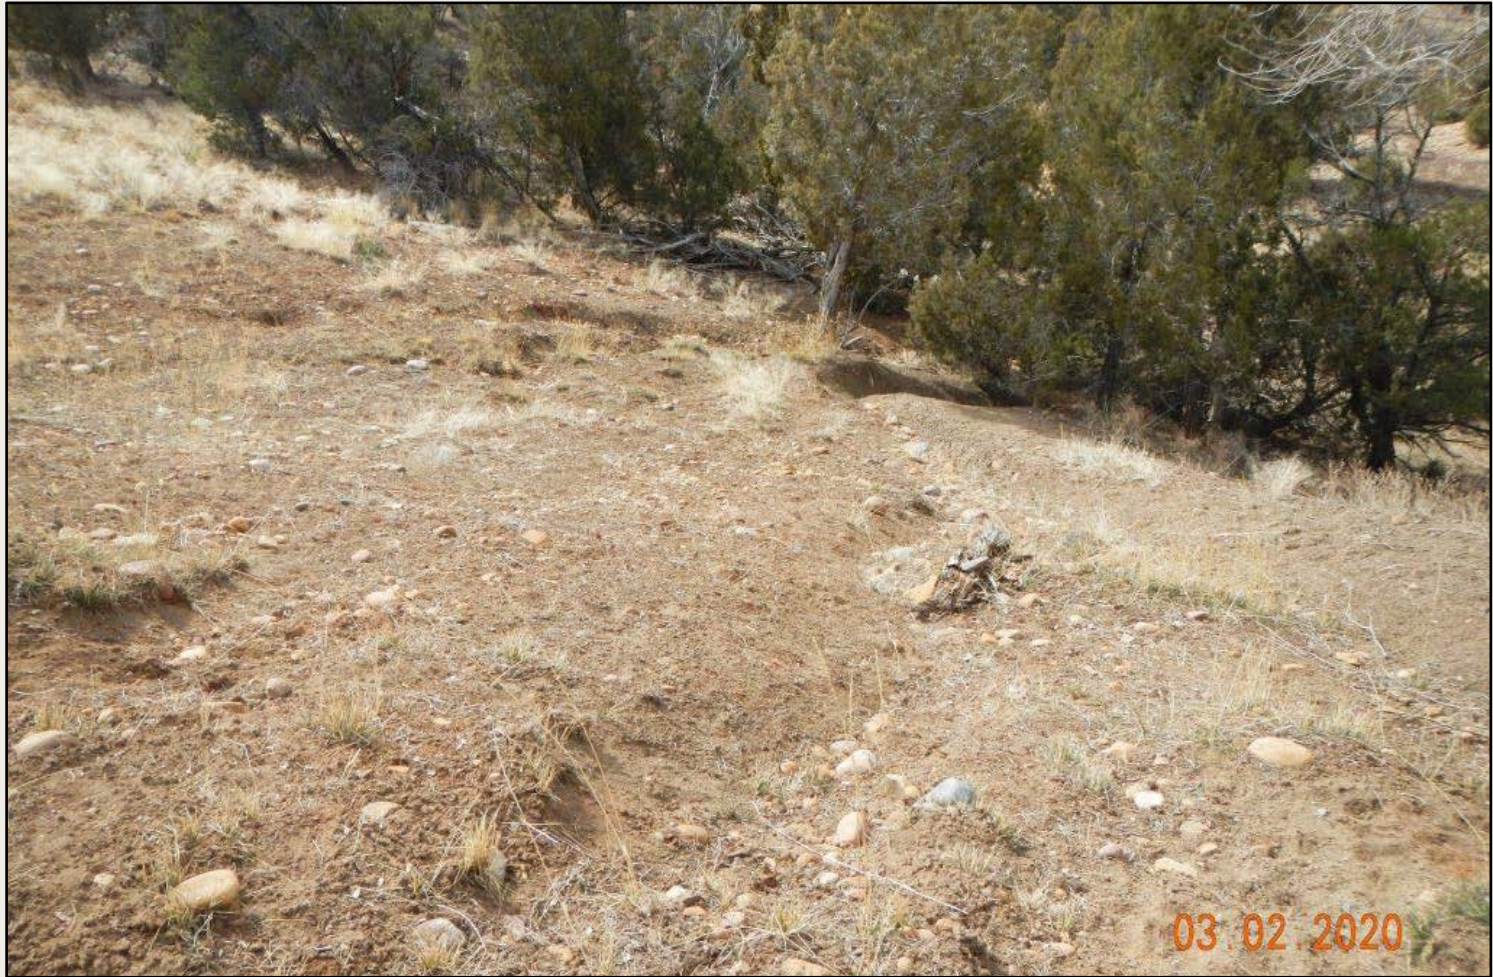
Photo 4. View of more erosional channels within the southern project area.

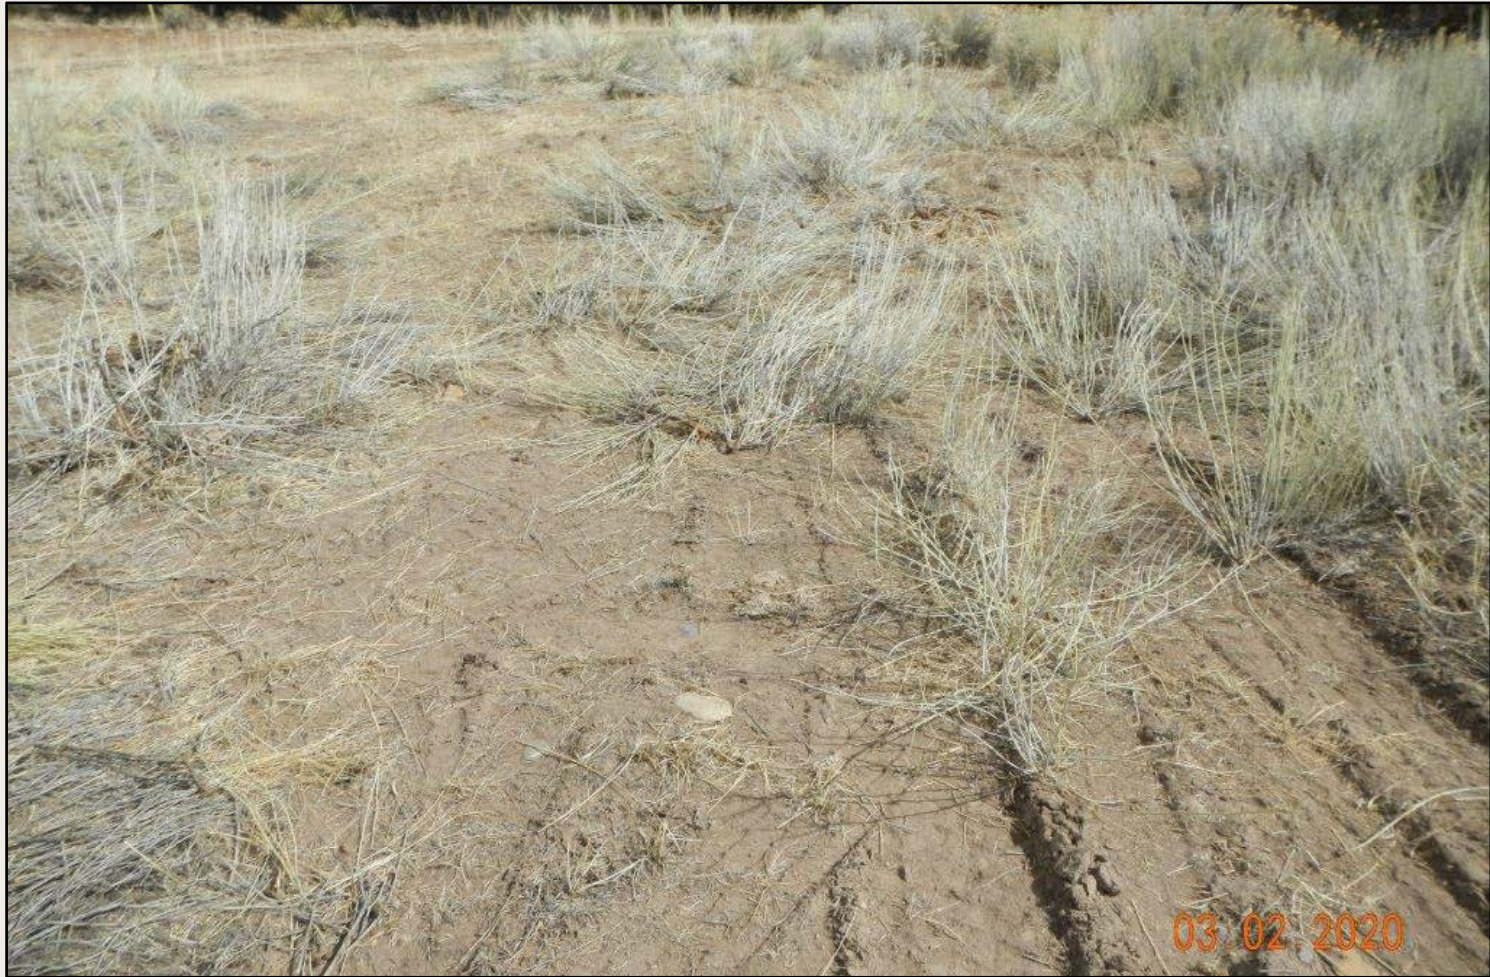
Photo 5. View of damaged vegetation and evidence of vehicle compaction within the flat revegetation area.

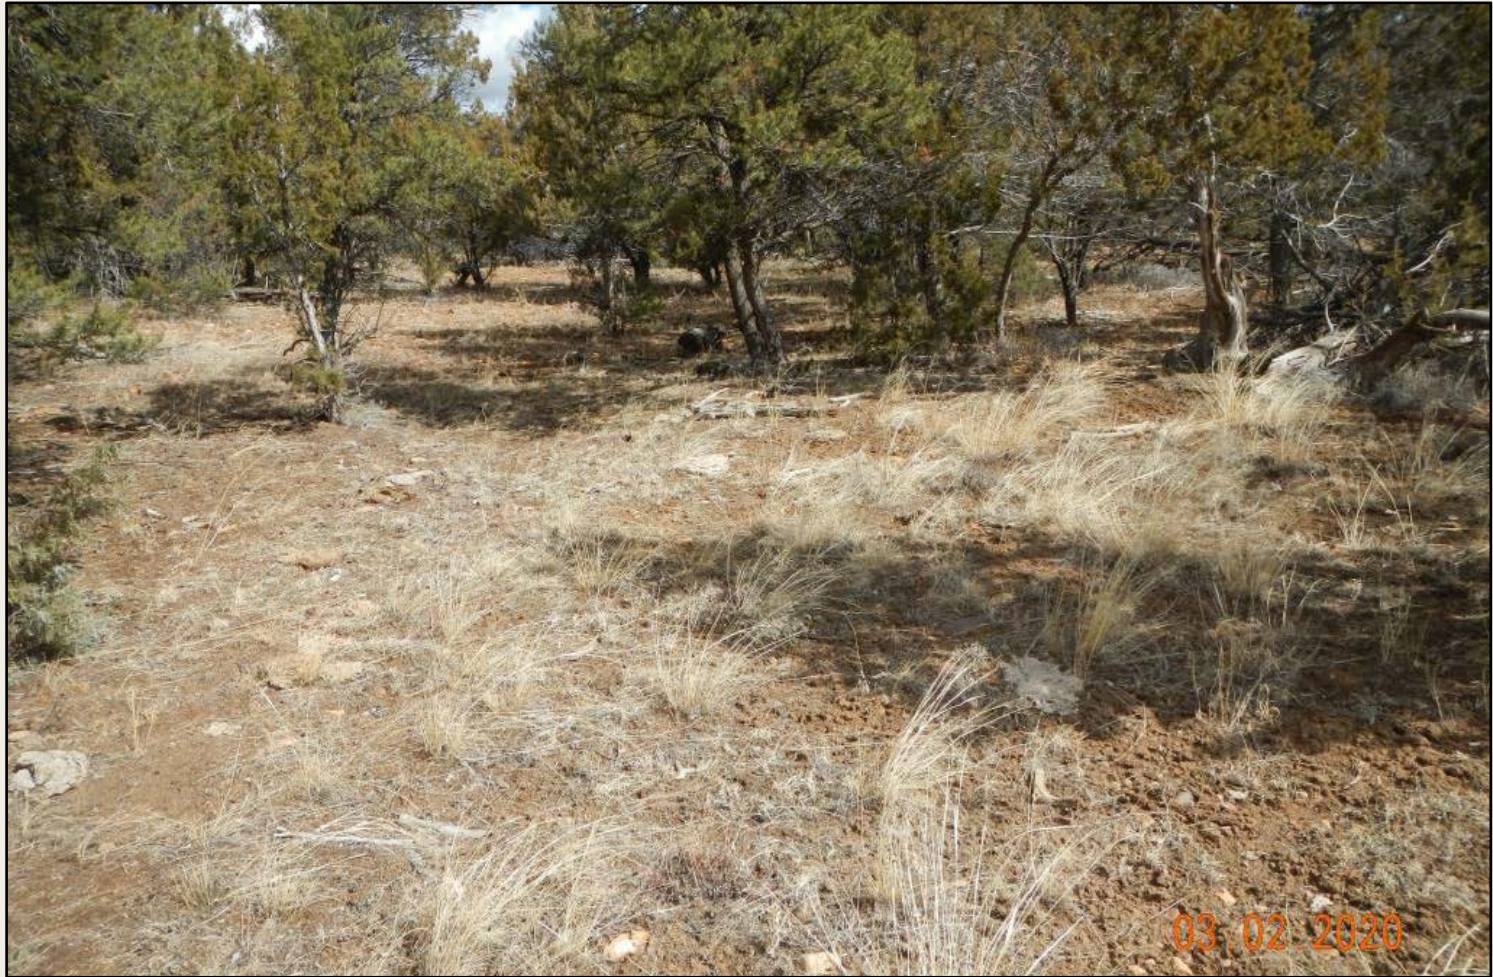
Photo 6. View of reference area vegetation comprised pinyon juniper woodland with herbaceous understory comprised of grasses such as Indian ricegrass and muttongrass and forbs in a dormant vegetative condition.
