Inspection Photos

3/2/2020

Operator: LARAMIE ENERGY LLC # 10433

Location ID: 436835

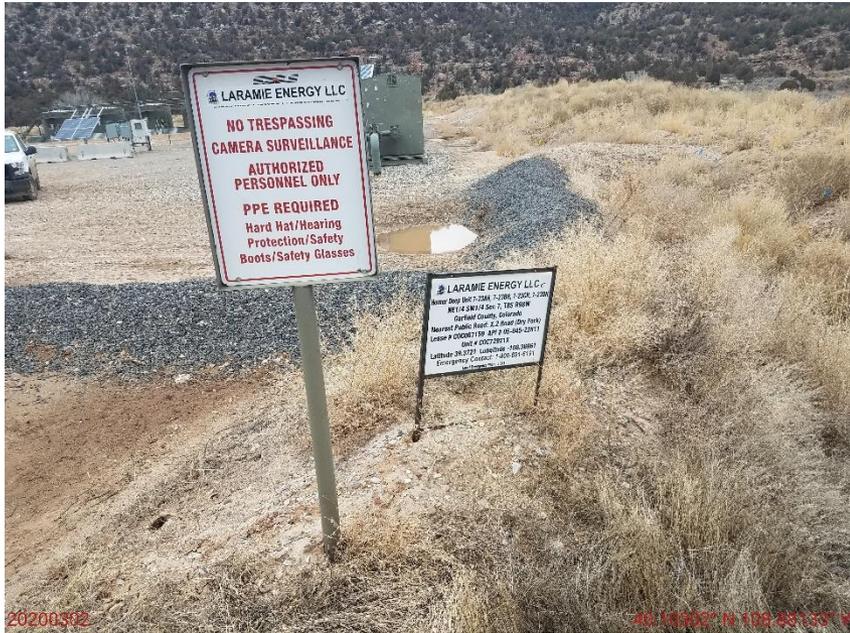
Photo 1: Photo taken from the Location entrance, facing west. Photo shows signage at Location entrance.

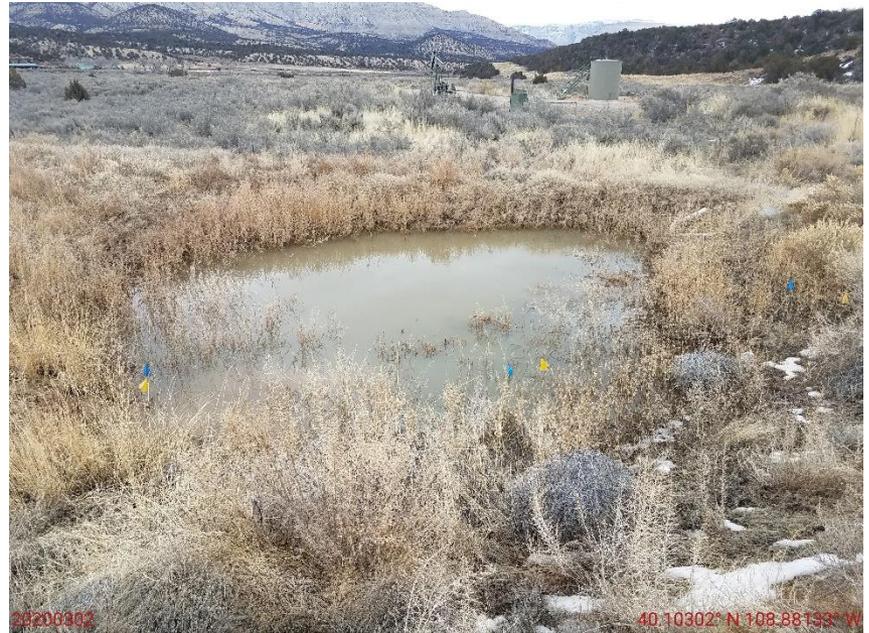
Photo 2: Photo taken from the sediment pond/trap on the east end of the Location, facing northeast. Photo shows BMP has not been constructed in accordance with good engineering practices; BMP missing an adequate outlet to allow for sediment laden-free stormwater discharge from the Location.

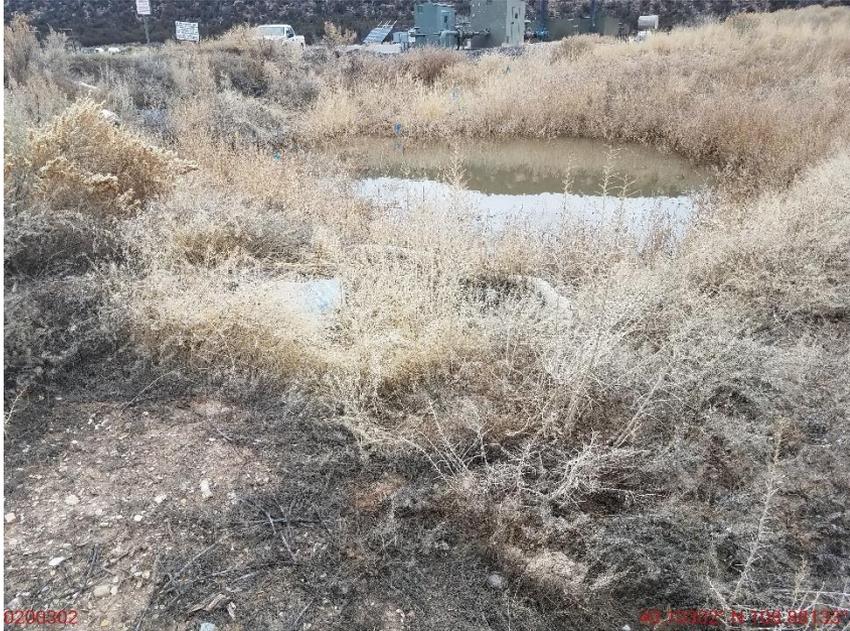
Photo 3: Continued from photo 2. Photo taken from east end of the sediment trap, facing west. Photo shows BMP has not been constructed in accordance with good engineering practices; BMP missing an adequate outlet to allow for sediment laden-free stormwater discharge from the Location.

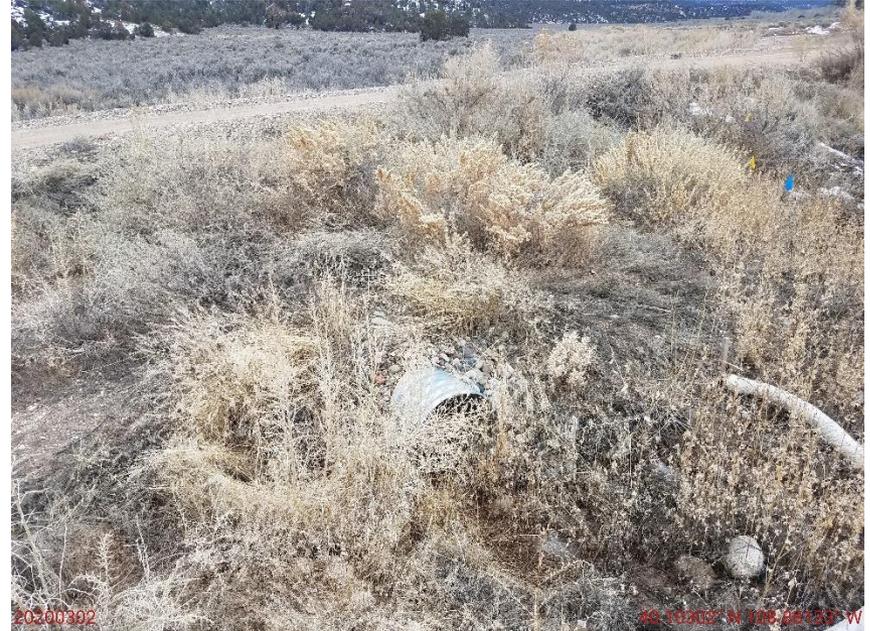
Photo 4: Continued from photo 2. Photo taken from east end of the sediment trap, facing south. Photo shows a culvert leading from the adjacent lands to the south, into the sediment trap. Based on the topography observed, it would appear as though water from the adjacent lands would travel through the culvert and into the sediment trap. Culvert inlets have not been protected/armored in accordance with good engineering practices.

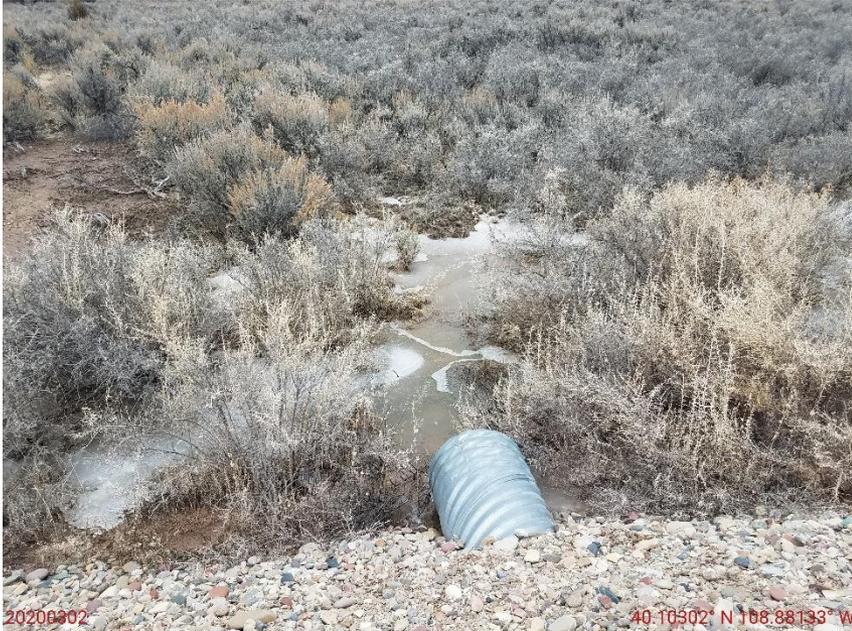
Photo 5: Continued from photo 4, photo shows culvert leading to sediment trap on the south end of the access road. See comments under photo 4.

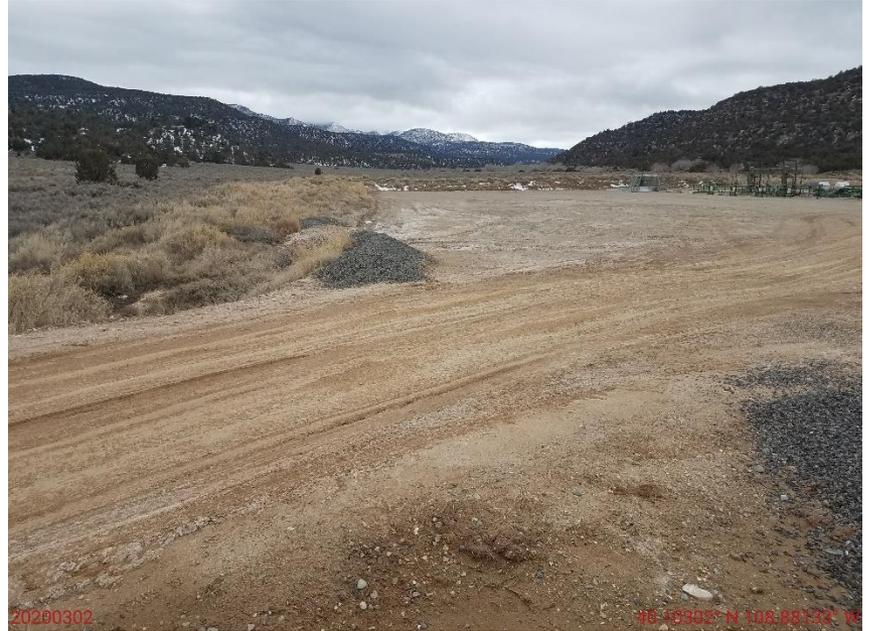
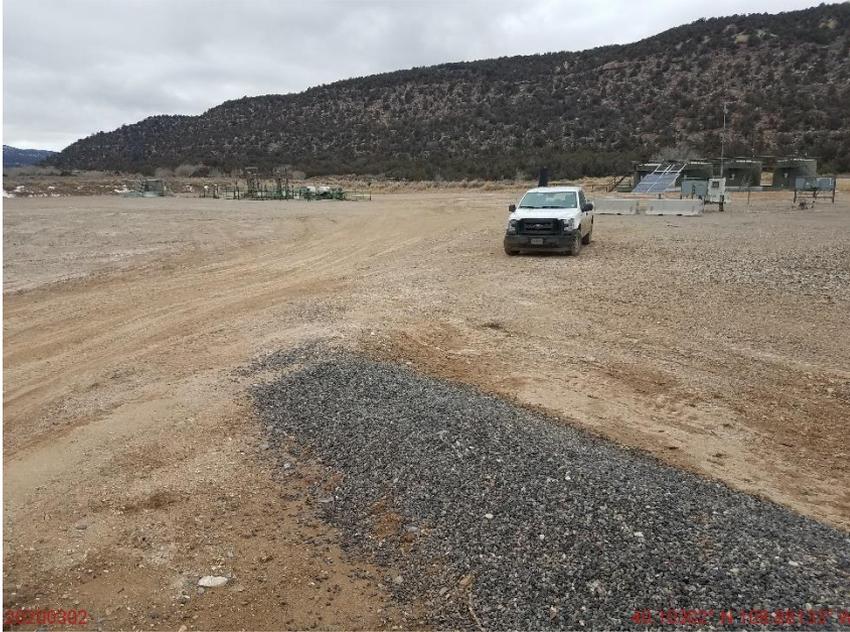
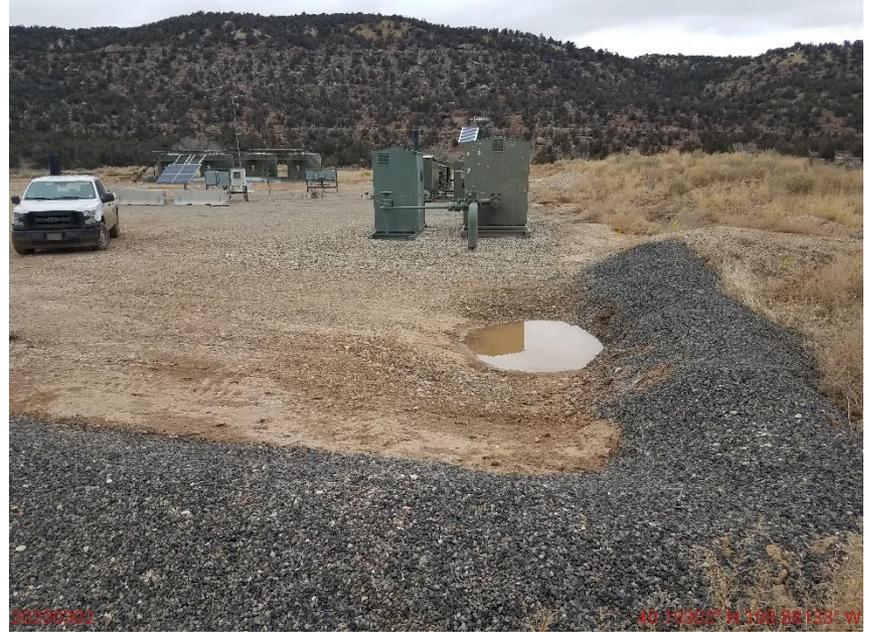
Photo 6: Photo taken from the east end of the Location (Location entrance), facing southwest. Photos 6-8 provide an overview of the Location from southwest, west to northwest.

Photo 7: See comments under photo 6.

Photo 8: See comments under photo 6.

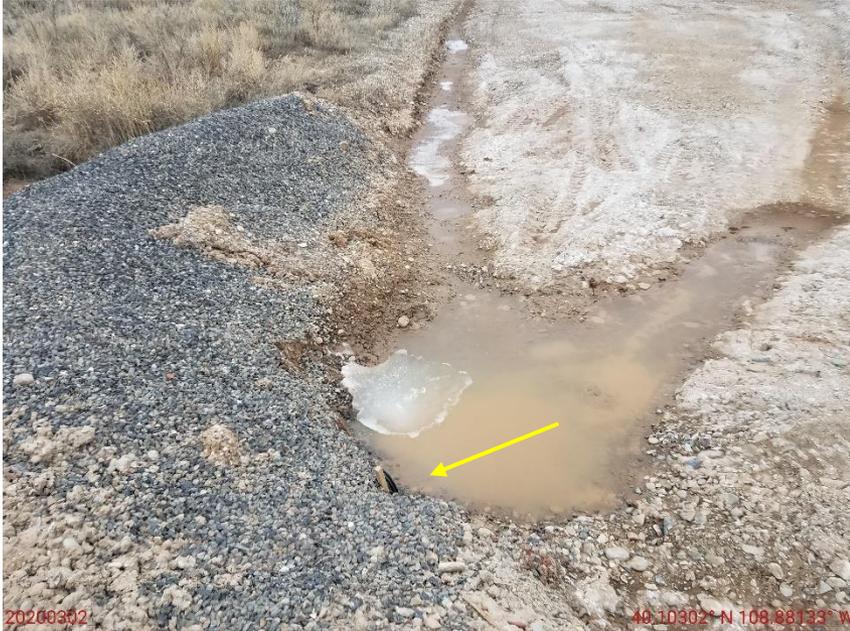
Photo 9: Photo taken from east end of the Location (southwest from the entrance). Photo shows area of the Location where Operator appears to have constructed stormwater diversion ditch to discharge stormwater from the pad off Location through a culvert (arrow). BMP has not been constructed in accordance with good engineering practices; BMP missing sufficient inlet/outlet protection to trap sediment and allow for sediment laden-free stormwater discharge.

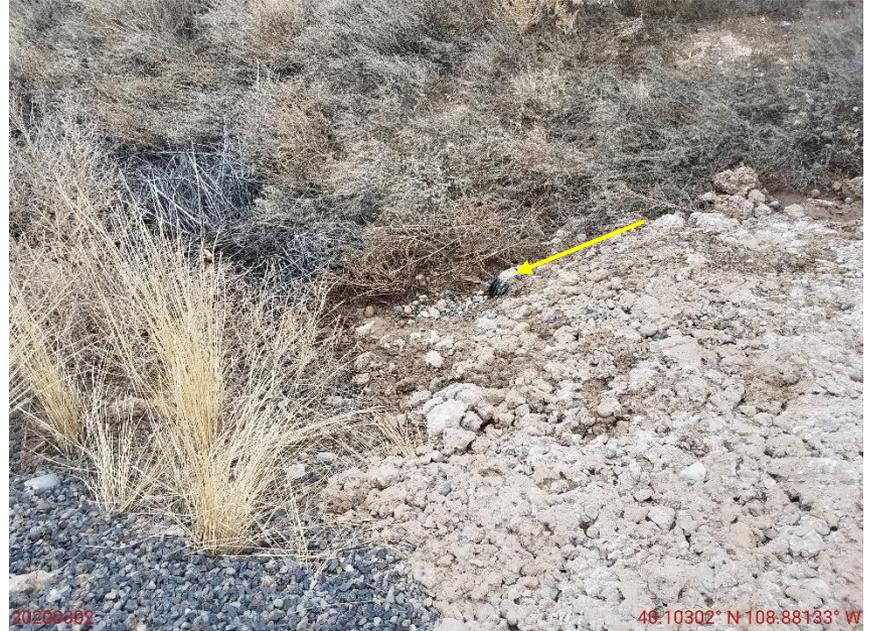
Photo 10: Continued from photo 9. Photo shows culvert outlet leading off Location. See comments under photo 9.

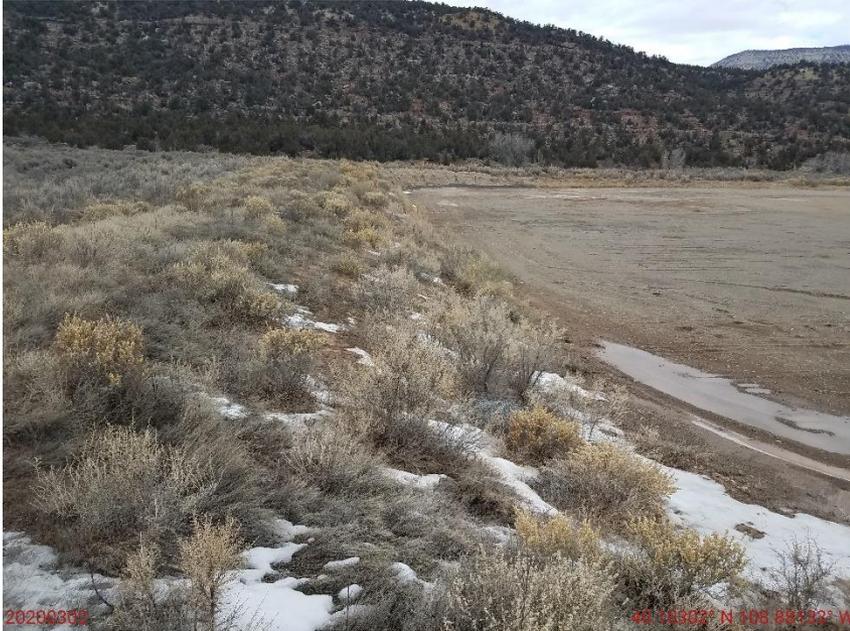
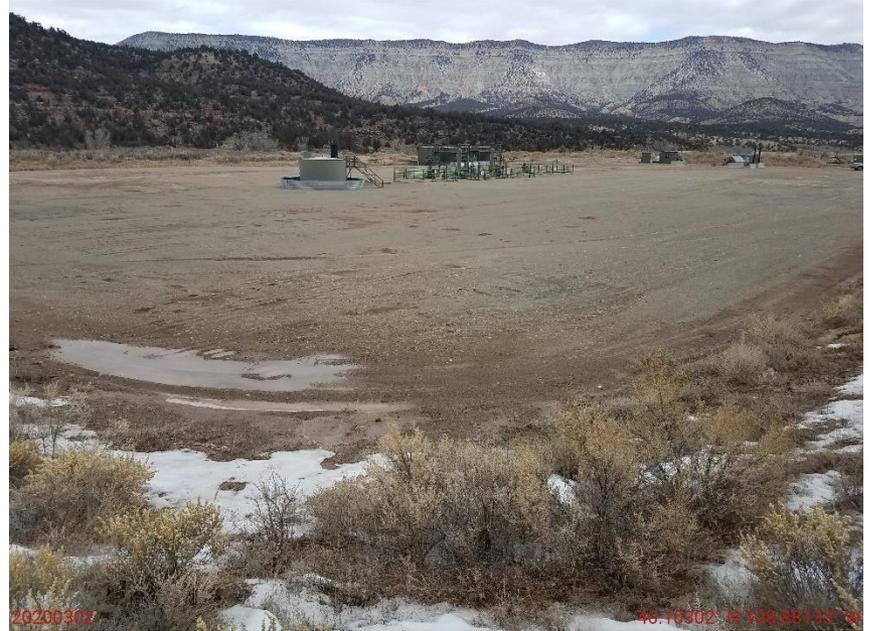
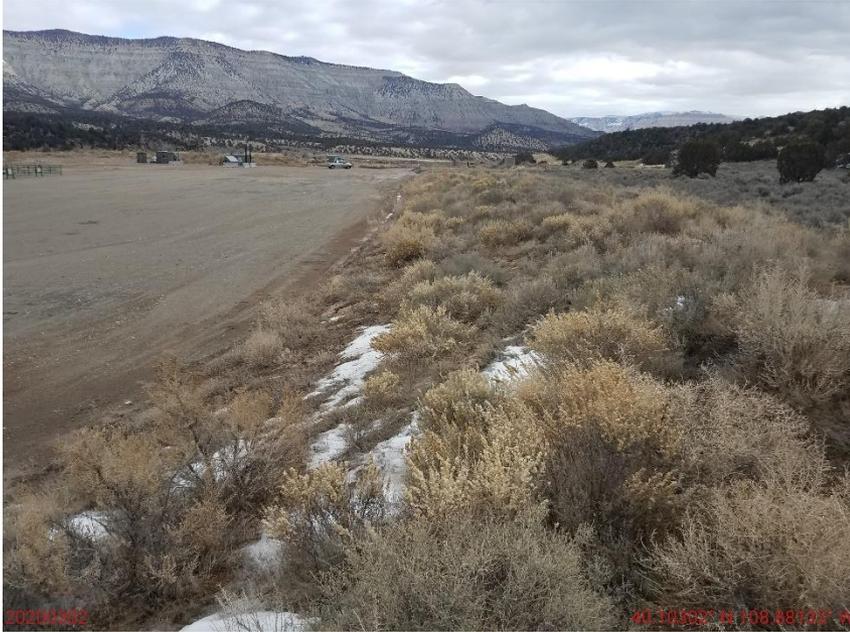
Photo 11: Photo taken from the south corner of the Location facing northwest. Photos 11-13 provide an overview of the Location from northwest, north to northeast. Photos show areas of the Location that are not needed for production and needs to be reclaimed in accordance with 1003 rules.

Photo 12: See comments under photo 11.

Photo 13: See comments under photo 11.

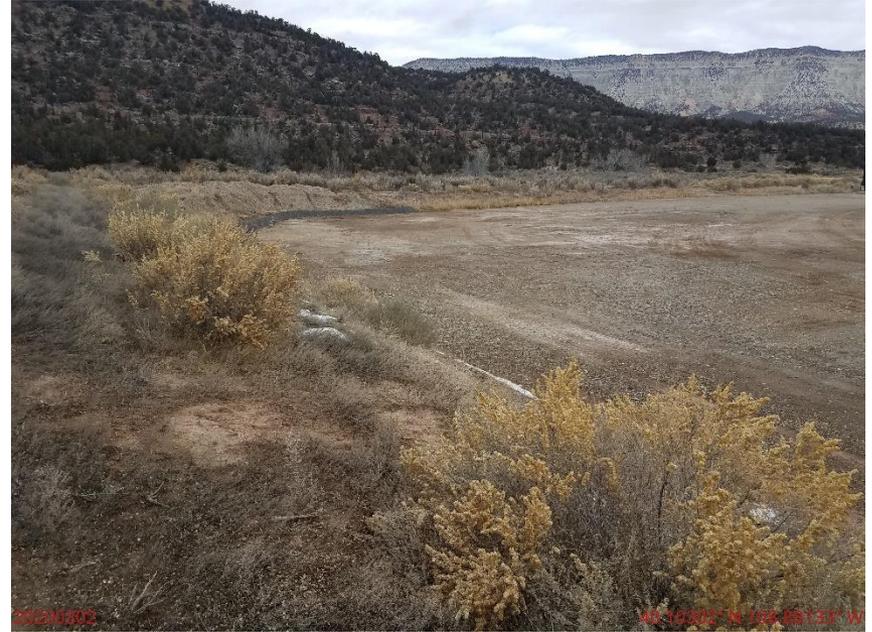
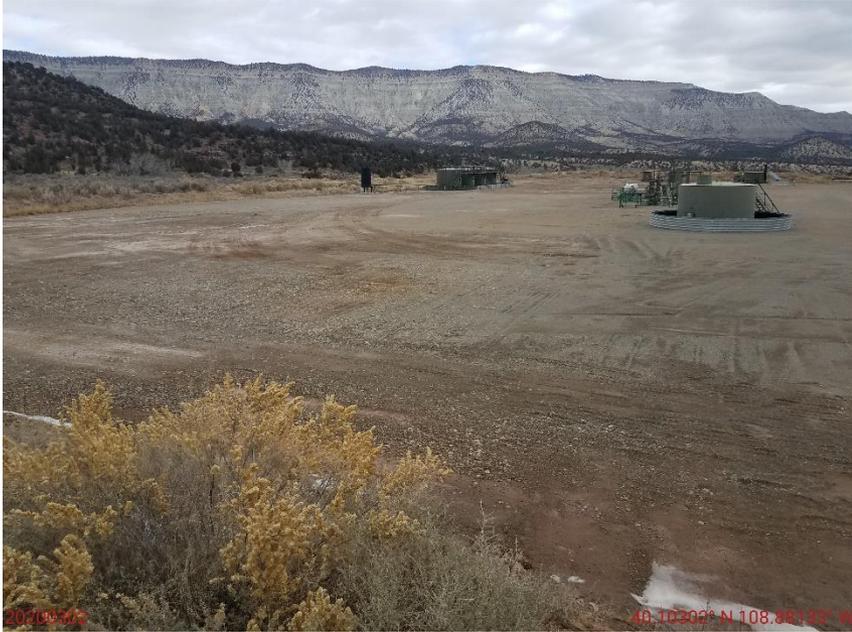
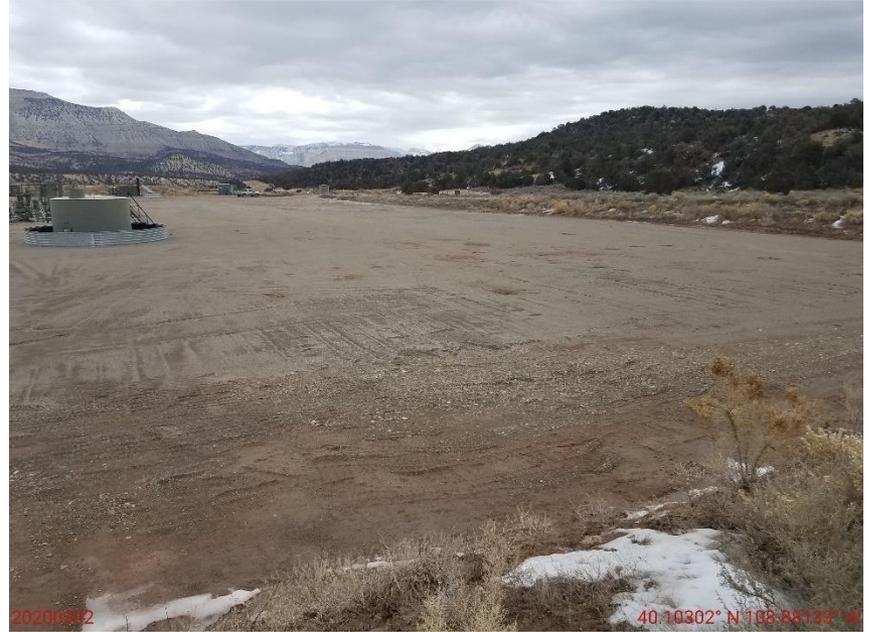
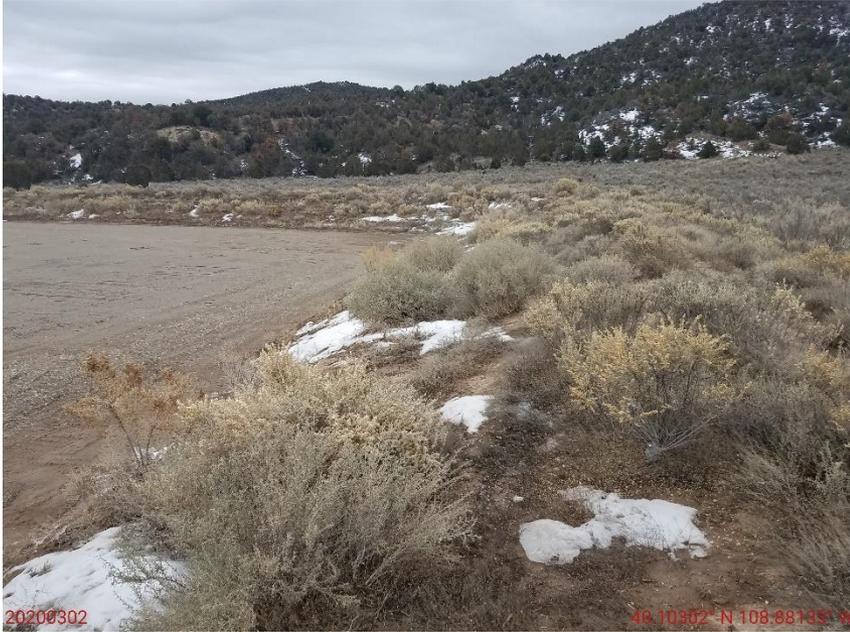
Photo 14: Photo taken from the southwest end of the Location facing northwest. Photos 14-17 provide an overview of the Location from northwest, north to northeast to east. Photos show areas of the Location that are not needed for production and needs to be reclaimed in accordance with 1003 rules.

Photo 15: See comments under photo 14.

Photo 16: See comments under photo 14.

Photo 17: See comments under photo 14.

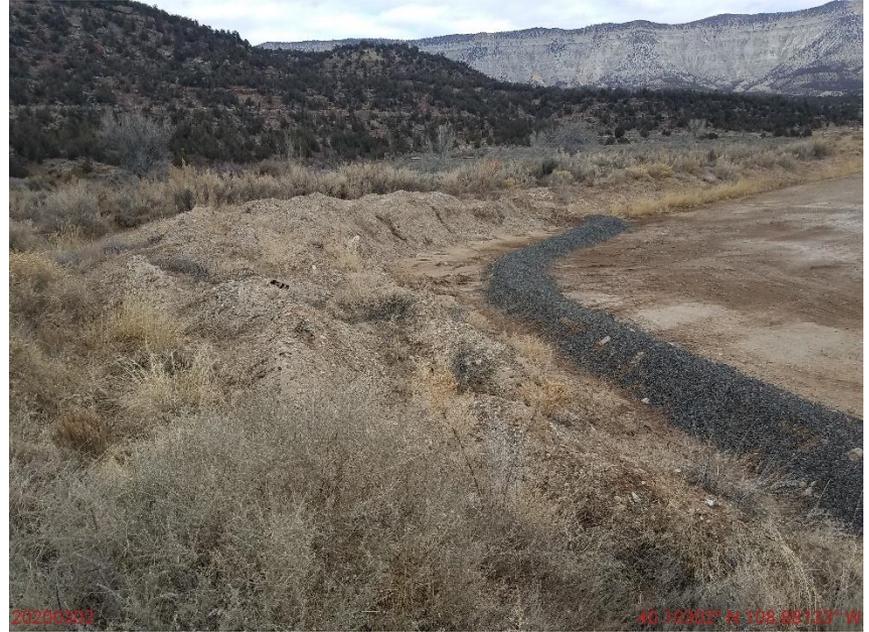
Photo 18: Photo taken from the western corner of the Location, facing west. Photo shows slopes of the Location have not been stabilized; erosion degradation evident.

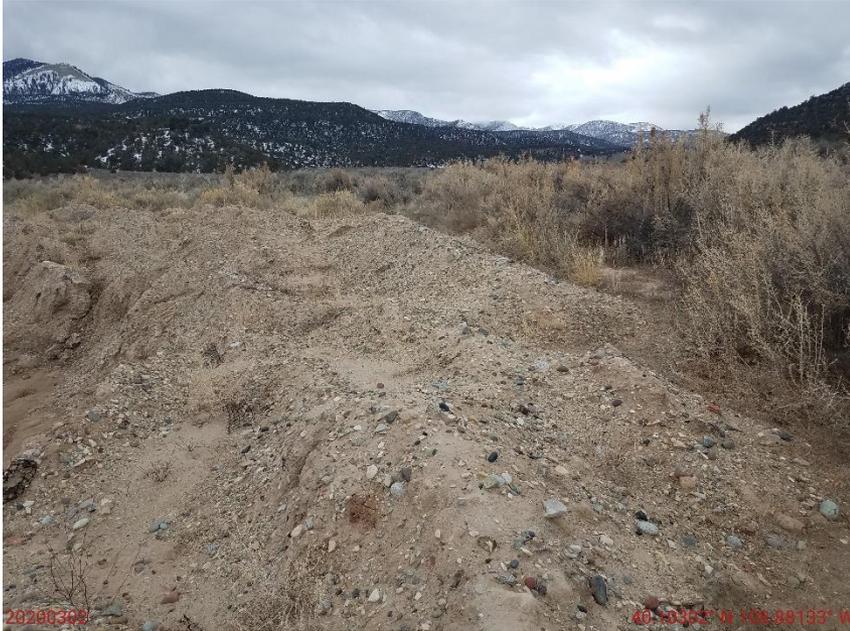
Photo 19: Photo taken from the western corner of the Location, facing southwest. Photo shows slopes of the Location have not been stabilized; erosion degradation evident.

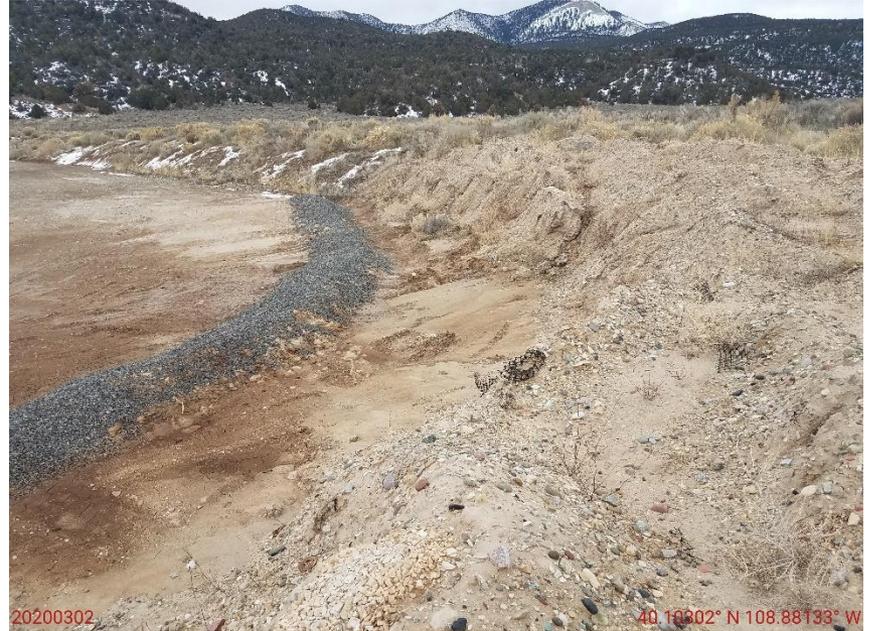
Photo 20: Photo taken from the western corner of the Location, facing southwest. Photo shows slopes of the Location have not been stabilized; erosion degradation evident.

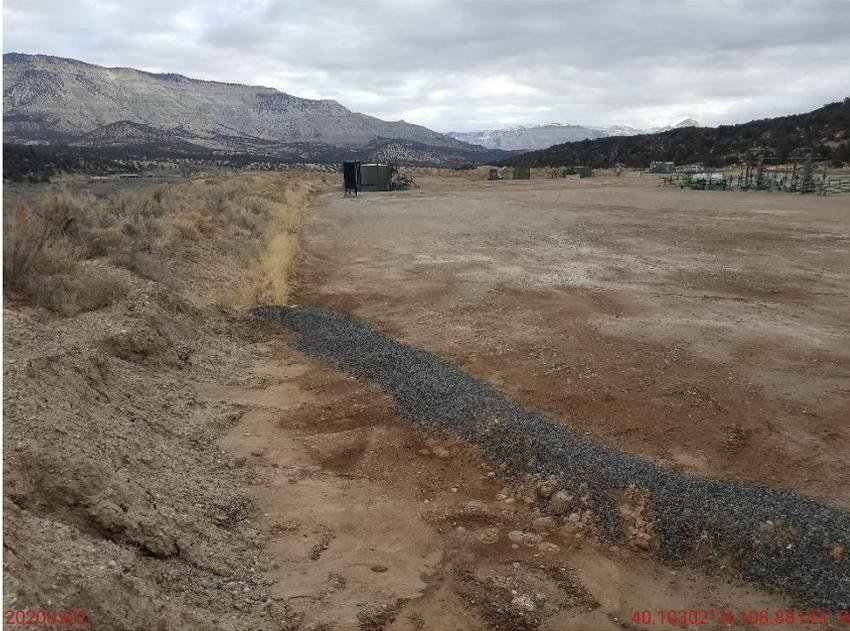
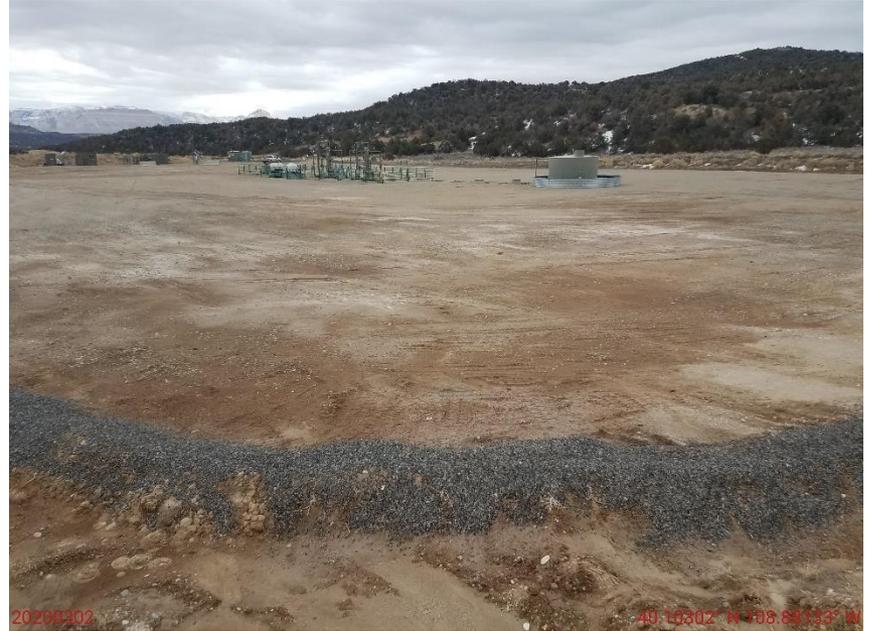
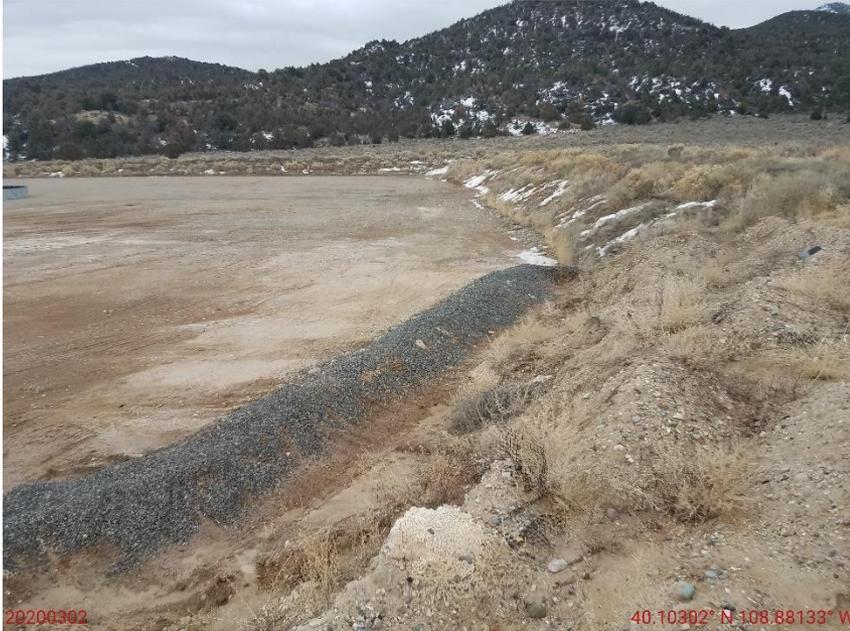
Photo 21: Photo taken from the western corner of the Location facing northeast. Photos 21-23 provide an overview of the Location from northeast, east to southeast. Photos show areas of the Location that are not needed for production and needs to be reclaimed in accordance with 1003 rules.

Photo 22: See comments under photo 21.

Photo 23: See comments under photo 21.

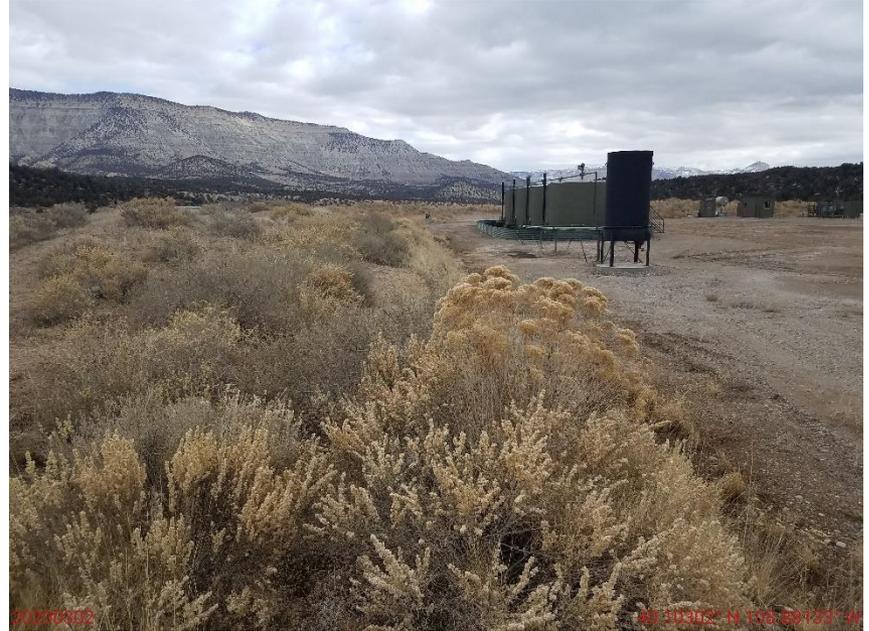
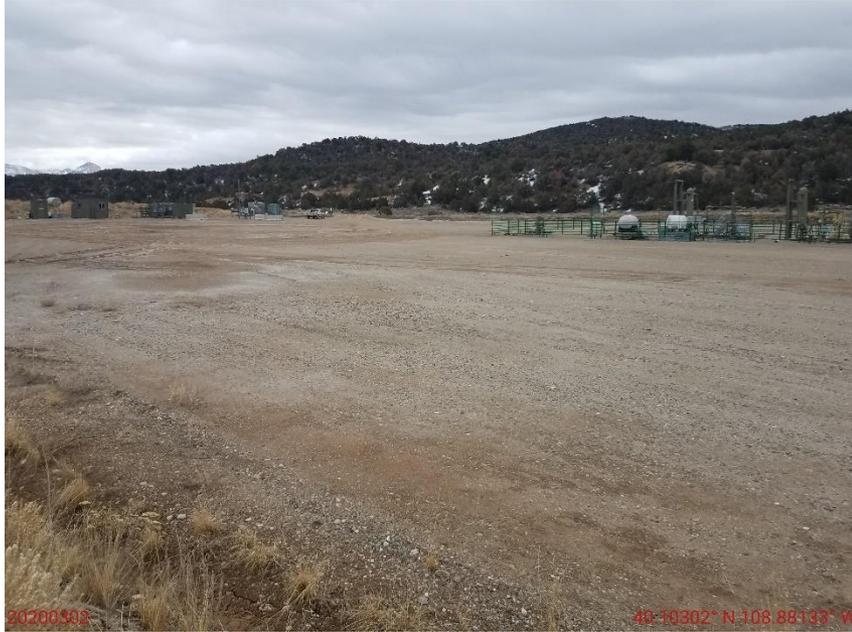
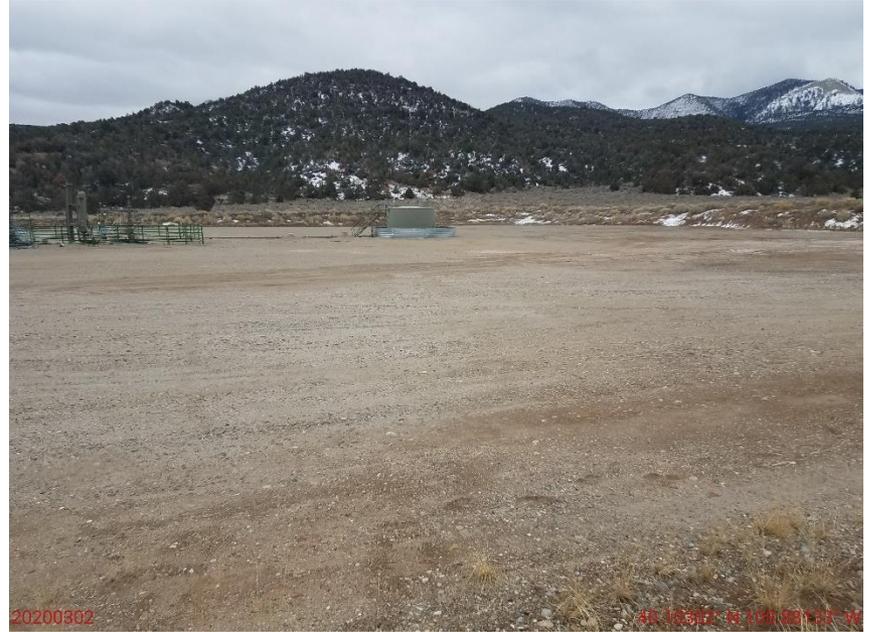
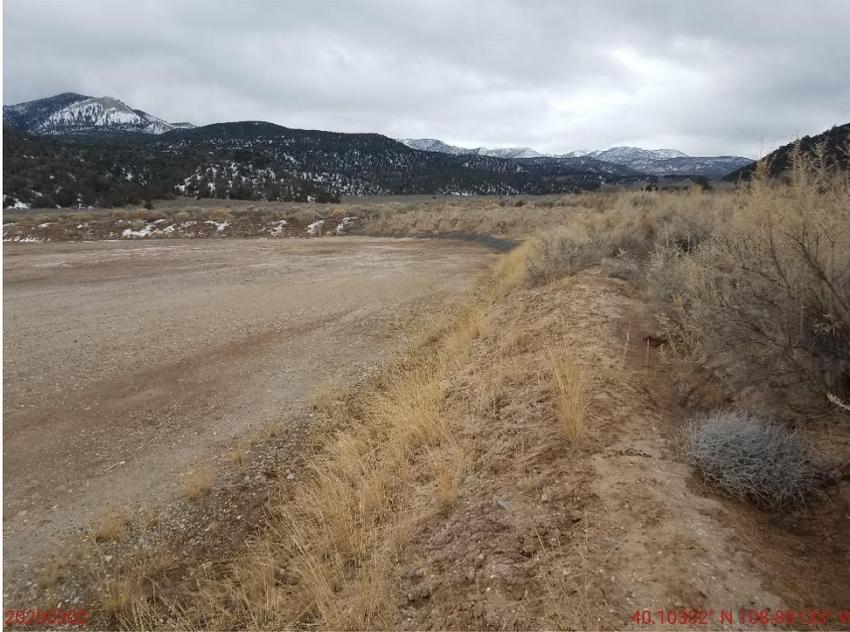
Photo 24: Photo taken from the northwest end of the Location, facing northeast. Photos 24-27 provide an overview of the Location from northeast, east, southeast to south. Photos show an overview of the Location, including areas of the Location that are not needed for production and needs to be reclaimed in accordance with 1003 rules.

Photo 25: See comments under photo 24.

Photo 26: See comments under photo 24.

Photo 27: See comments under photo 24.

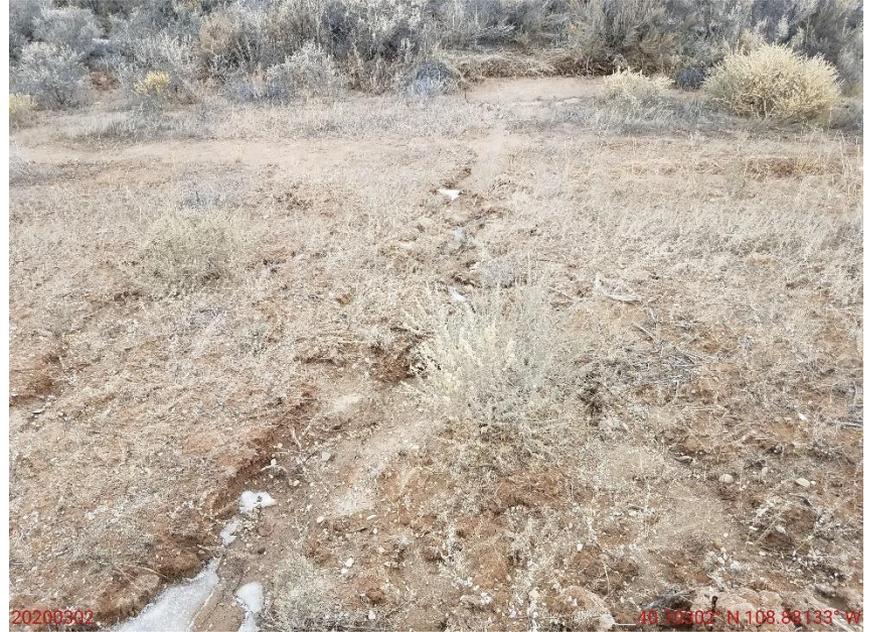
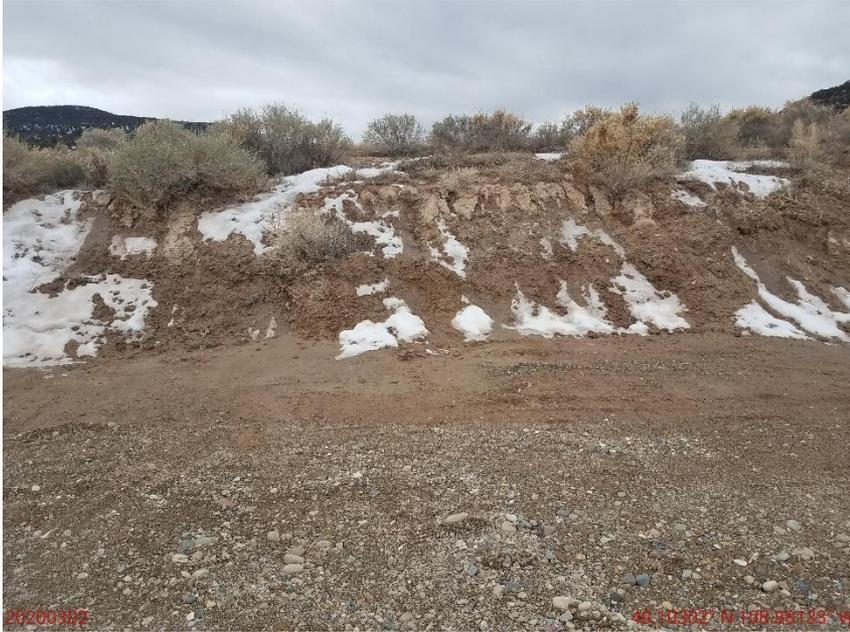
Photo 28: Photo taken from the soil stockpile on the northwest end of the Location. Photo shows erosion degradation evident on slopes.

Photo 39: See comments under photo 28.

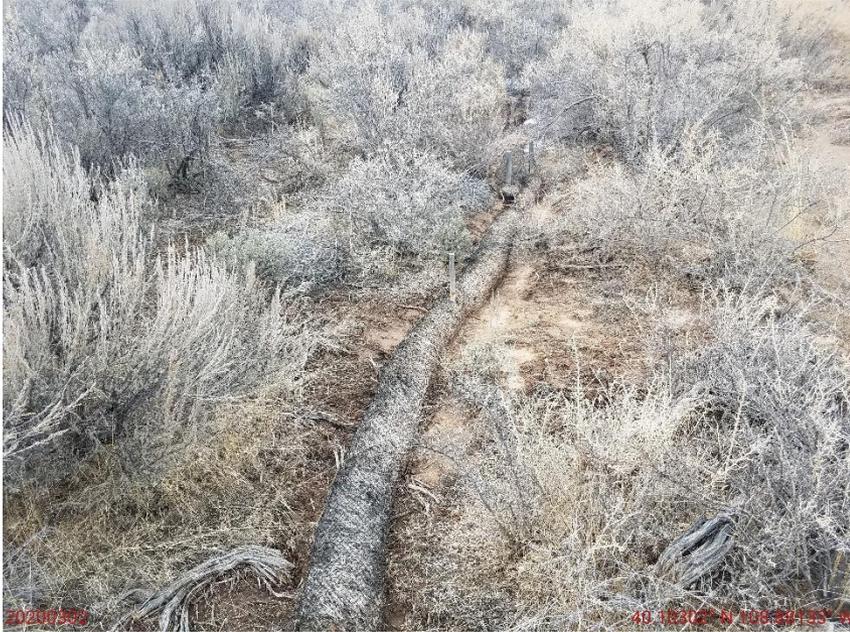
Photo 29: Photo taken from the perimeter of the Location's disturbance area. Operator appears to have installed straw wattles along the northwest/north/northeastern perimeter of the Location. BMPs appear to have remained intact but also show signs of degradation; maintenance advised.

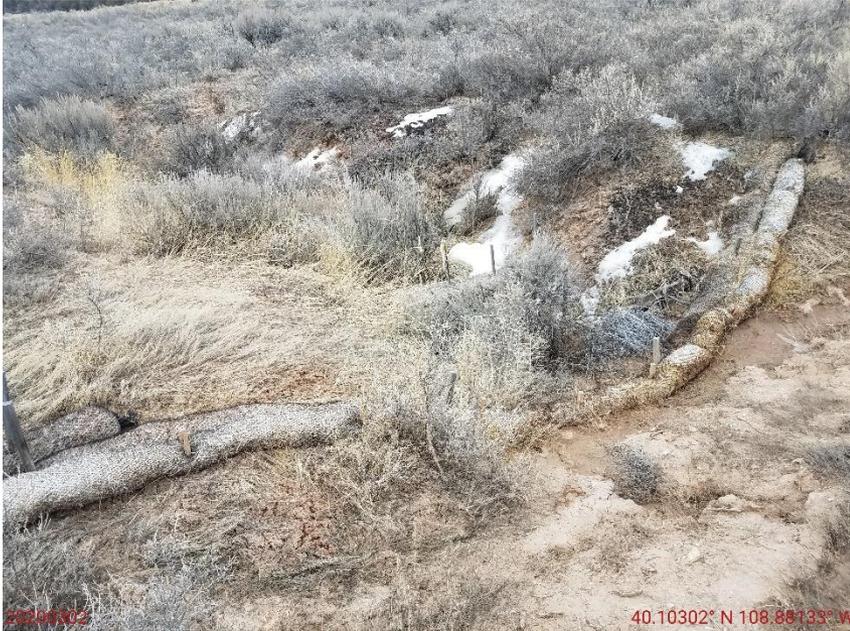
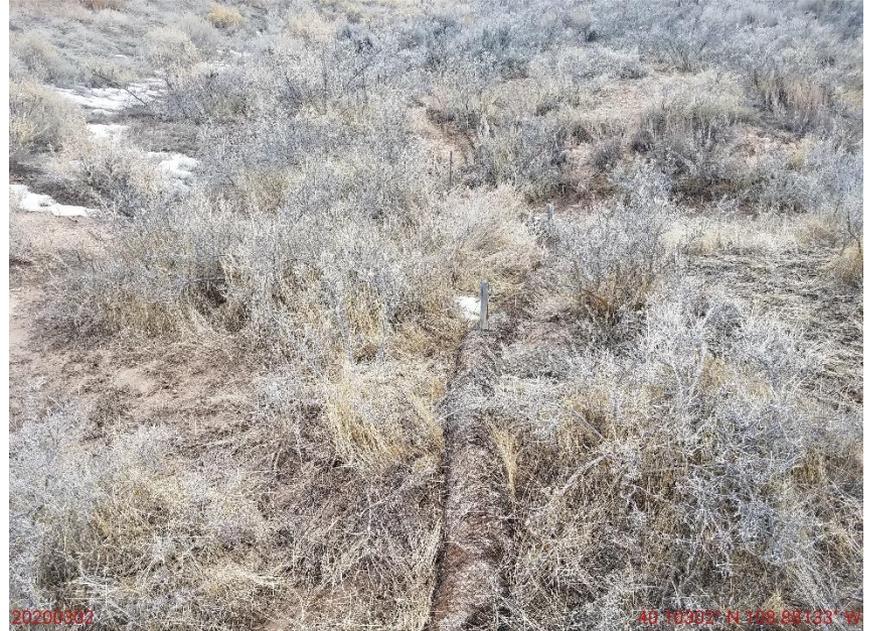
Photo 33: Photo taken from a drainage on the northeast end of the Location. Photo shows Operator has installed straw wattles and straw bales as stormwater BMPs. BMPs appear to have remained intact but also show signs of degradation; maintenance advised.

Photo 34: See comments under photo 33.

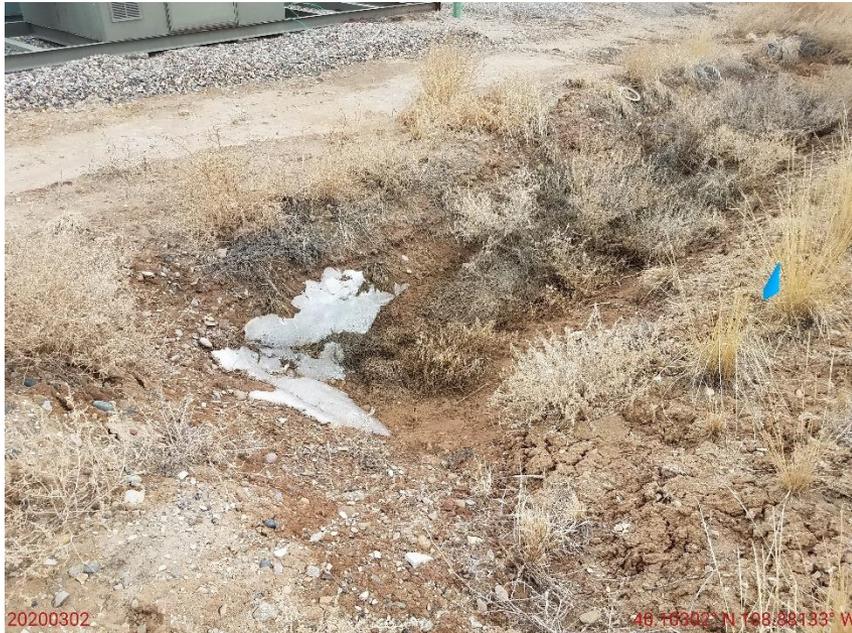
Photo 35: Photo taken from the stormwater ditch on the northeast end of the pad. Stormwater ditch has not been constructed with a proper outlet to allow for stormwater discharge; A berm has been constructed across the ditch damming the ditch.

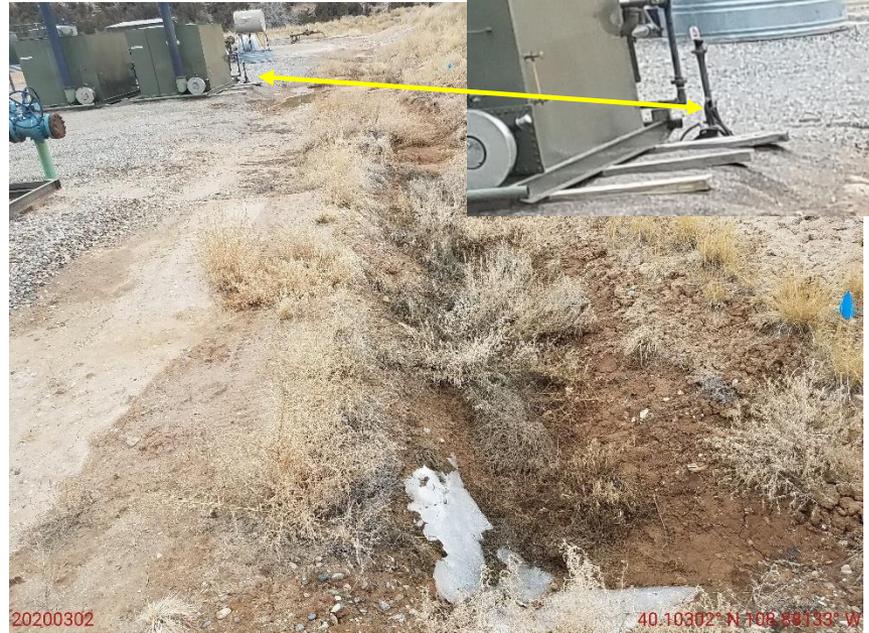
Photo 36: Continued from photo 35. Photo also shows riser identified in FIR 698100016 remaining on the Location; Corrective actions required Operator to remove riser.

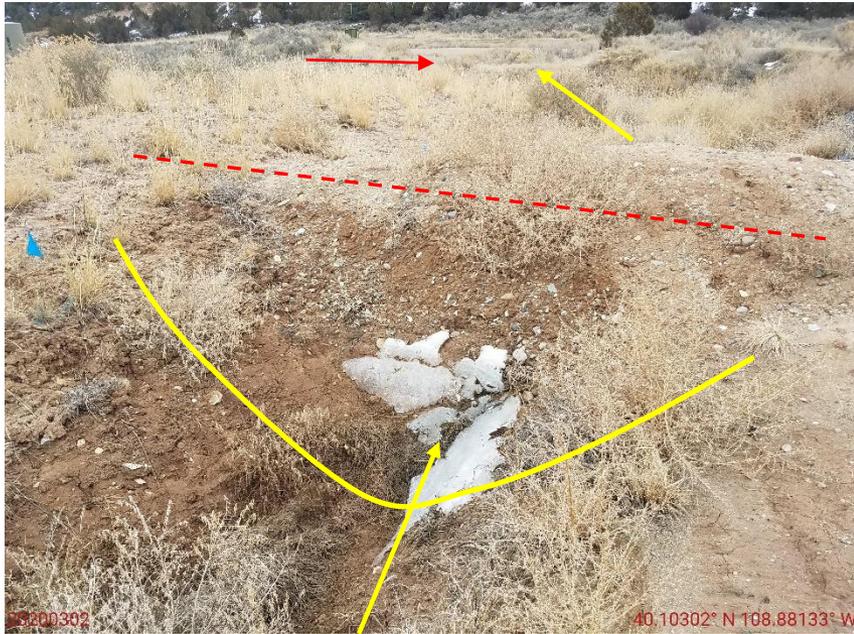
Photo 37: Continued from photo 35. Photo shows berm (red) across the ditch (yellow). Sediment trap in background (red arrow).

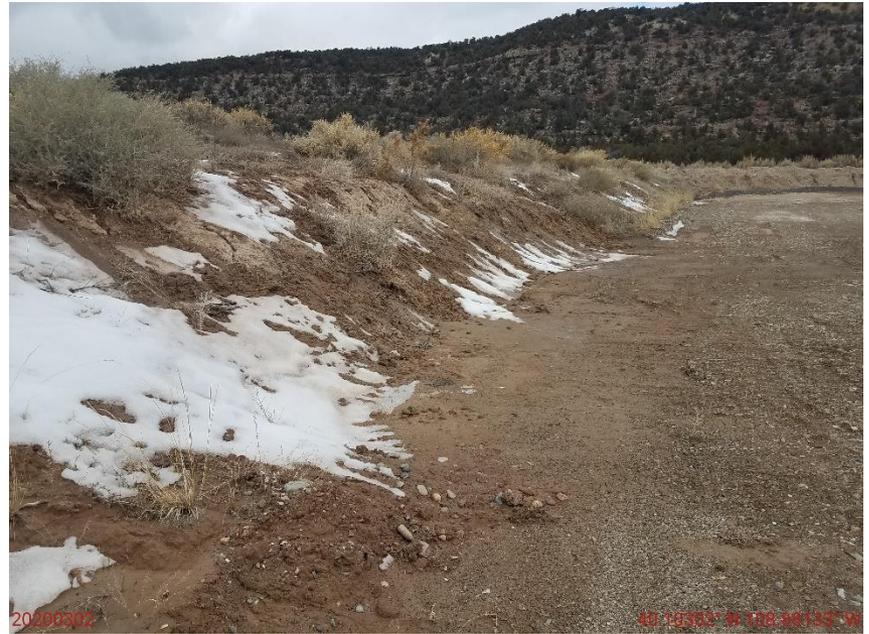
Photo 38: Photo taken from the slopes on the southwest end of the Location. Photo shows areas of the slopes that have not been sufficiently stabilized.

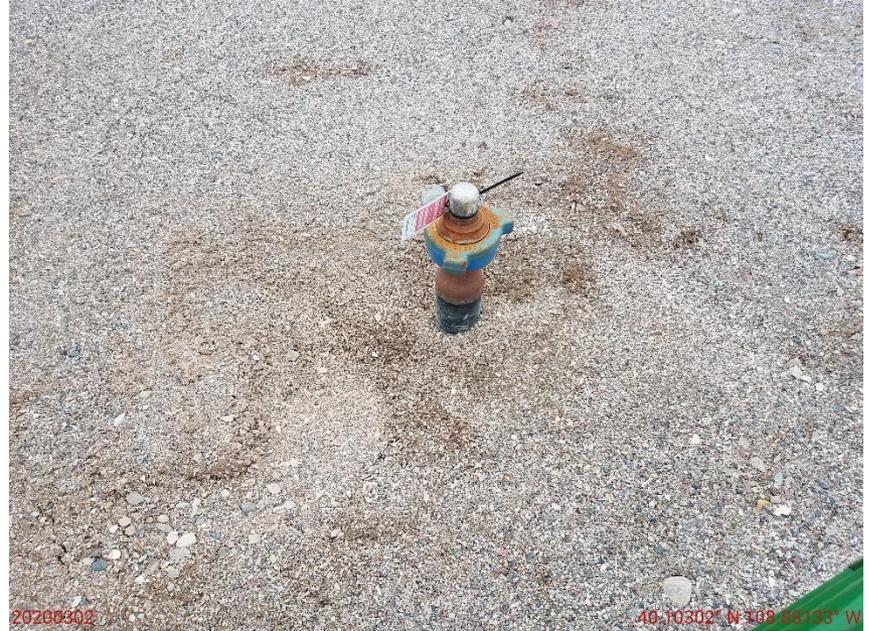
Photo 42: Photo of riser on the adjacent to well 045-22423. Equipment appears to be unused/unneeded.

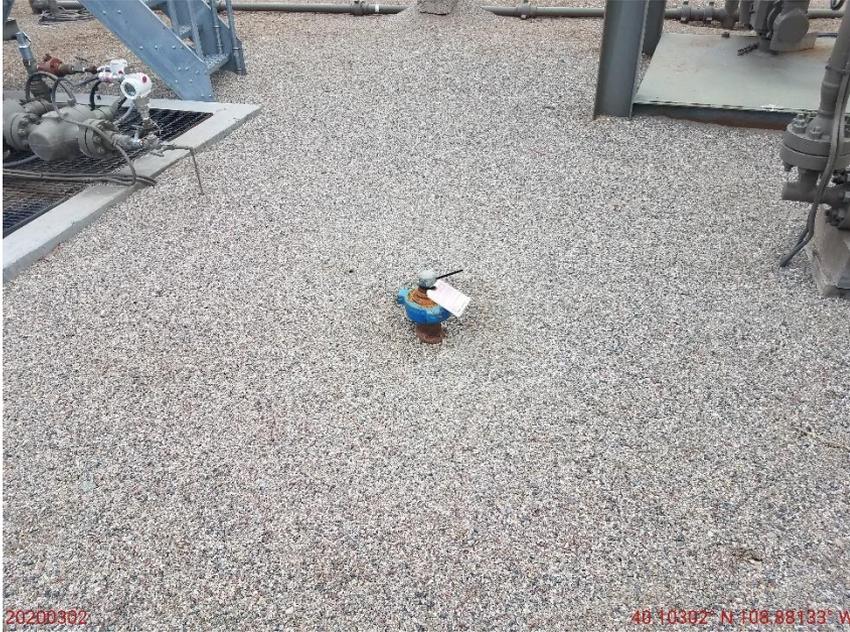
Photo 43: Additional riser adjacent to the wells. Equipment appears to be unused/unneeded.

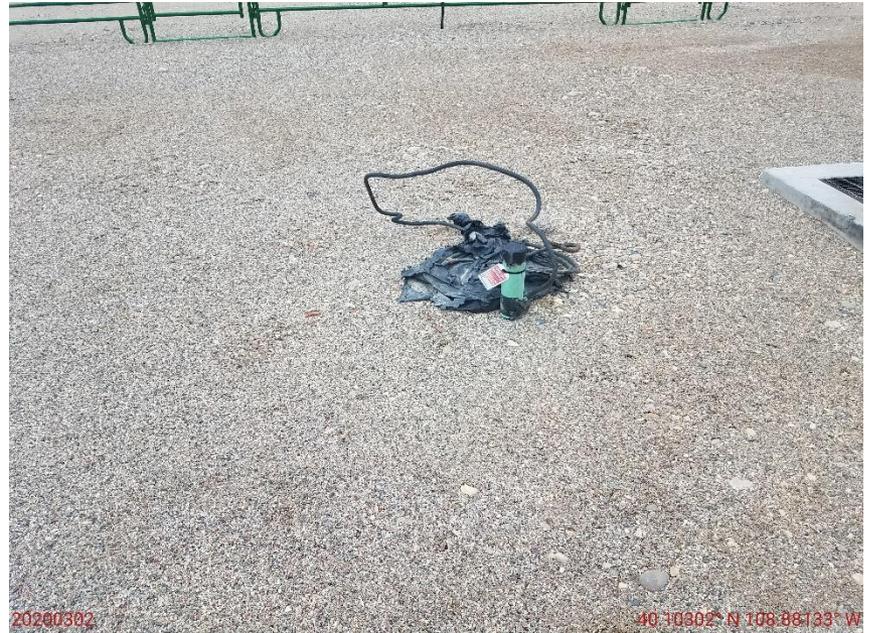
Photo 46: Additional riser/pipe adjacent to the wells. Equipment appears to be unused/unneeded.
