Inspection Photos

3/2/2020

Operator: LARAMIE ENERGY LLC # 10433

Location ID: 436835

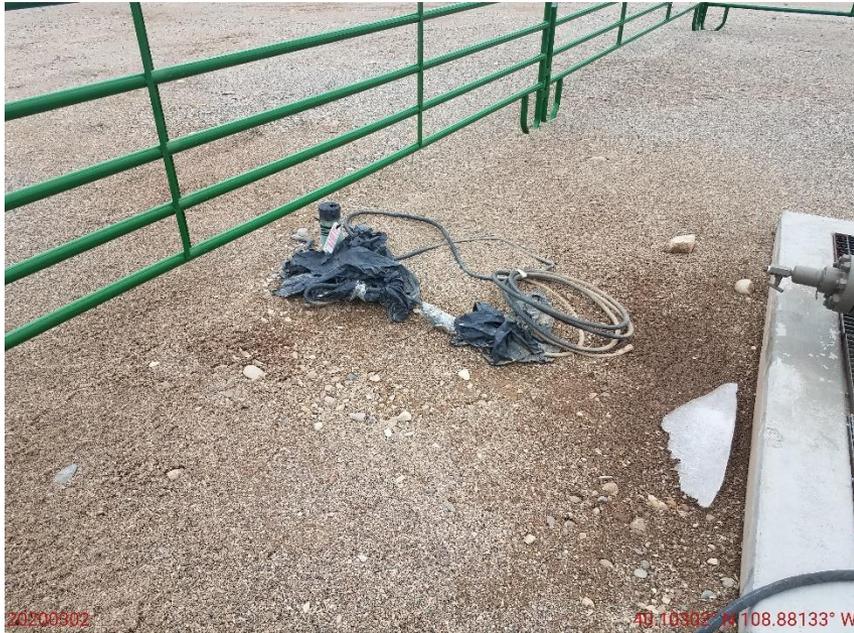
Photo 47: Additional riser/pipe adjacent to the wells. Equipment appears to be unused/unnecessary.

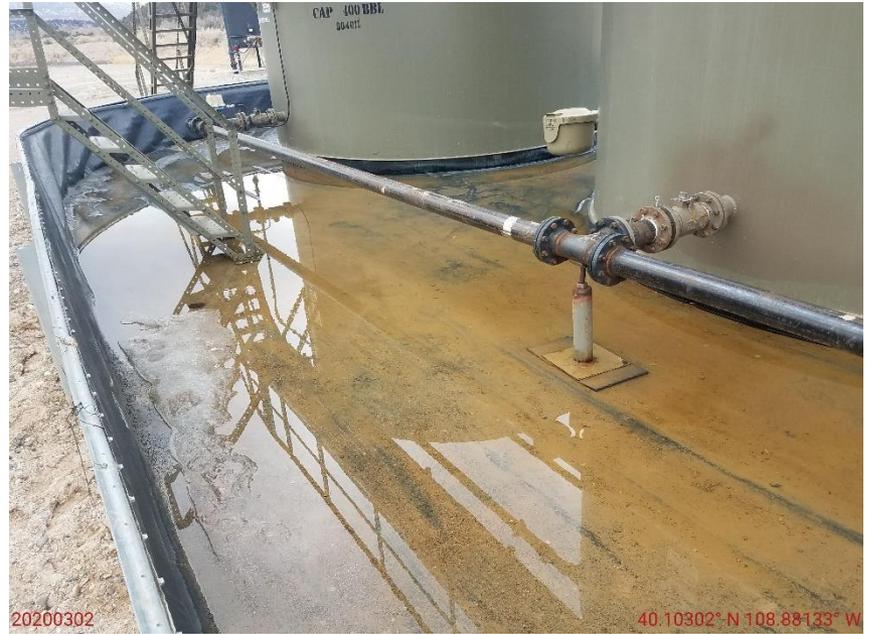
Photo 52: Photo shows fluids within secondary containment. Fluids like stormwater from snowmelt within berms.

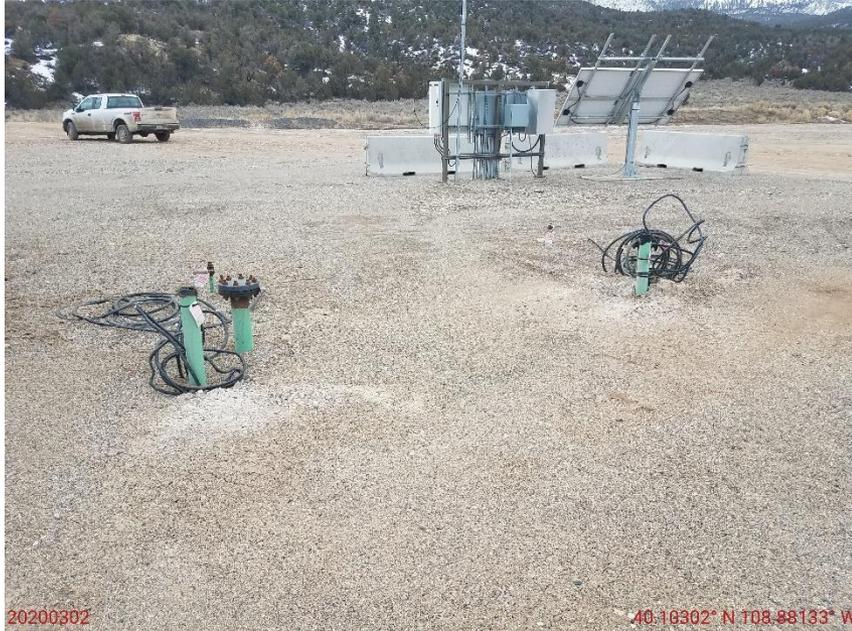
Photo 57: Photo taken from the northeast end of the Location. Photo shows 5 additional riser/pipe on Location. Equipment appears to be unused/unneeded.

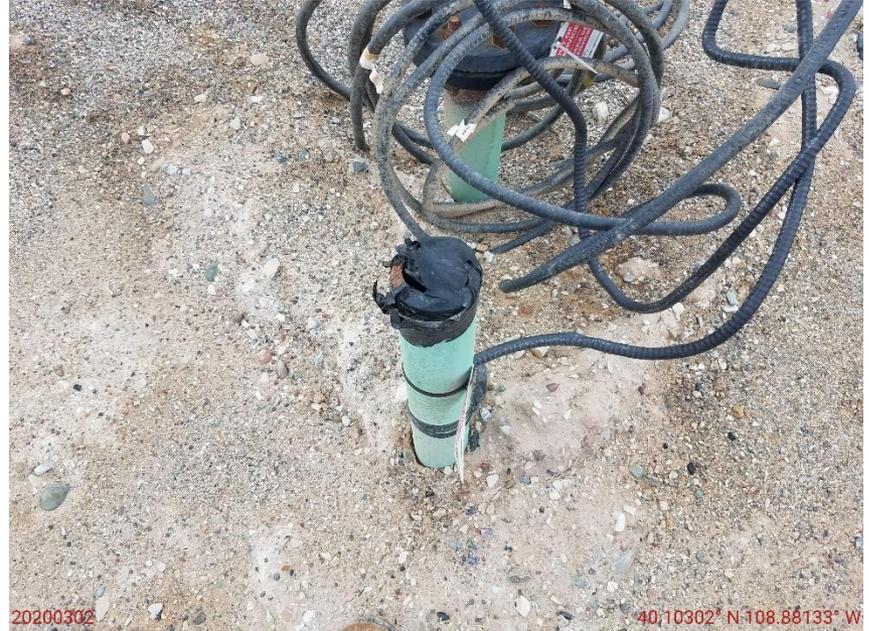
Photo 58: Continued from photo 57. Photo shows cap material degrading.

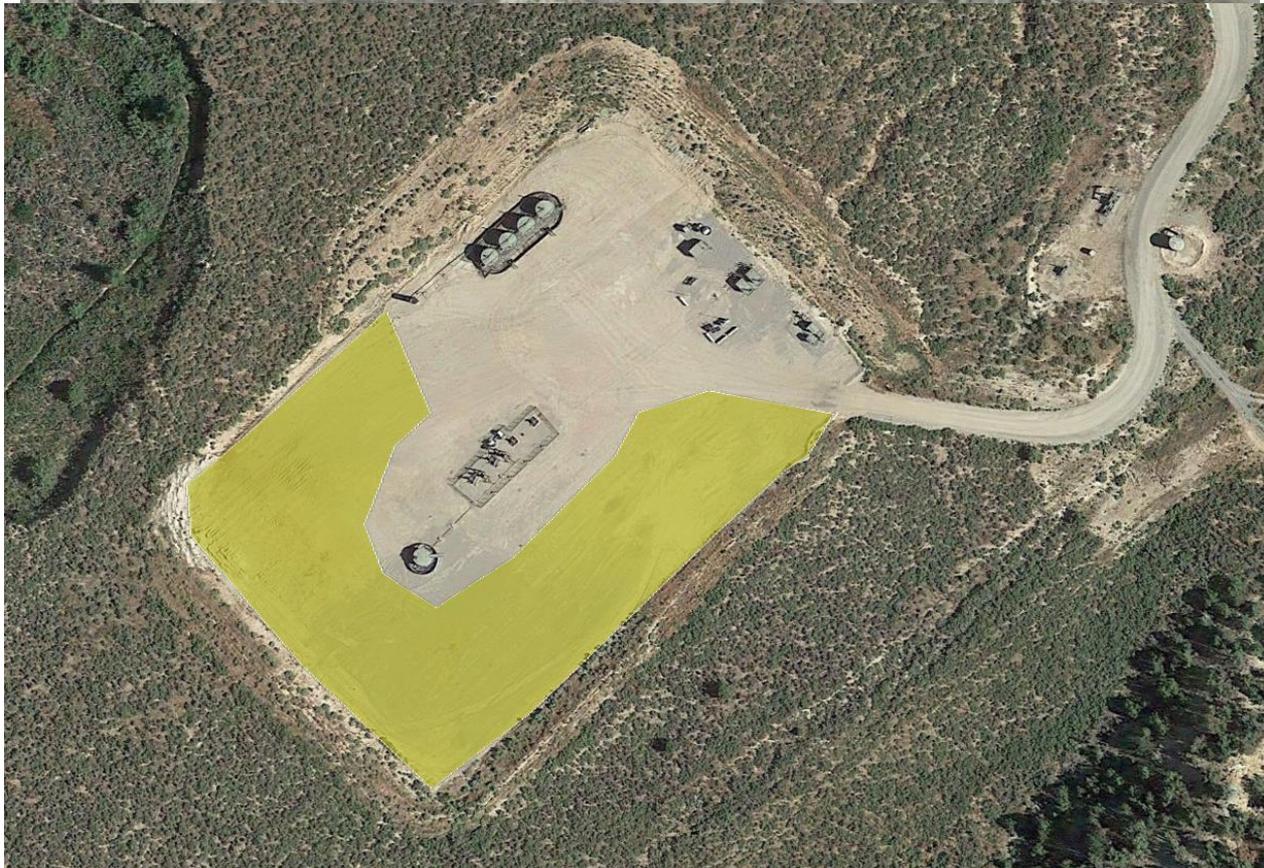
Photo 61: 2019 Google Earth Aerial imagery. 2A #400820779 states size of Location post interim reclamation to be 2.67 acres. Photo shows Reclamation Specialist measured the area of the current production area, including stormwater BMPs via a Trimble handheld GPS unit; The current production area is 4.5 acres in size. Interim reclamation has not been conducted. Photo shows areas on the west, south and eastern ends of the current pad that do not appear to be needed for production activities.

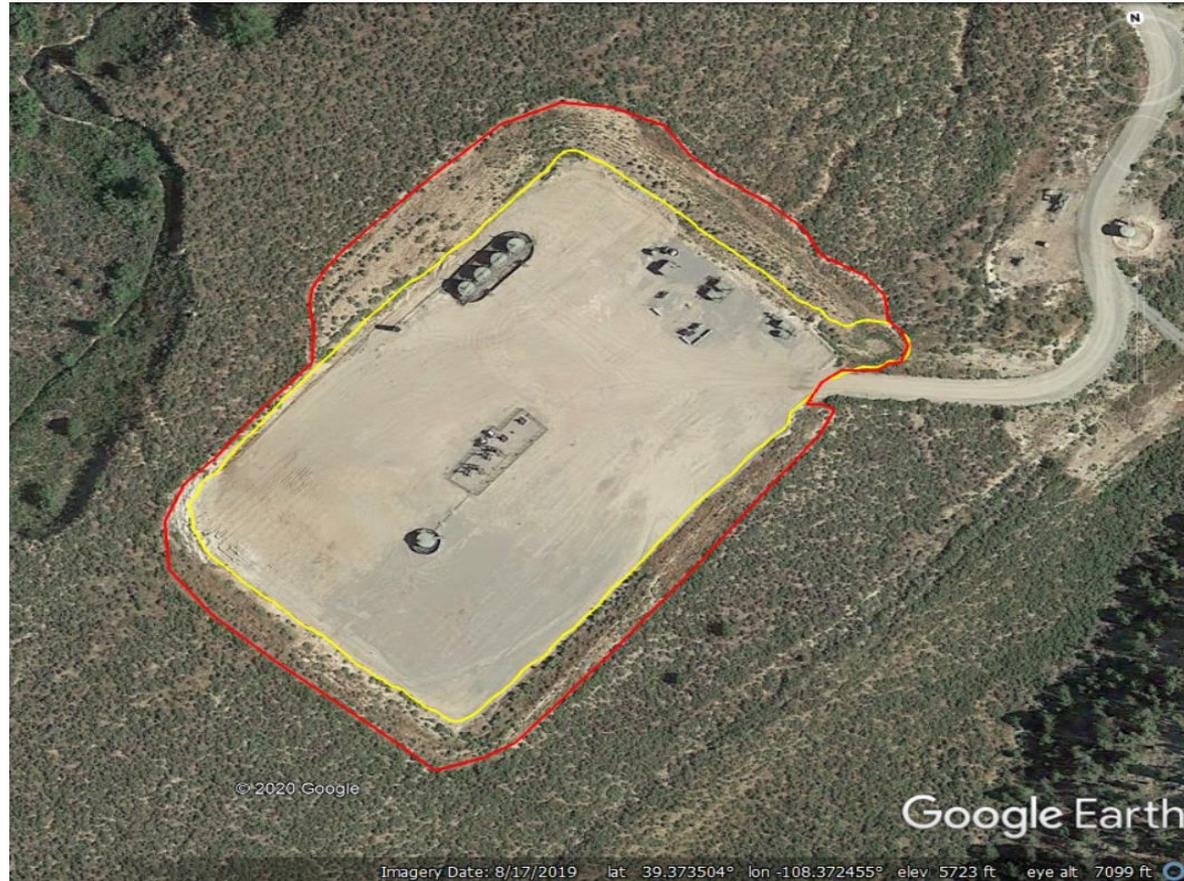
Photo 62: 2019 Google Earth Aerial imagery. Photo shows total disturbance area of the Location (red) to be 6.32 acres in size. Current area of the pad (including sediment trap) is ~4.5 acres.
