Inspection Photos
Operator: Williford Resources
API#: 067-06143
Date: 3/4/2020

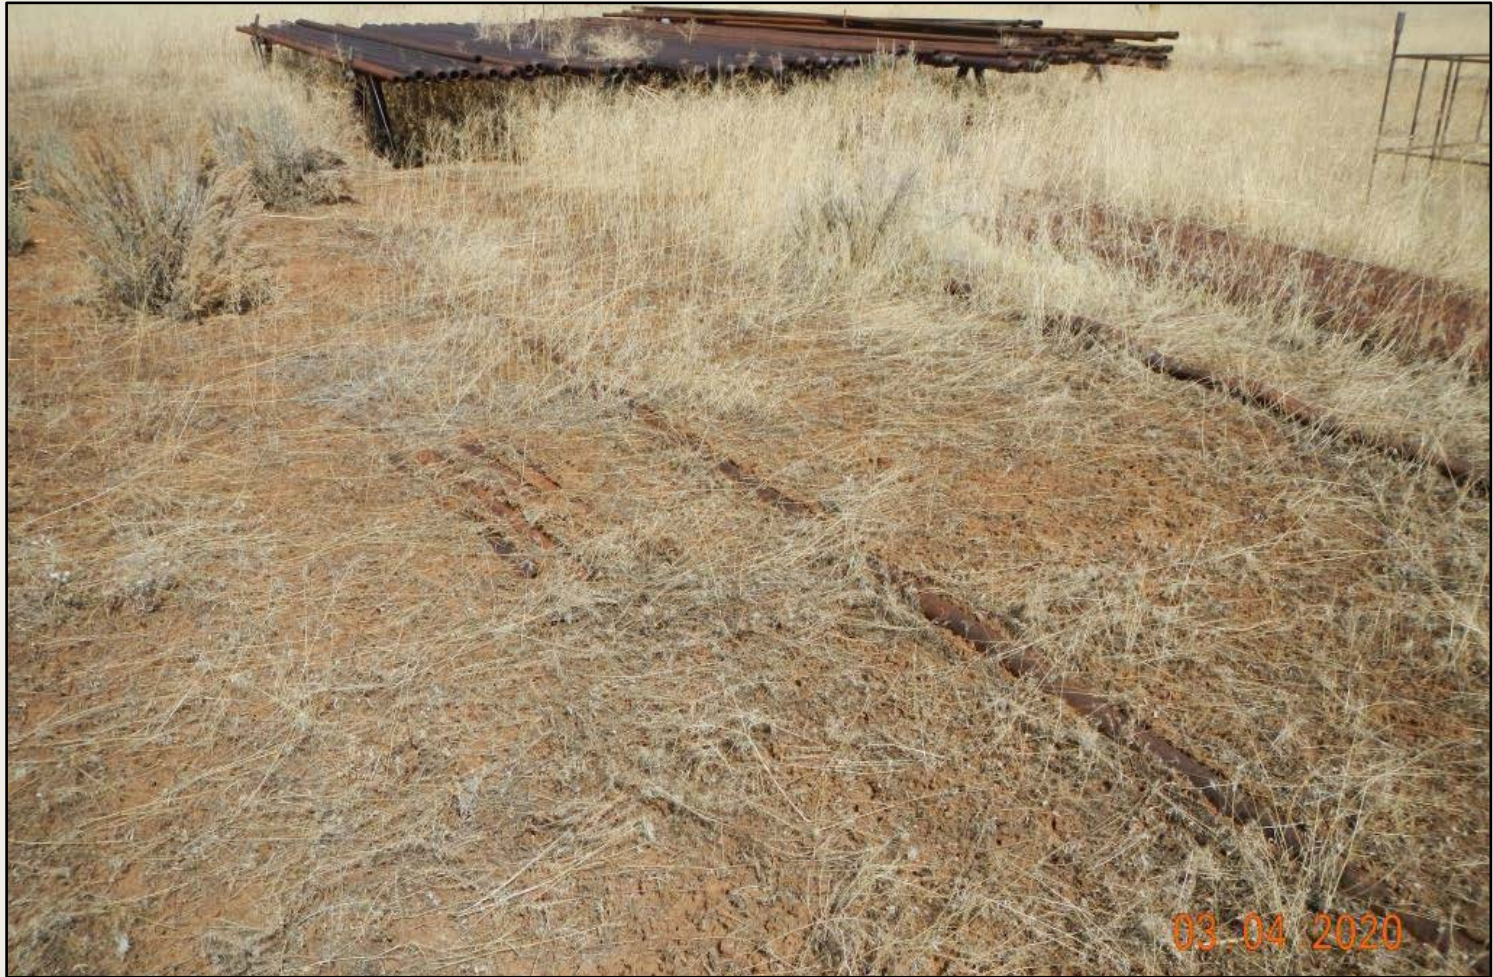
Photo 1. View pipe debris stored within the southern project area.

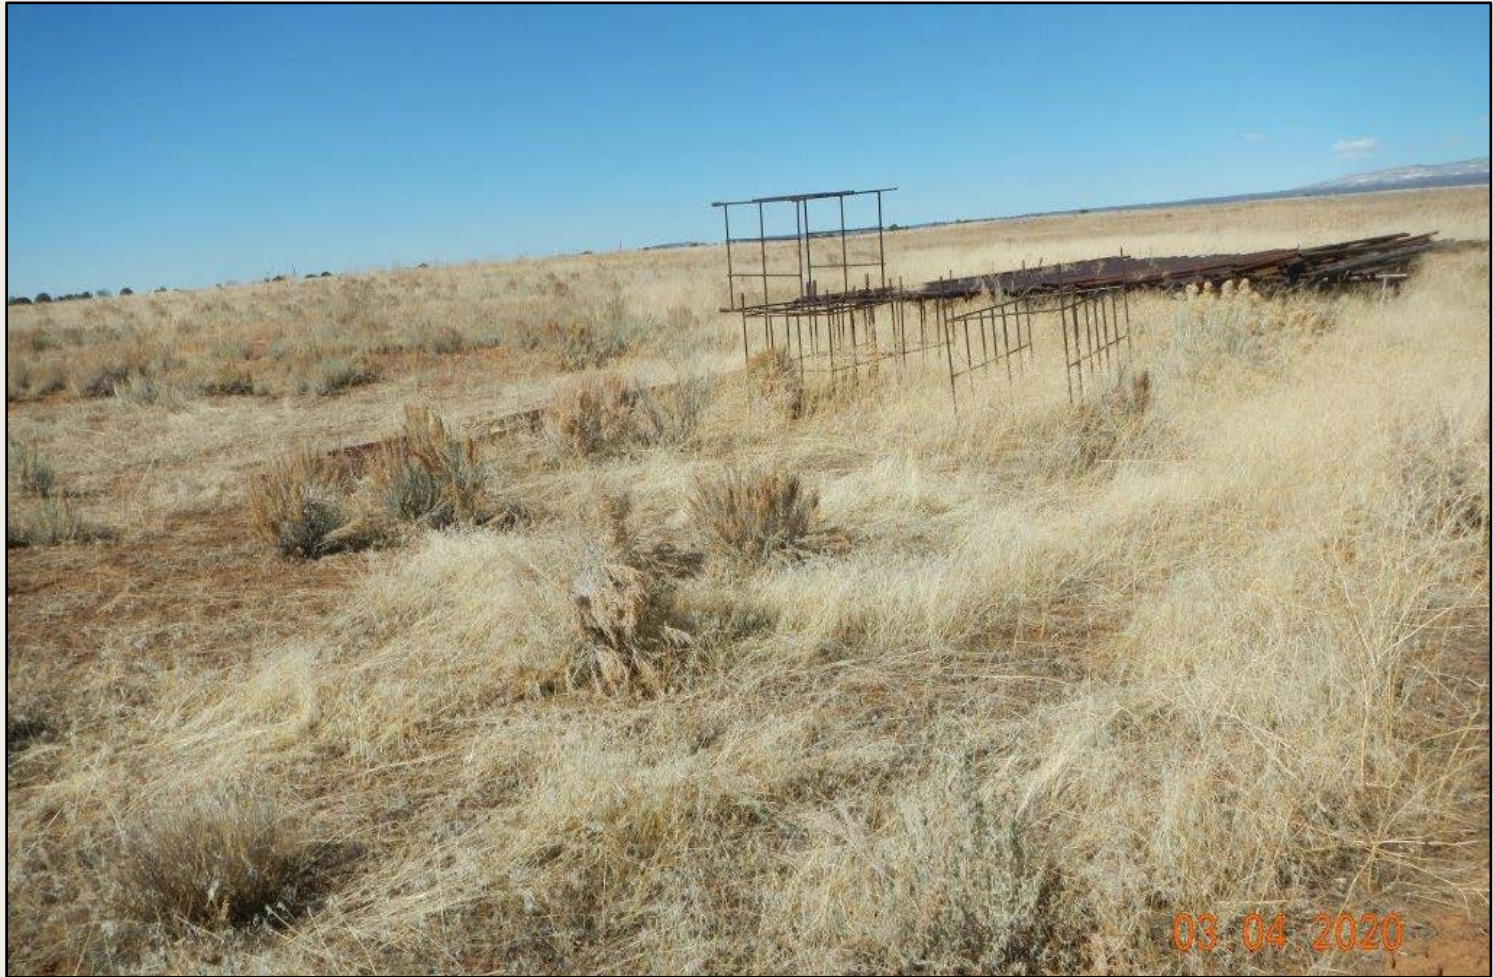
Photo 2. View of the project area from the southeastern edge facing northwestward.
