Inspection Photos

API: 061-06365

Operator: STRACHAN EXPLORATION

Inspection Date: 3/6/2020

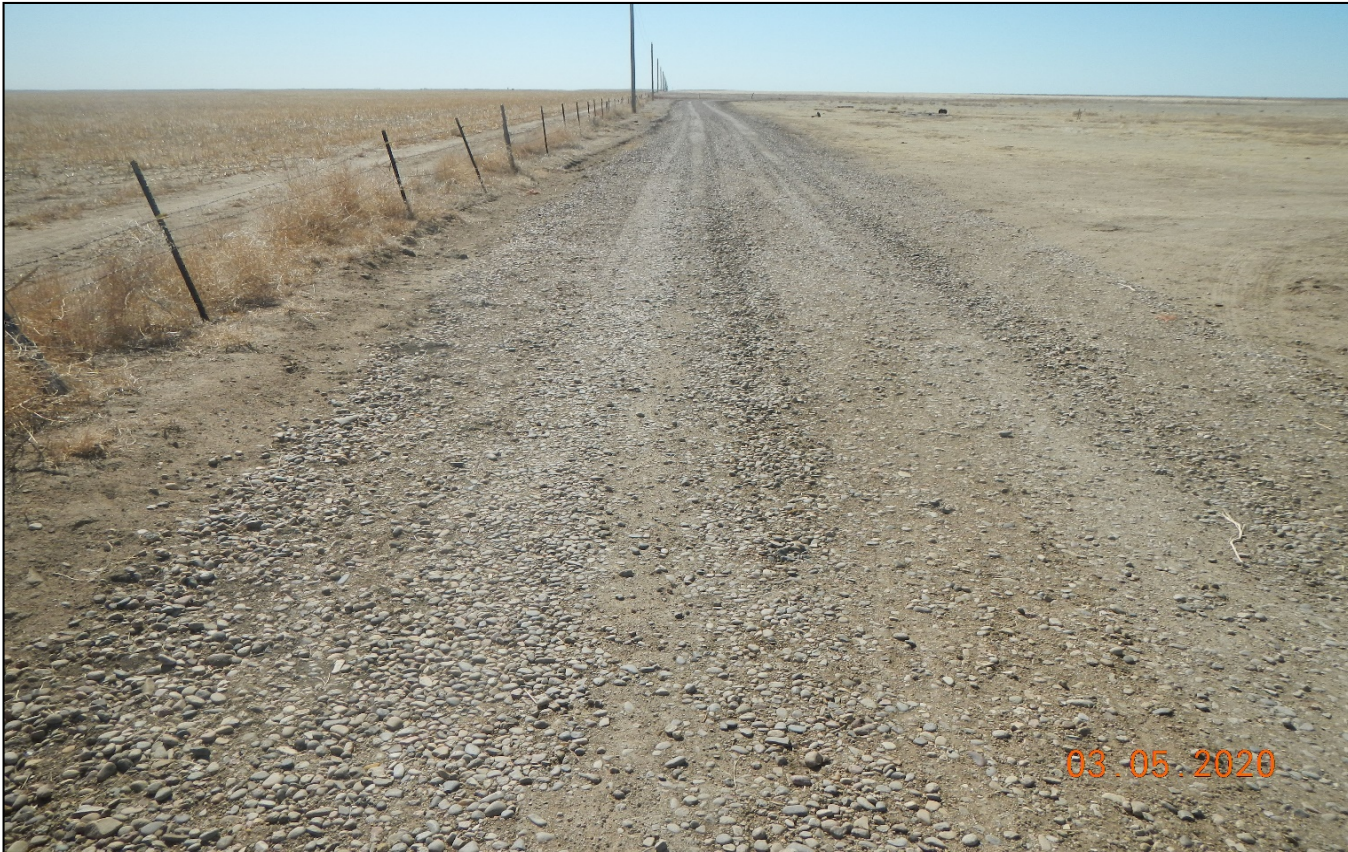
Photo 1. Facing south at the beginning of the access road. The road is graveled and maintained.

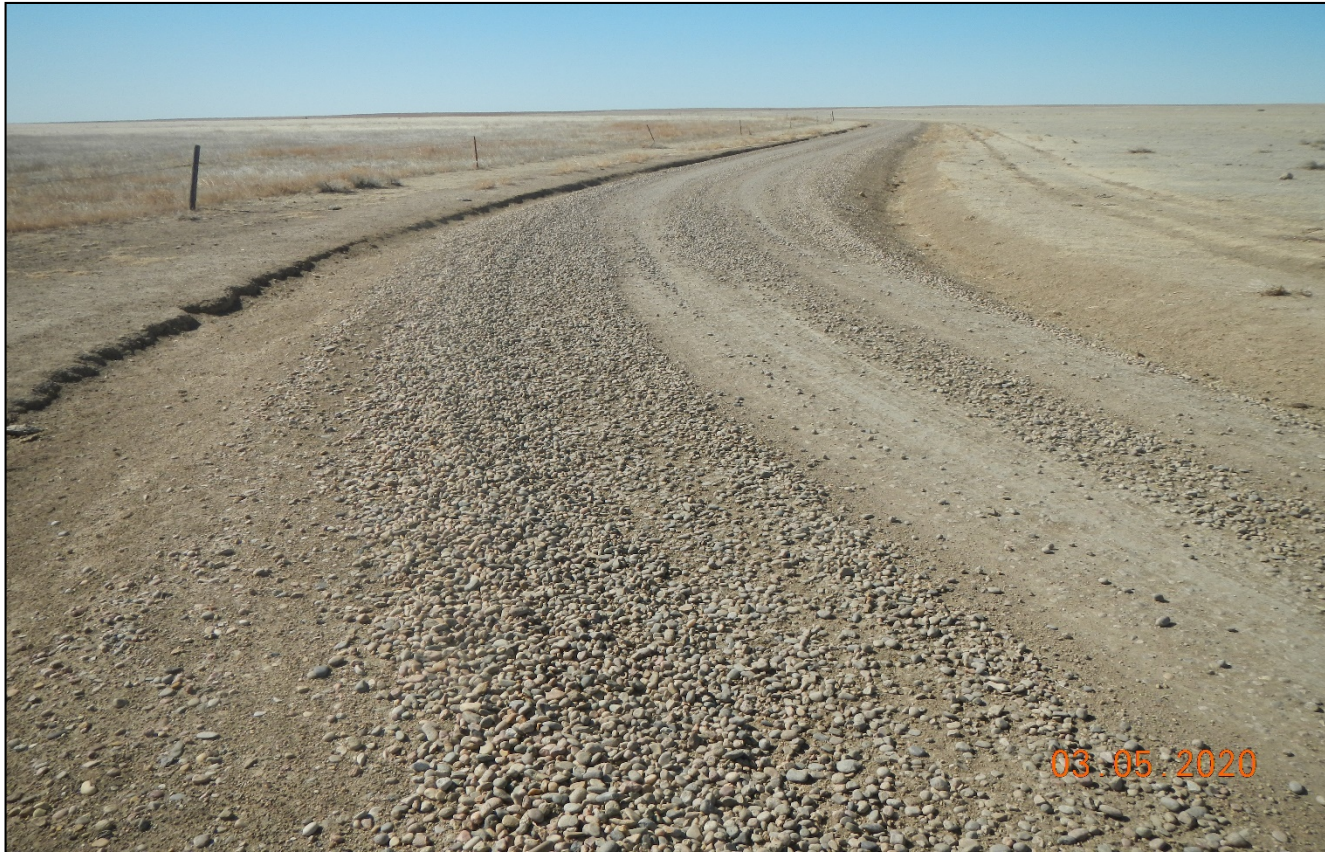
Photo 2. Facing southwest along the road. The road has been built up and graveled.

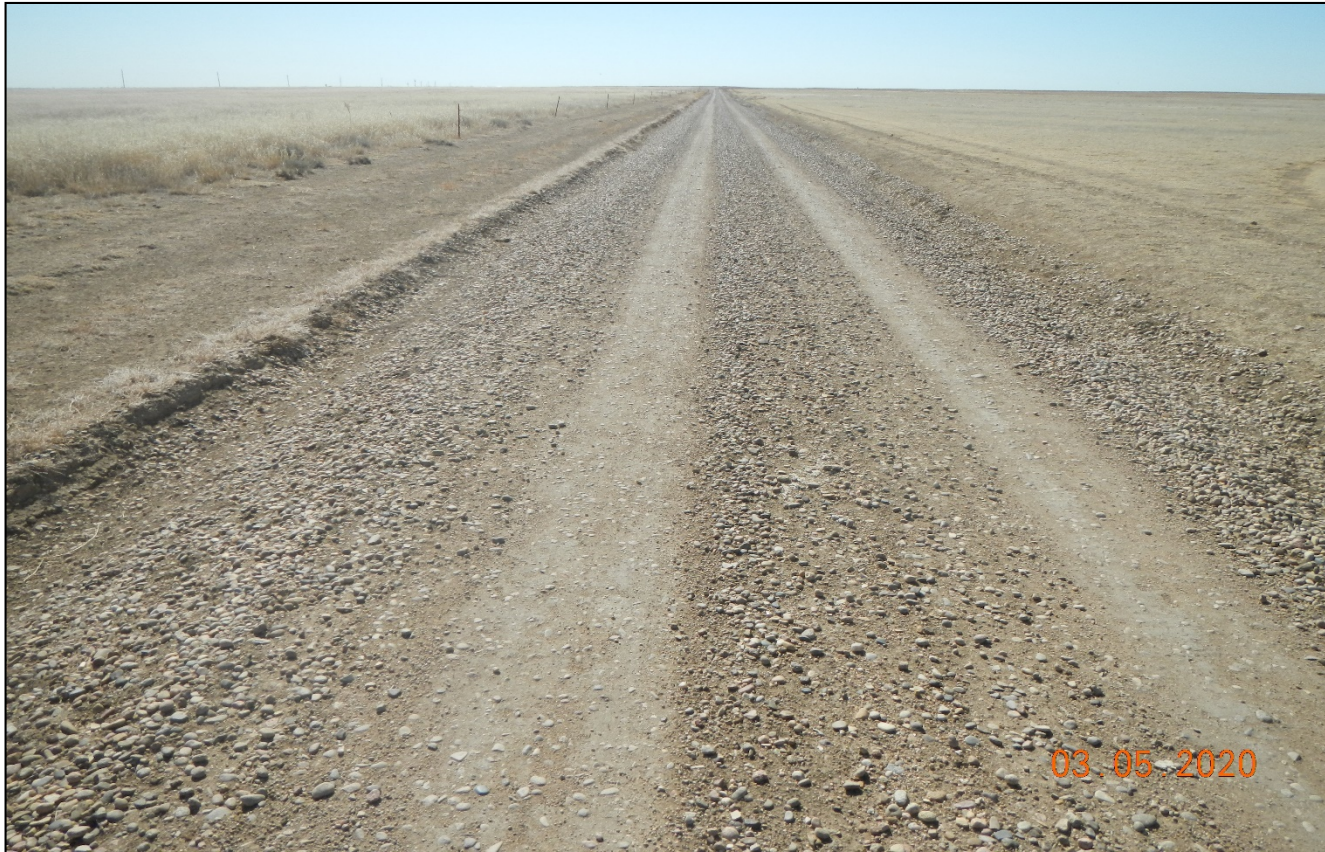
Photo 3. Facing south along the access road.

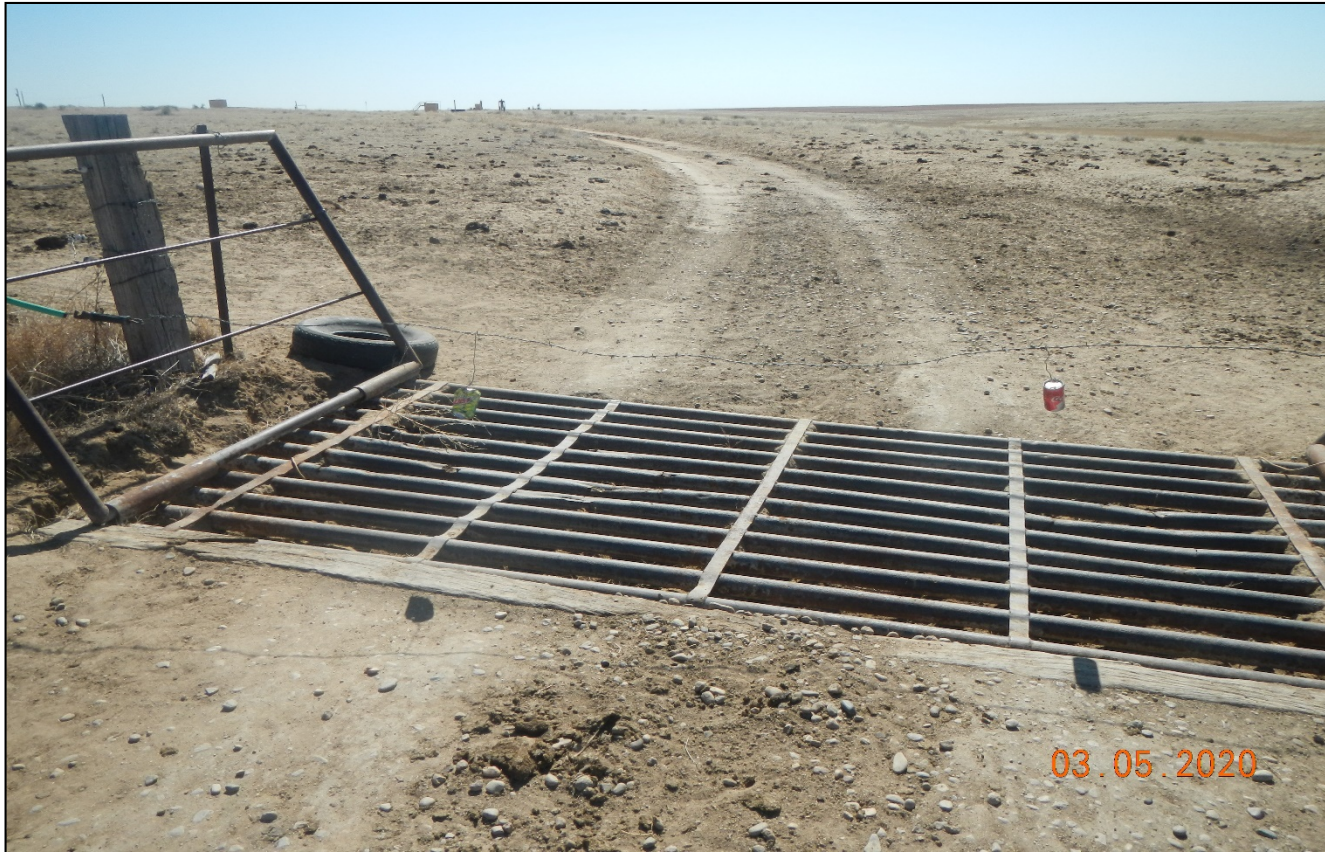
Photo 4. The cattle guard has been cleaned out of sediment and maintained.

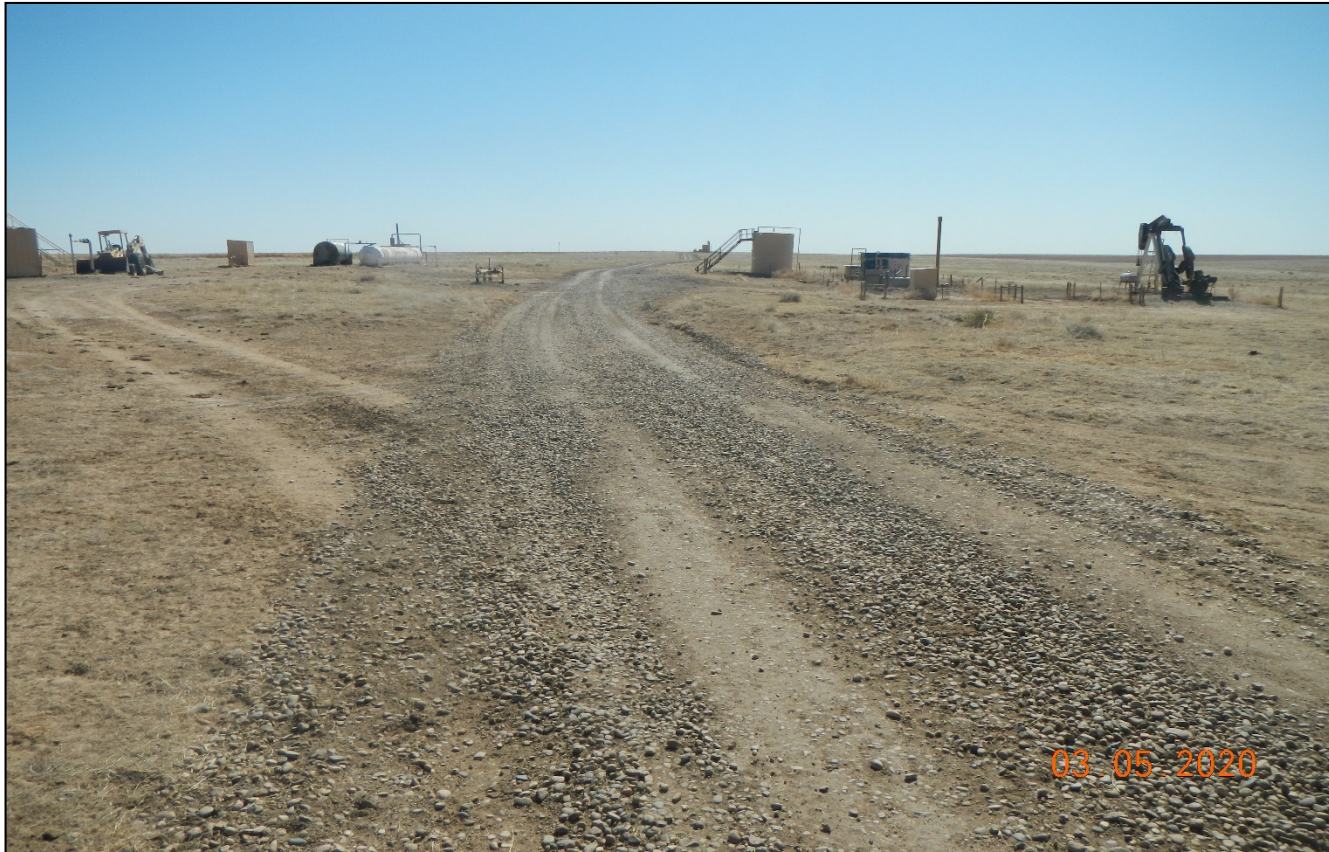
Photo 5. Facing southeast toward the location.

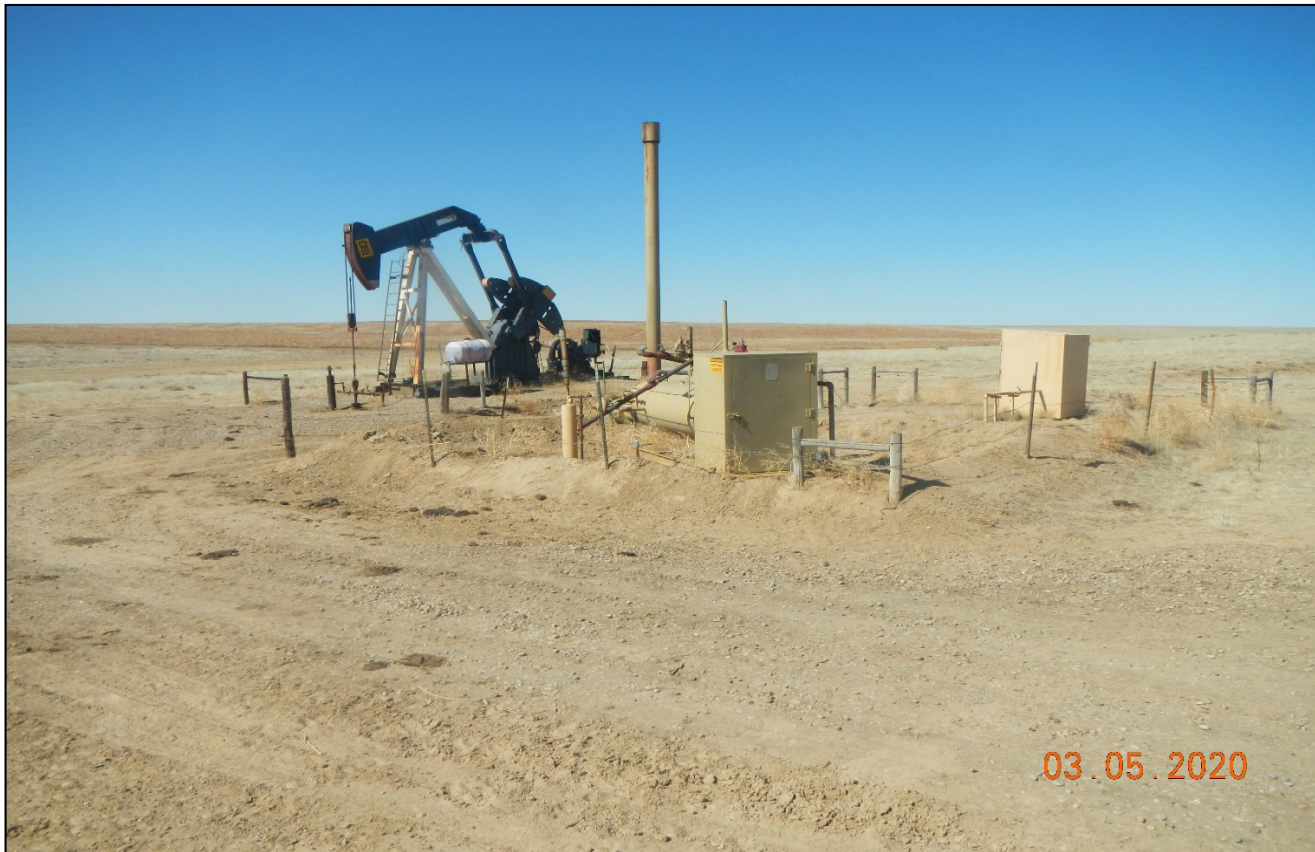
Photo 6. Facing toward the well site.

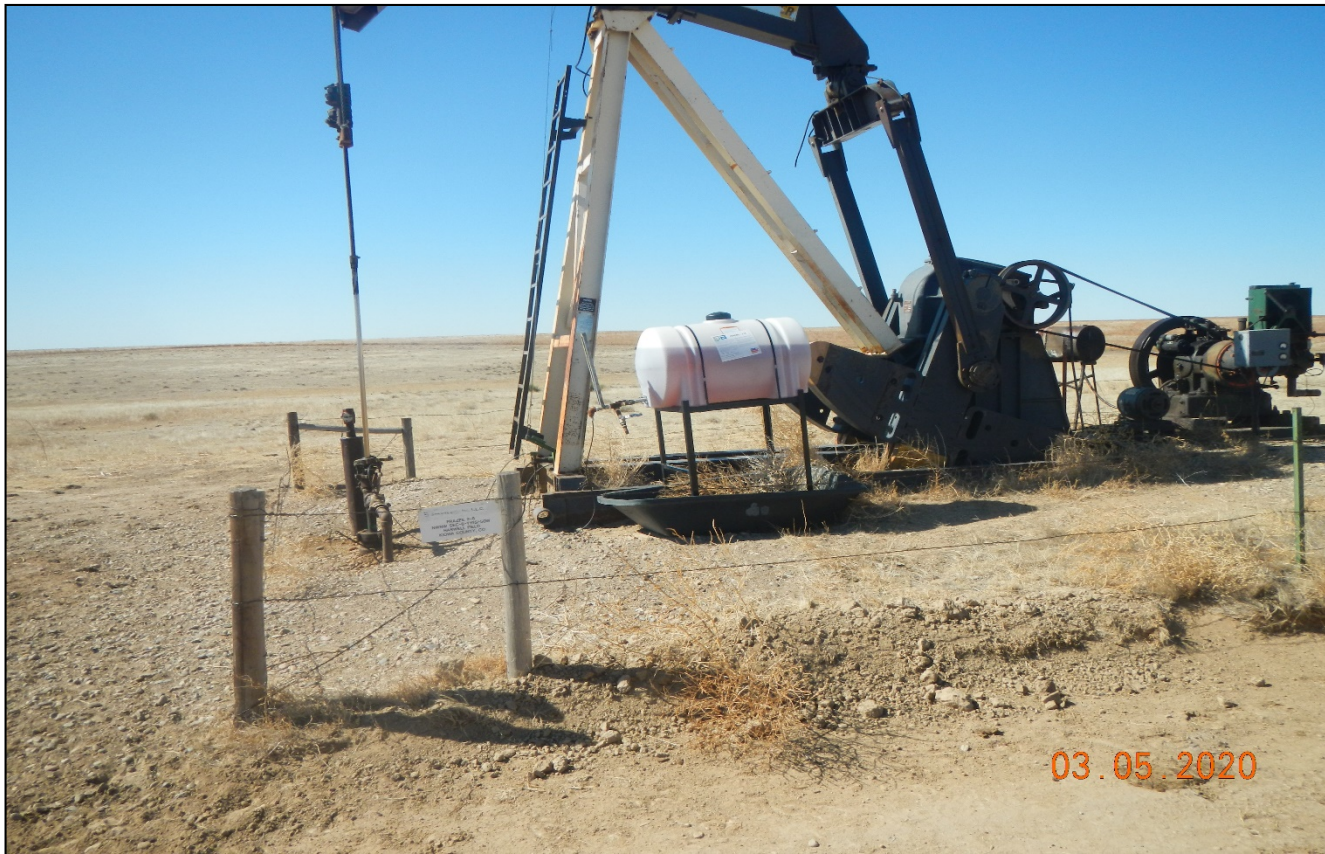
Photo 7. Facing toward the well site. Sign is posted on the fence. There was no sign of oil stained soil.

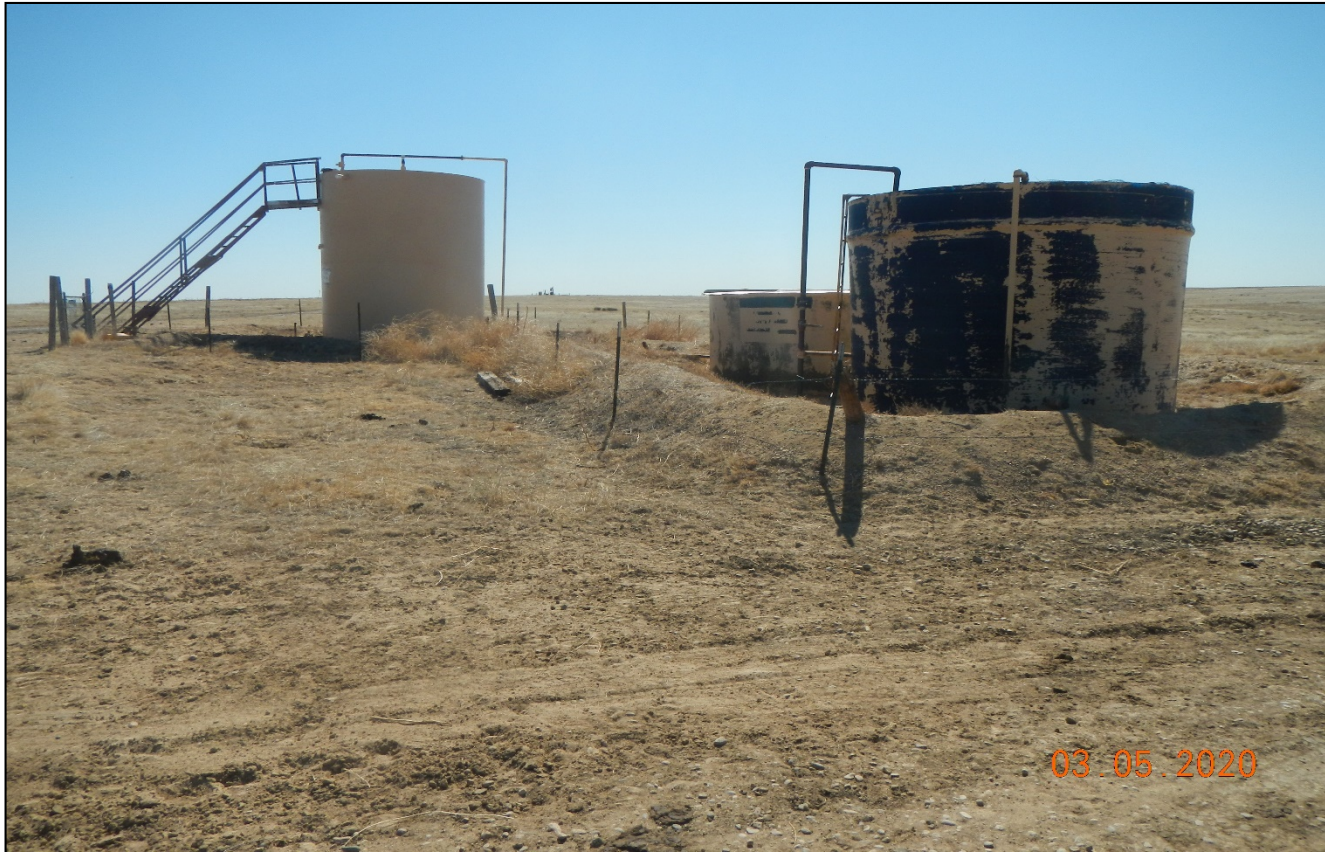
Photo 8. Facing toward the tank battery. Berms are maintained around tanks.

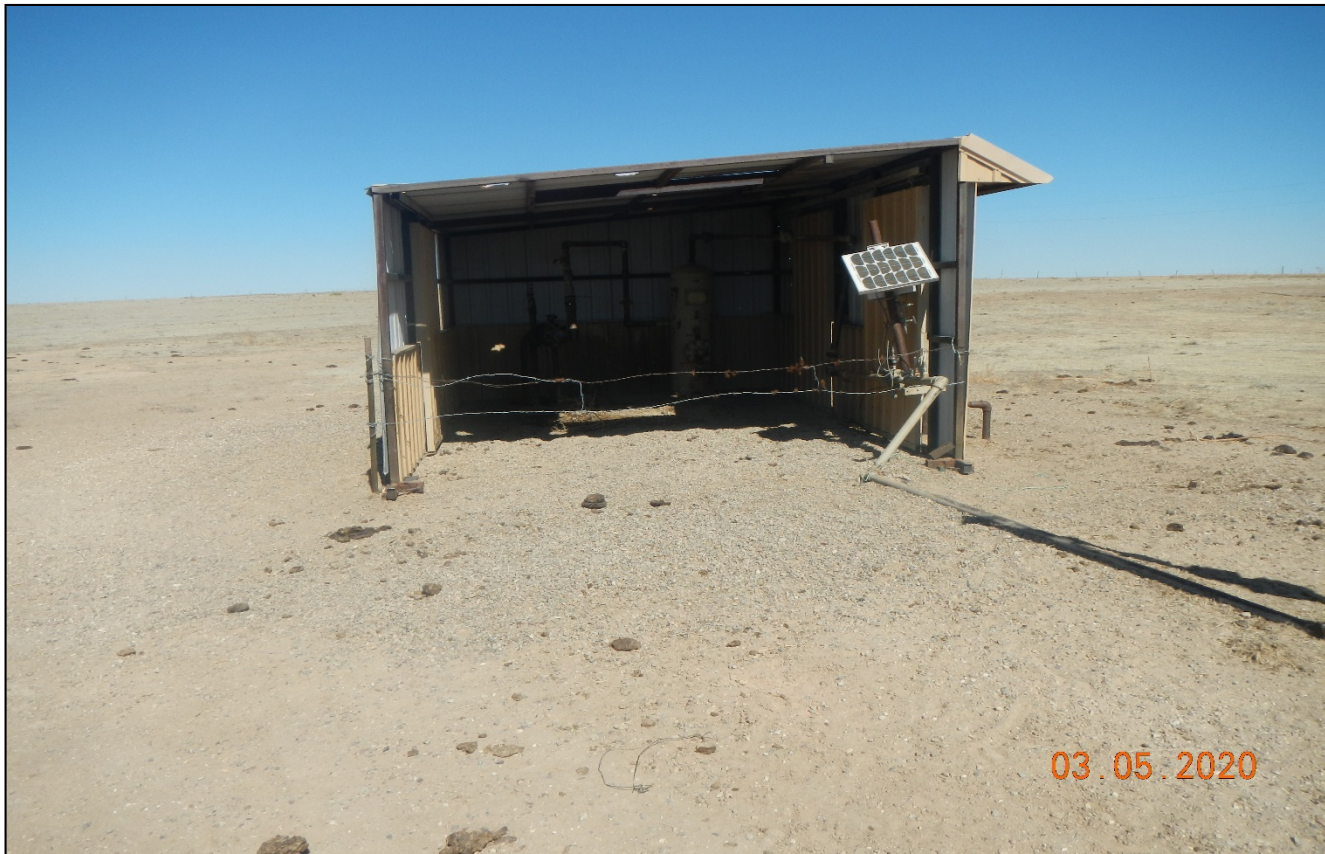
Photo 9. The shed is maintained and no sign of oil stained soil was observed.

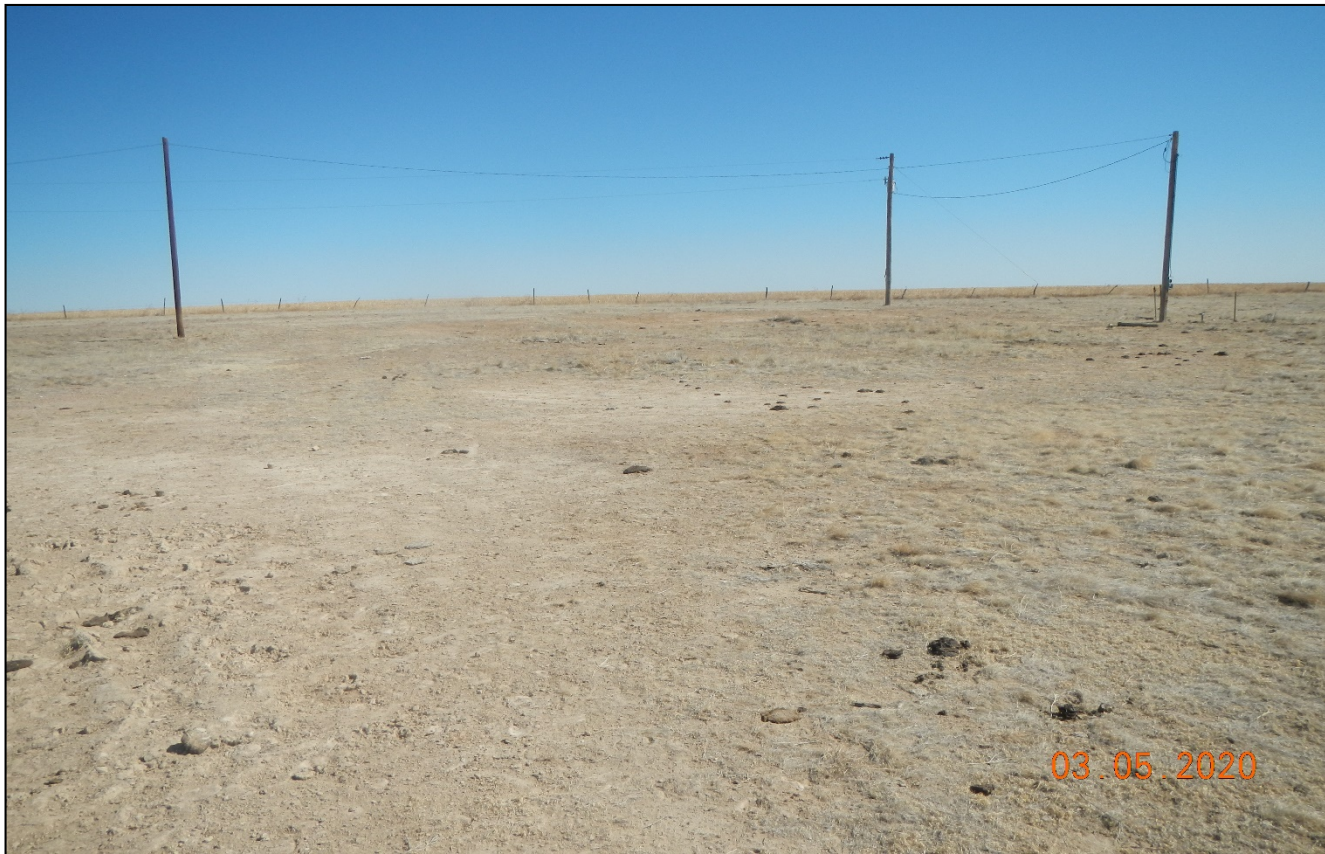
Photo 10. Facing northeast at the location. The unused equipment has been removed. This area will need to be reclaimed.

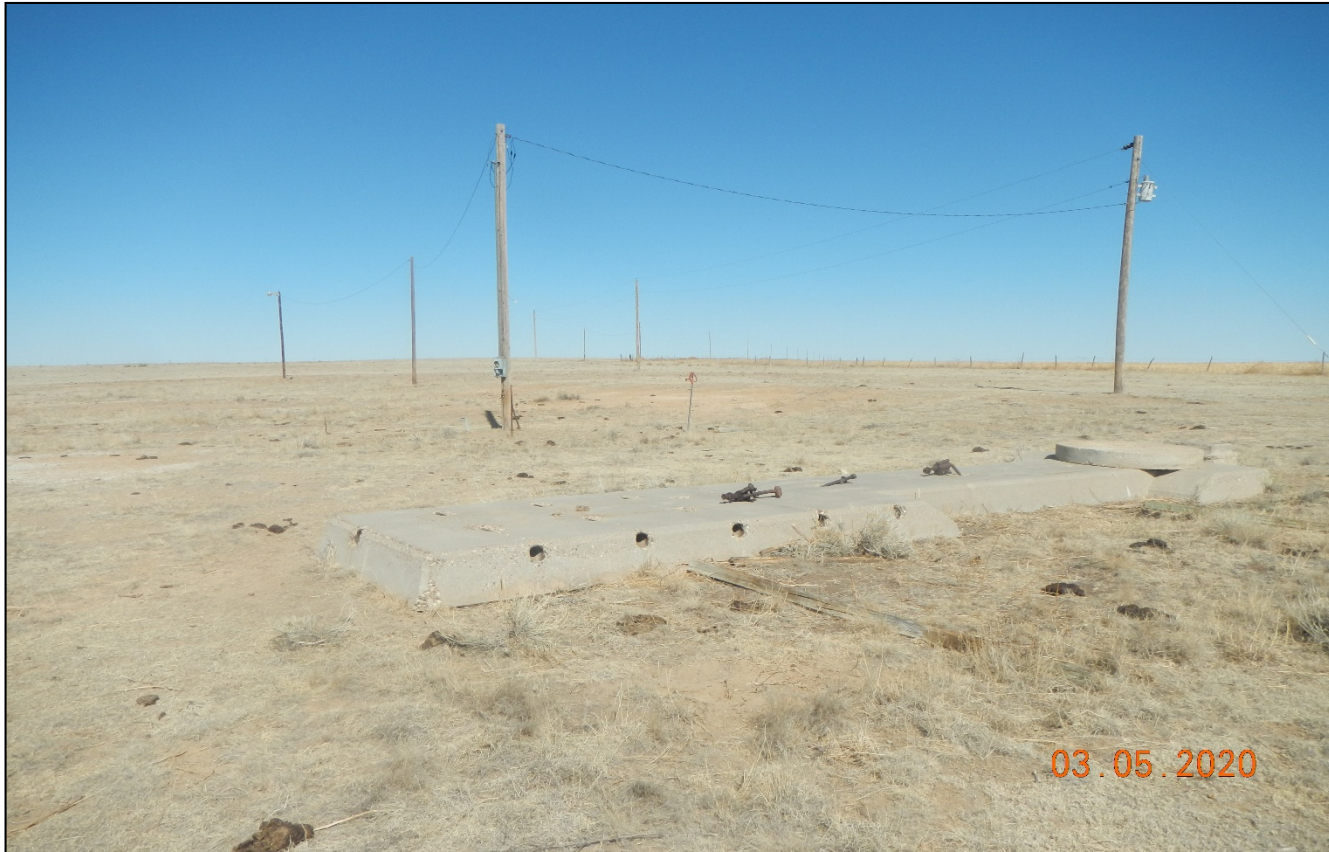
Photo 11. The cement pad remains at the northeast side of the location. This is considered unused equipment and needs to be removed.

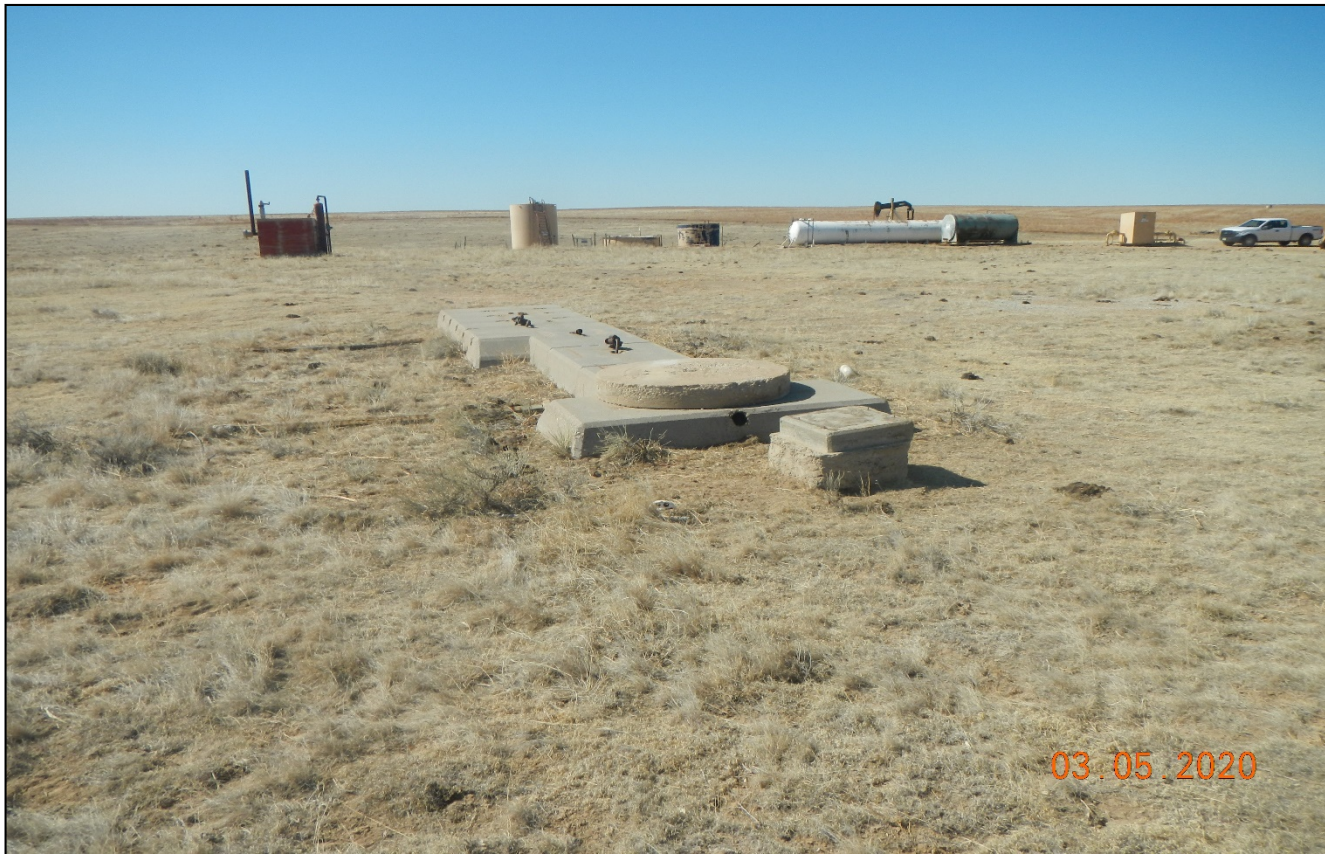
Photo 12. Facing back southwest toward the location. The cement pad needs to be removed.

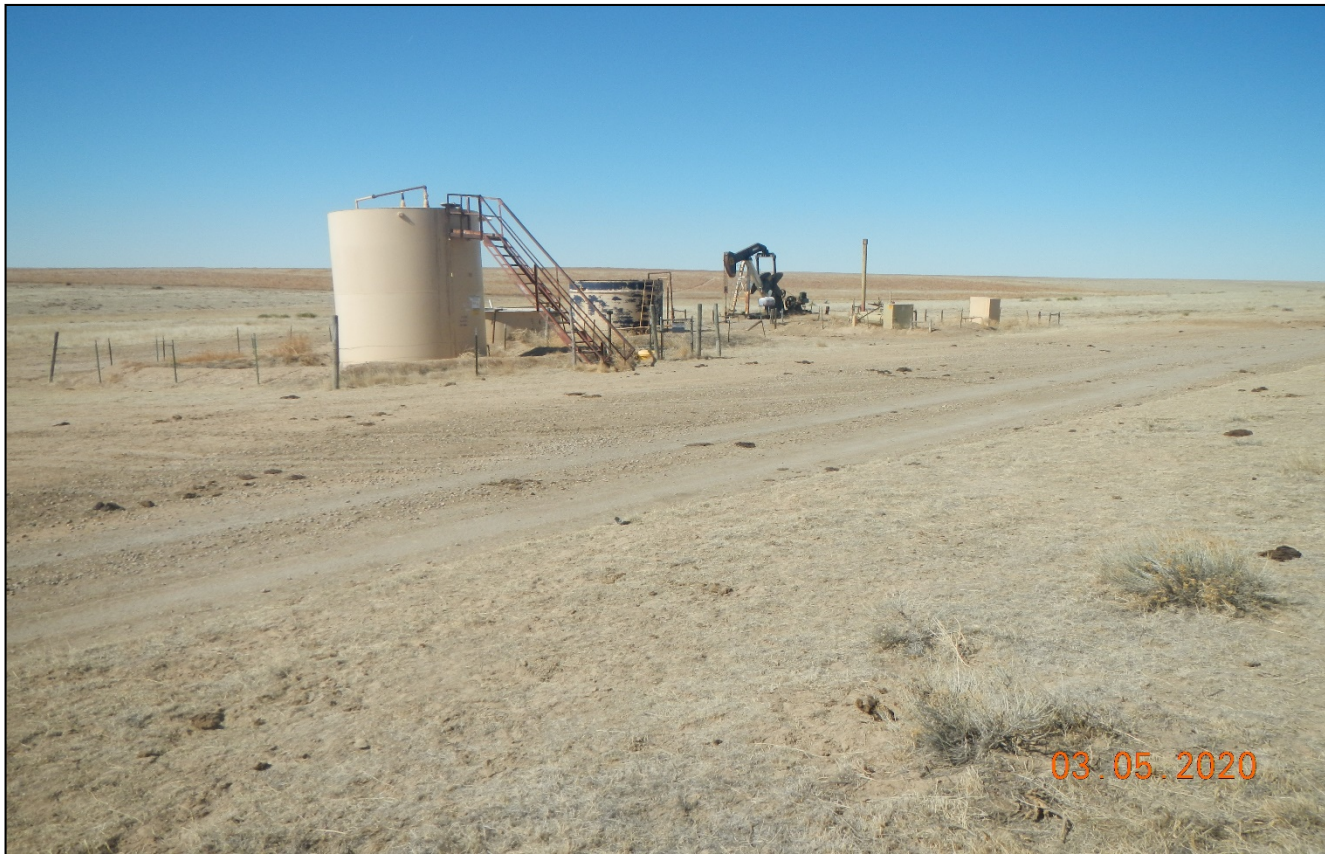
Photo 13. Facing southwest toward the tank battery and well site.
