Inspection Photos
Operator: BP America
API#: 067-05139
Date: 3/10/2020

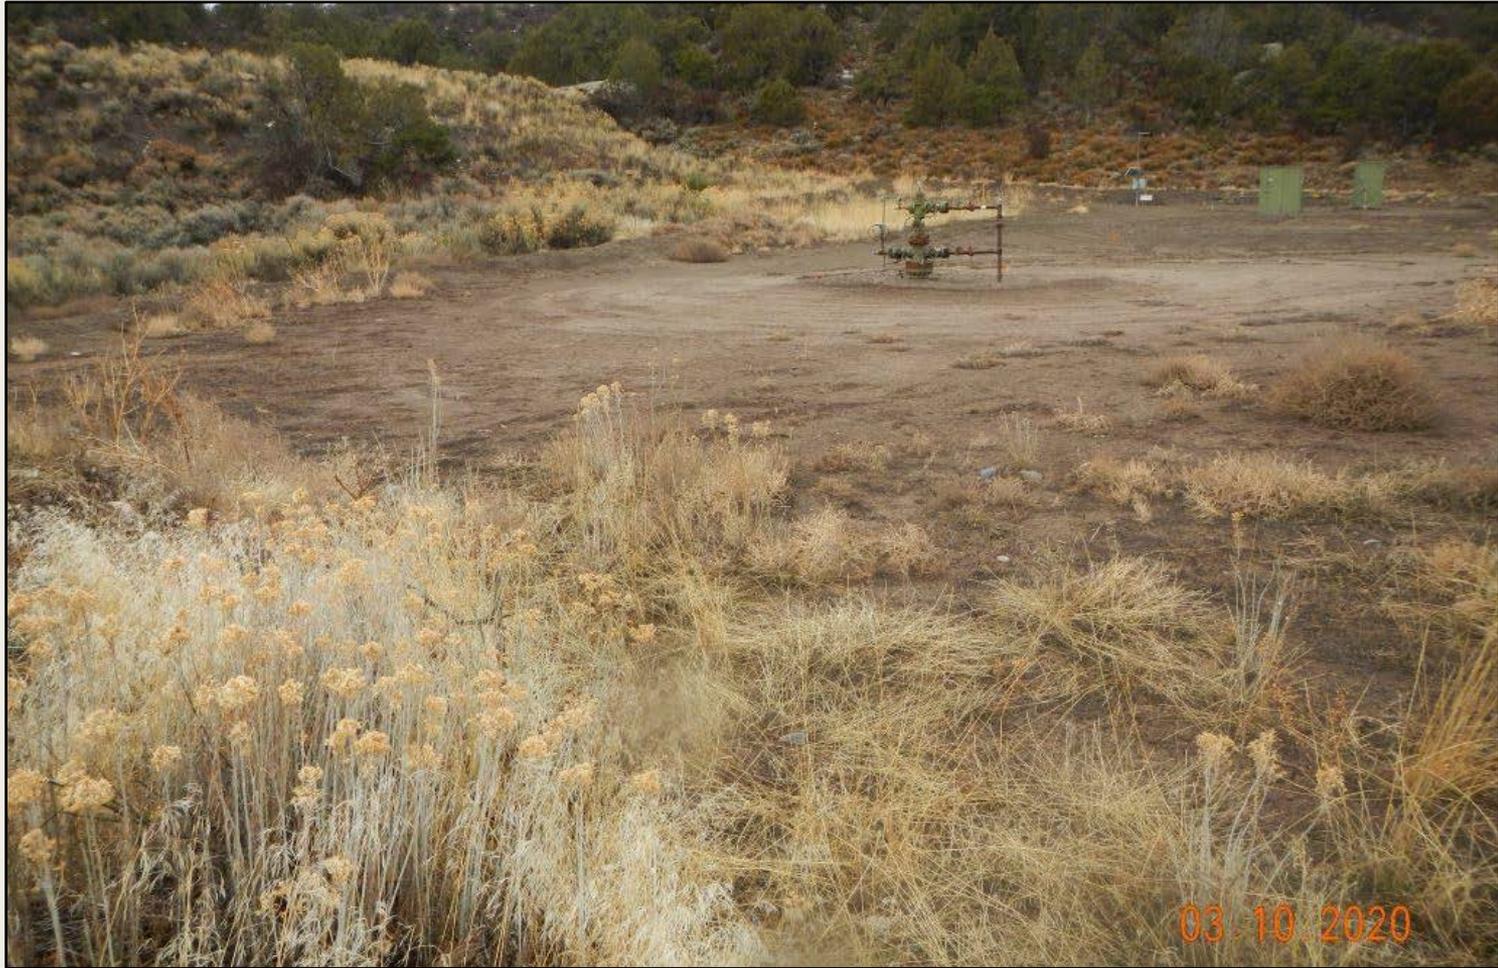
Photo 1. View of the project area from the northeastern corner facing center.

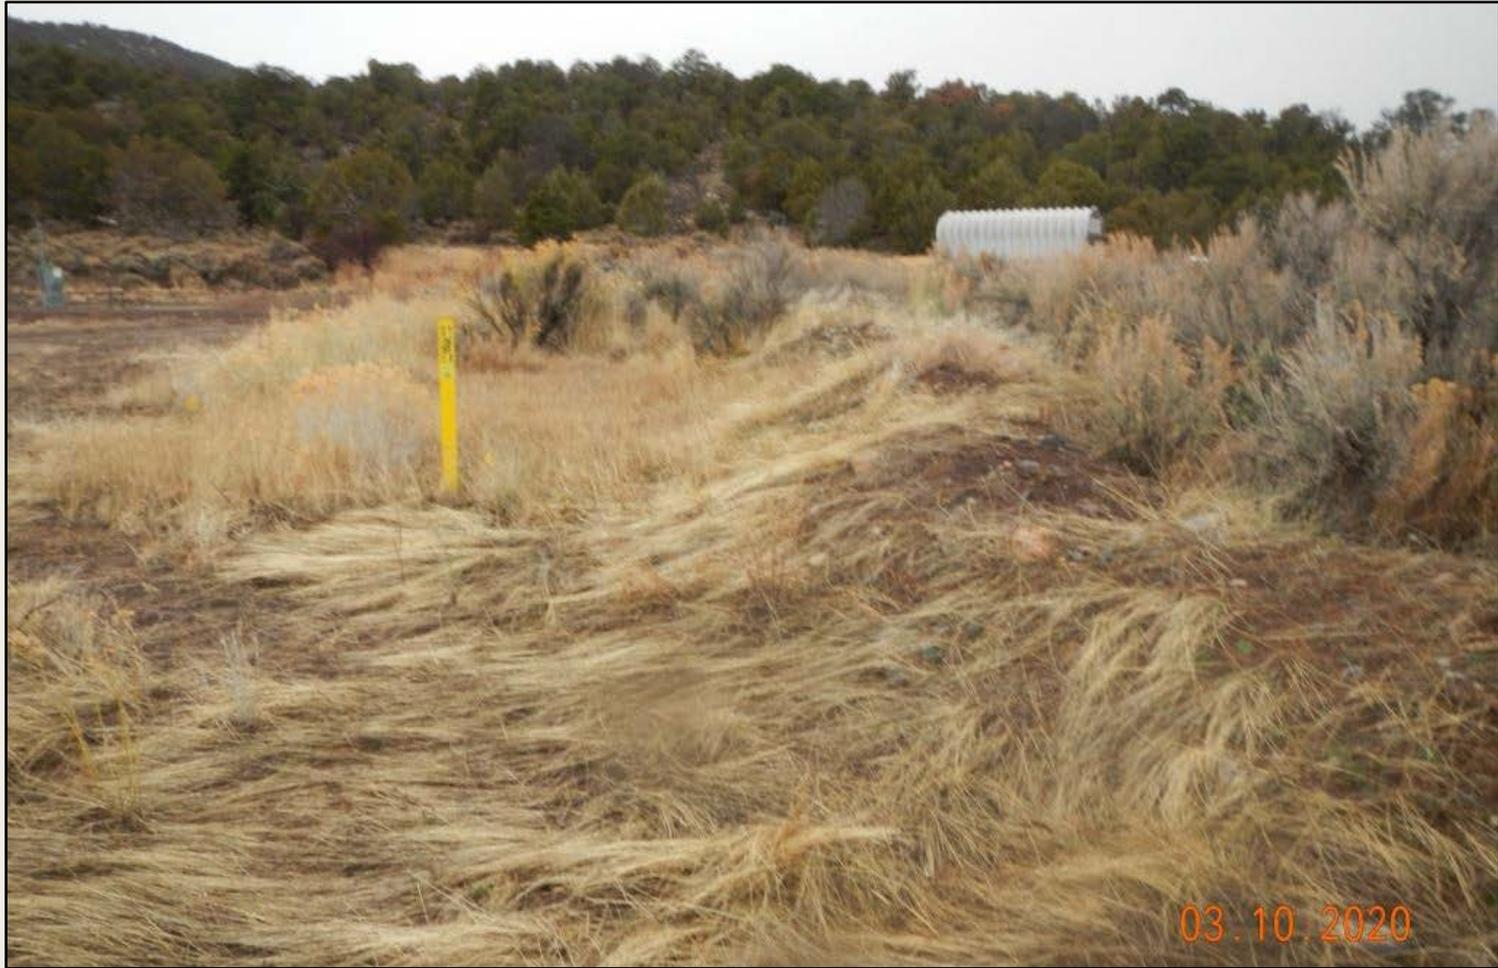
Photo 2. View of the northern project area from the northeastern corner facing northwestward. Revegetation is progressing largely with western wheatgrass and rubber rabbitbrush.

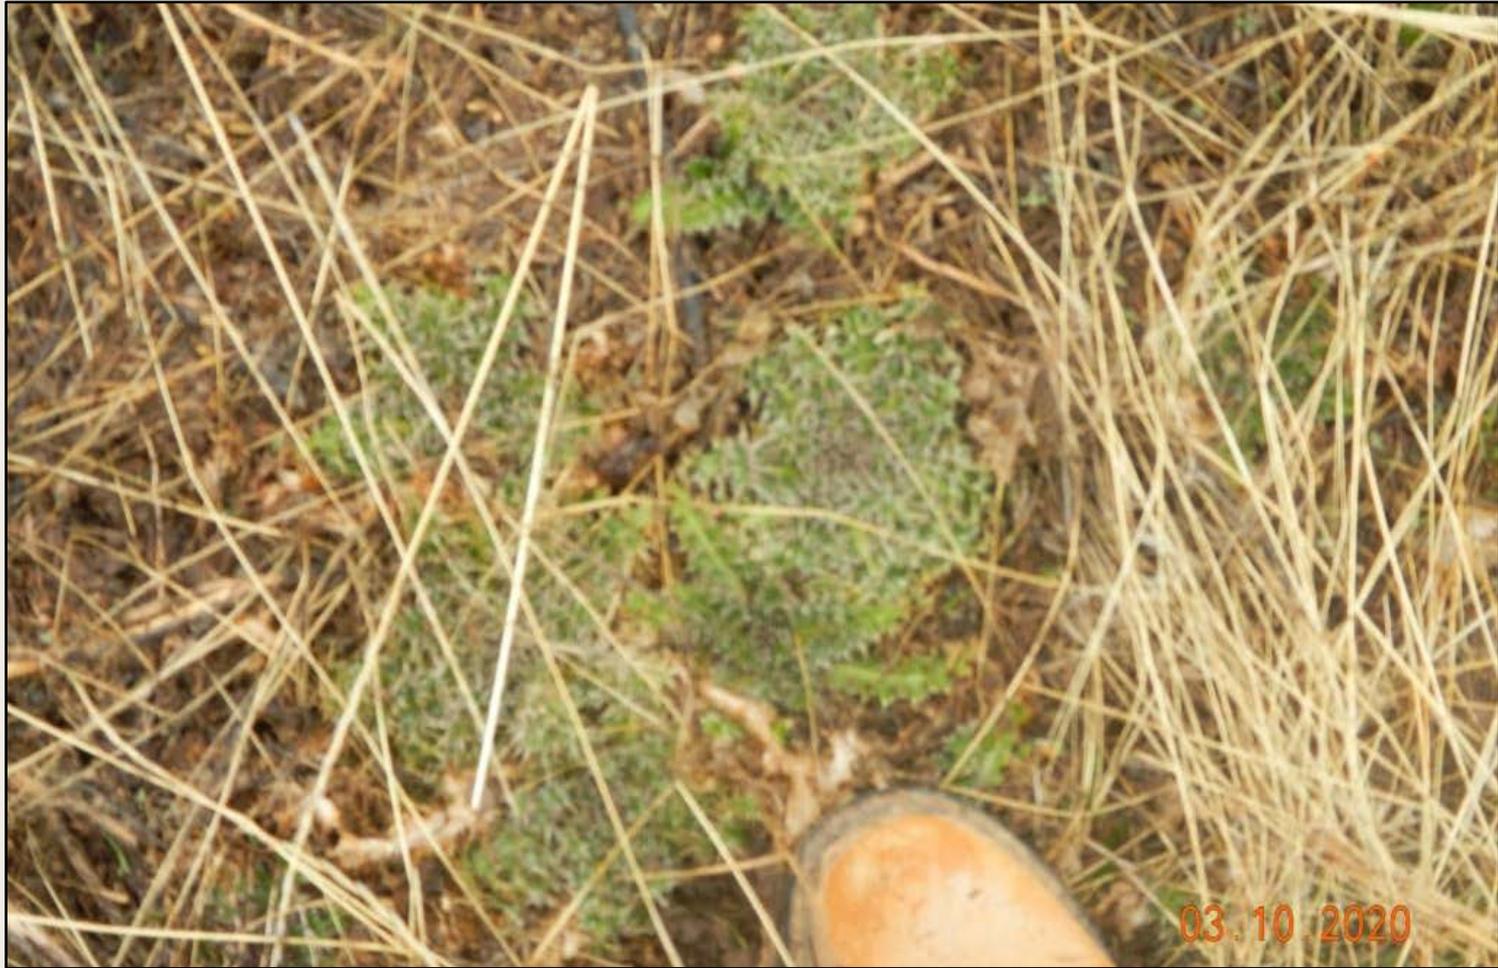
Photo 3. View of dense musk thistle rosettes within the project area.

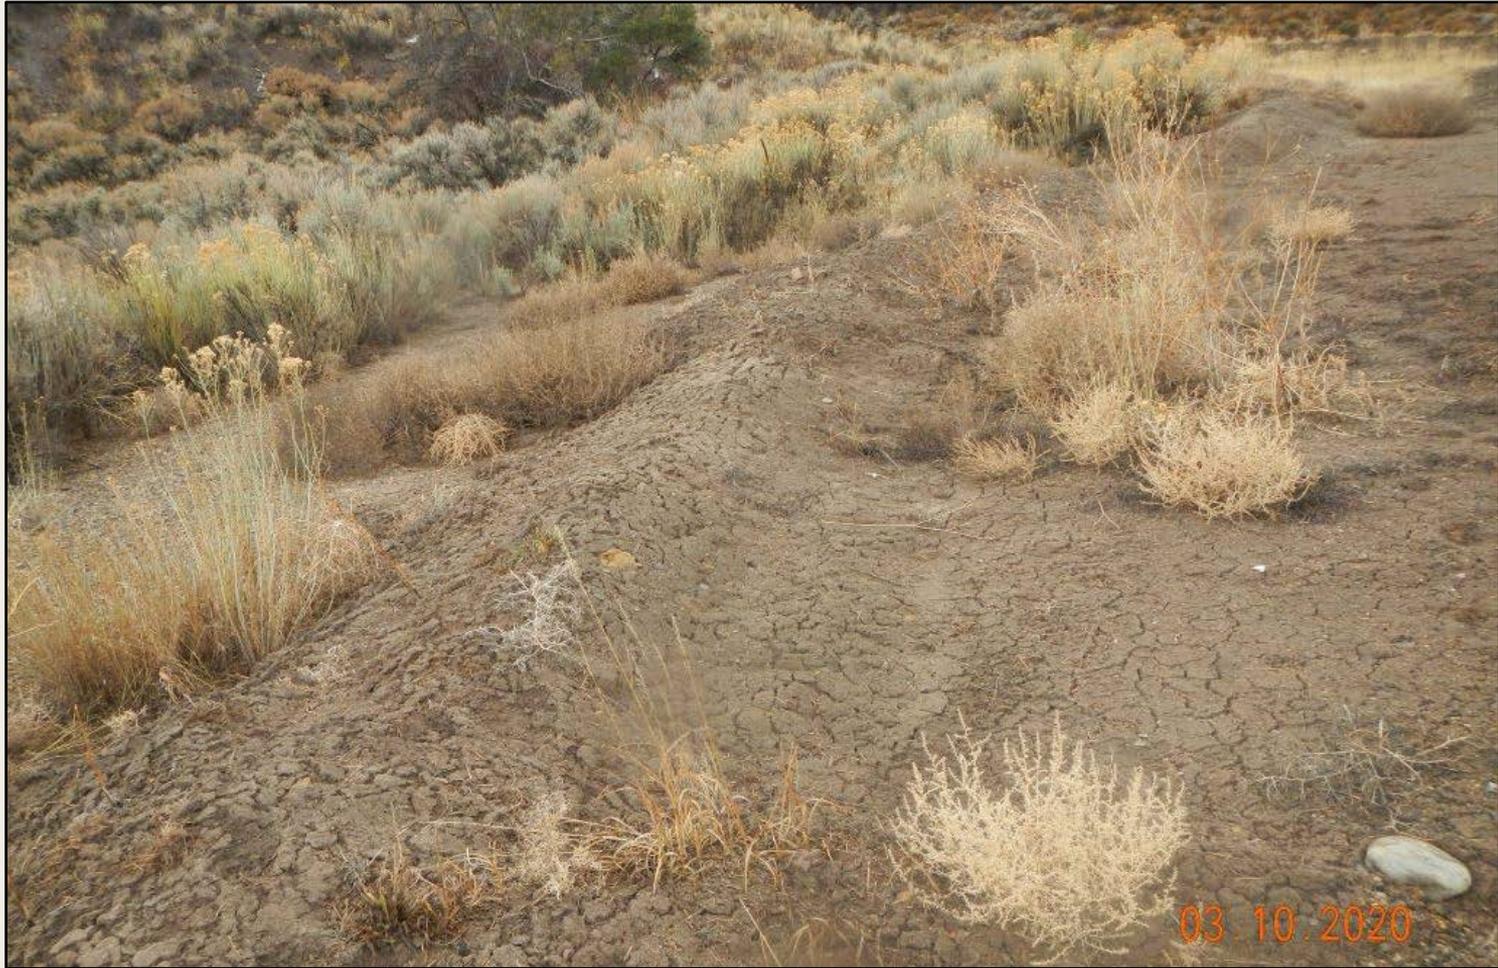
Photo 4. View of berm along the southern edge of the working area that remains unstabilized.

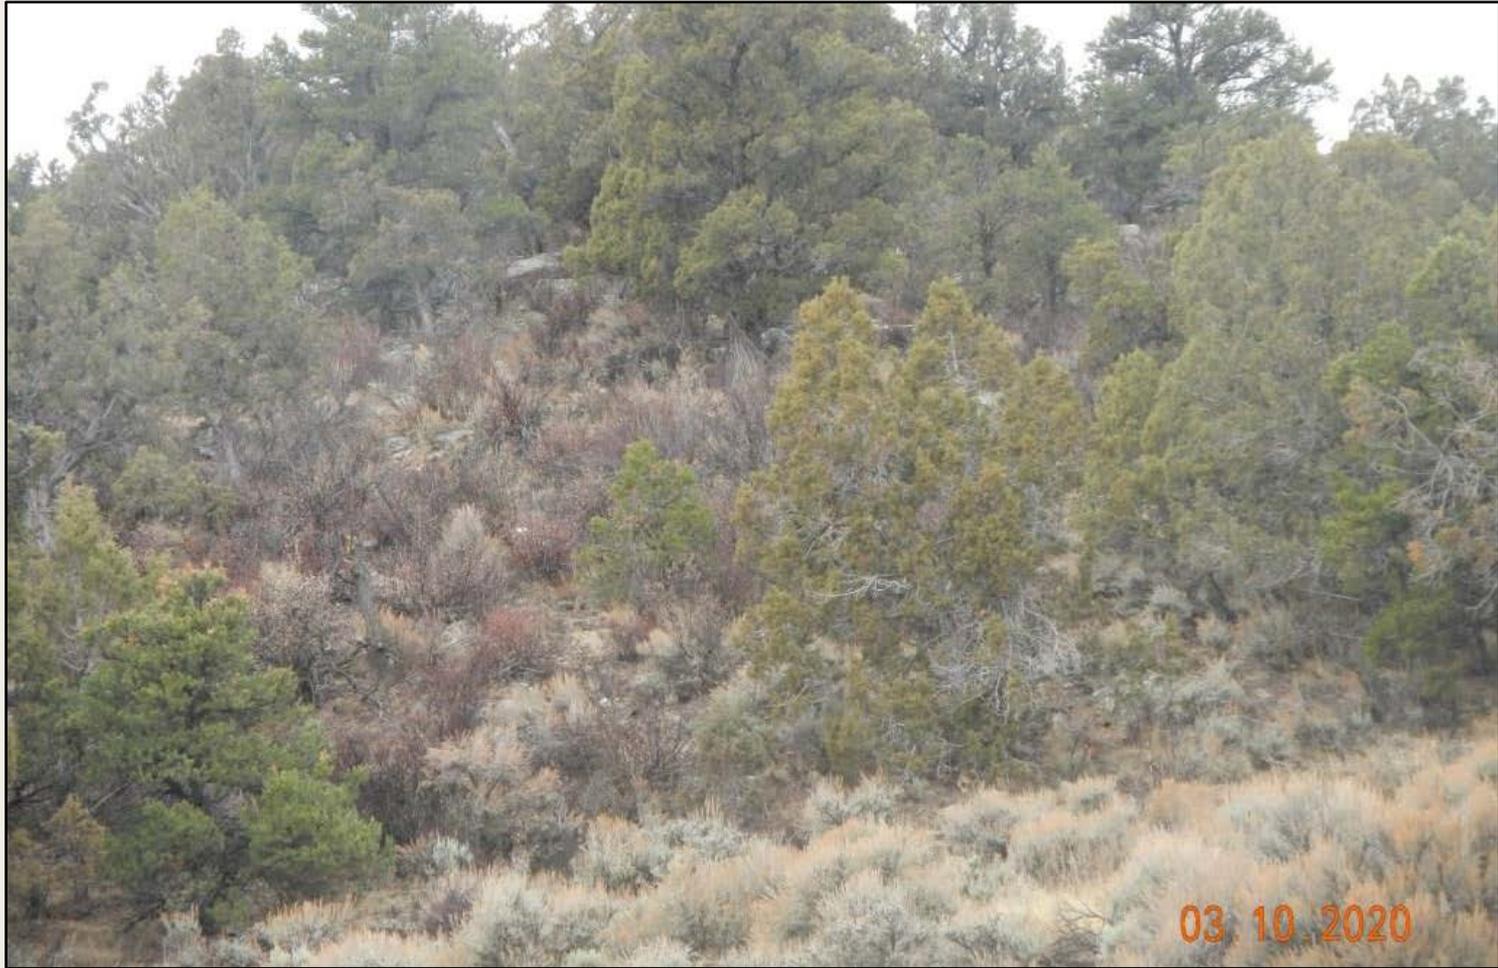
Photo 5. View of reference area vegetation comprised of pinyon juniper woodland, with shrubby understory comprised of sagebrush and mountain mahogany.
